COGCC Environmental Field Inspection Report Photo Attachment

Inspection Date: July 18, 2017

Steven J. Arauza, P.G.

COGCC Environmental Protection Specialist

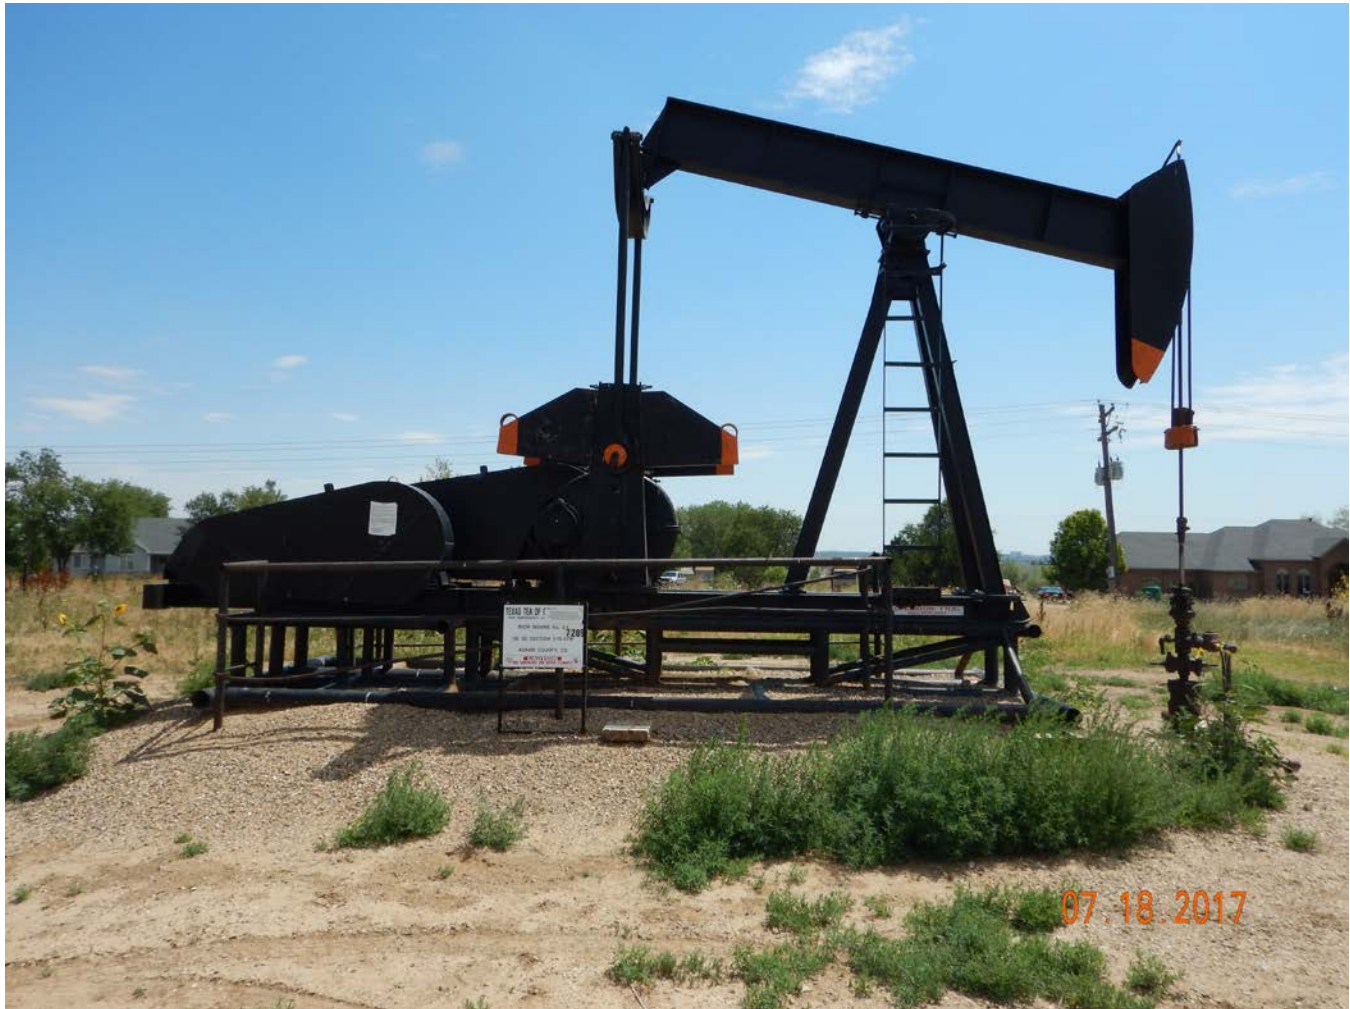
*Photo 1- Wellhead sign, wellhead, and pumping unit.*

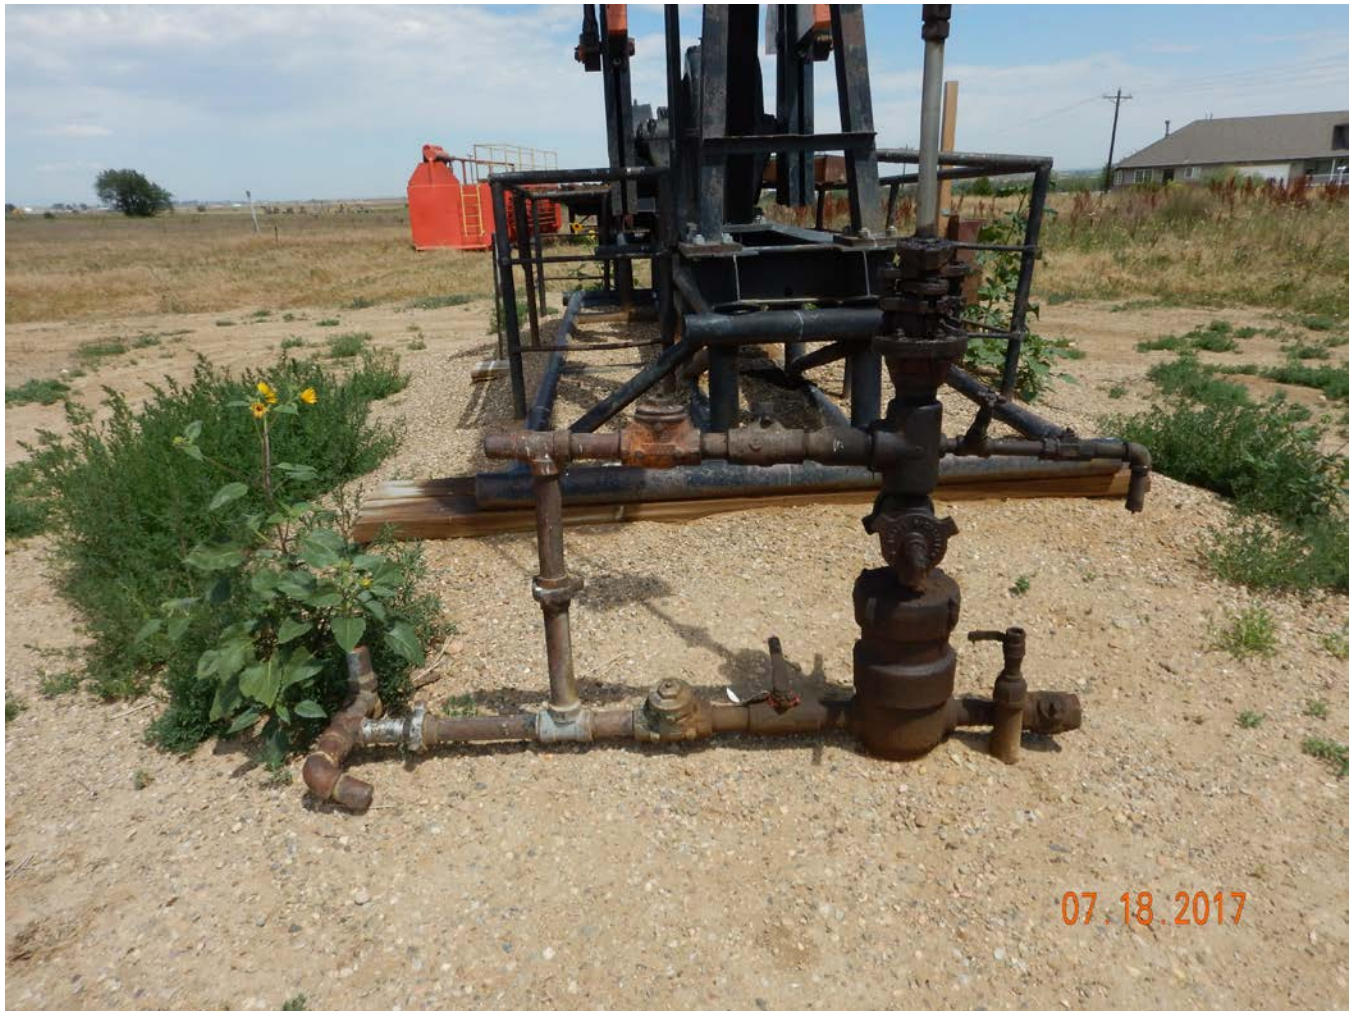
*Photo 2 – Localized, oil stains on wellhead equipment, note COGCC tag with instructions not to operate remains attached.*

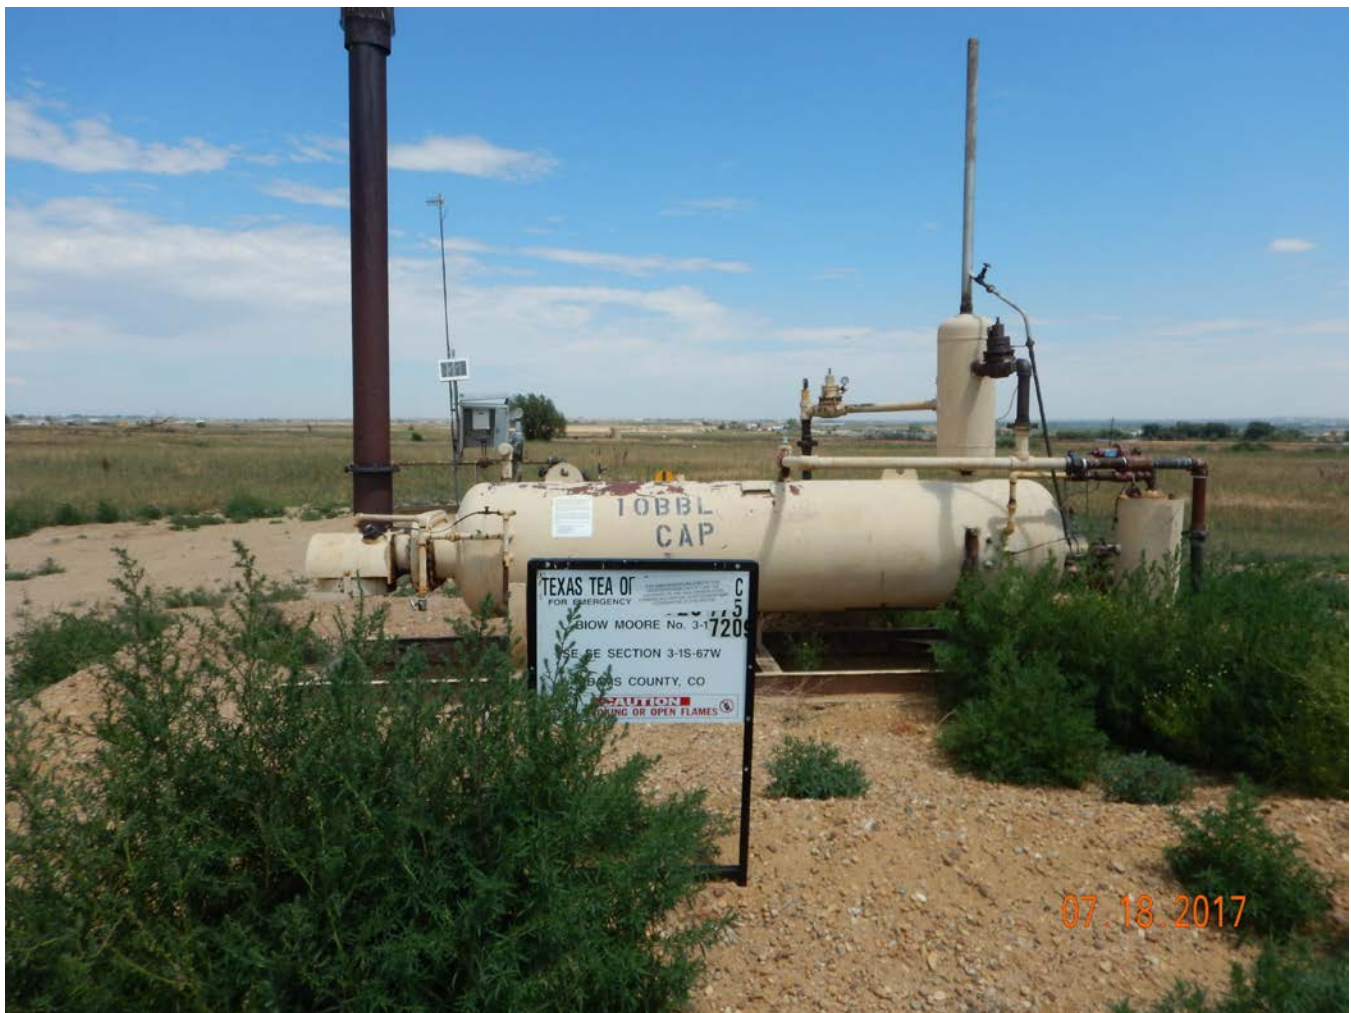
*Photo 3 - Weed growth at separator.*

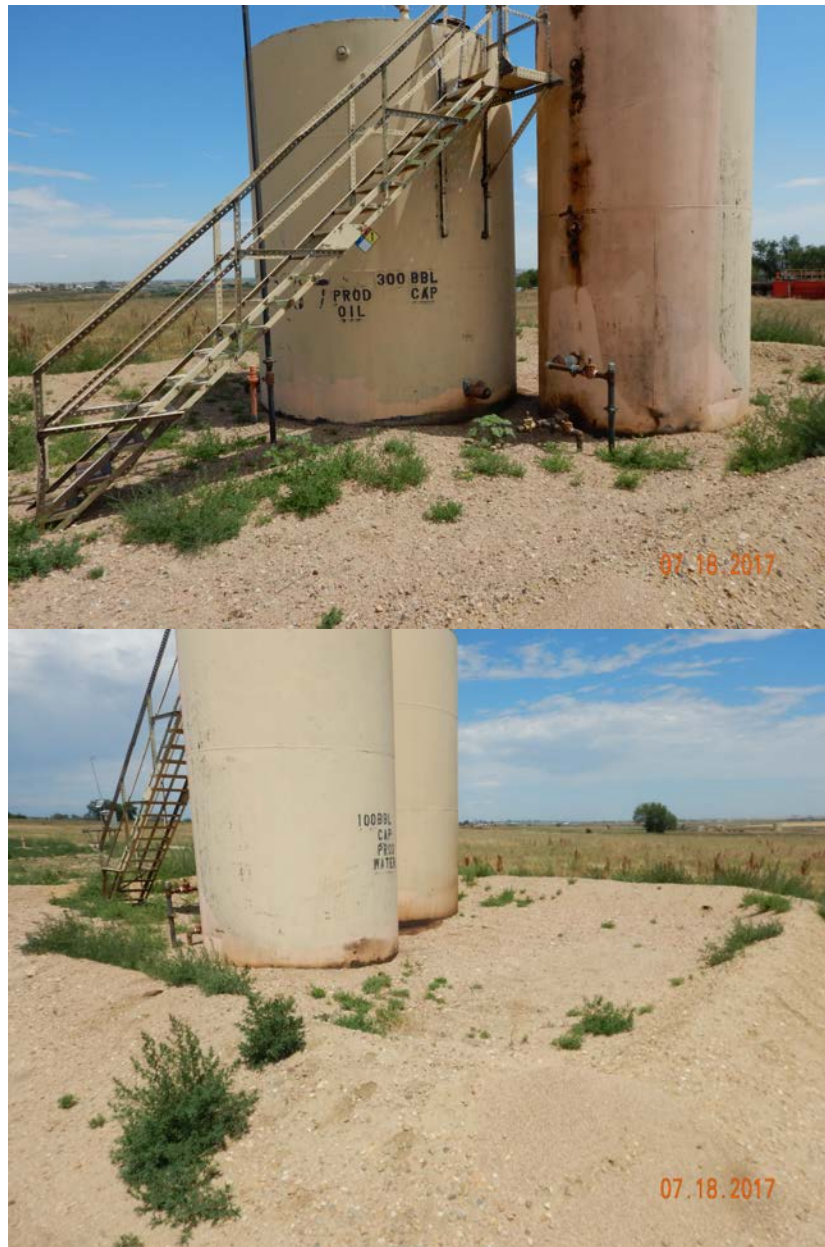
*Photos 4 & 5- Tank battery with earthen berm, note fluorescent paint on abandoned flowline riser beside crude oil AST (top).*

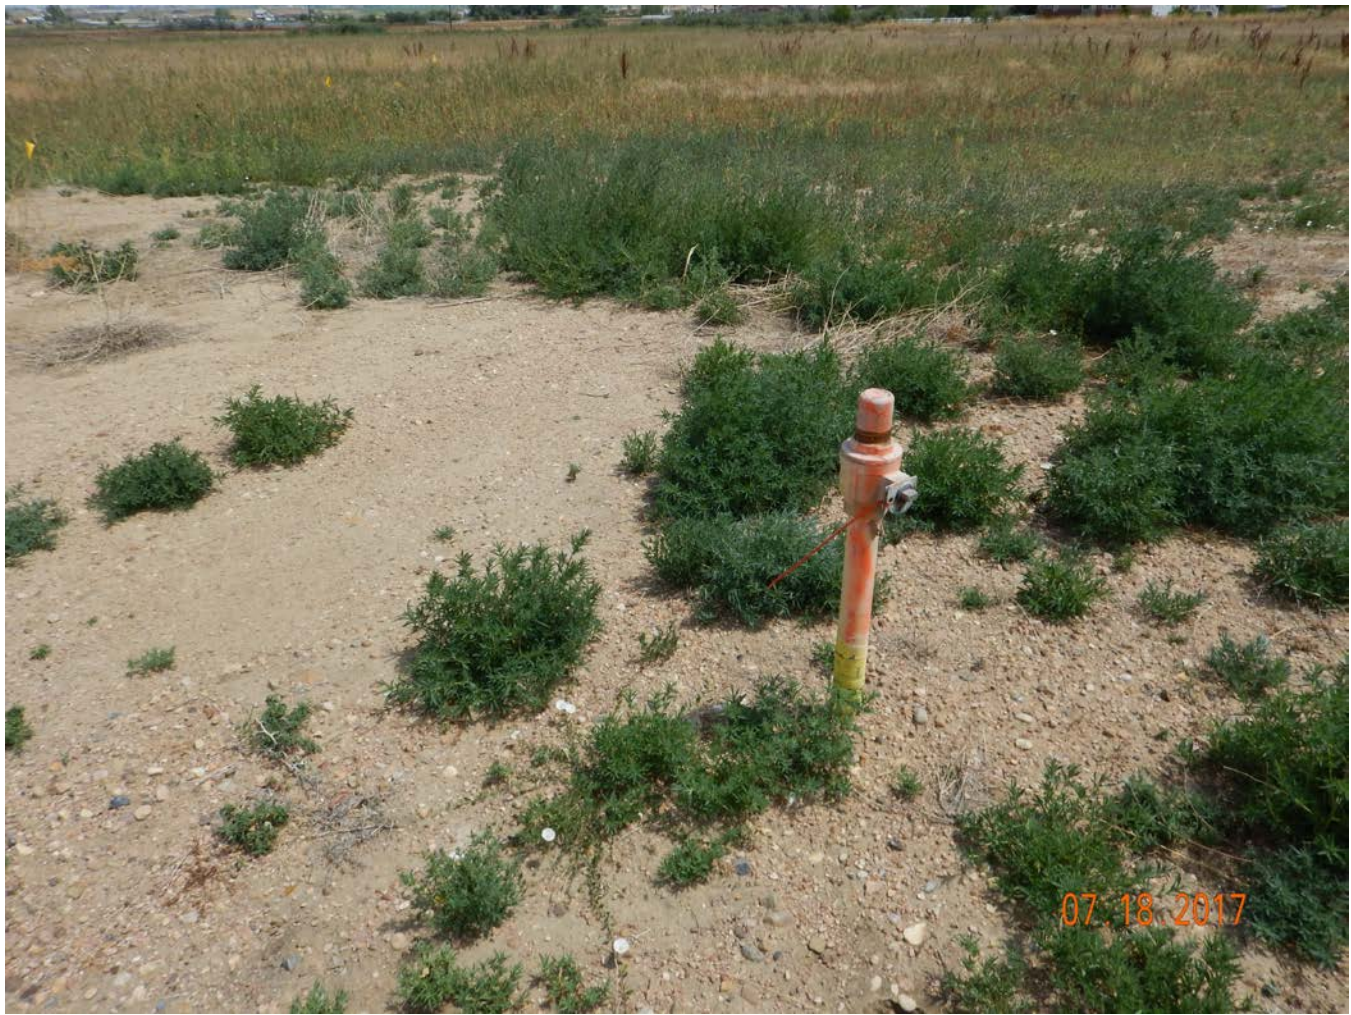
*Photo 6 - Abandoned flowline riser, painted and tagged to comply with Flowline NTO.*

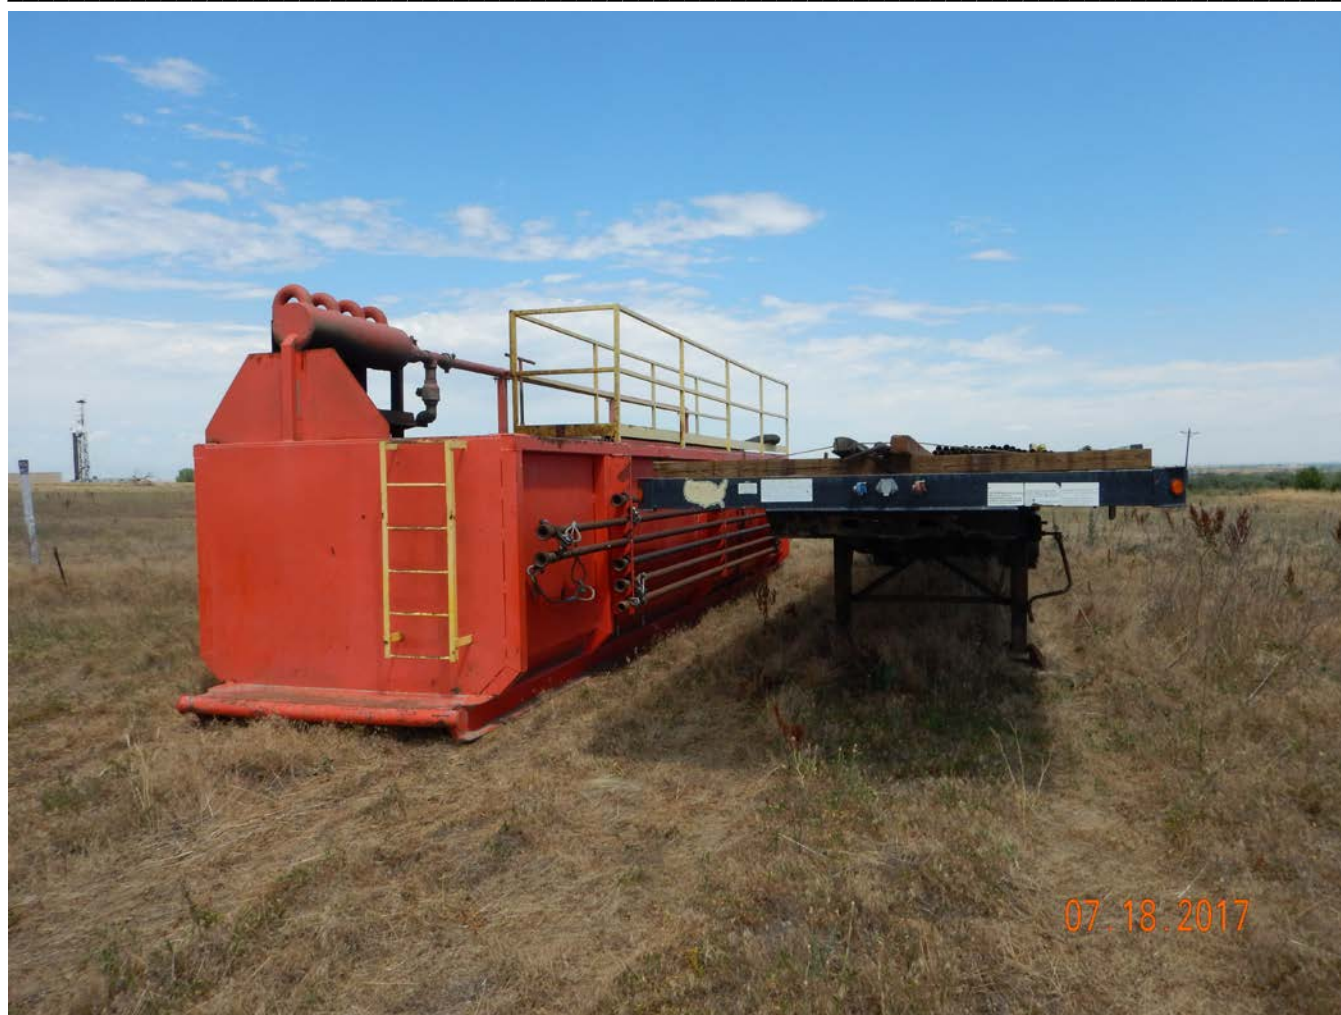
*Photo 7 – Frac tank and pipe trailer north of pump jack.*
