COGCC Environmental Field Inspection Report Photo Attachment

Inspection Date: **July 18, 2017**

Steven J. Arauza, P.G.

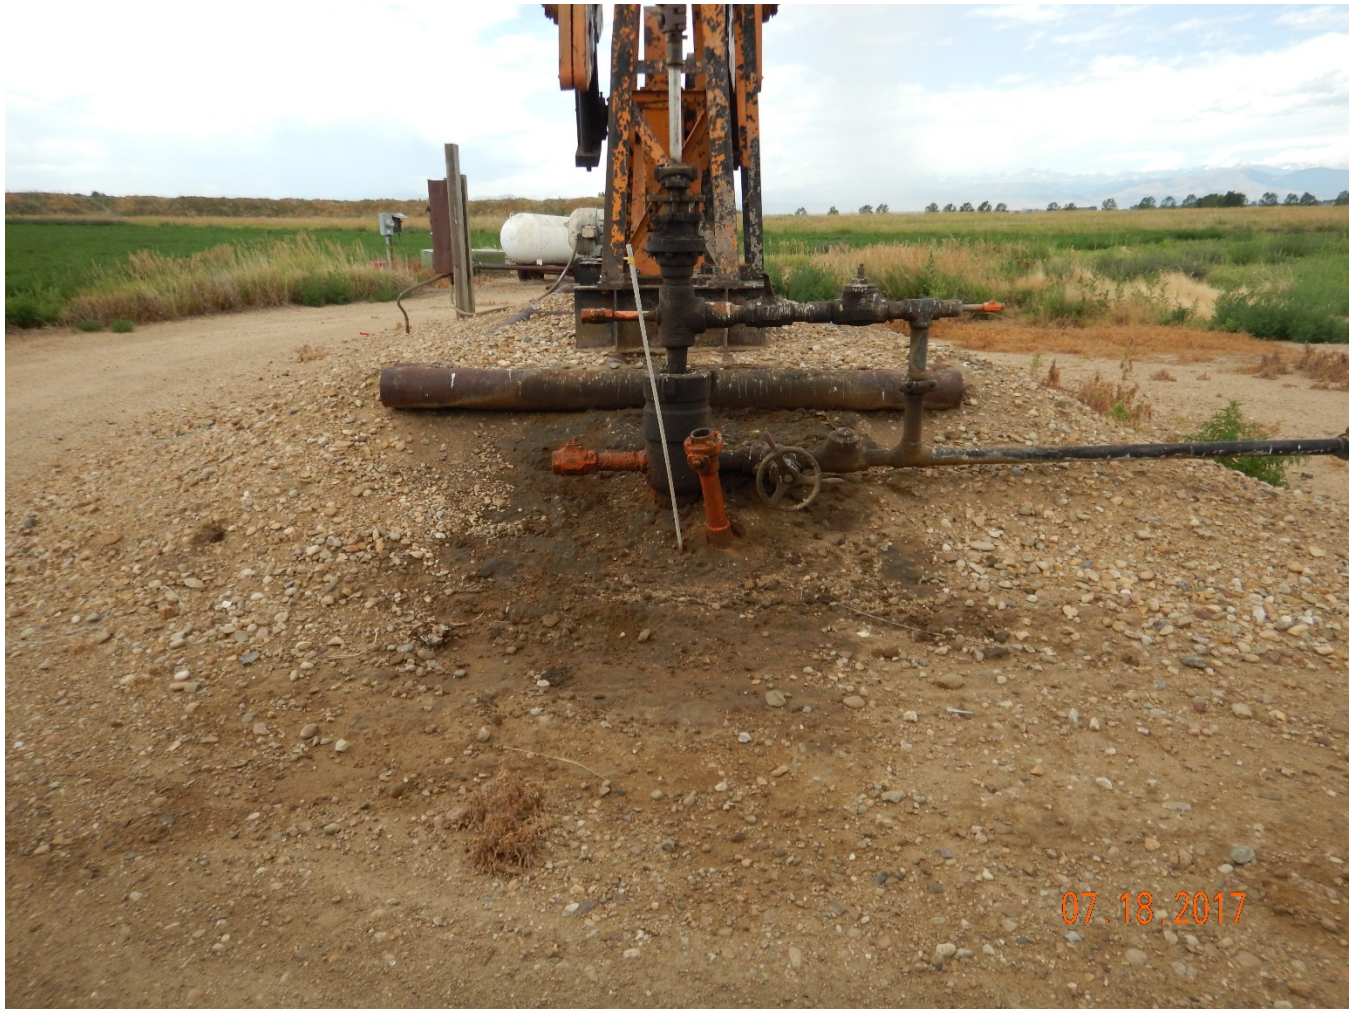
Figure 1 – Oil-stained soil, uncapped equipment, and flowline risers at wellhead. Note: Trailer, electrical boxes, and additional junk in background.

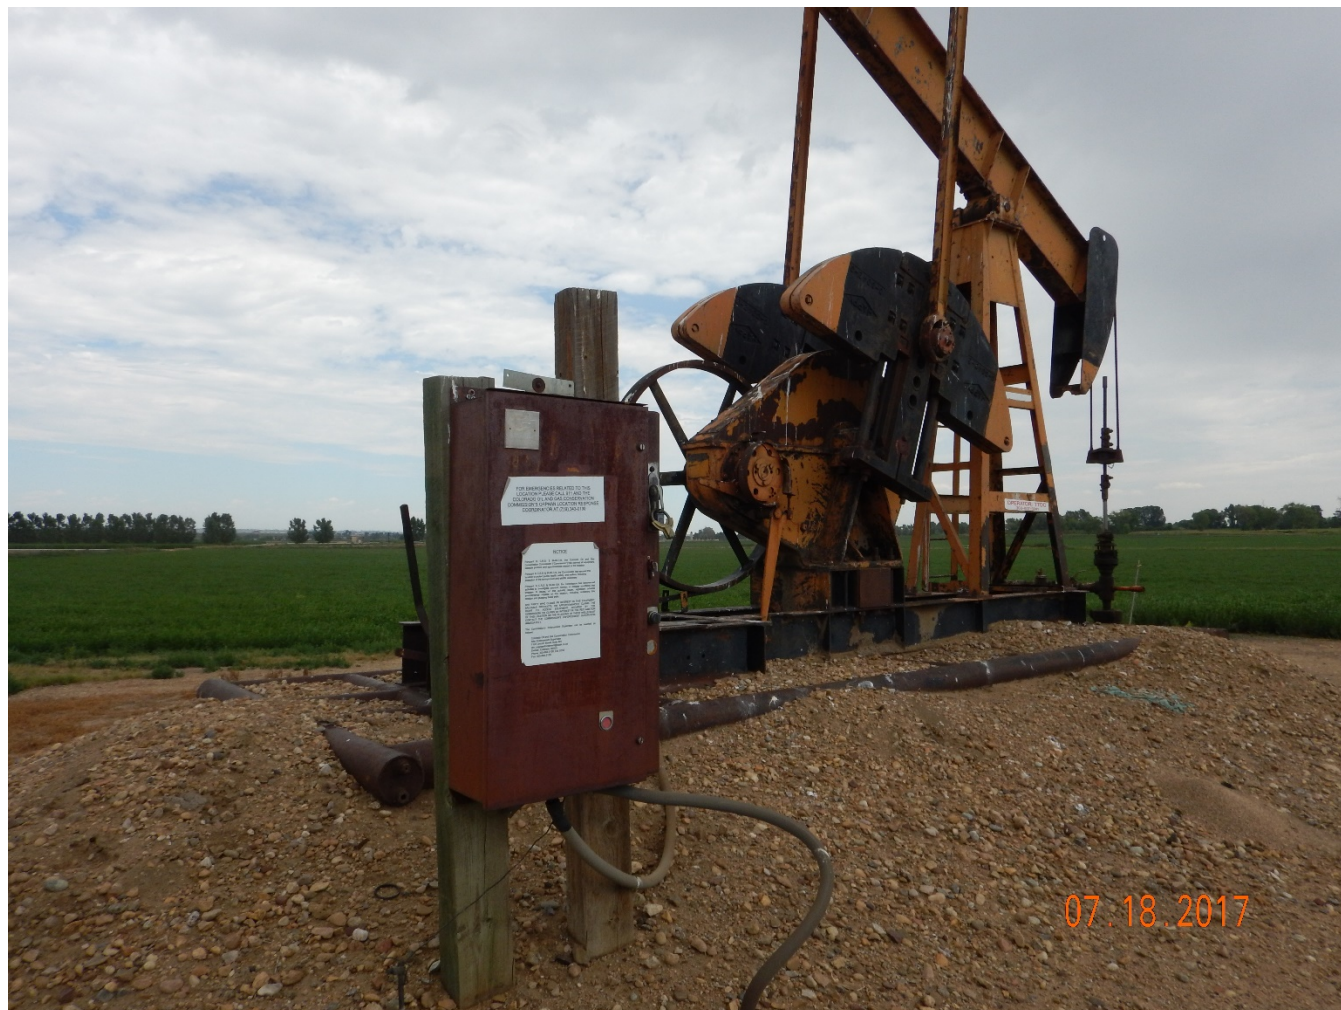
Figure 2 - COGCC emergency contact information affixed to electrical control panel.

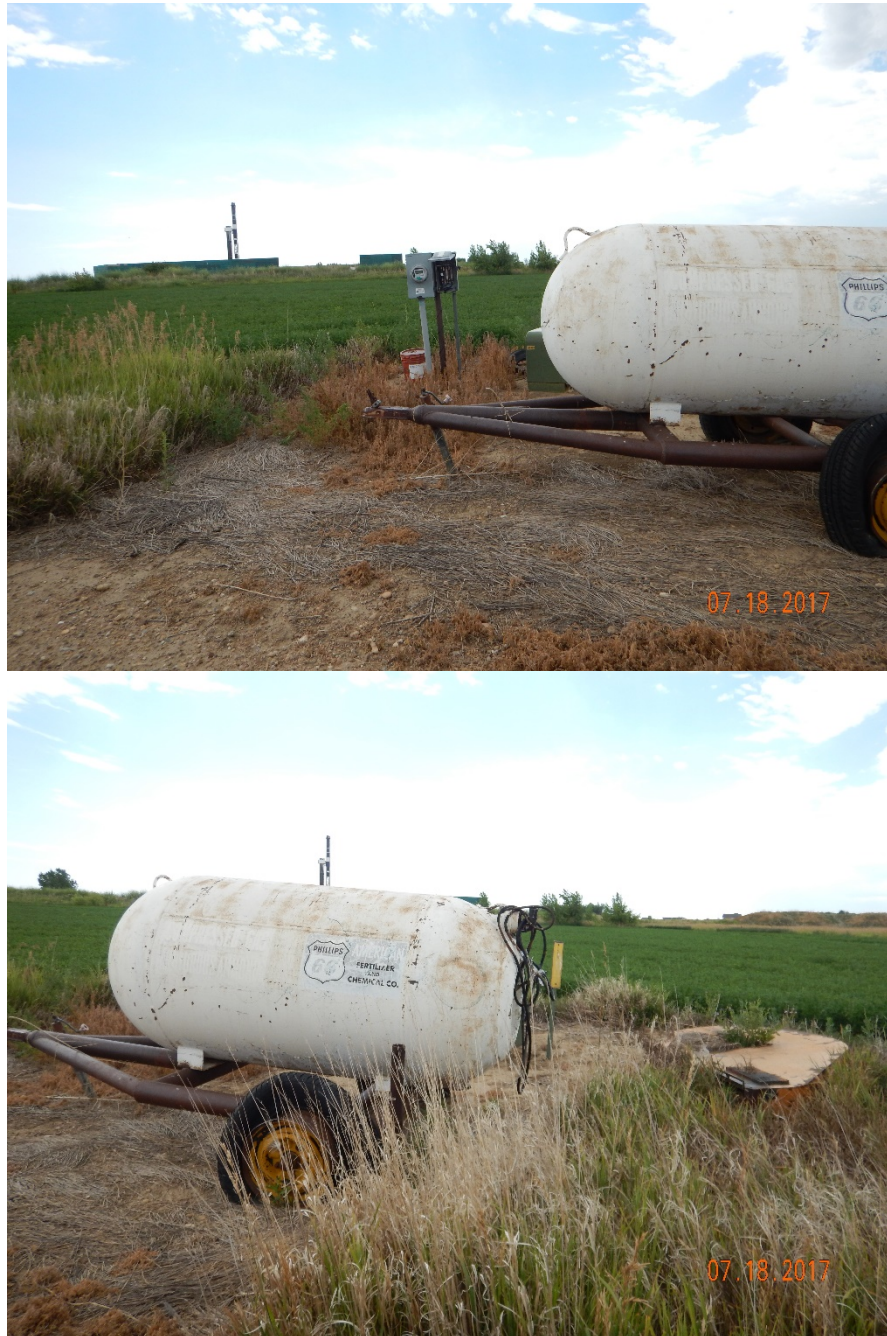
Figure 3 - Electrical boxes, transformers, ammonia tank, motor oil bucket, and metal panel (debris) southwest of pumping unit.

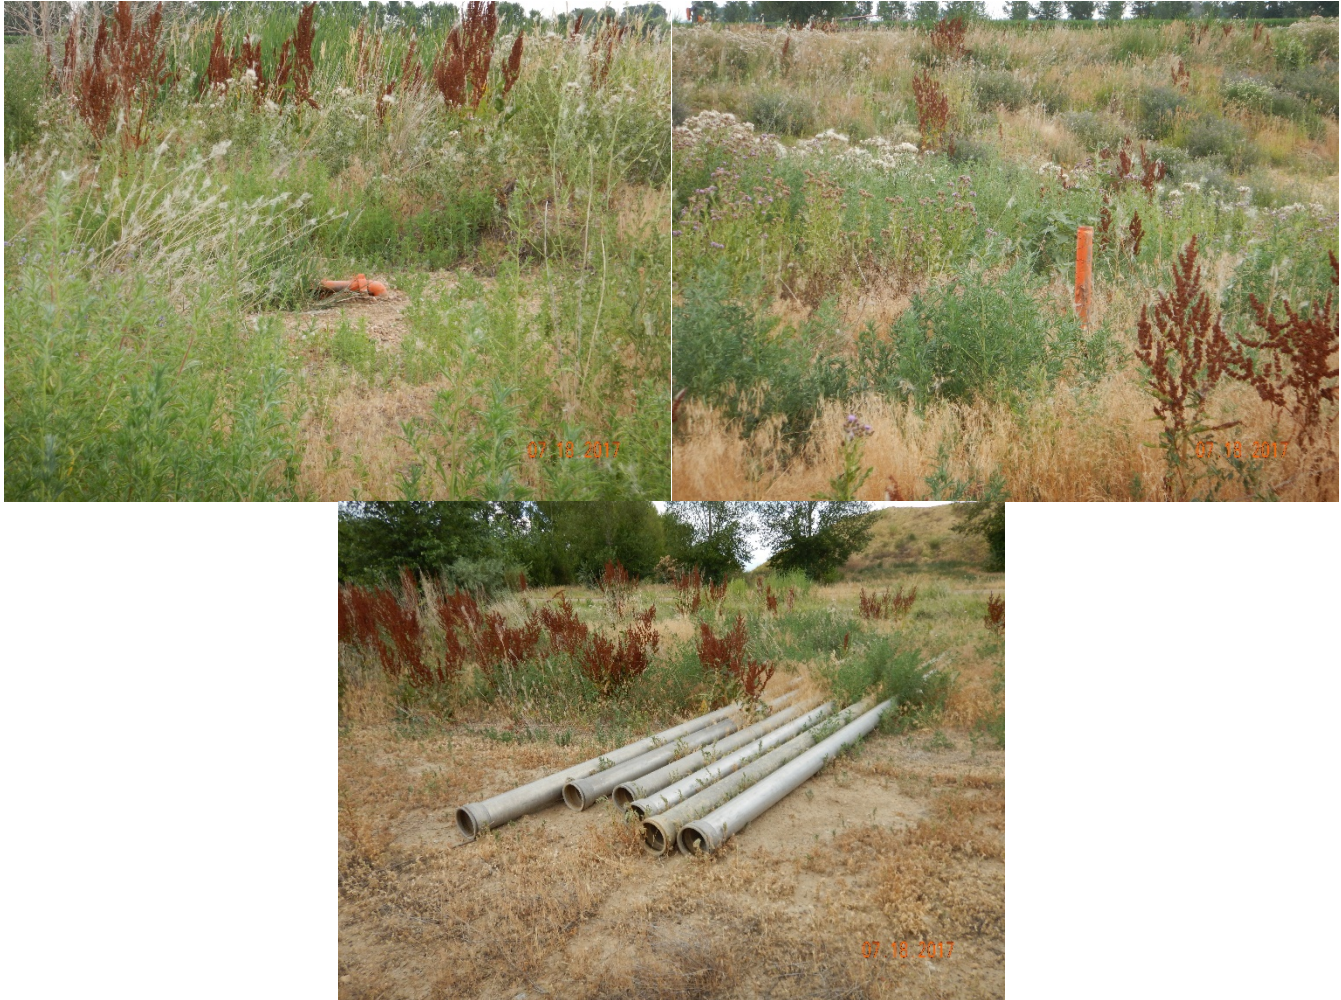
Figure 4 - Abandoned flowline risers (top) and unused pipe (bottom) at former tank battery.
