July 20, 2017 COGCC Environmental Field Inspection of DIVERSIFIED ENERGY LLC (Diversified)  
Bingham Location ID: 313094.

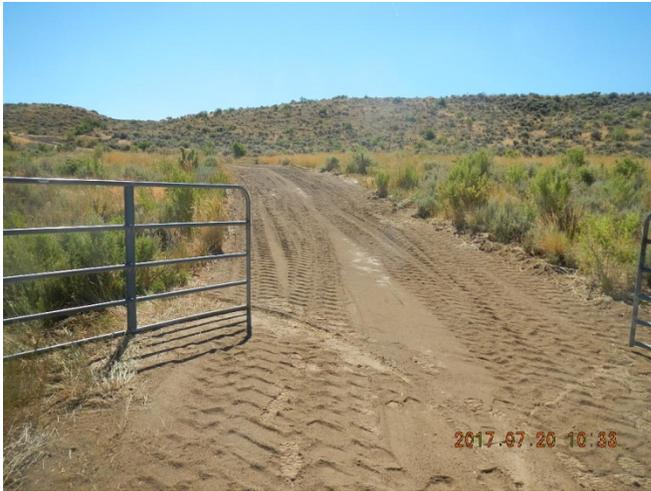
View looking up lease road (recent grading).

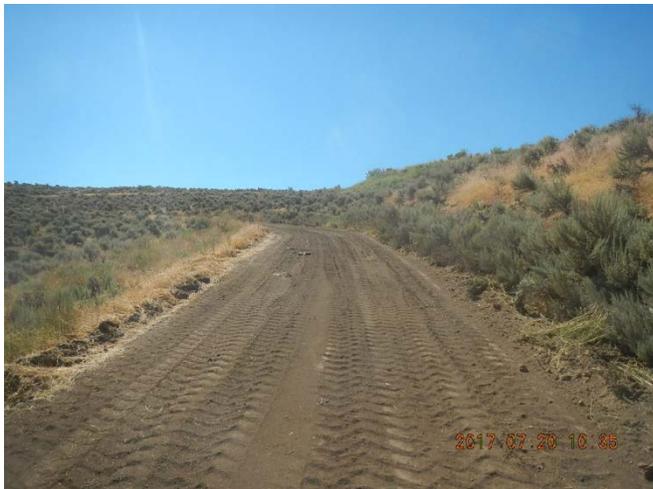
Plastic liner incorporated in recent grading throughout lease road.

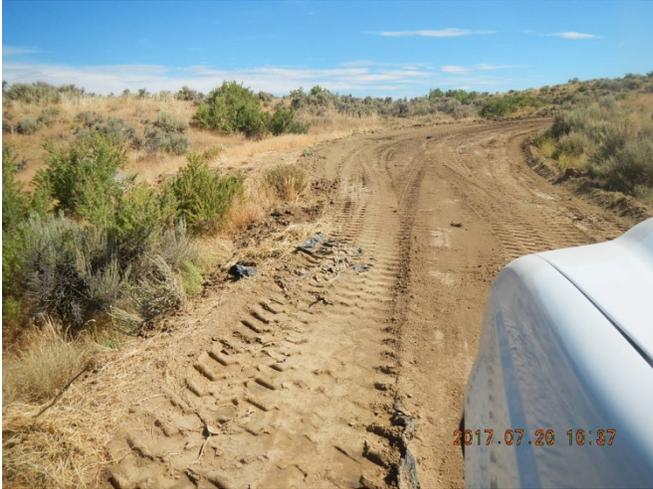
throughout lease road.

Plastic liner incorporated in recent grading

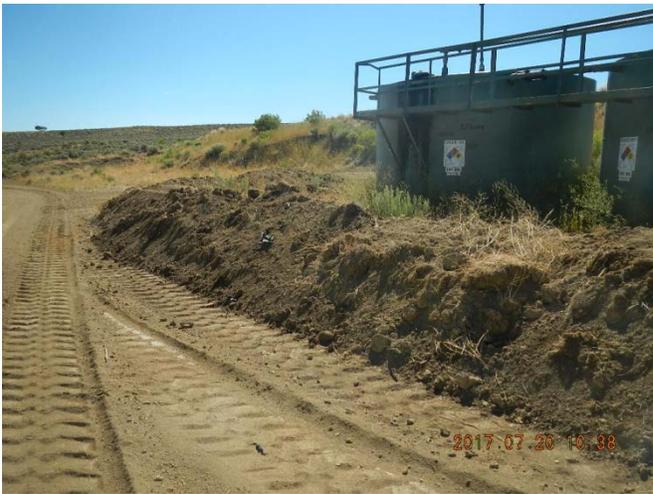
dirt work.

Plastic liner incorporated in tank berm from recent

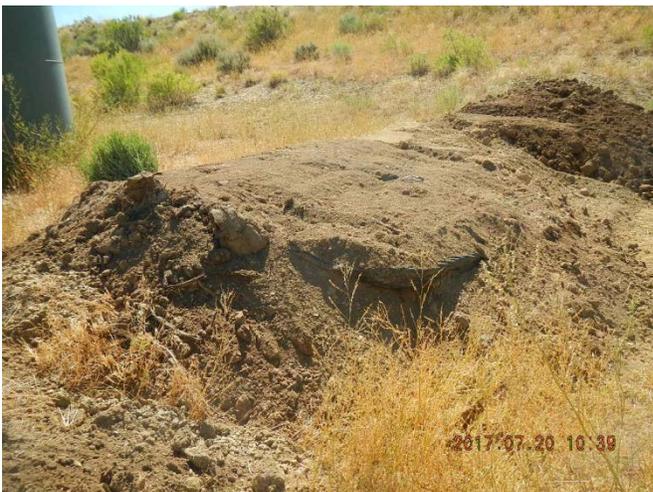
dirt work.

Plastic liner incorporated in tank berm from recent

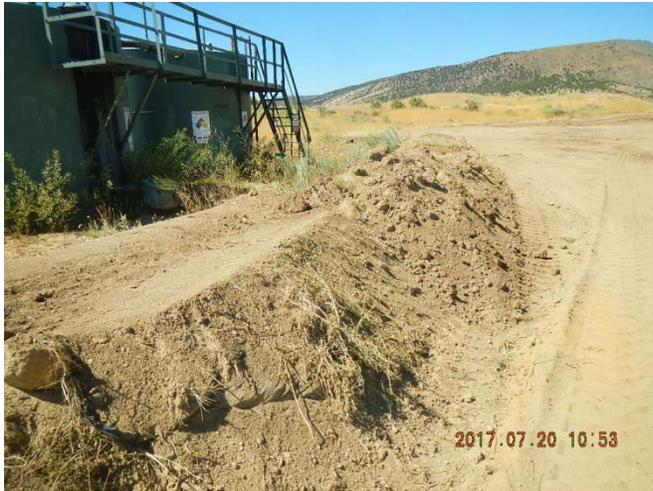
dirt work.

Plastic liner incorporated in tank berm from recent

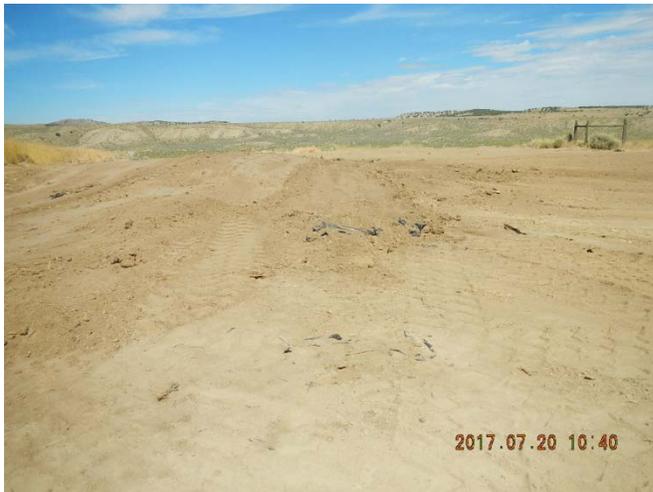
Treatment area.

Plastic liner incorporated in material in former Land

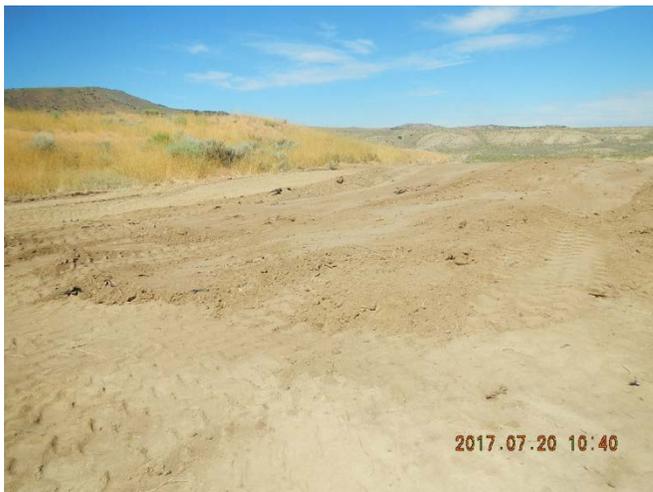
Treatment area.

Plastic liner incorporated in material in former Land

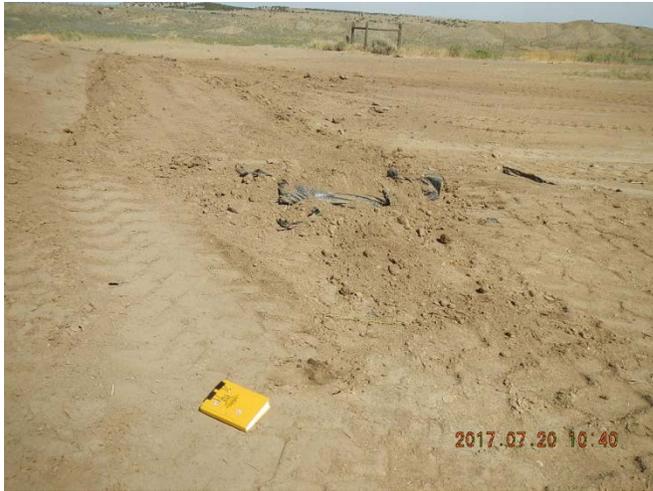
treatment area.

Appears to be oily stained material in former Land

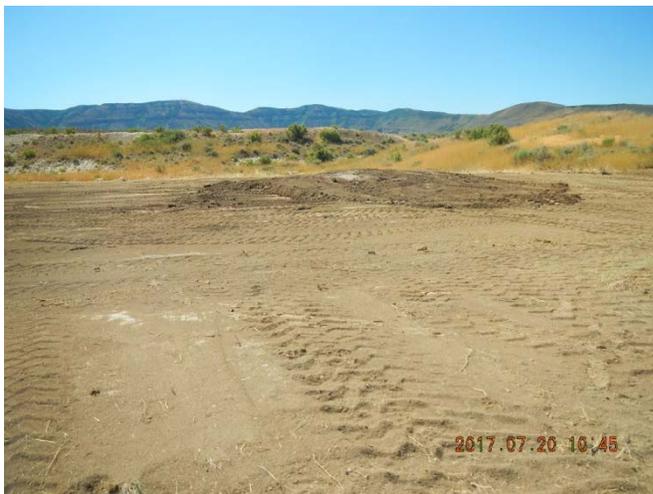
Former Land treatment area (plastic liner pieces).

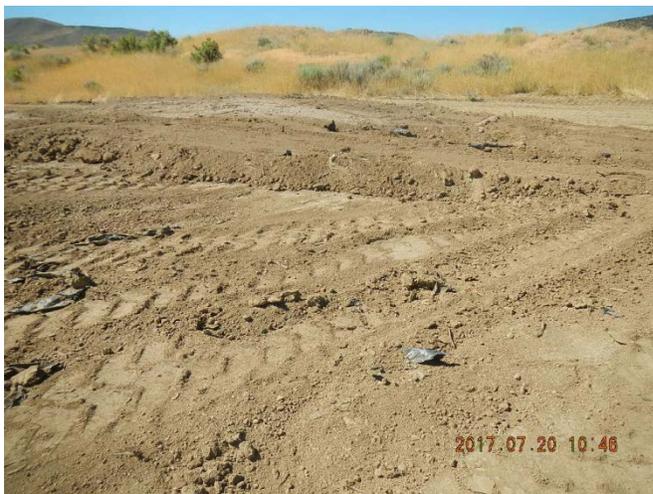
Former Land treatment area (plastic liner pieces).

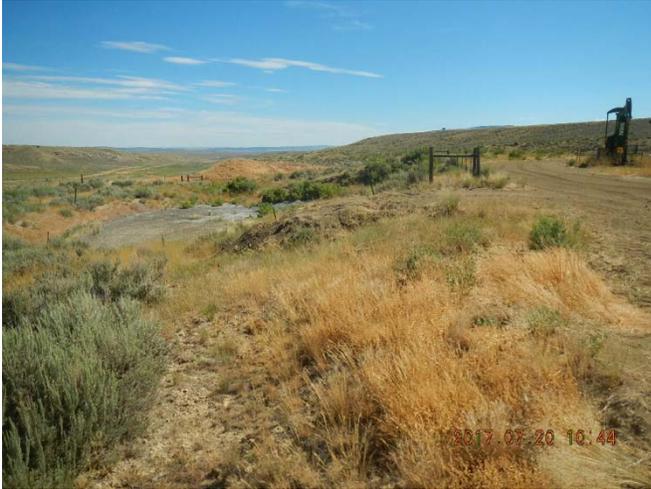
Material appears to be pushed off of Location.

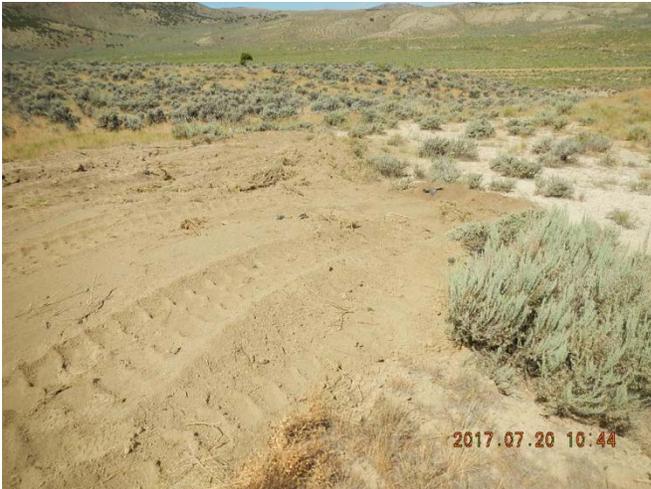
Plastic liner in material pushed off of Location.

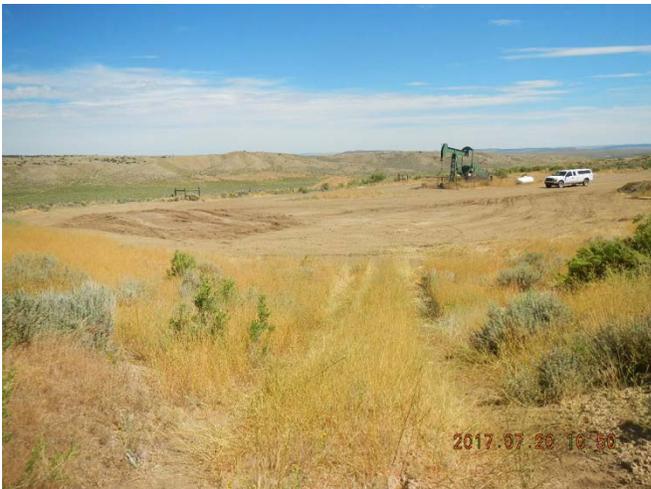
Looking east across Location.

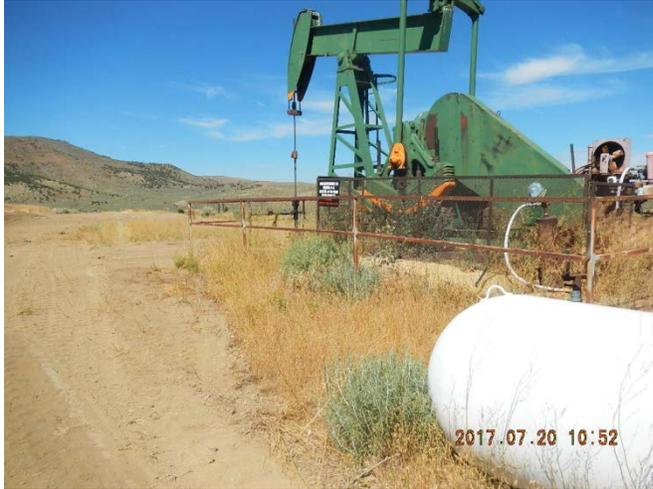
Bingham 1-14 well (vegetation).

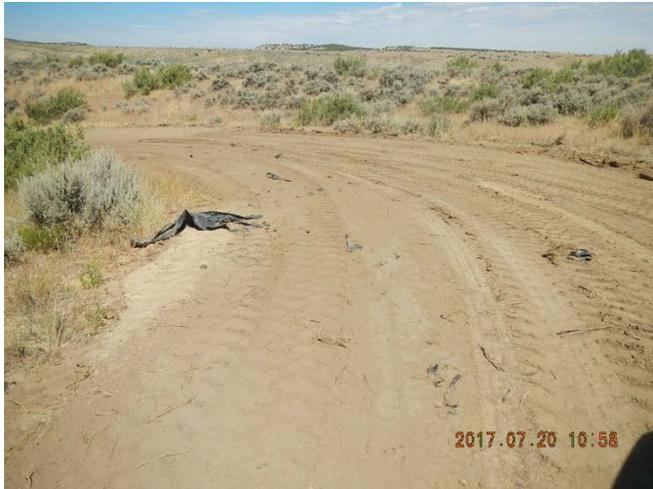
Plastic liner incorporated in recent grading throughout lease road.

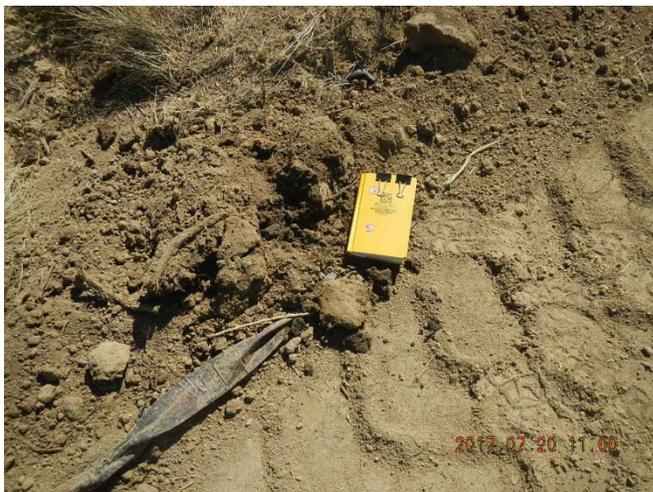
Appears to be oily material (hydrocarbon odor present) and plastic liner in recent grading on lease road.
