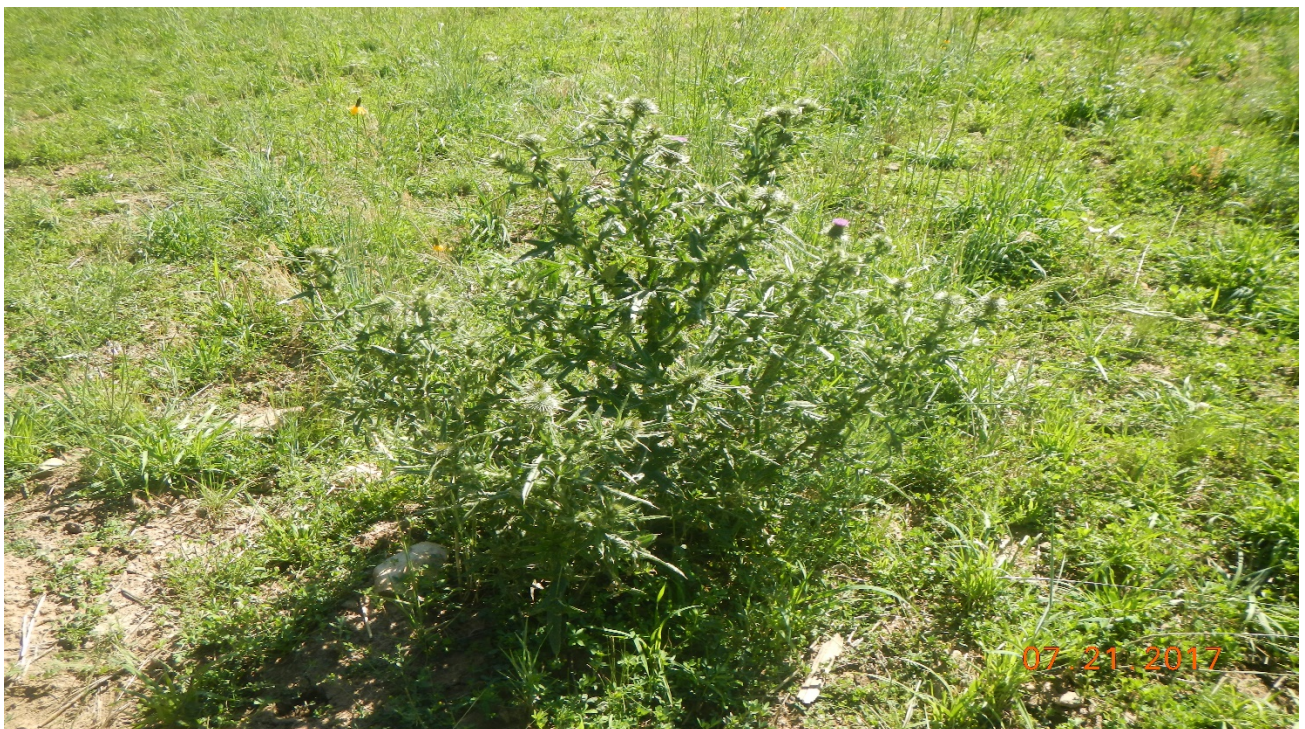
**photo 6:** There is List B noxious weeds (Bull thistle) at the northwest side of the location.

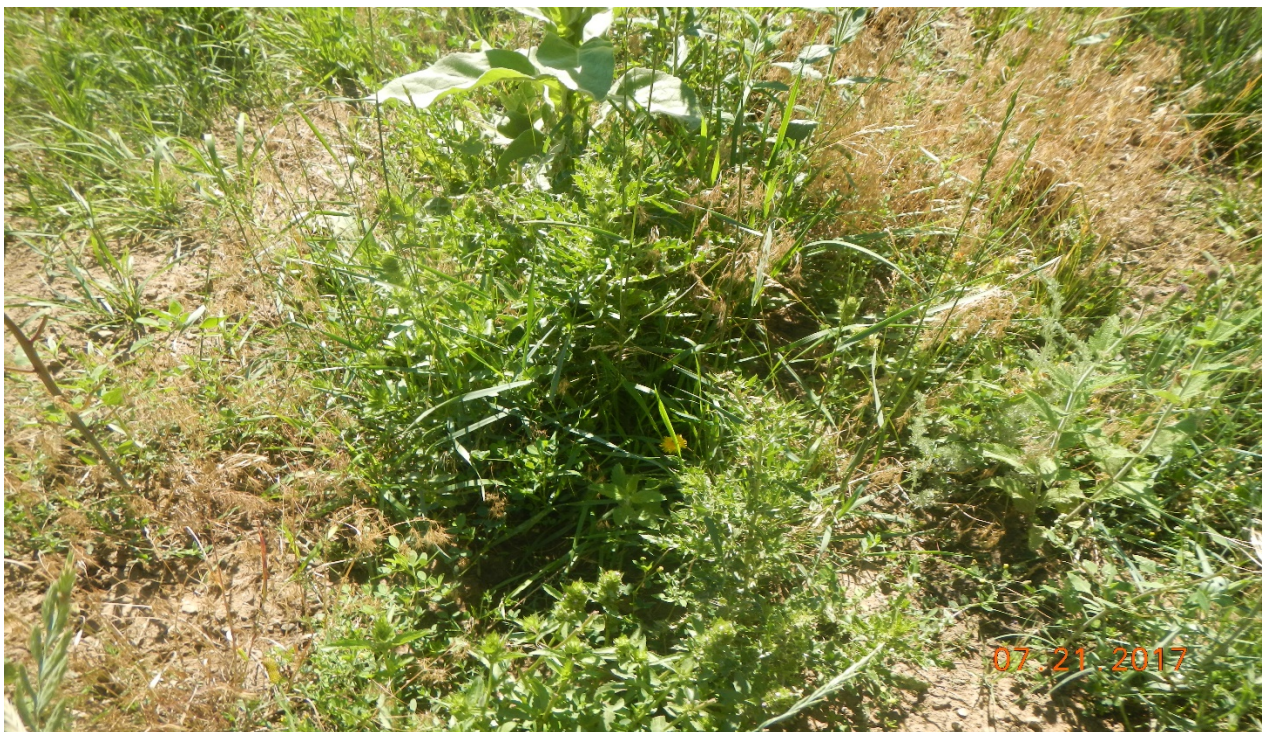
**photo 8:** There is List B noxious weeds (Canada thistle) at the southwest side of the location.

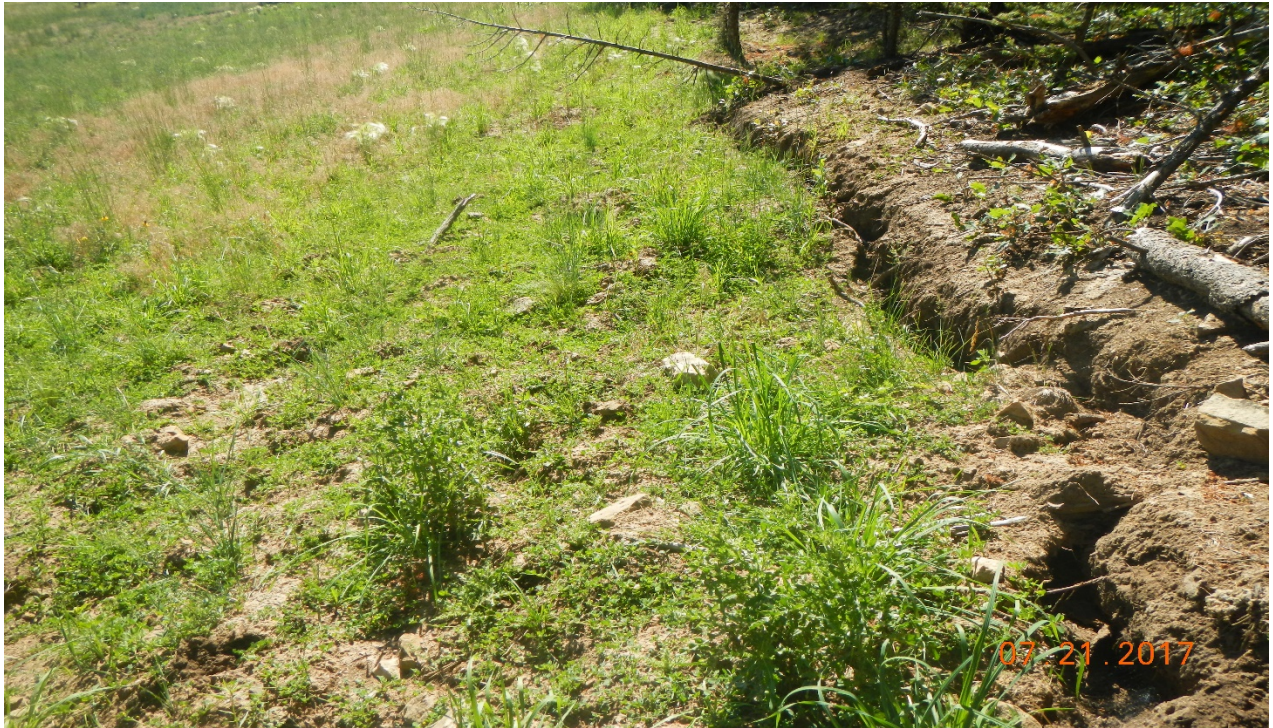
**photo 9:** There is subsidence occurring along the south side where soil was placed into the cut slope.
