Inspection Photos
Location Name: Roy Dutcher 2
API: 05-123-08945

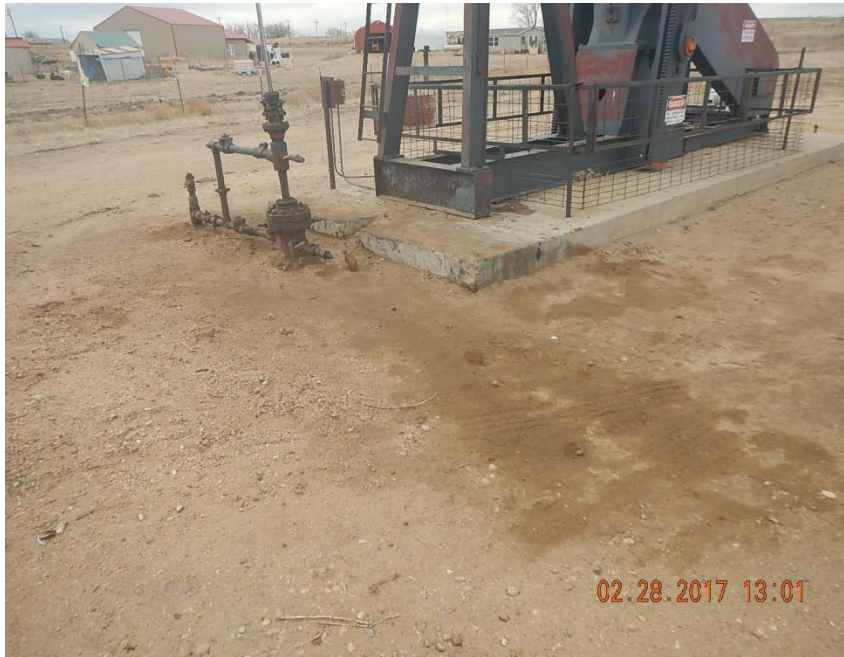
Photo from prior inspection for comparison

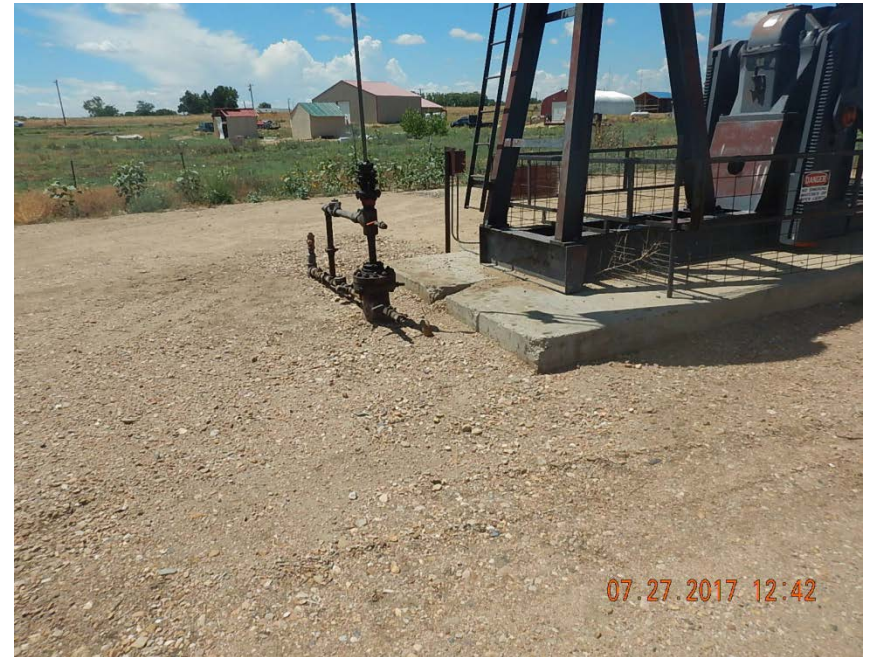
Photo 1: Stained soil removed

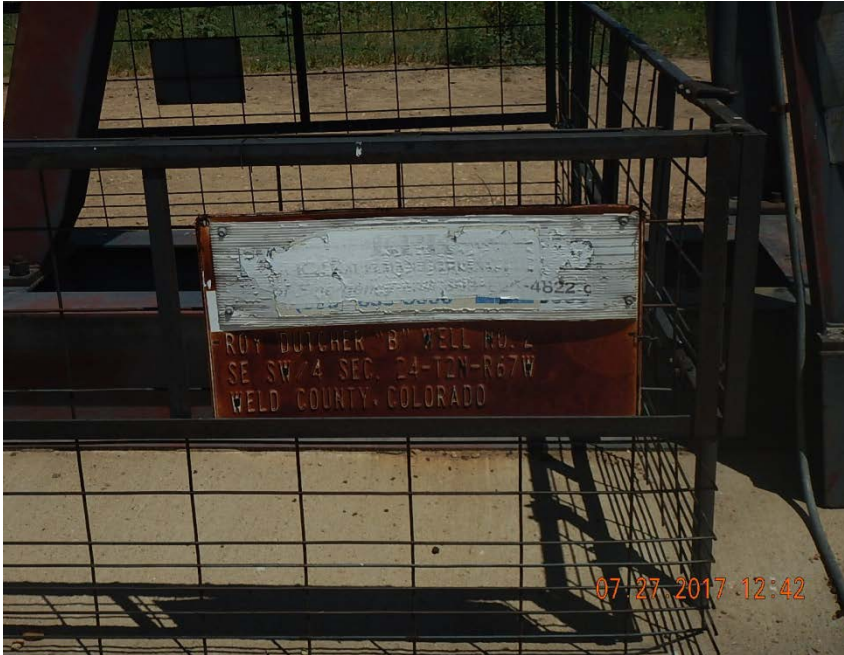
Photo 2: Wellhead sign unreadable
