Inspection Photos

Operator: PETRO-CANADA RESOURCES (USA) INC -
72085

Location ID: 311698

Inspection Doc. Number: 675103759

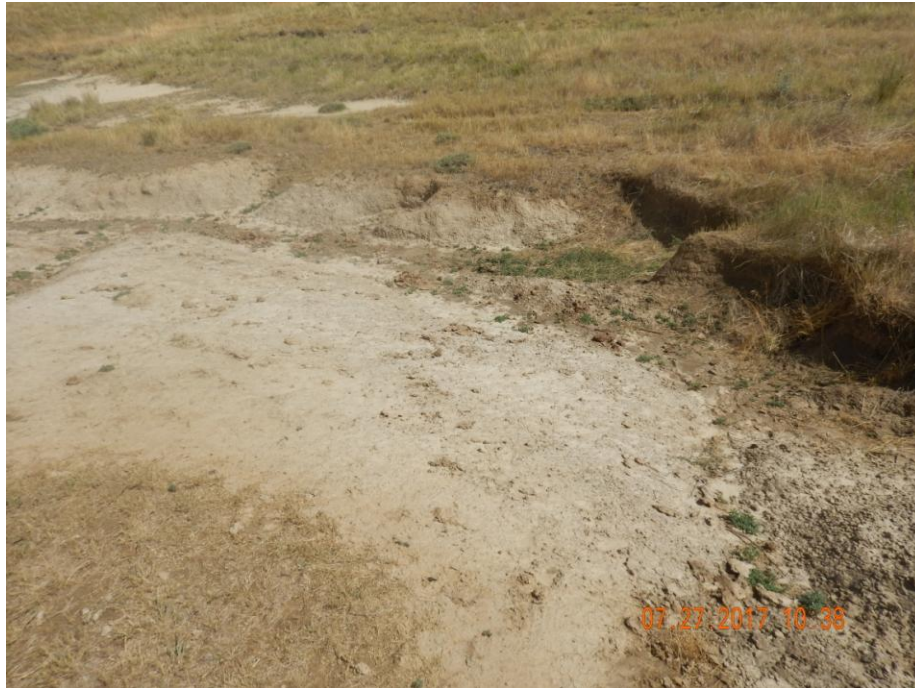
Photo 1: Photo taken from the south side of the drainage, adjacent to the pit and well location, facing north. Photo shows area of degradation that remain un-stabilized. Further degradation since previous inspection evident. See photos from inspection doc. # 682500927 for additional details.

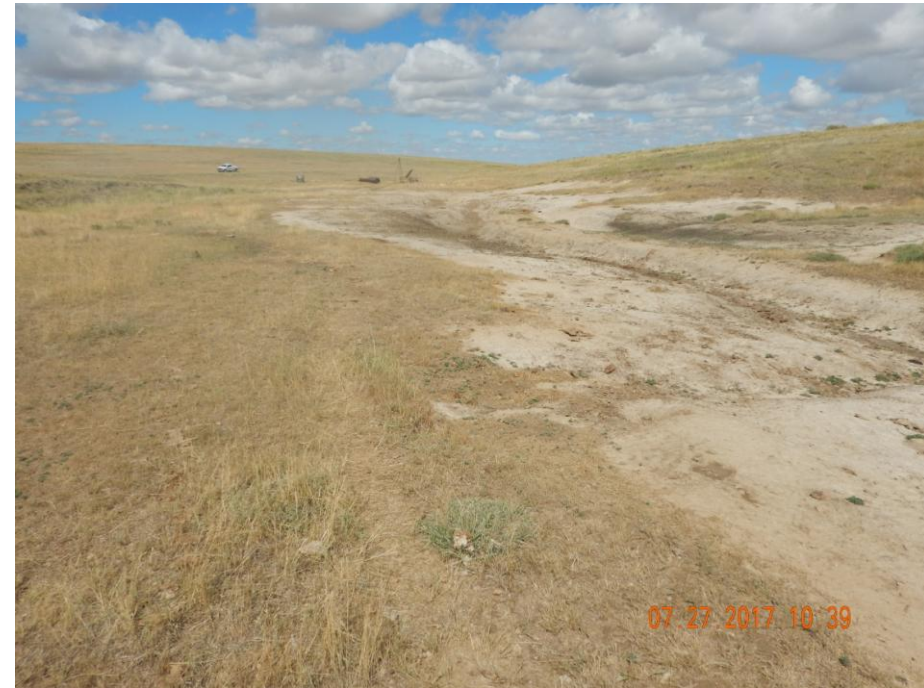
Photo 2: Photo taken from the south side of the drainage, adjacent to the pit and well location, facing northwest. Photo shows area of degradation that remain un-stabilized. Further degradation since previous inspection evident. See photos from inspection doc. # 682500927 for additional details.

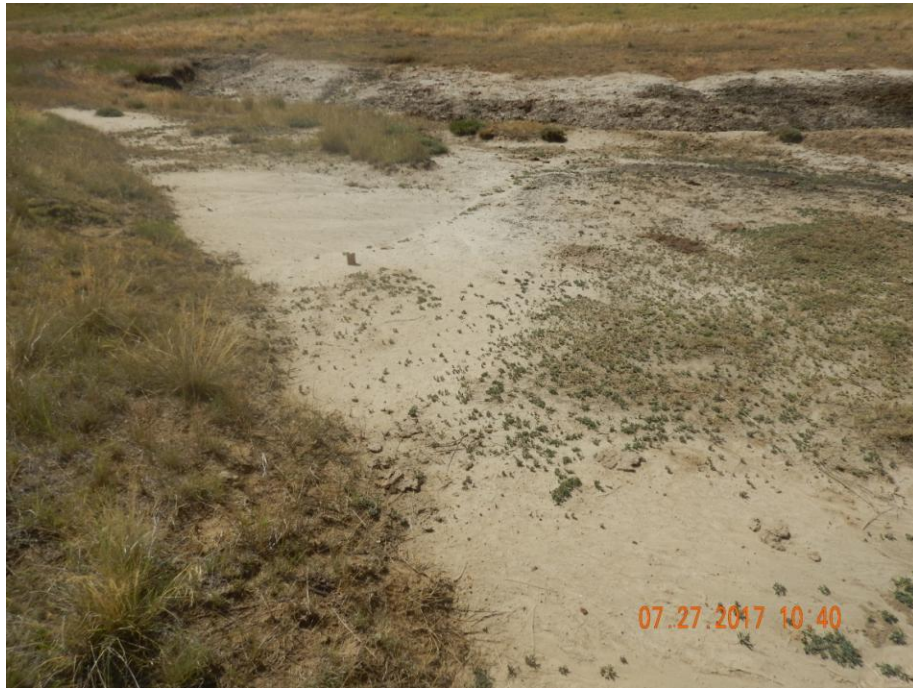
Photo 3: Photo taken from the north side of the drainage, adjacent to the pit and well location, facing south. Photo shows area of degradation that remain un-stabilized. Further degradation since previous inspection evident. See photos from inspection doc. # 682500927 for additional details.

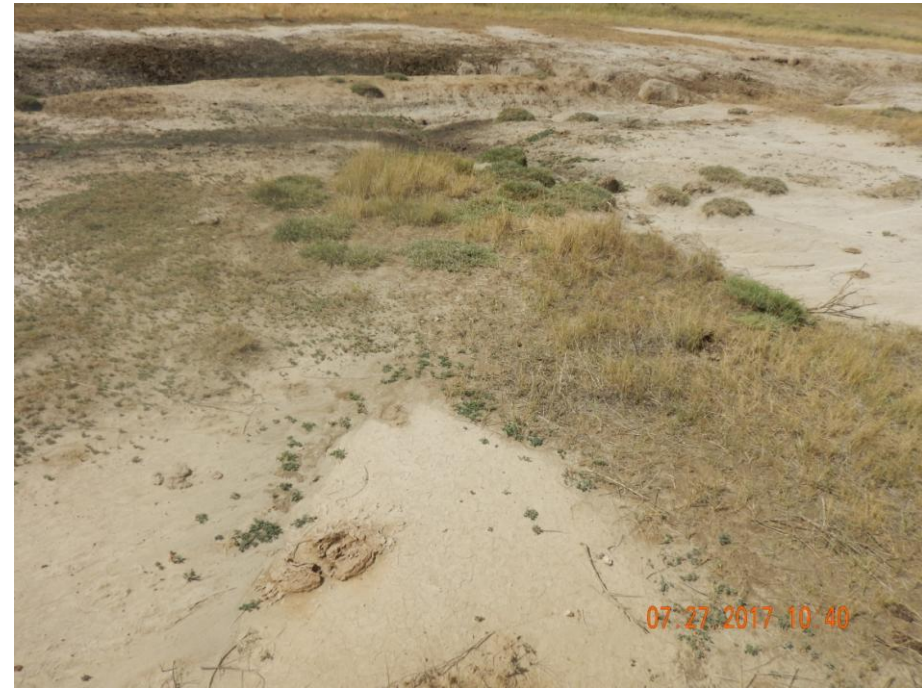
Photo 4: Photo taken from the north side of the drainage, adjacent to the pit and well location, facing southwest. Photo shows area of degradation that remain un-stabilized. Further degradation since previous inspection evident. See photos from inspection doc. # 682500927 for additional details.

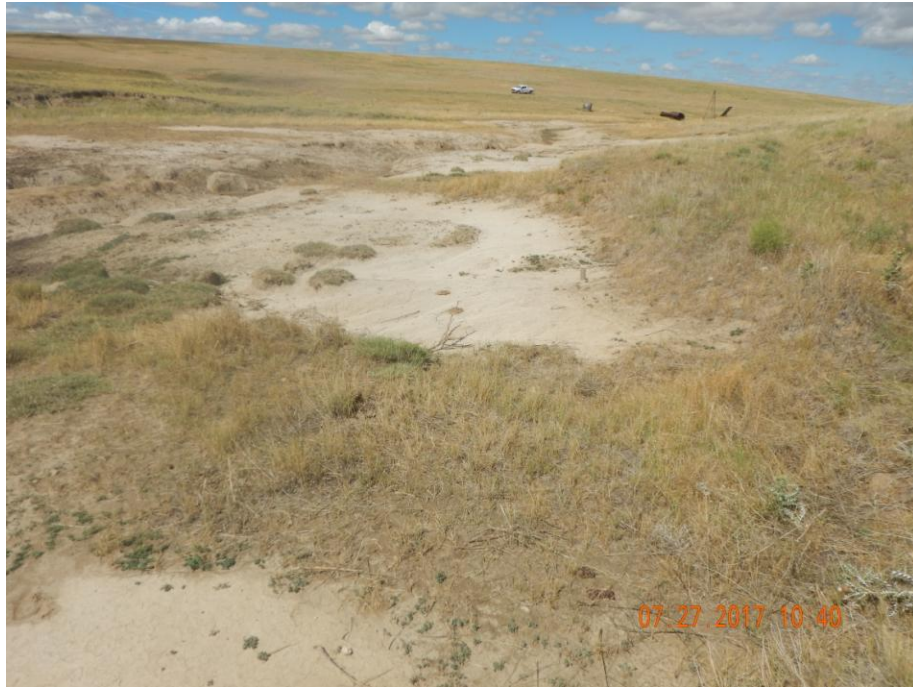
Photo 5: Photo taken from the north side of the drainage, adjacent to the pit and well location, facing west. Photo shows area of degradation that remain un-stabilized. Further degradation since previous inspection evident. See photos from inspection doc. # 682500927 for additional details.

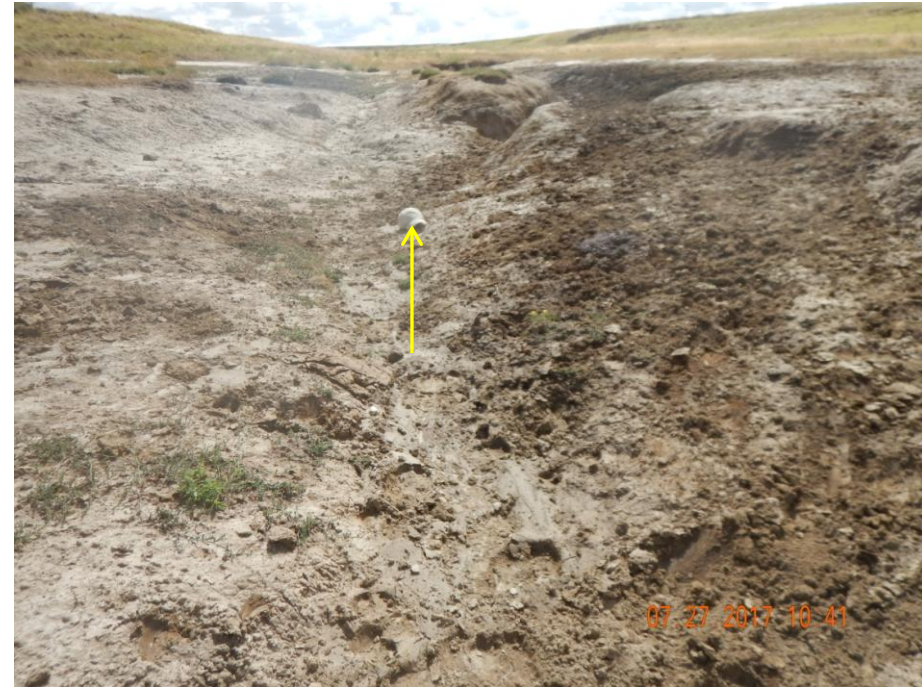
Photo 6: Photo taken from within the drainage, west of the well/pits, facing east. Photo shows area of degradation that remain un-stabilized. Further degradation since previous inspection evident. See photos from inspection doc. # 682500927 for additional details. Hat indicated by yellow arrow used for reference.

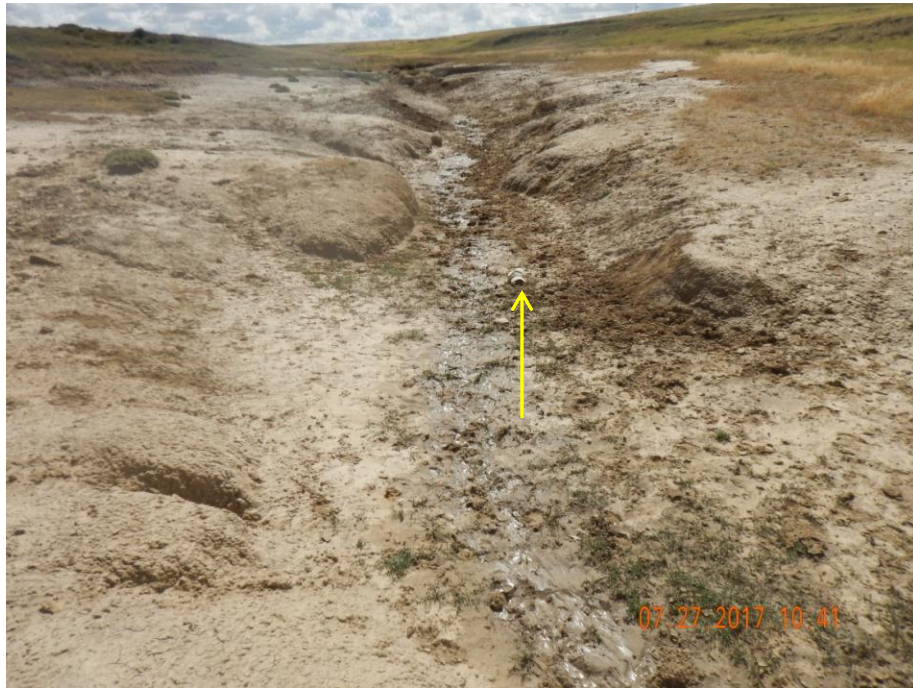
Photo 7: Photo taken from within the drainage, west of the well/pits, facing east. Photo shows area of degradation that remain un-stabilized. Further degradation since previous inspection evident. See photos from inspection doc. # 682500927 for additional details. Hat indicated by yellow arrow used for reference.

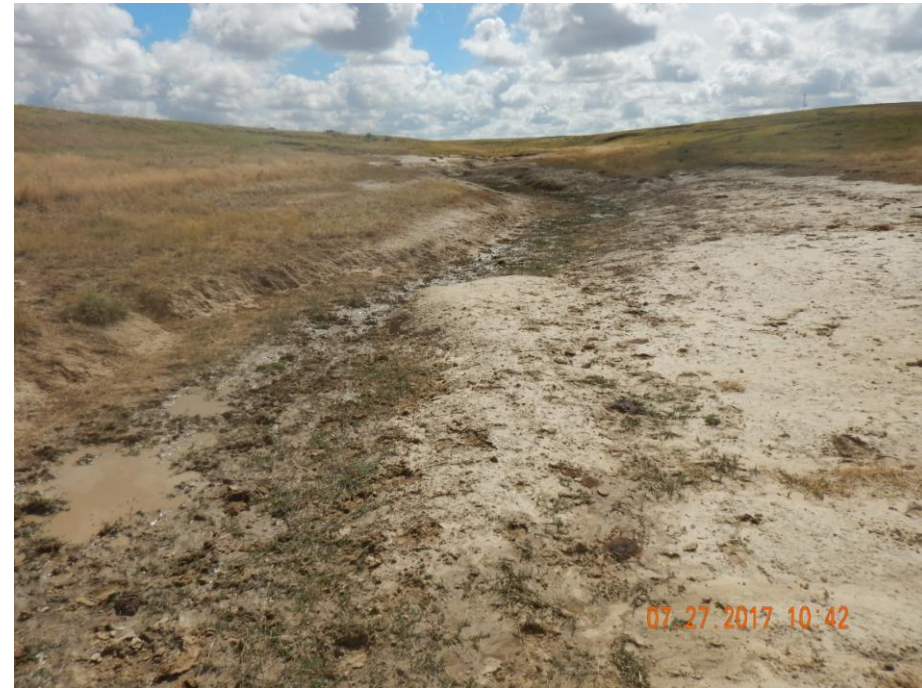
Photo 8: Photo taken from within the drainage, west of the well/pits, facing east. Photo shows area of degradation that remain un-stabilized. Further degradation since previous inspection evident. See photos from inspection doc. # 682500927 for additional details.
