Inspection Photos

Operator: PETRO-CANADA RESOURCES (USA) INC -
72085

Location ID: 311664

Inspection Doc. Number: 675103763

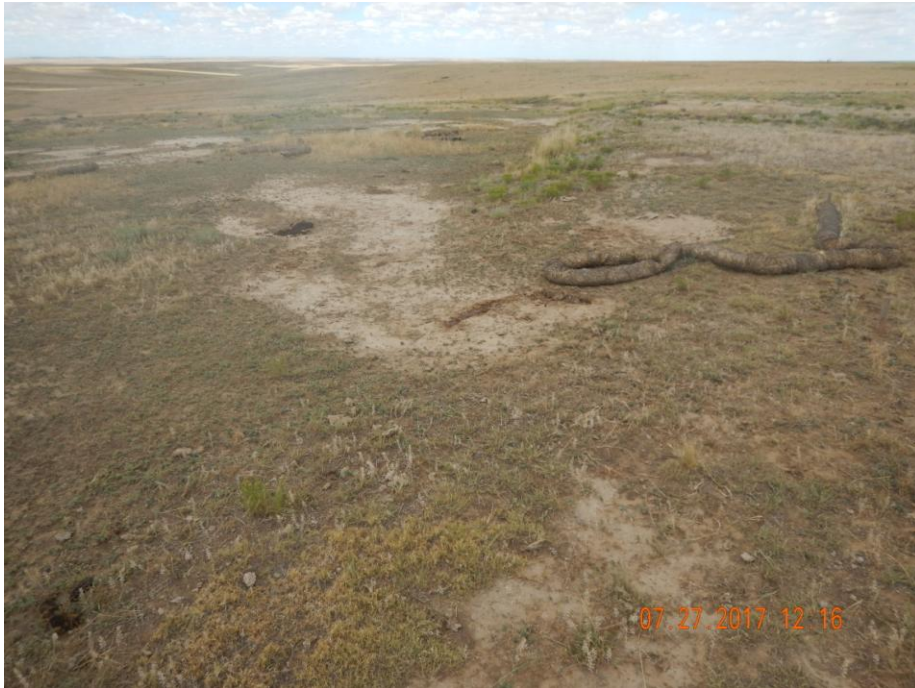
Photo 1: Photo taken from the northern disturbance area, facing northwest. Photo shows erosion has not been stabilized, not BMPs have been installed and/or maintained. No evidence of any additional remediation or reclamation efforts observed. Straw wattles observed in photo appear to be same wattles from previous inspections up to and over a year ago. BMPs in disrepair and is now debris.

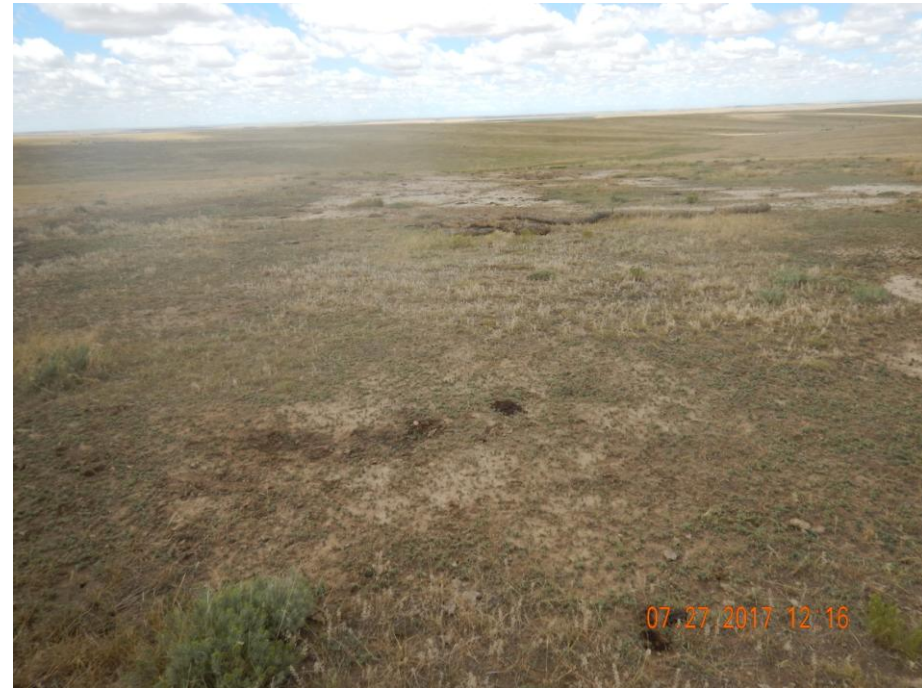
Photo 2: Photo taken from the northern disturbance area, facing west. Photo shows erosion has not been stabilized, not BMPs have been installed and/or maintained. No evidence of any additional remediation or reclamation efforts observed. Straw wattles observed in photo appear to be same wattles from previous inspections up to and over a year ago. BMPs in disrepair and is now debris.

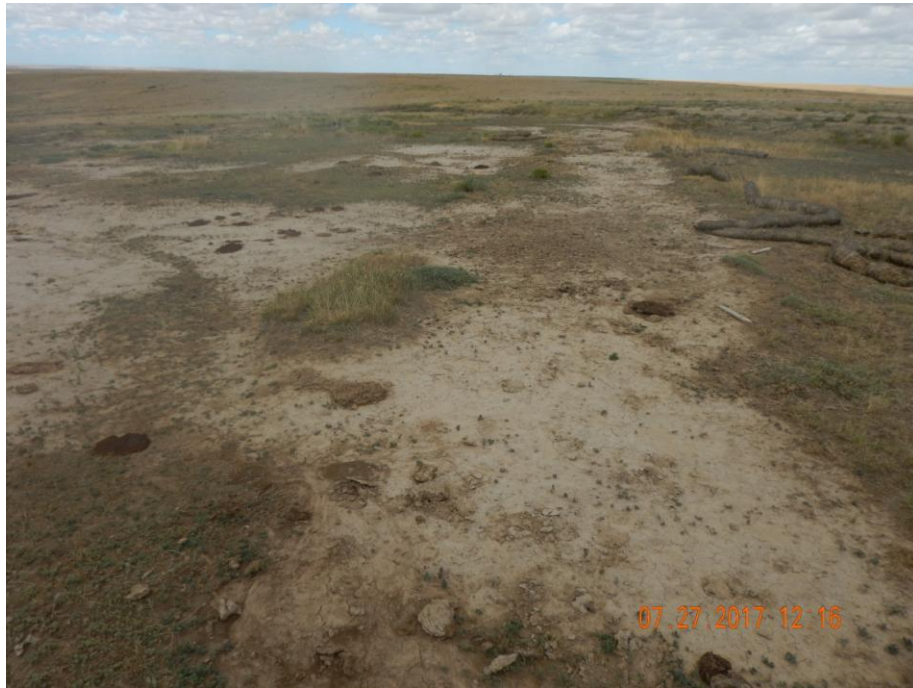
Photo 3: Photo taken from the northern disturbance area, facing north. Photo shows erosion has not been stabilized, not BMPs have been installed and/or maintained. No evidence of any additional remediation or reclamation efforts observed. Straw wattles observed in photo appear to be same wattles from previous inspections up to and over a year ago. BMPs in disrepair and is now debris.

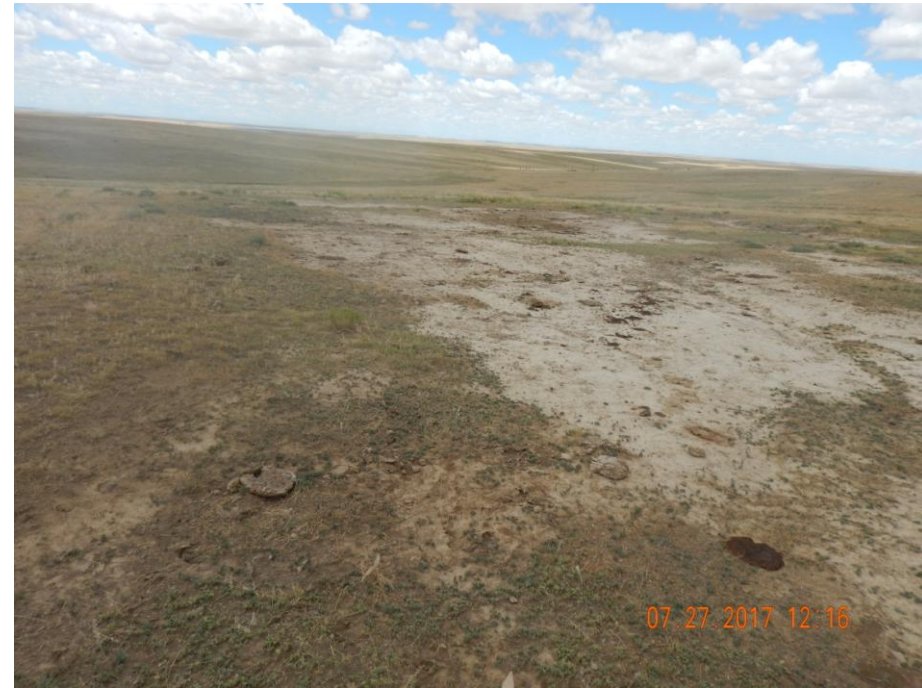
Photo 4: Photo taken from the northern disturbance area, facing west. Photo shows erosion has not been stabilized, not BMPs have been installed and/or maintained. No evidence of any additional remediation or reclamation efforts observed. Straw wattles observed in photo appear to be same wattles from previous inspections up to and over a year ago. BMPs in disrepair and is now debris.

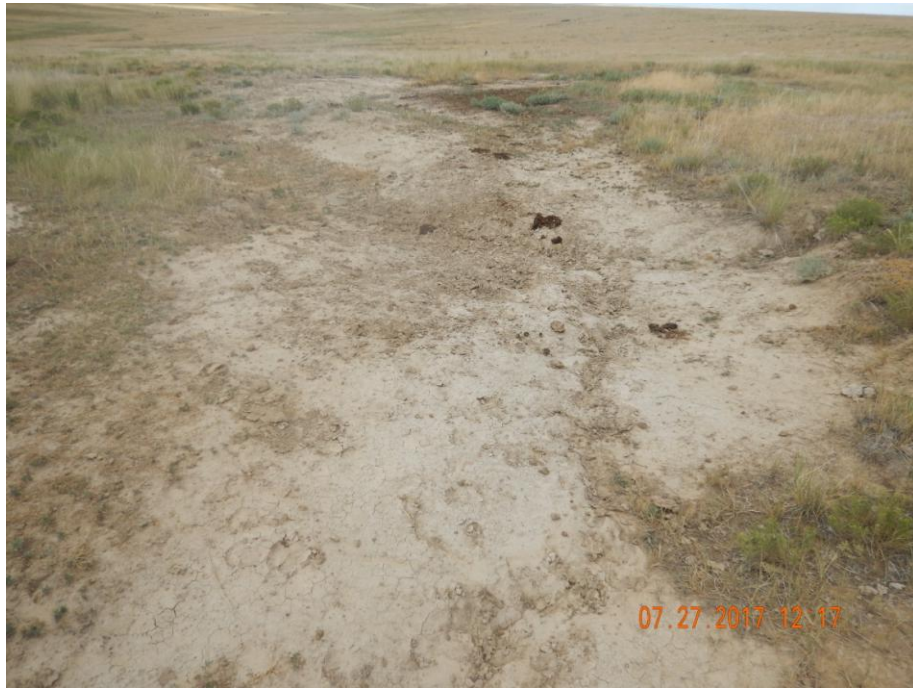
Photo 5: Photo taken from the down slope on the northern disturbance area, facing east towards the access road. Photo shows erosion has not been stabilized, not BMPs have been installed and/or maintained. No evidence of any additional remediation or reclamation efforts observed.

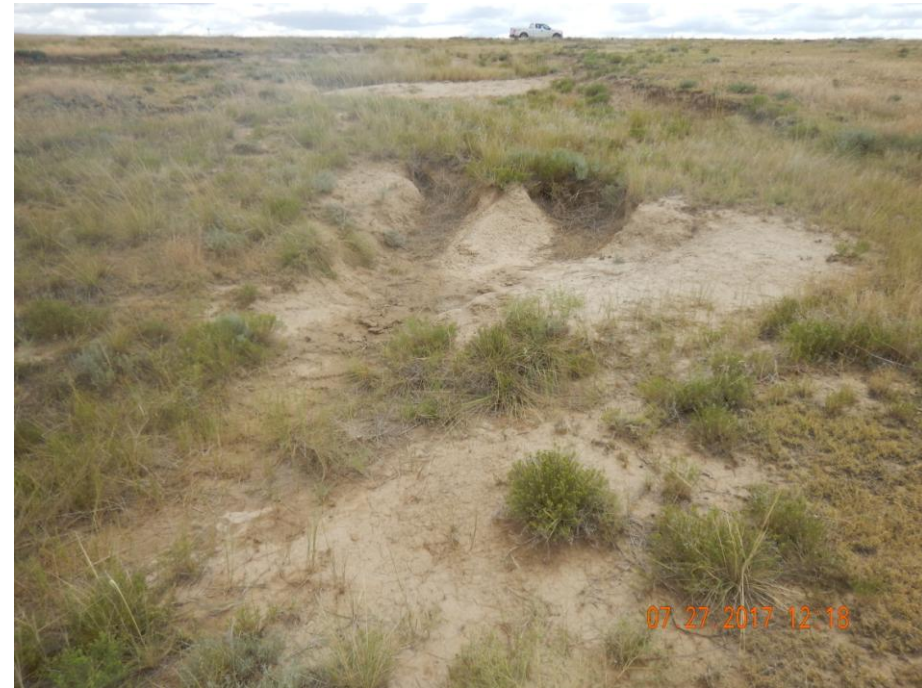
Photo 6: Photo taken from the down slope on the northern disturbance area, facing east towards the access road. Photo shows erosion has not been stabilized, not BMPs have been installed and/or maintained. No evidence of any additional remediation or reclamation efforts observed.

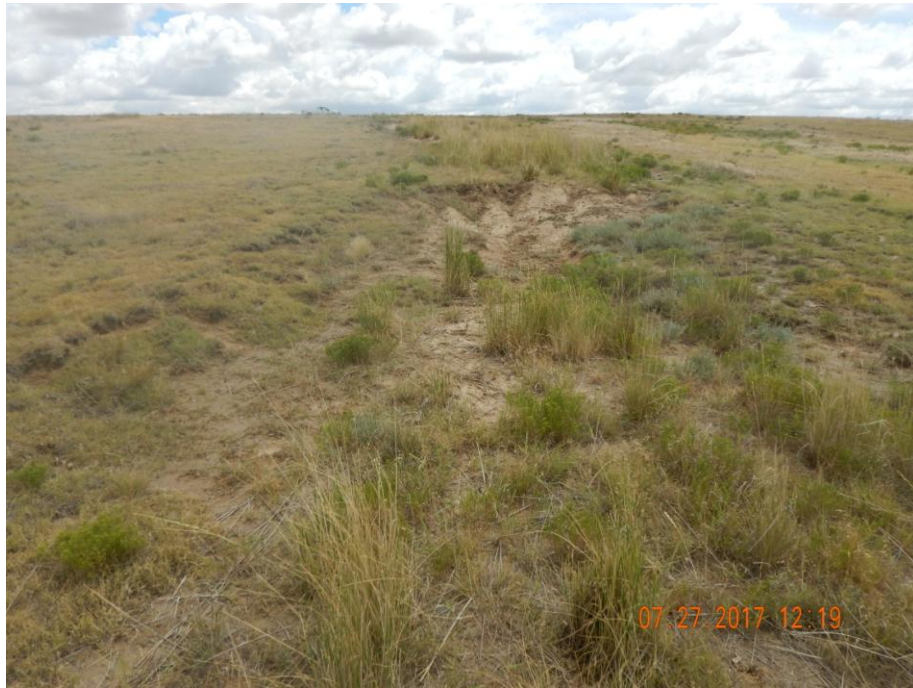
Photo 7: to taken from the down slope on the northern disturbance area, facing east towards the access road. Photo shows erosion has not been stabilized, not BMPs have been installed and/or maintained. No evidence of any additional remediation or reclamation efforts observed.

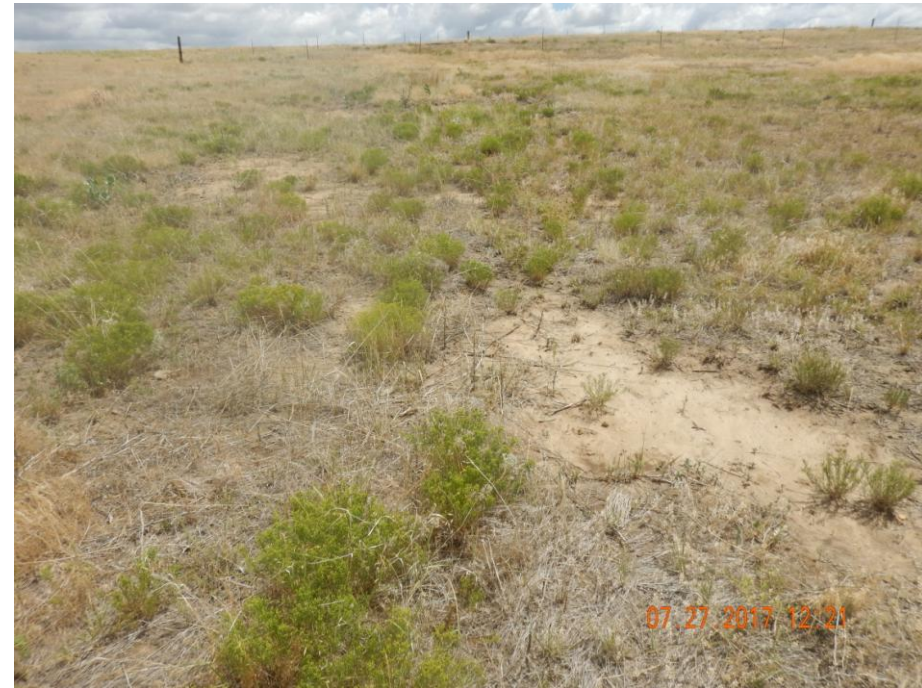
Photo 8: to taken from the down slope on the southern disturbance area, facing east towards the access road. Photo shows areas of the disturbance that remain un-vegetated and un-stabilized. No evidence of any additional remediation or reclamation efforts observed.

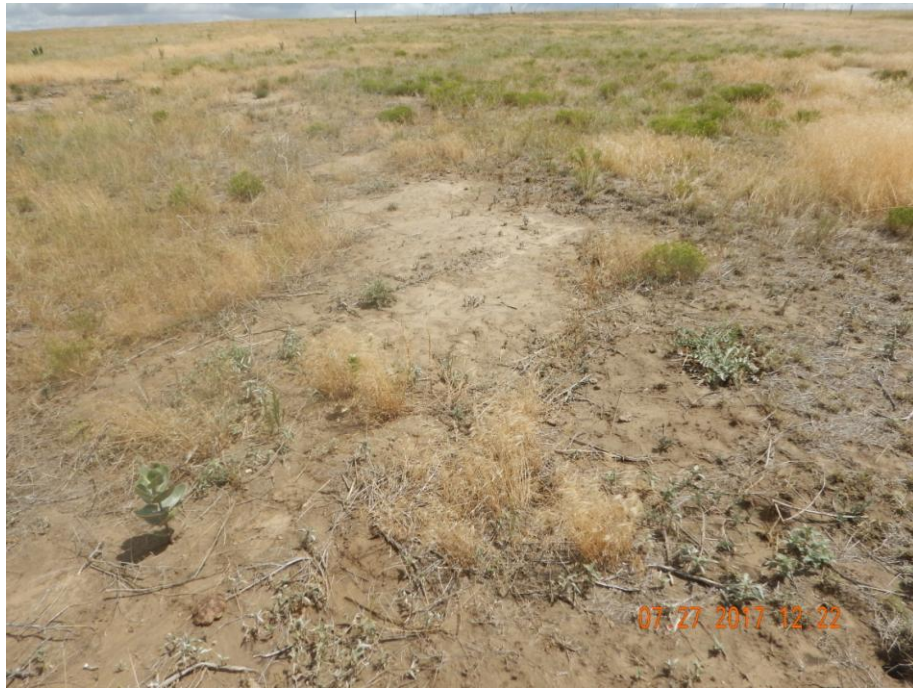
Photo 9: Photo taken from the down slope on the southern disturbance area, facing east towards the access road. Photo shows areas of the disturbance that remain un-vegetated and un-stabilized. No evidence of any additional remediation or reclamation efforts observed.

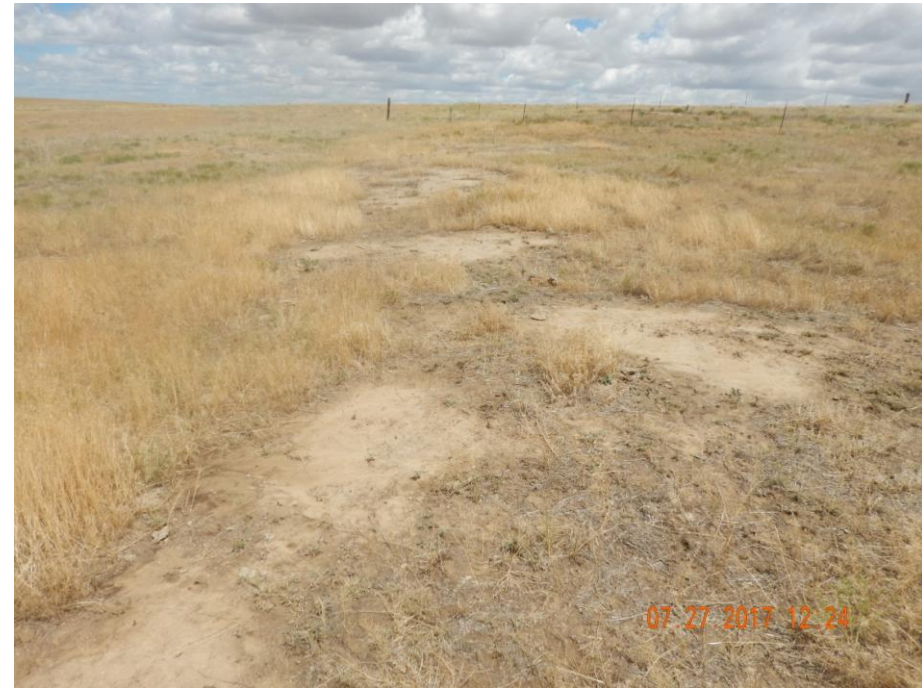
Photo 10: Photo taken from the down slope on the southern disturbance area, facing east towards the access road. Photo shows areas of the disturbance that remain un-vegetated and un-stabilized. No evidence of any additional remediation or reclamation efforts observed.

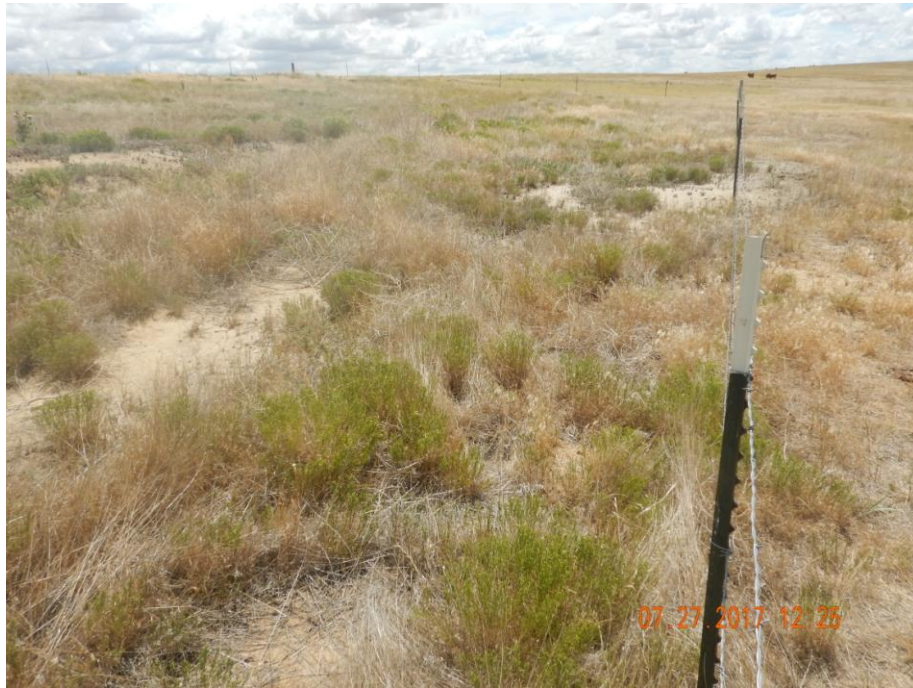
Photo 11: Photo taken from the fenced remediation area. Photo shows areas of the remediation area that remain bare and exposed soil. No evidence of any additional remediation or reclamation efforts observed.

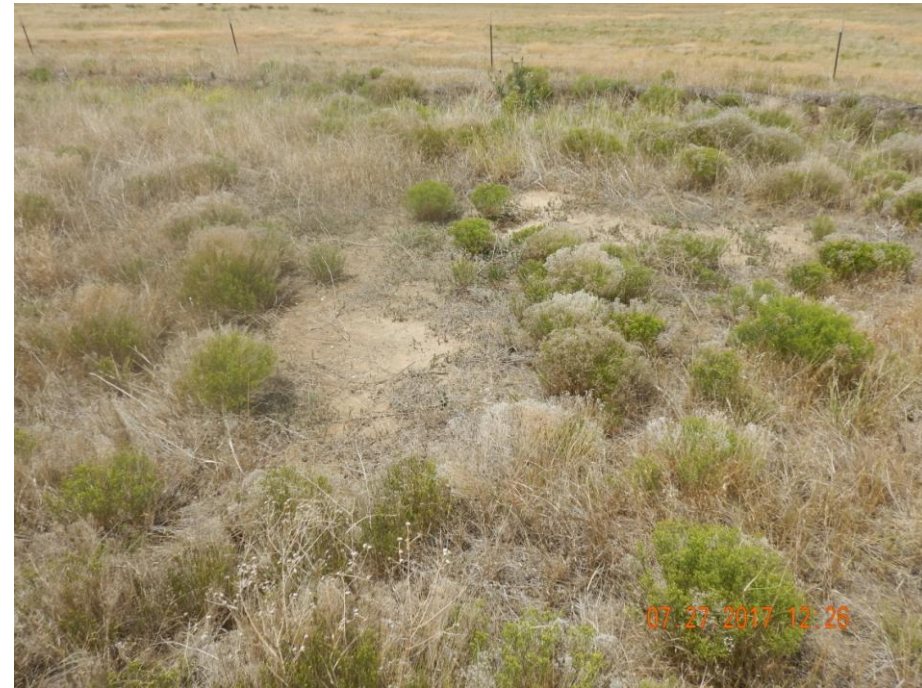
Photo 12: Photo taken from the fenced remediation area. Photo shows areas of the remediation area that remain bare and exposed soil. No evidence of any additional remediation or reclamation efforts observed.
