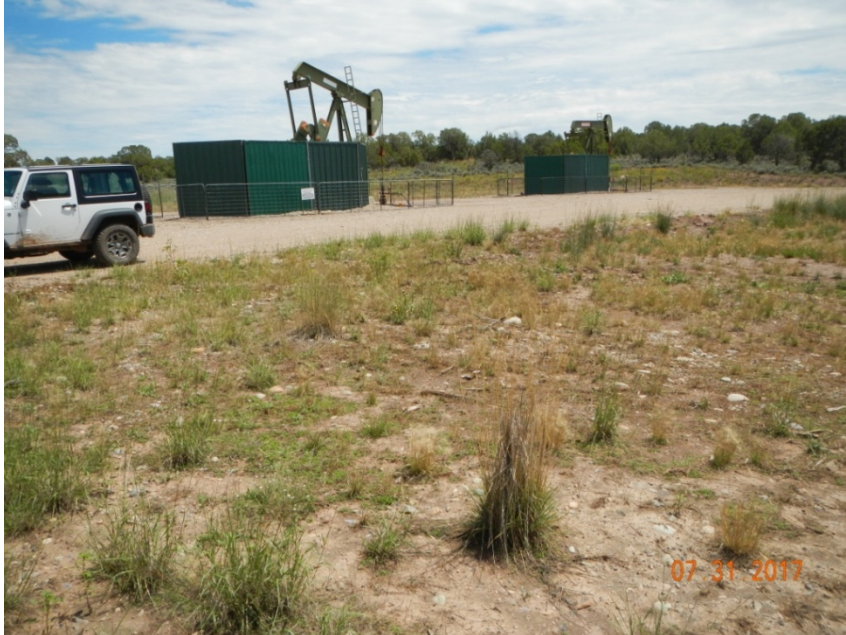
Photo 1: View of the project area from the northwestern corner facing center.

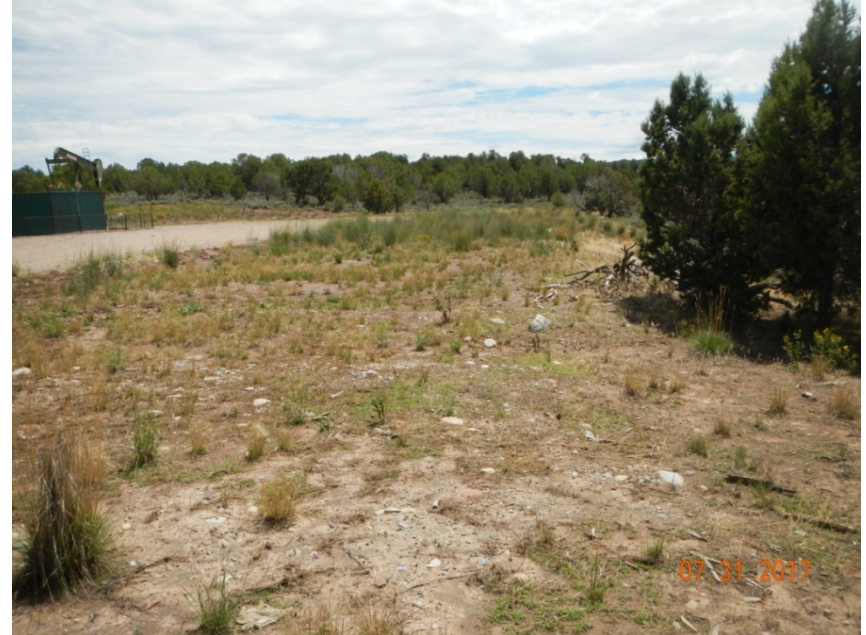
Photo 2: View of the western portion of the project area from the northwestern corner of the well pad facing southward. Areas documented from previous inspections are reclaimed.

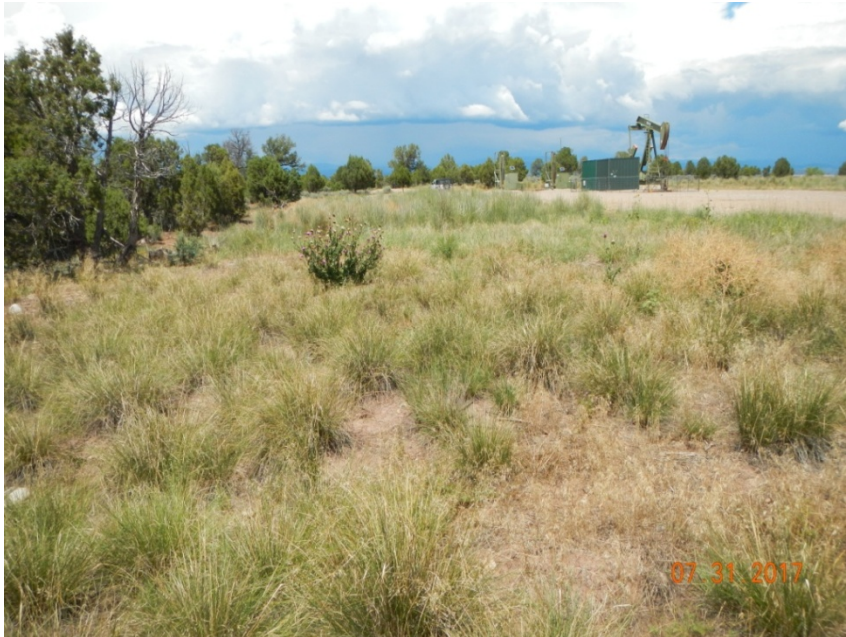
Photo 3: Another view of reclamation area in the western portion of the project area. Scattered musk thistles in the project area should be controlled by the operator of the producing wells.

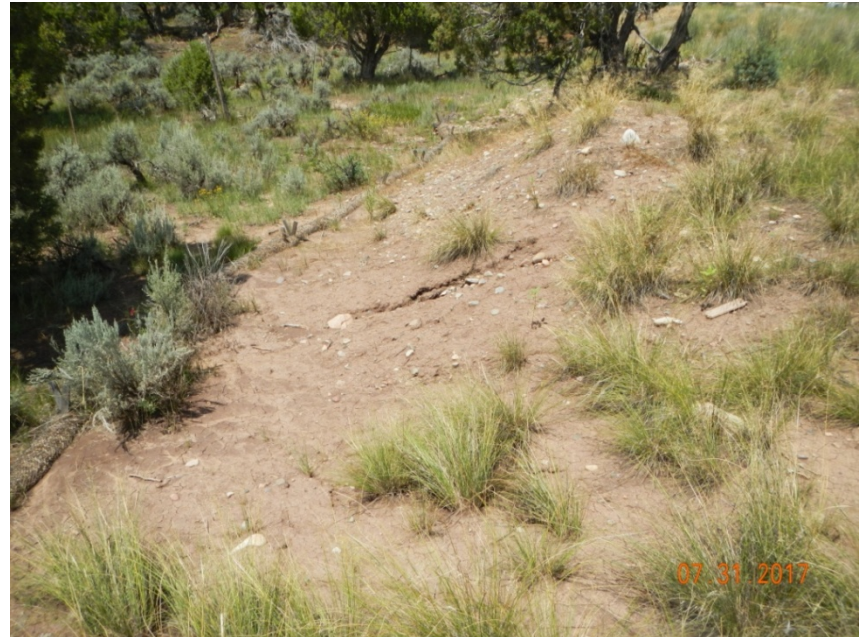
Photo 4: Erosion is continuing along the western edge of the project area and should be controlled by the operator of producing wells.
