# Inspection Photos

Operator: FOUNDATION ENERGY  
MANAGEMENT LLC - 10112

Location ID: 330865

Inspection Doc. Number: 675103803  
Weld County, CO

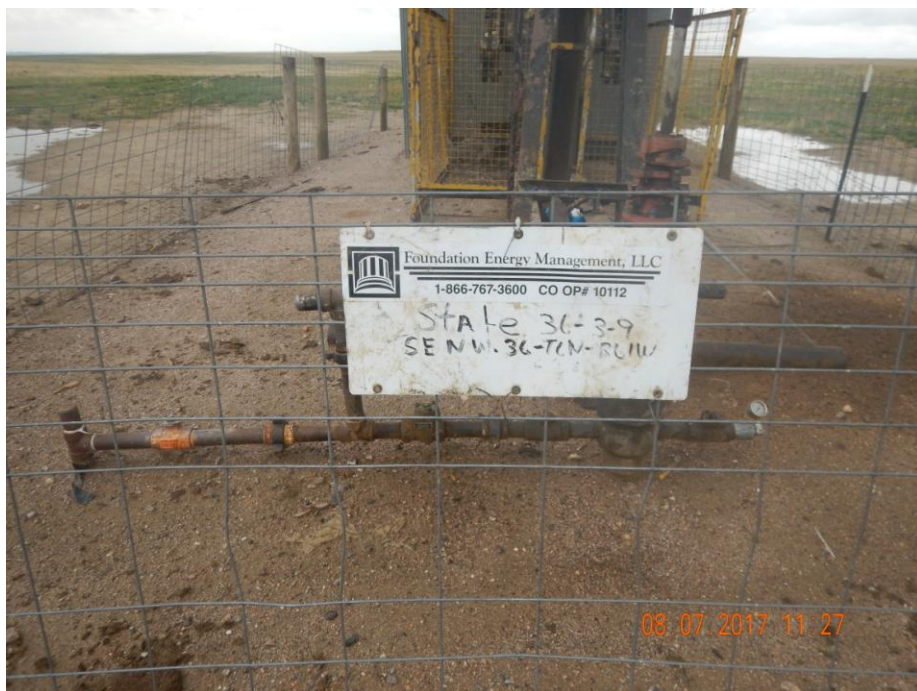
**Photo 1:** Photo of sign at wellhead.

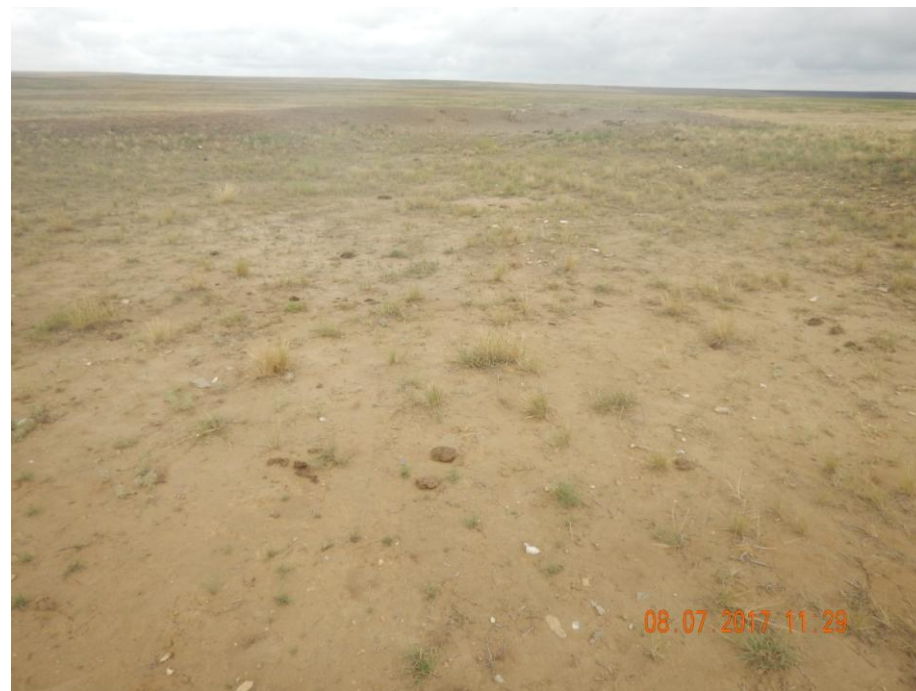
**Photo 2:** Photo taken from the northwest end of the location, facing west. Photo shows iron tubing that had been stored in the interim area have been removed.

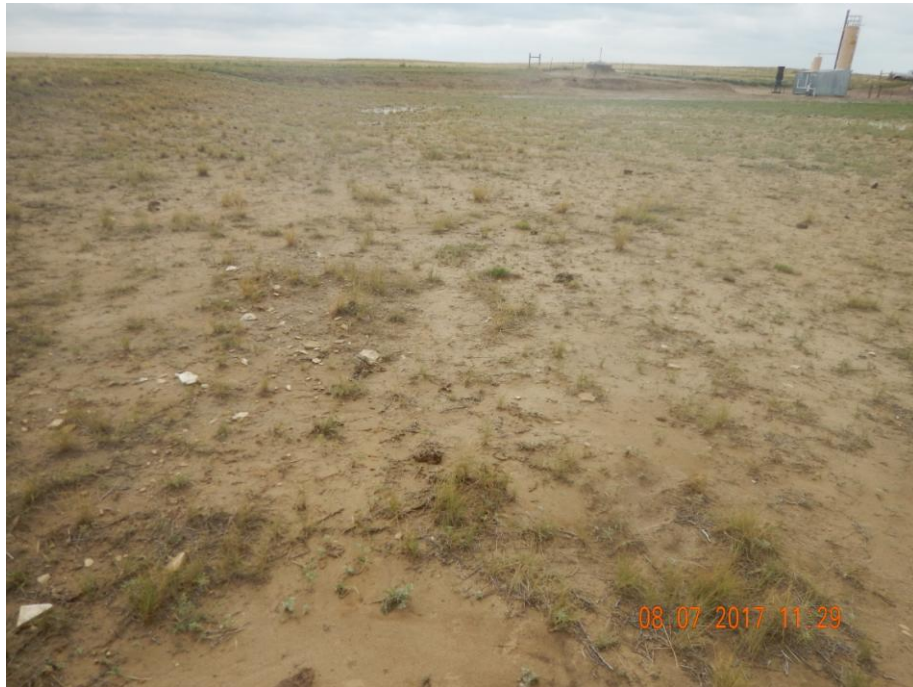
**Photo 3:** Photo taken from the northwest corner of the location, facing east. Photo shows vegetation over the interim area. Previous inspections required operator to perform interim reclamation. Interim areas have not been reclaimed and revegetated per reclamation rule 1003

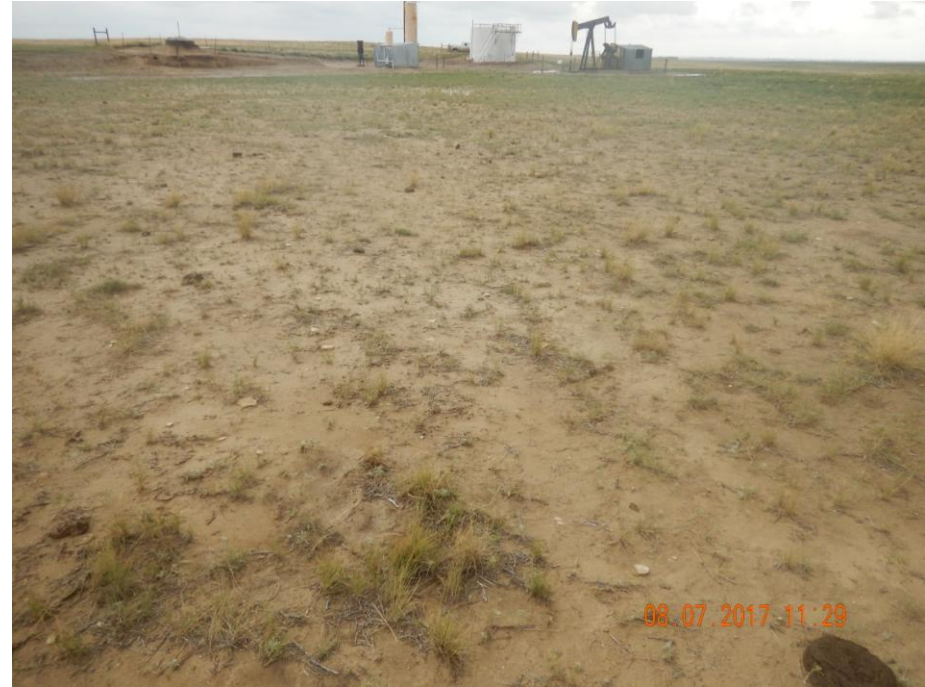
**Photo 4:** Photo taken from the northwest corner of the location, facing southeast. Photo shows vegetation over the interim area. Previous inspections required operator to perform interim reclamation. Interim areas have not been reclaimed and revegetated per reclamation rule 1003

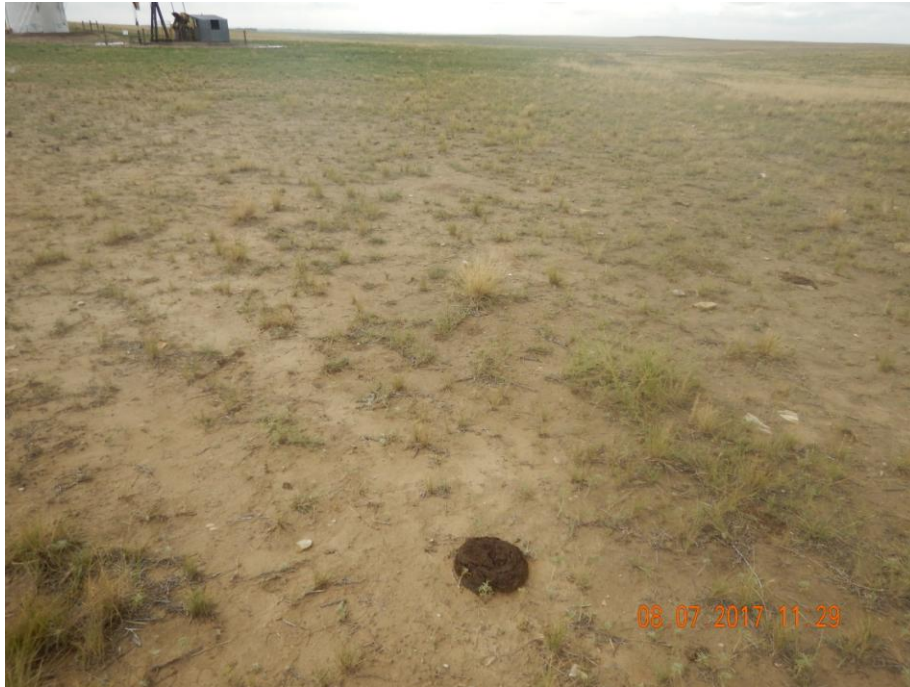
**Photo 5:** Photo taken from the northwest corner of the location, facing south. Photo shows vegetation over the interim area. Previous inspections required operator to perform interim reclamation. Interim areas have not been reclaimed and revegetated per reclamation rule 1003

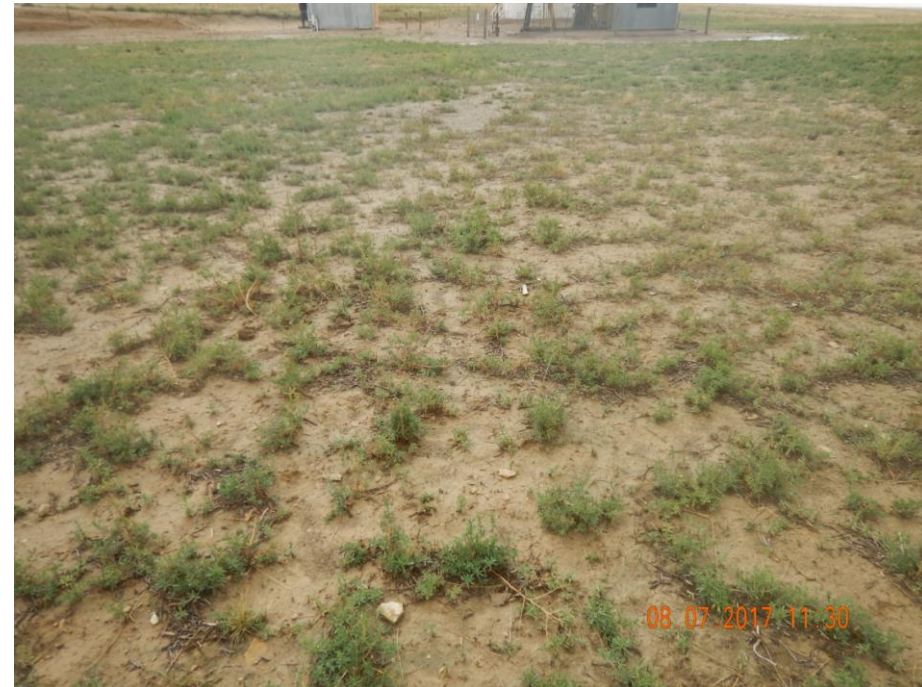
**Photo 6:** Photo taken from the west end of the location. Photo shows vegetation throughout the interim area is predominantly undesirable weedy plant species such as kochia, russian thistle and puncturevine.

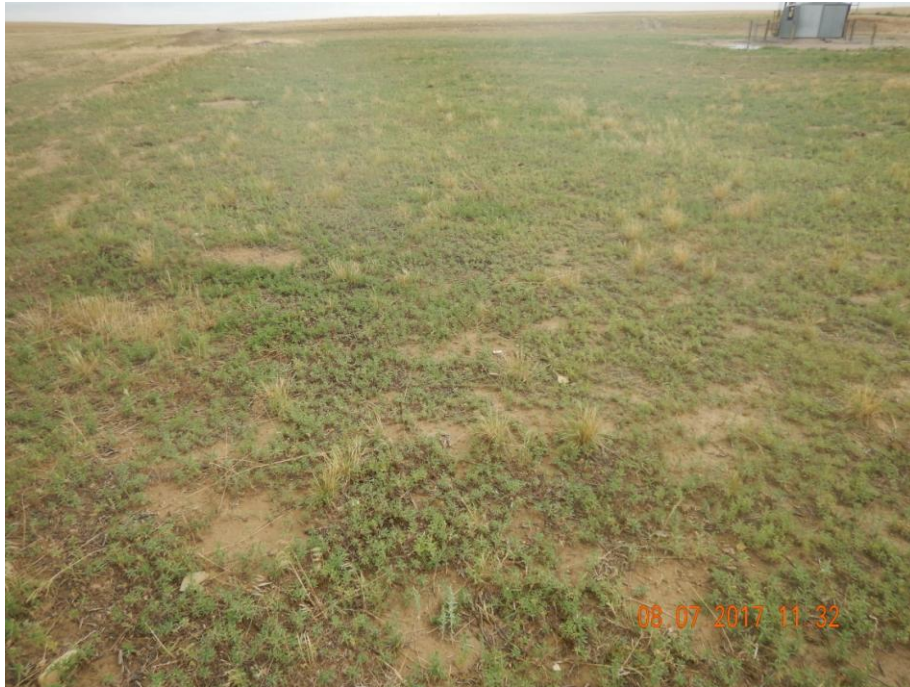
**Photo 7:** Photo taken from the southwest corner of the location, facing north. Photo shows vegetation over the interim area. Vegetation throughout the interim area is predominantly undesirable weedy plant species such as kochia, russian thistle and puncturevine. Previous inspections required operator to perform interim reclamation. Interim areas have not been reclaimed and revegetated per reclamation rule 1003

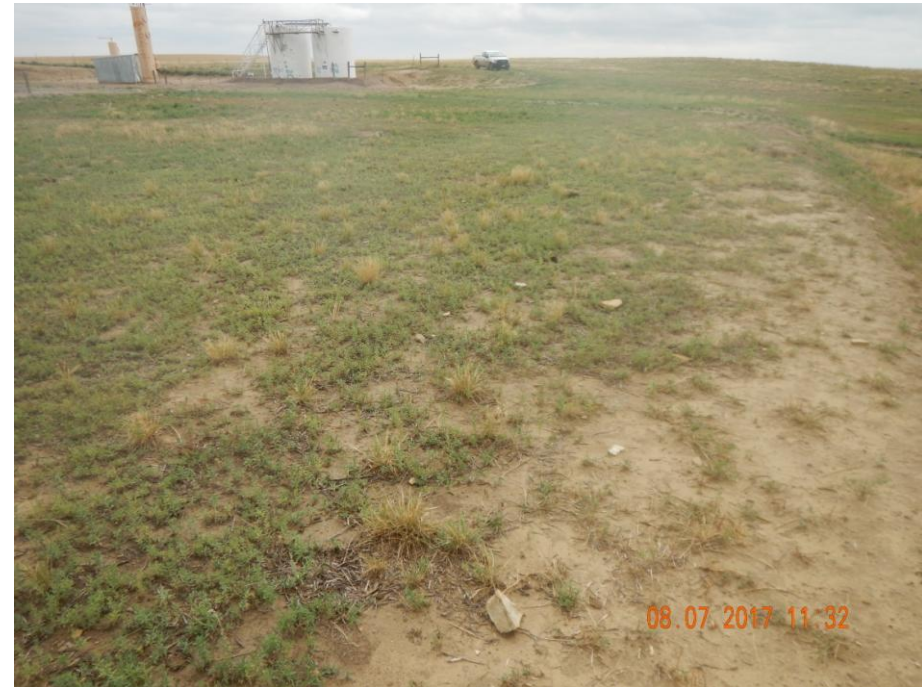
**Photo 8:** Photo taken from the southwest corner of the location, facing east. Photo shows vegetation over the interim area. Vegetation throughout the interim area is predominantly undesirable weedy plant species such as kochia, russian thistle and puncturevine. Previous inspections required operator to perform interim reclamation. Interim areas have not been reclaimed and revegetated per reclamation rule 1003

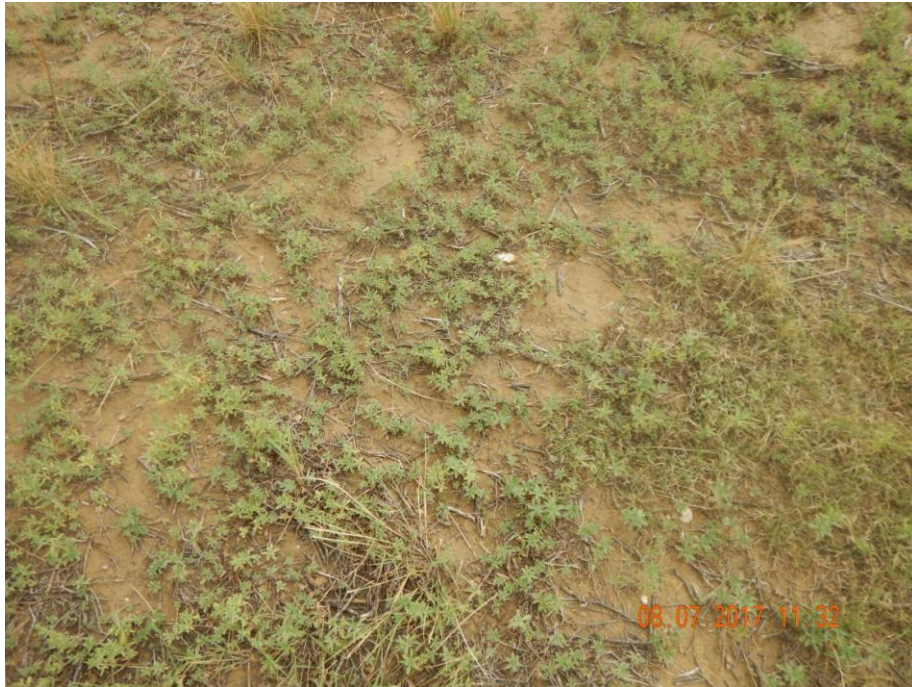
**Photo 7:** Photo taken from the southwest end of the location. Photo shows vegetation throughout the interim area is predominantly undesirable weedy plant species such as kochia, russian thistle and puncturevine.

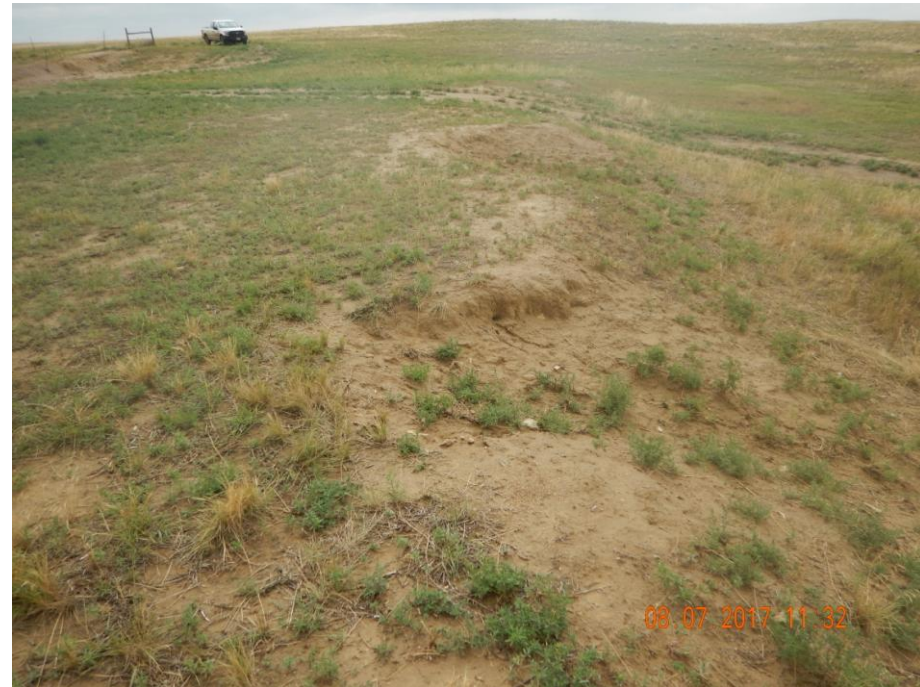
**Photo 8:** Photo taken from the south end of the location, facing east. Photo shows erosion degradation on the location has not been repaired, and stormwater and sediment control BMPs have not been installed.
