Stormwater Inspection

August 8, 2017

Operator: EXTRACTION OIL & GAS LLC- #10459

Inspection Photos
Location Name: Rancho Water Valley Pad /41-4
Location ID: 427157

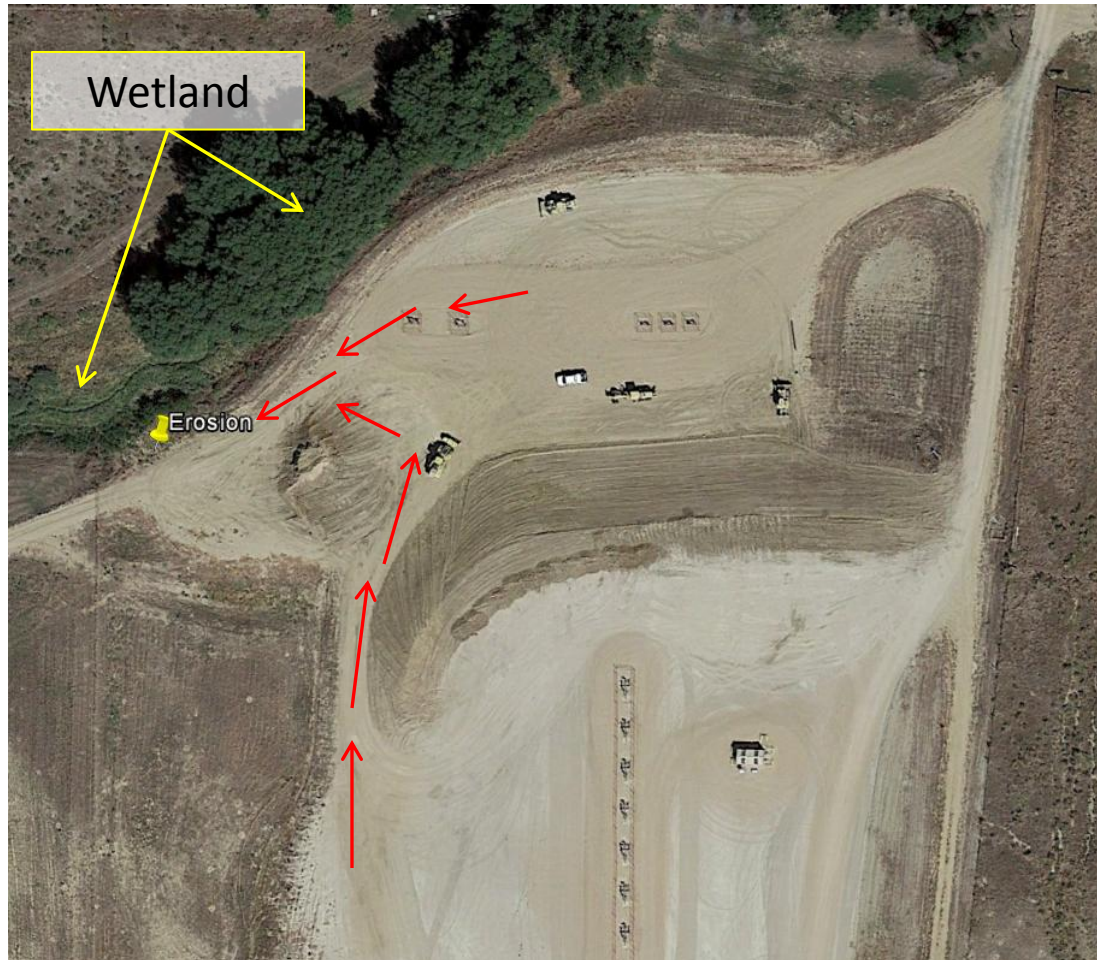
Google Earth aerial imagery taken 9/7/2016 illustrating the Rancho Water Valley Pad in relation to the erosion issue. Red arrows illustrate the direction of stormwater flows from the Rancho Water Valley Pad location that has caused erosion off location into a wetland. See following image of designated wetland.

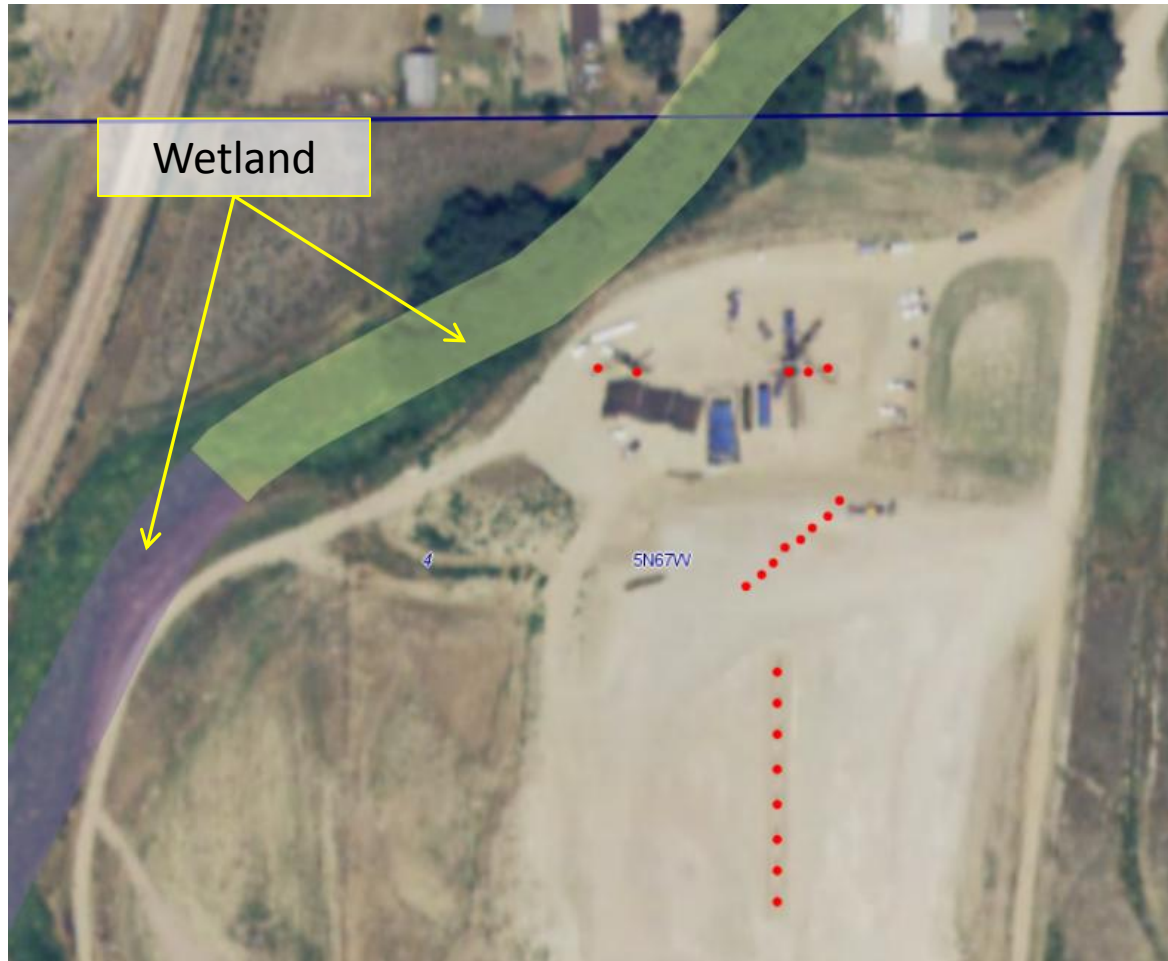
COGCC GISOnline image illustrating Freshwater Emergent Wetland and Freshwater Forested/Shrub Wetland.

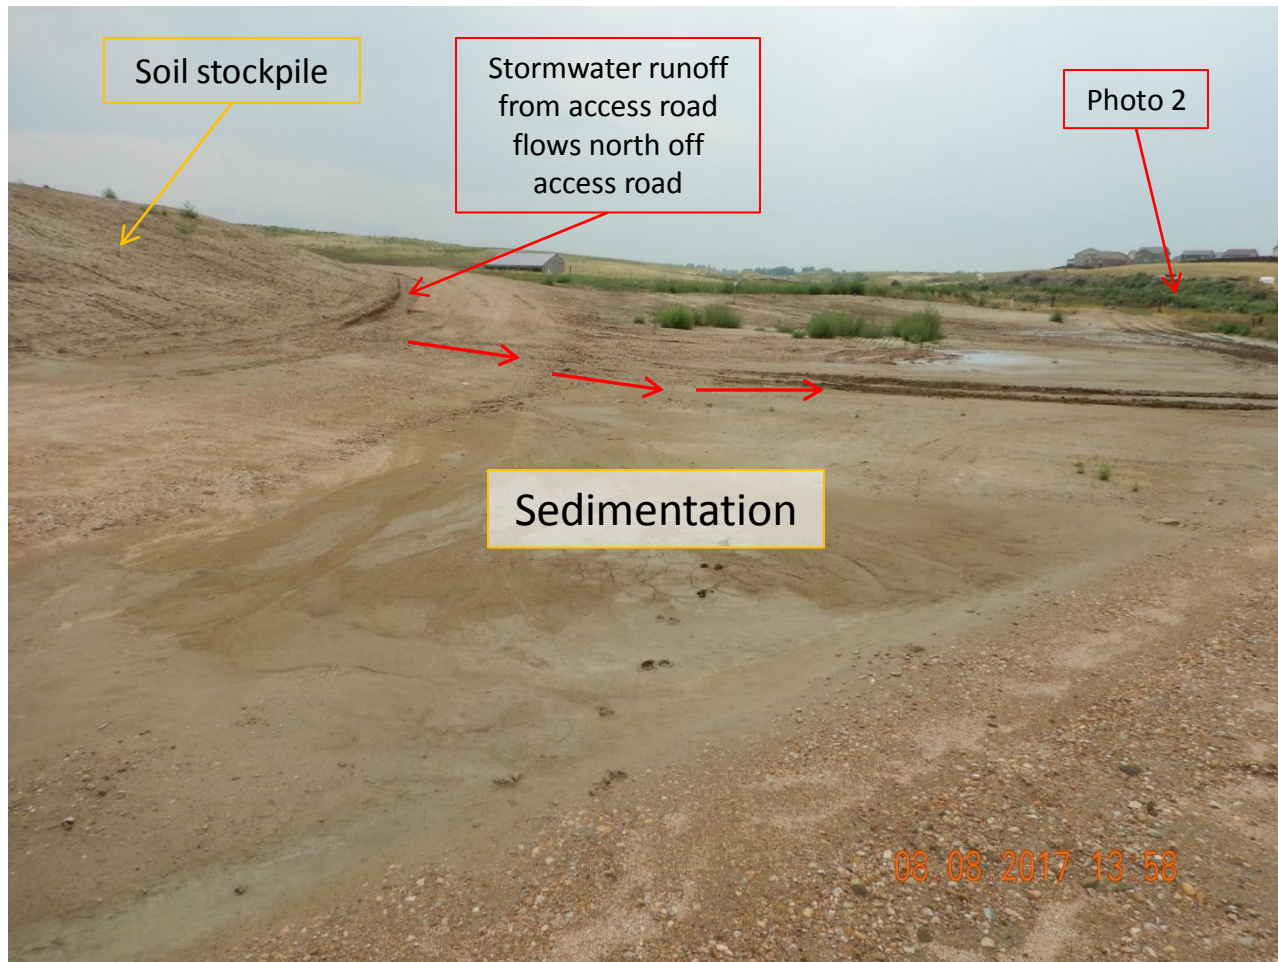
Photo 1. Photo taken from the northern Rancho Pad, facing West. Sediment is being depositing and settling out (sedimentation) from rill erosion occurring on a soil stockpile. Stormwater runoff is coming from the access road and the northern location which then travels west and causing erosion off location into a wetland.

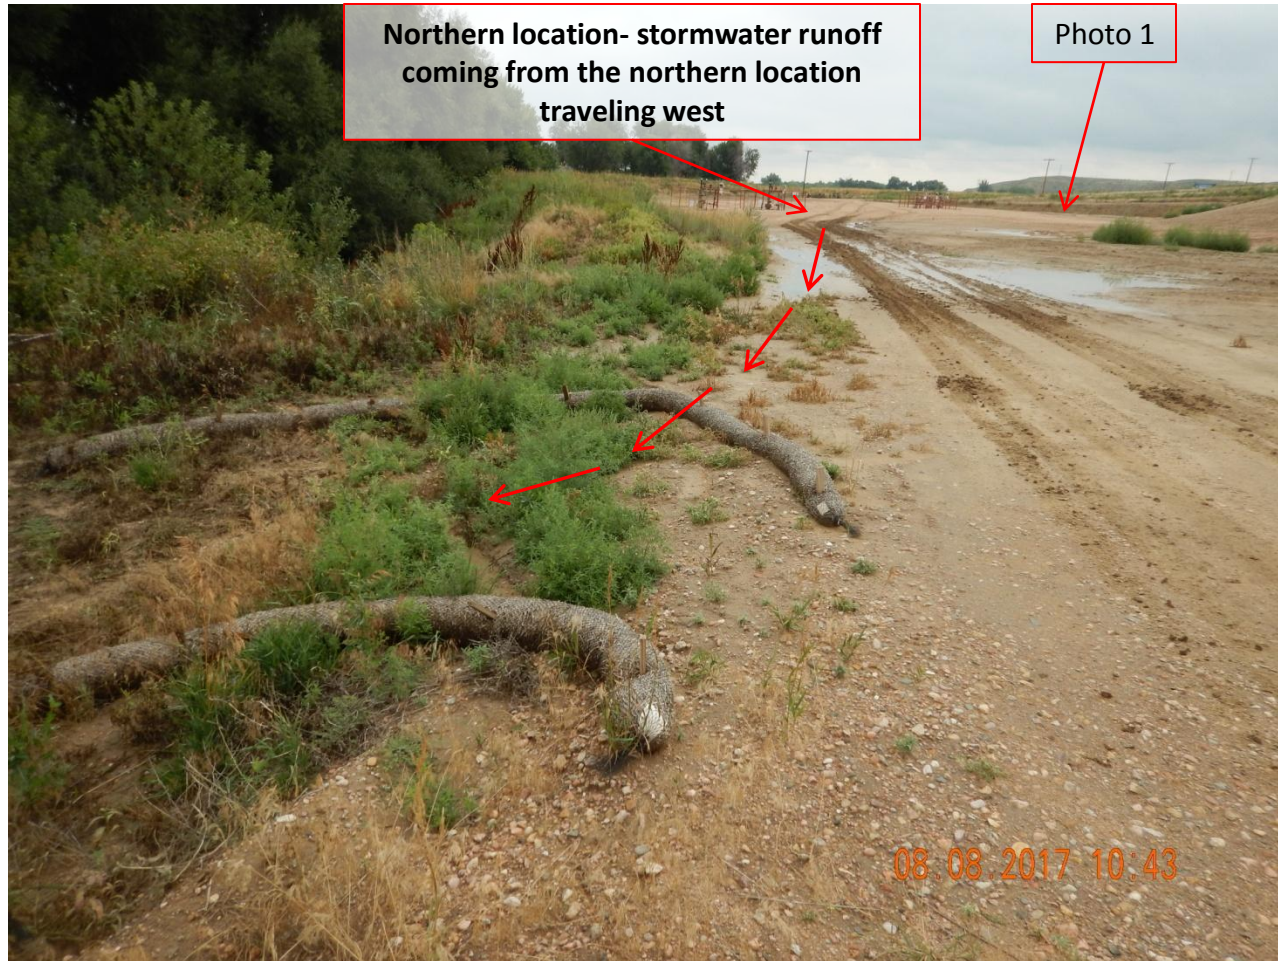
Photo 2. Photo taken from the area of erosion, facing East. This photo illustrates stormwater runoff coming from the northern location that is traveling west and causing erosion off location into a wetland.

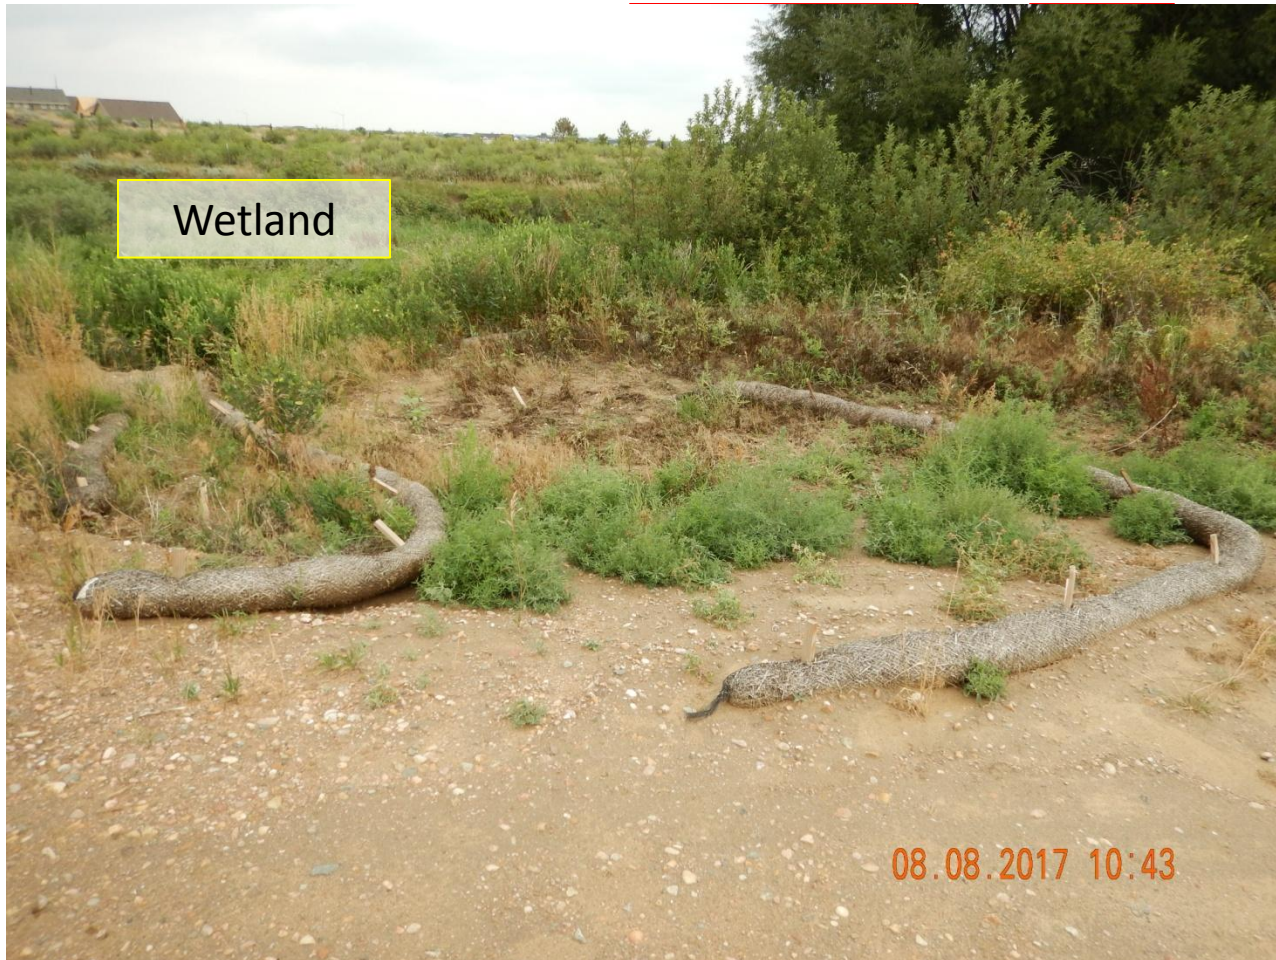
Photo 3. Photo taken from the area of erosion, facing North. Photo illustrates stormwater runoff that has caused wattle BMPs to dislodge and cause gully erosion. Operator claims these wattle BMPs are not theirs because it is off location and that the wattle BMPs are DCPs.

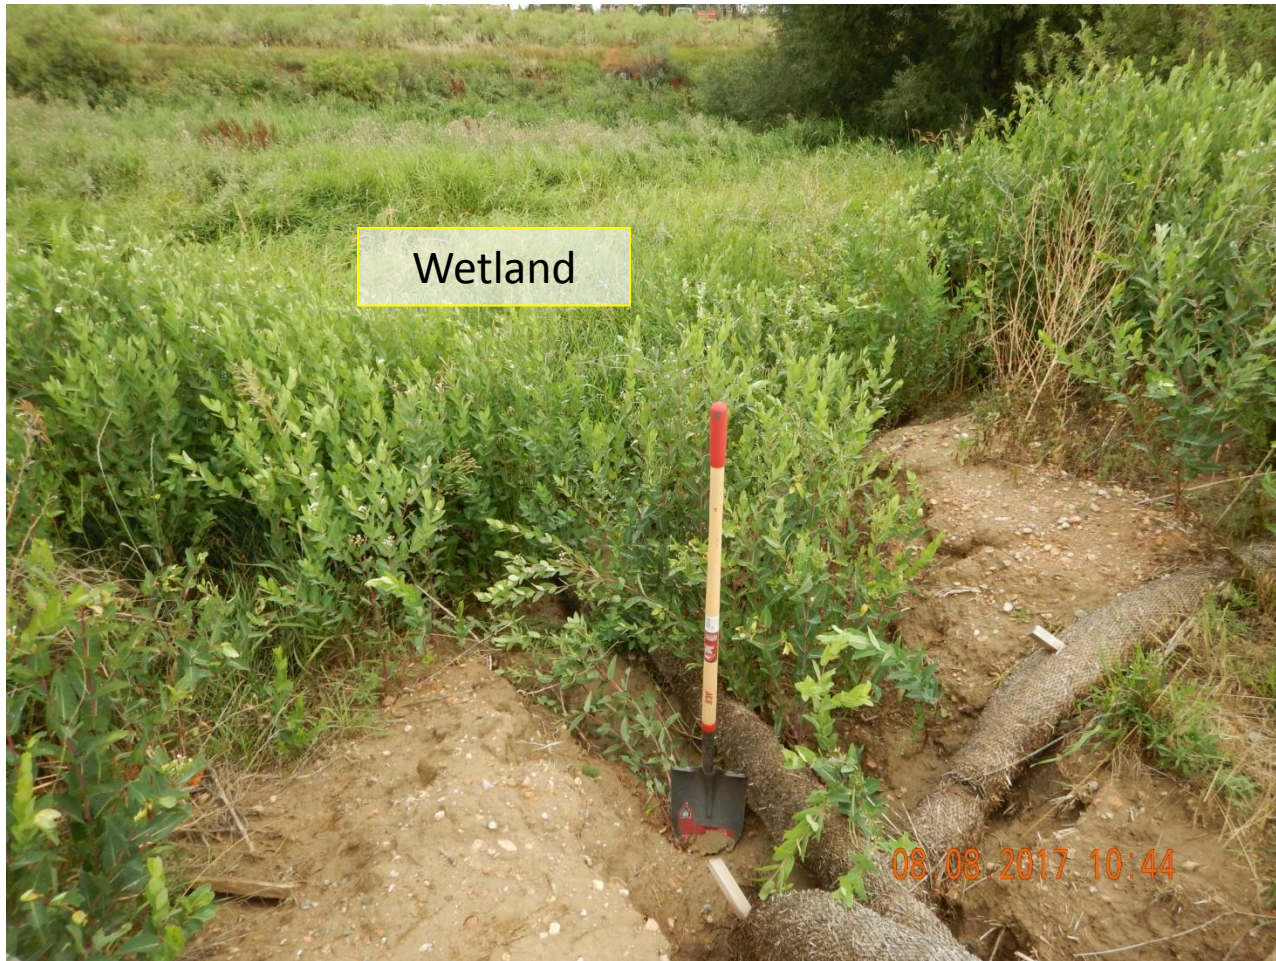
Photo 4. Photo taken from the area of erosion, facing North. Photo illustrates gully erosion, approximately 3' in depth, into a wetland.

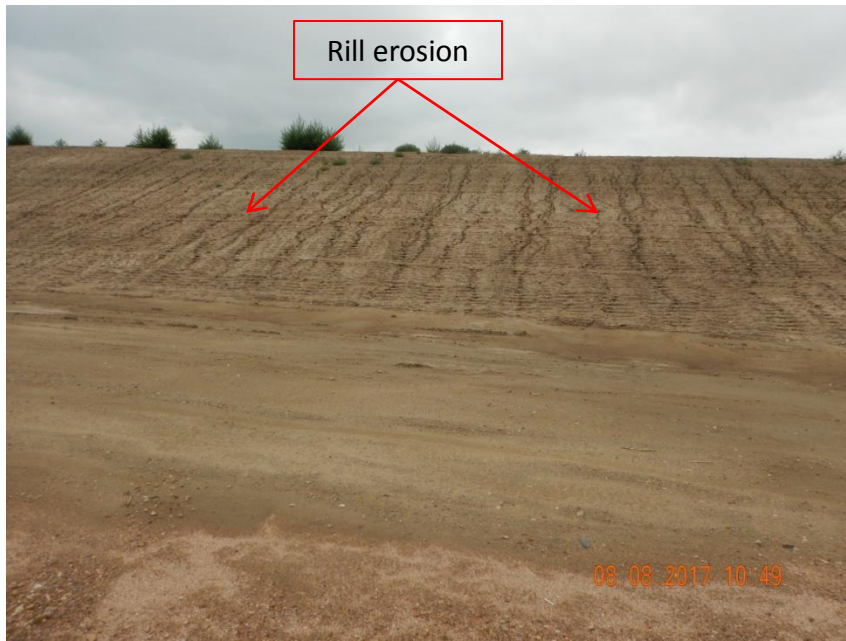
Photo 5. Photo taken from the northern location, facing South. This is the previously mentioned soil stockpile where rill erosion occurring and causing sedimentation at the toe of the soil stockpile. Soil stockpile needs to be stabilized to prevent rill erosion.

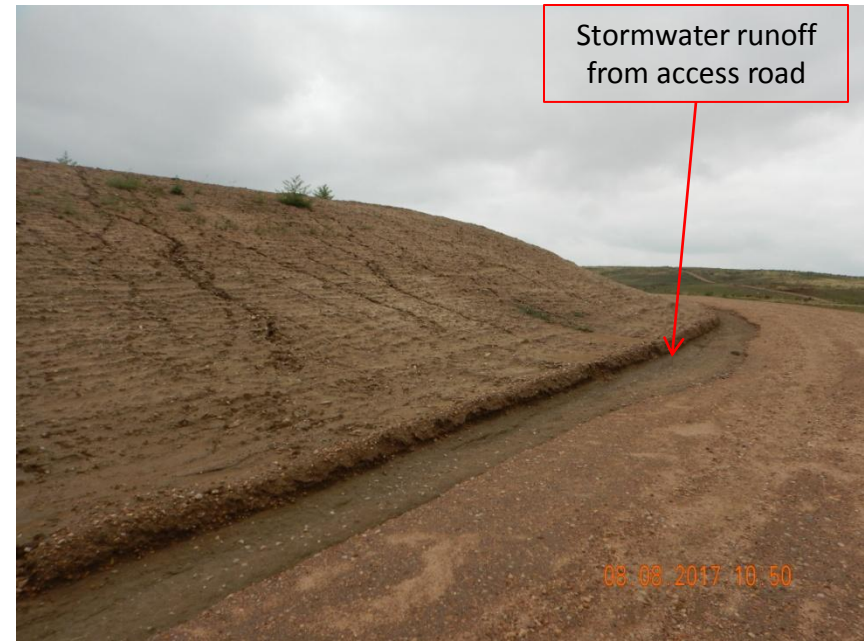
Photo 6. Photo taken from a portion of the access road, facing Southwest. This is the previously mentioned access road where stormwater runoff is traveling along the access road along the toe of the soil stockpile. Soil stockpile needs to be stabilized to prevent rill erosion.

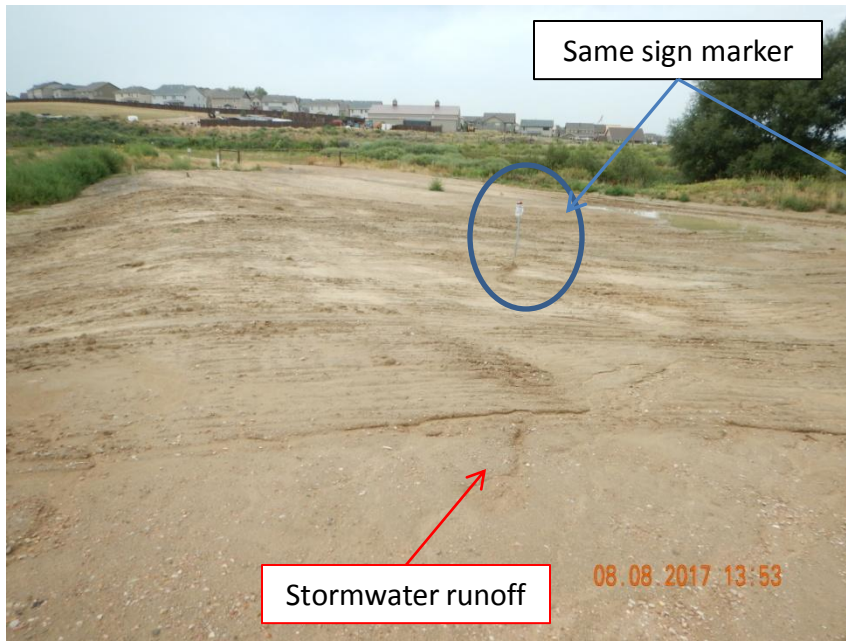
Photo 7. Photo taken from an eastern portion of the DCP pipeline area, facing West. Photo illustrates stormwater runoff coming from the access road of the Rancho Pad off location.

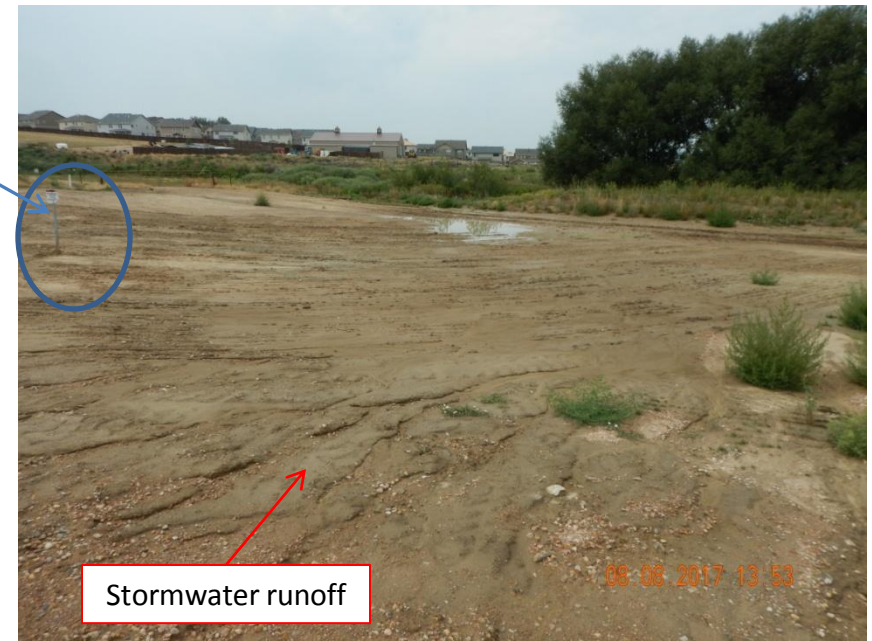
Photo 8. Photo taken from an eastern portion of a DCP pipeline area, facing West. Photo illustrates stormwater runoff coming from the access road of the Rancho Pad off location.

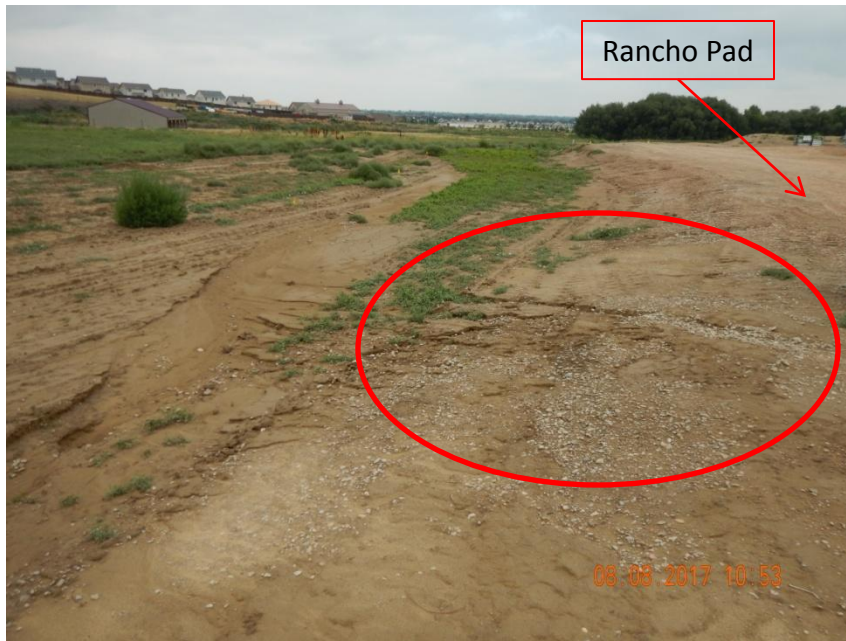
Photo 9. Photo taken from the western Rancho Pad, facing North. Photo illustrates stormwater erosion coming from the Rancho Pad and causing erosion off location.

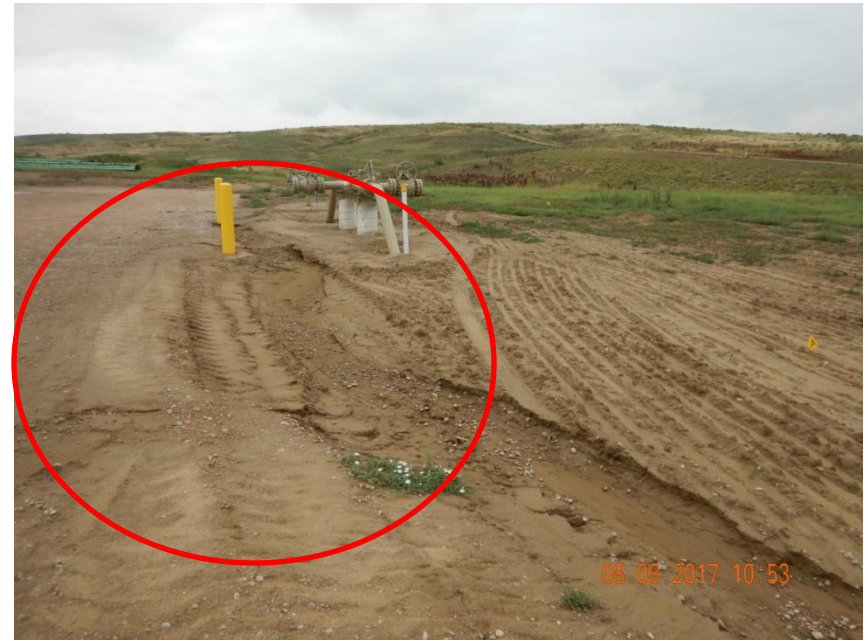
Photo 10. Photo taken from the western Rancho Pad, facing South. Photo illustrates stormwater erosion coming from the Rancho Pad and causing erosion off location.

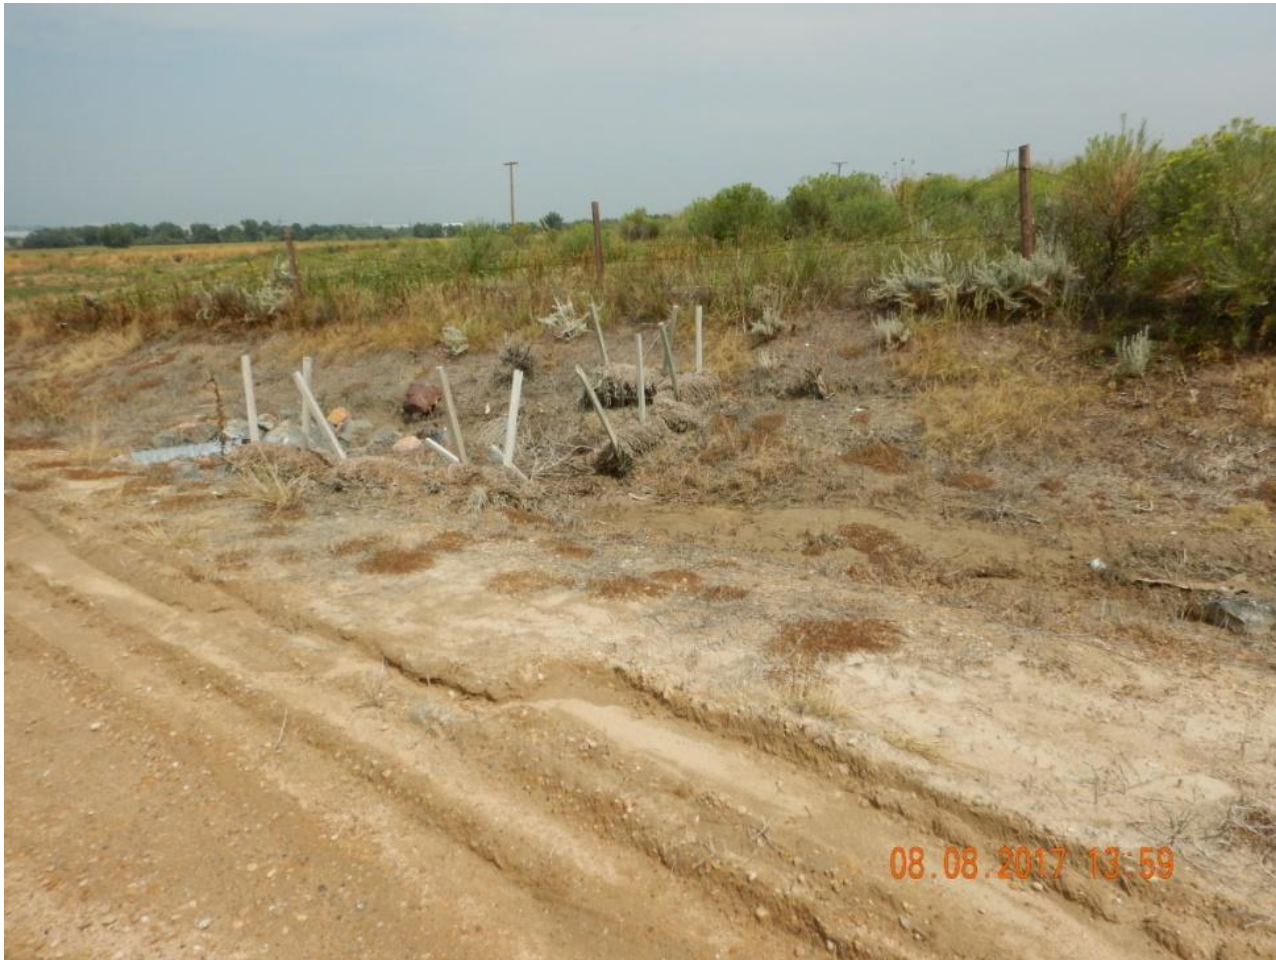
Photo 11. Photo taken from the eastern perimeter, facing Northeast. Stormwater BMPs for inlet protection are in need of maintenance.

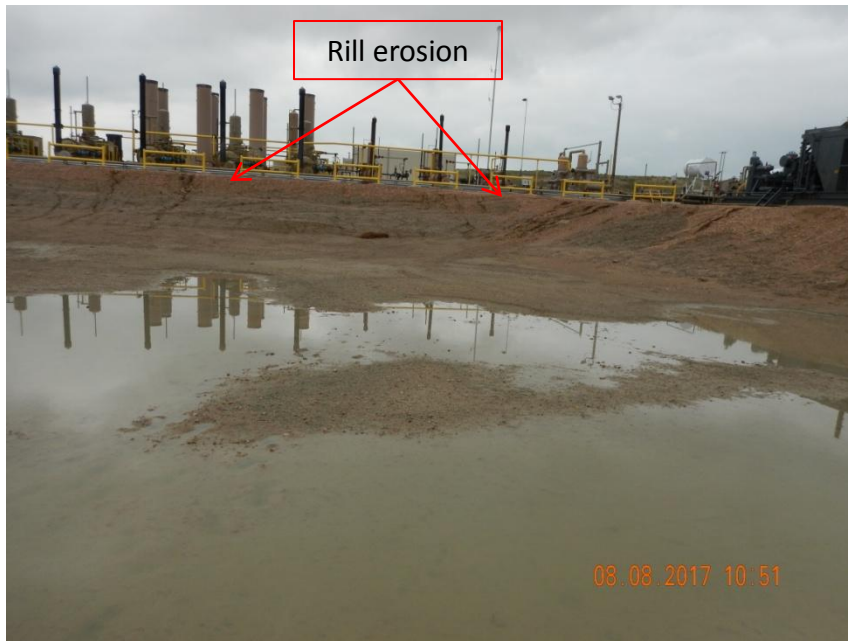
Photo 12. Photo taken from the Rancho Pad, facing South. Photo illustrates rill erosion occurring along the fill slopes of the production area.

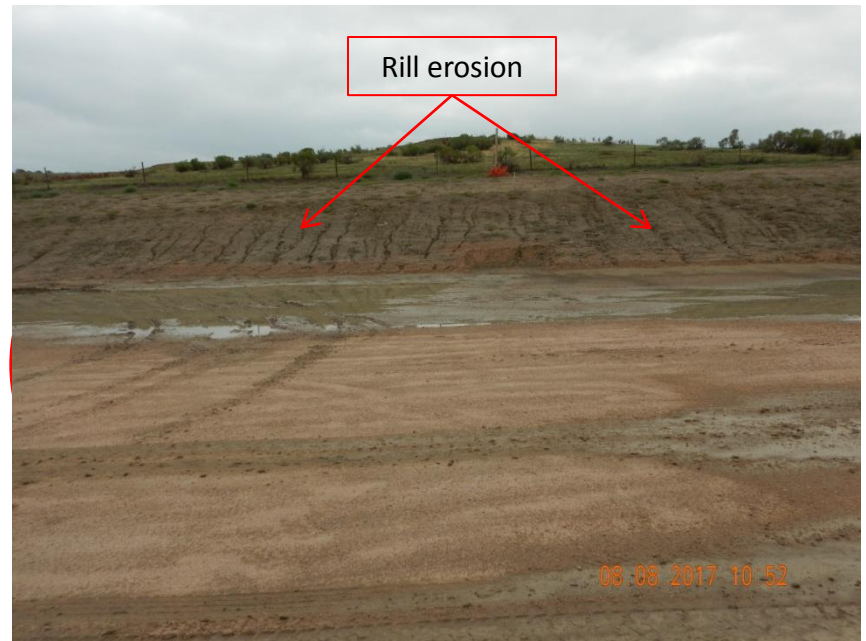
Photo 13. Photo taken from the eastern Rancho Pad, facing East. Photo illustrates rill erosion occurring along the cut slopes.
