Inspection Photos
Location Name SP 431-14
API: 05-045-19704

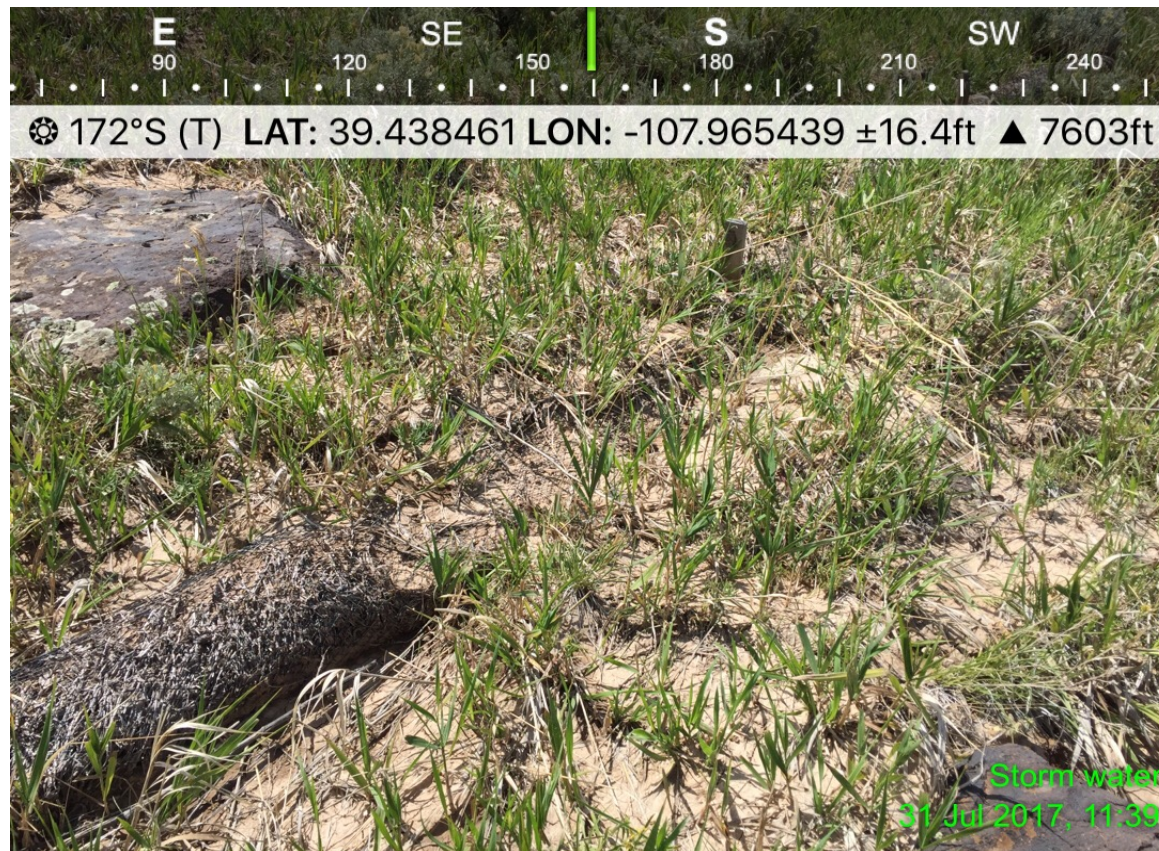
Photo 1. BMP damaged or not maintained

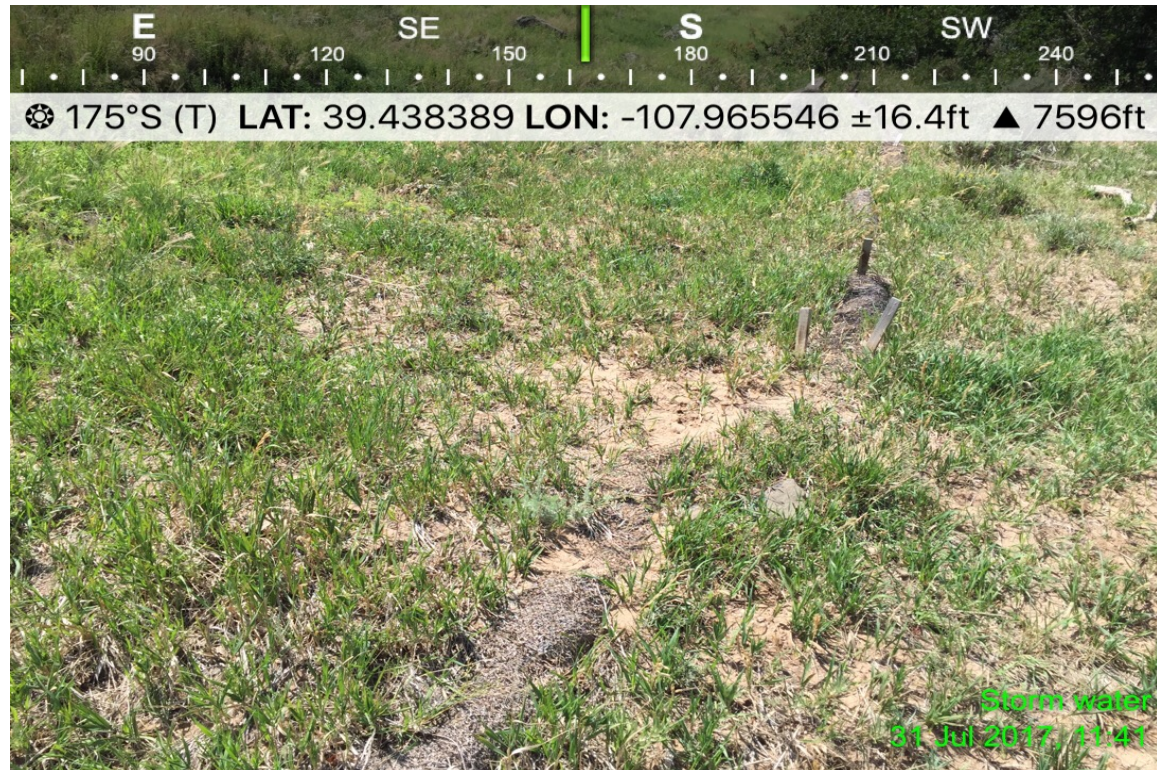
Photo 2. BMP damaged or not maintained

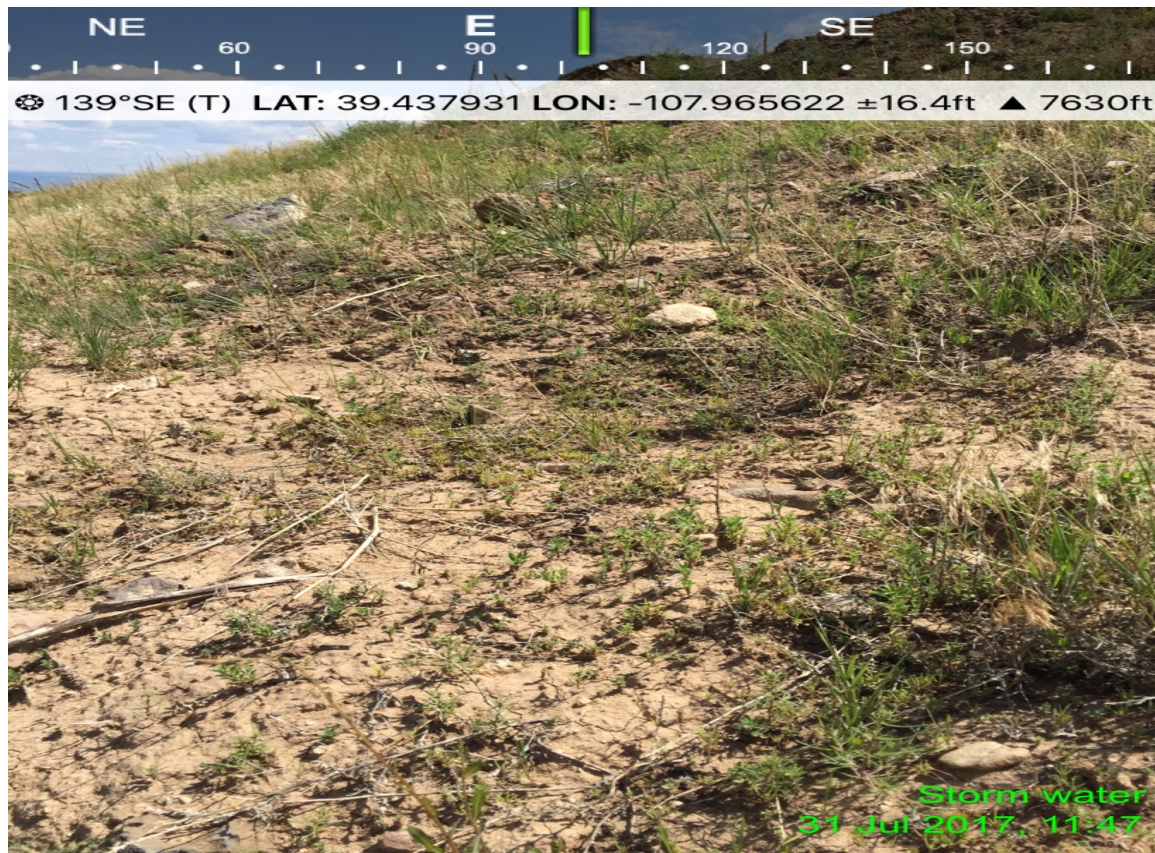
Photo 3. Sediment migration from pad surface

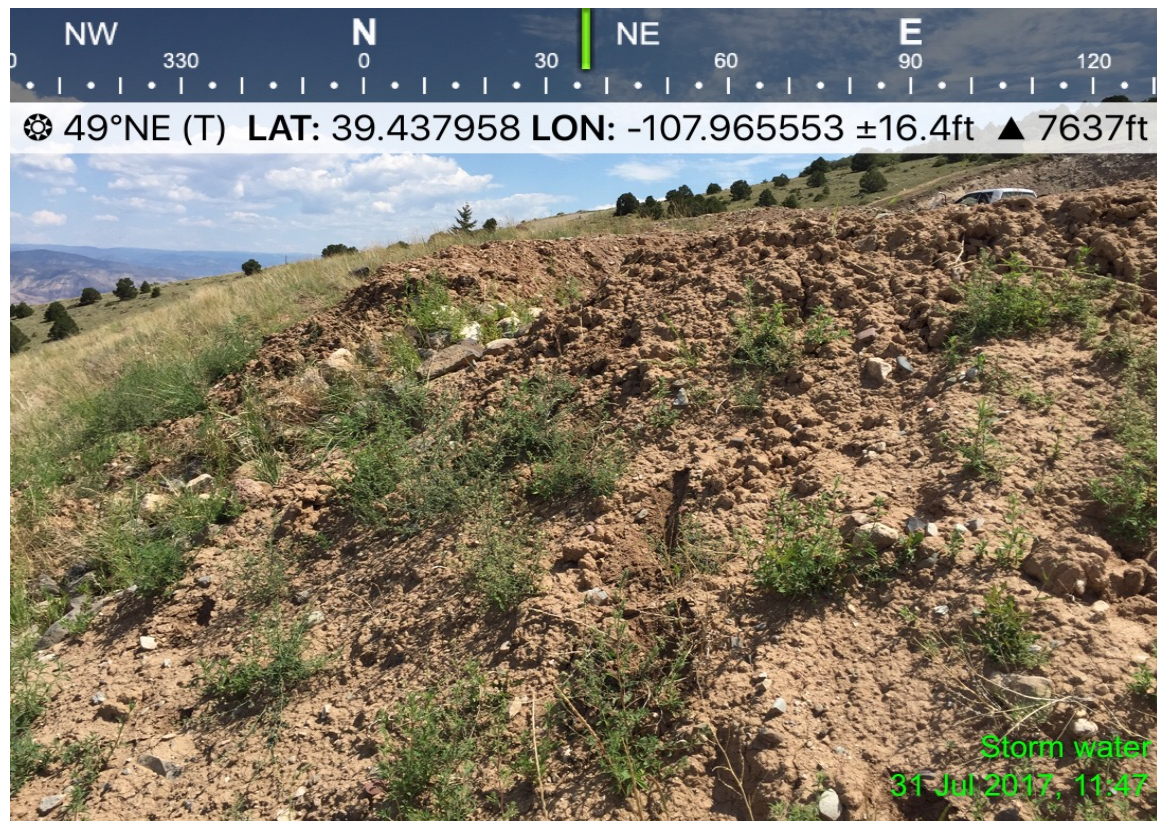
Photo 4. Sediment migration from pad surface

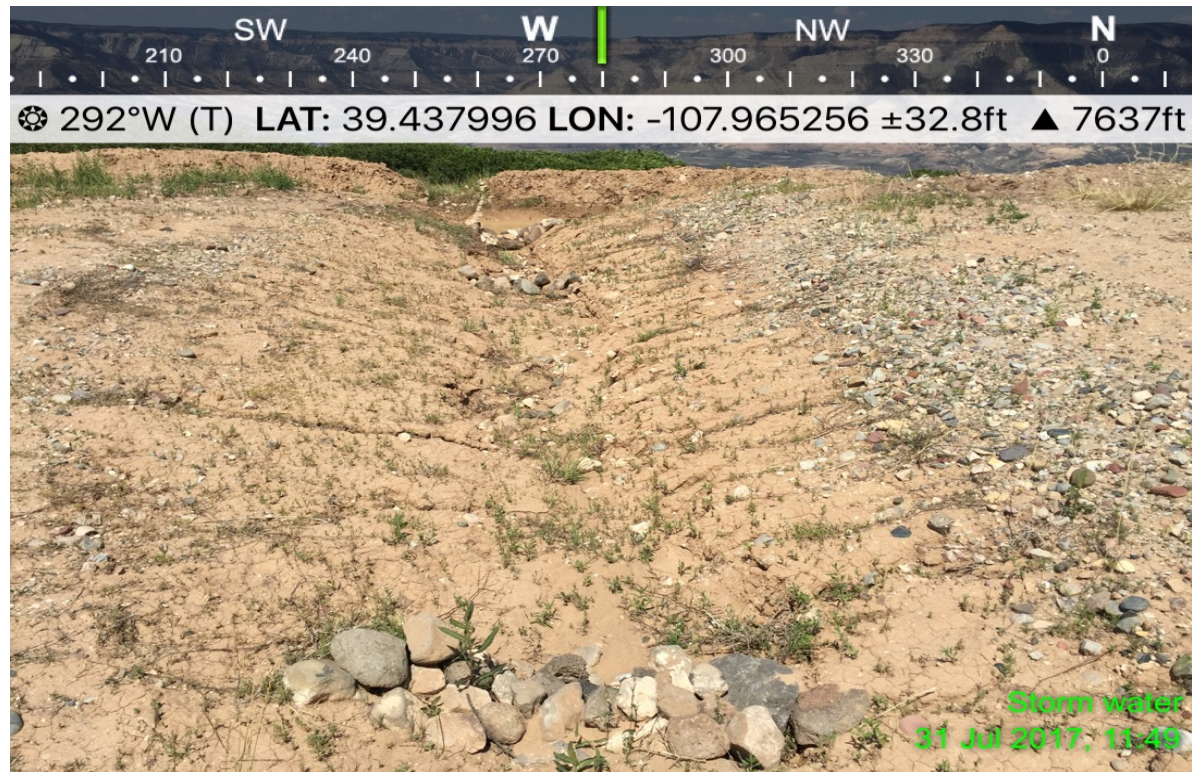
Photo 5. Erosion on pad surface

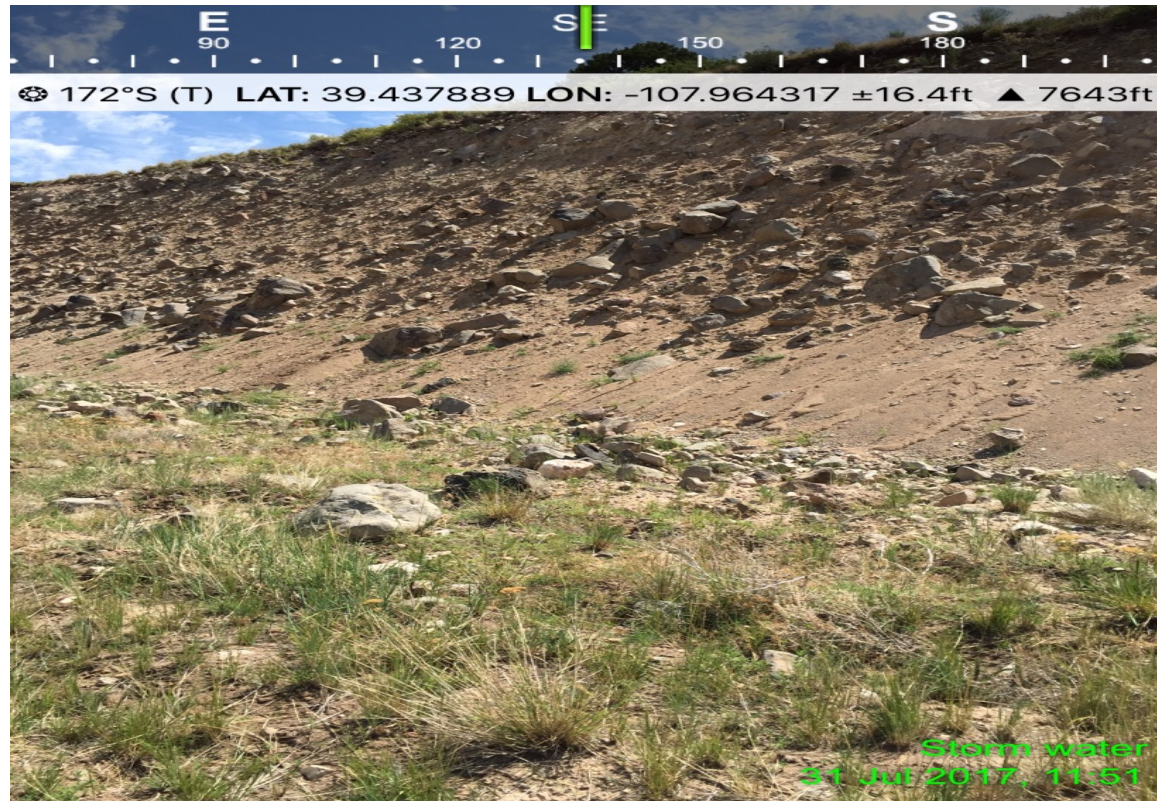
Photo 5. Cut slope not stabilized, debris and sediment moving onto pad

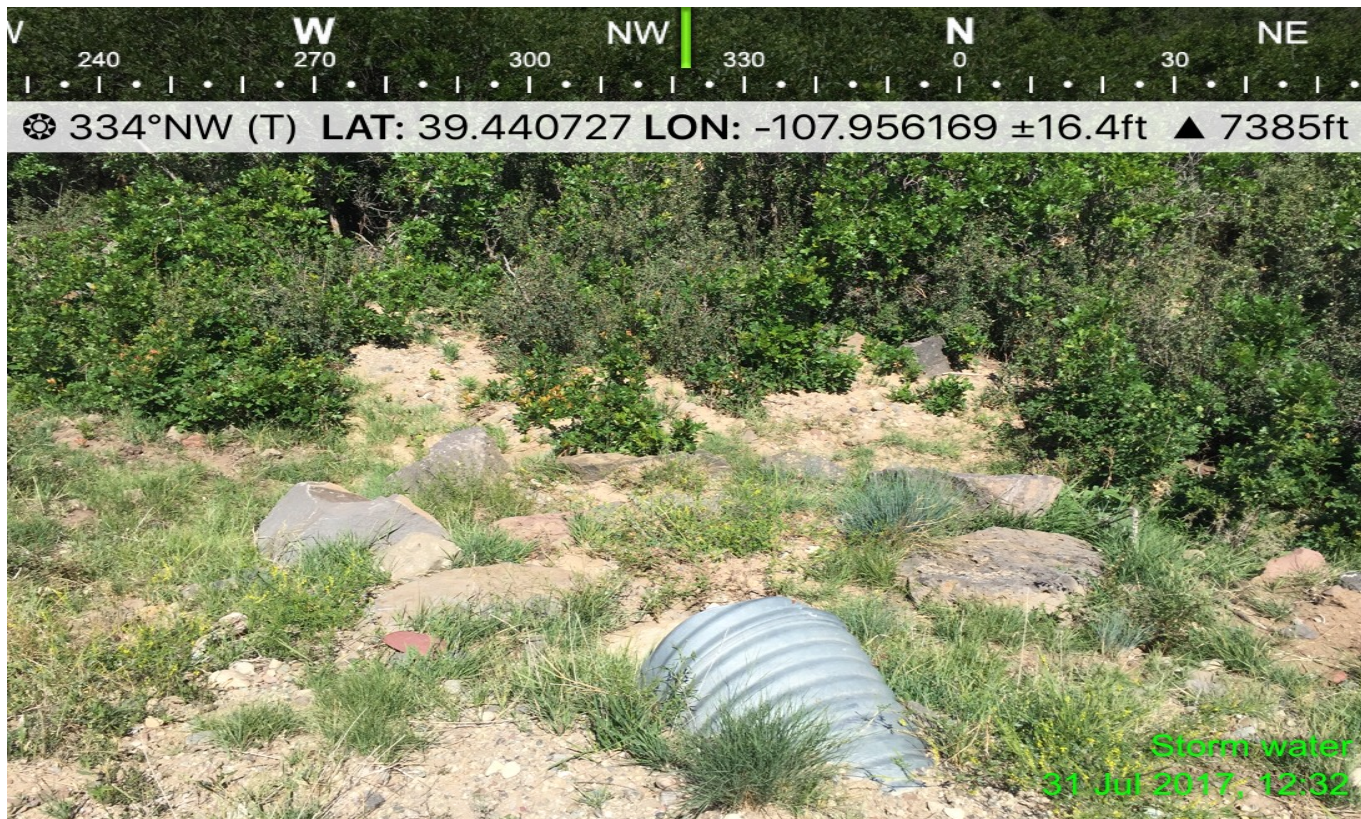
Photo 5. Sediment migration along lease road.
