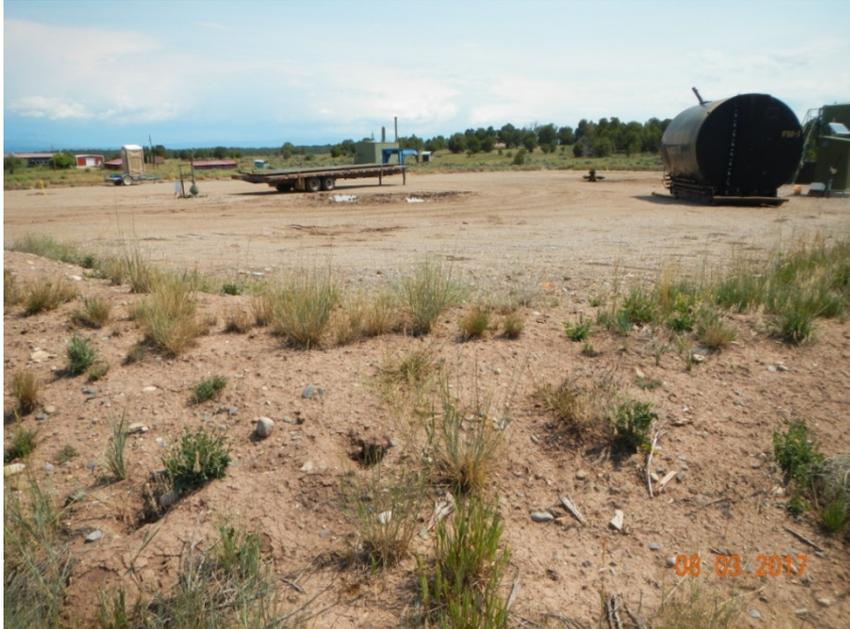
Photo 1: View of the project area from the southwestern edge facing center.

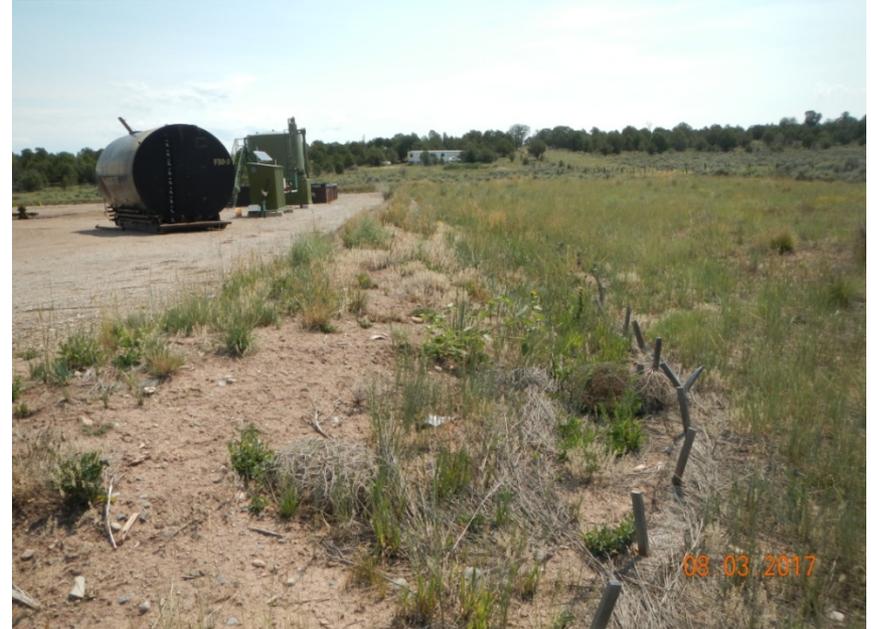
Photo 2: View of the southern portion of the project area from the southwestern edge of the well pad facing eastward. Revegetation is progressing with grasses such as crested wheatgrass (*Agropyron cristatum*) and western wheatgrass (*Pascopyrum smithii*).

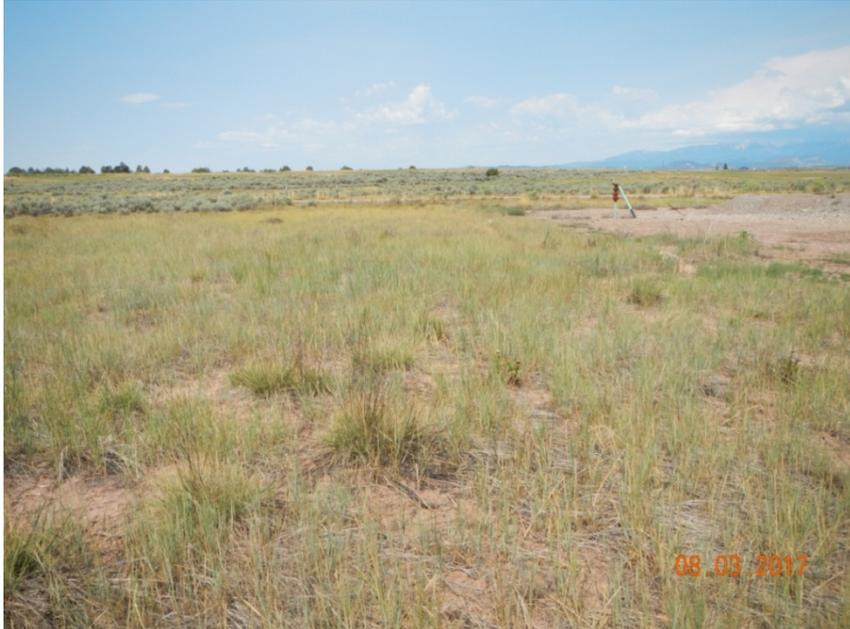
Photo 3: View of the southwestern portion of the project area from the southwestern edge of the well pad facing westward.

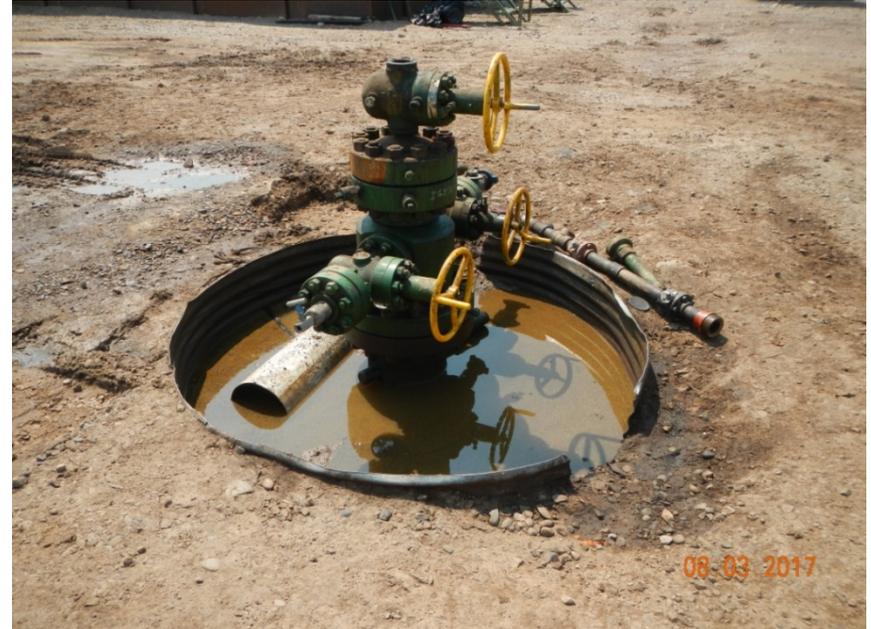
Photo 4: View of what appears to be oil and water in wellhead cellar.

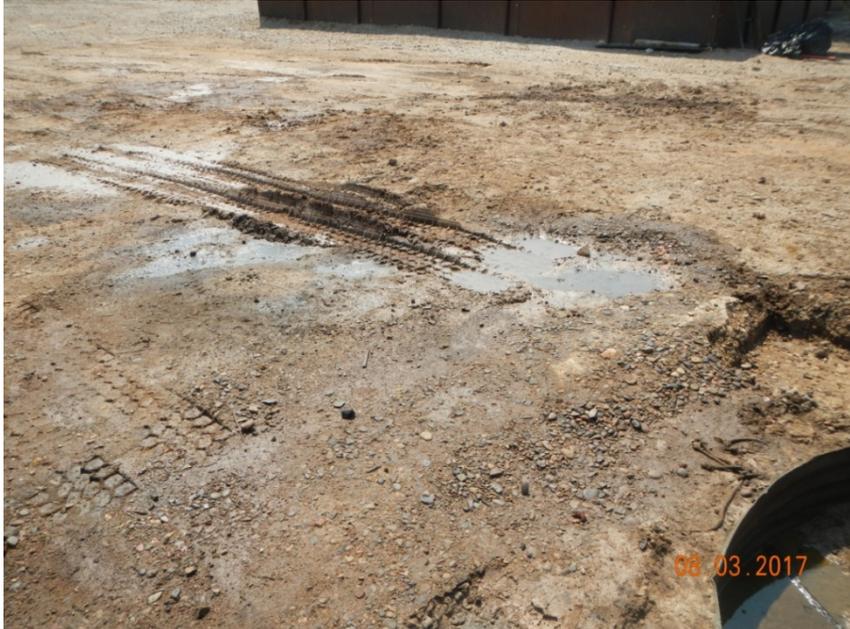
Photo 5: View of oil stained soils adjacent to wellhead.

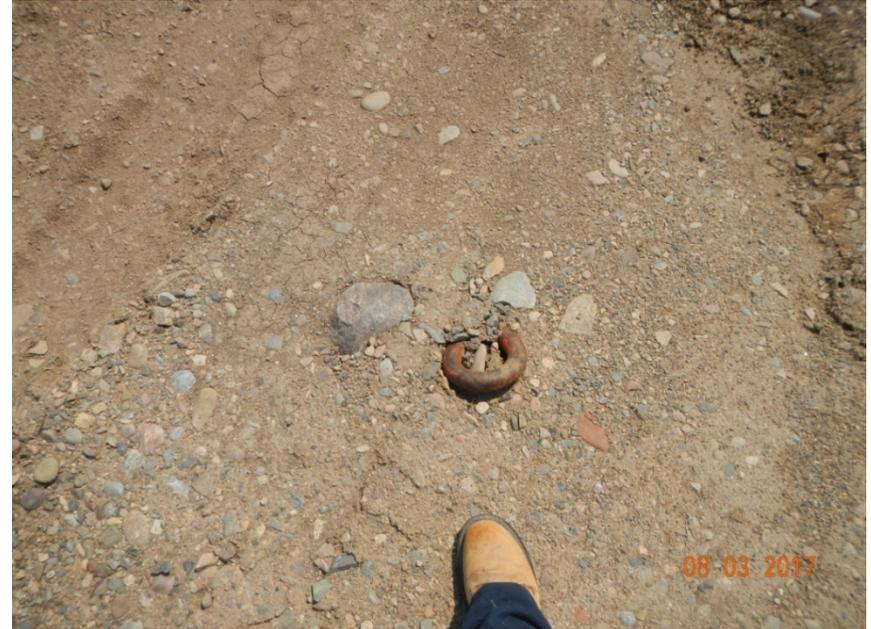
Photo 6: View of unmarked rig anchor in southern portion of well pad.

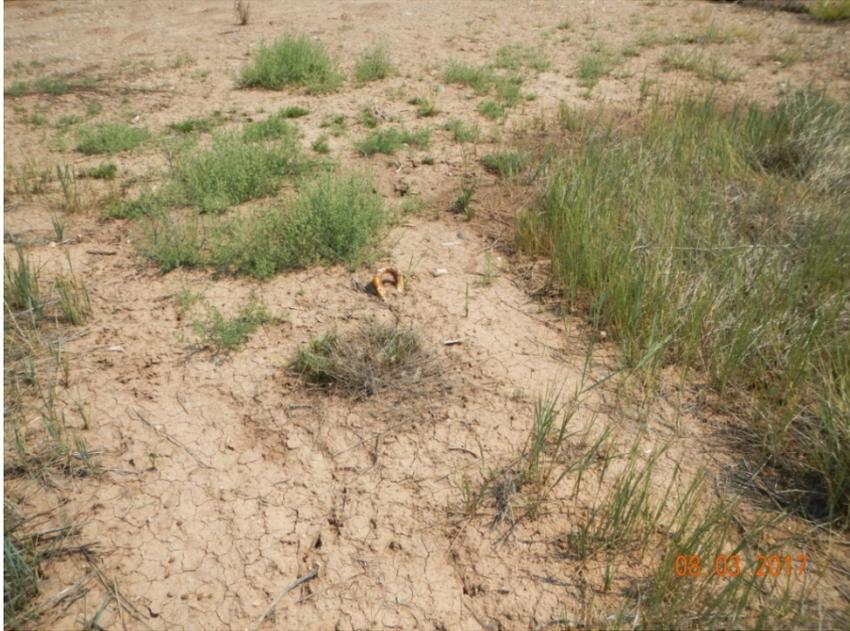
Photo 7: View of another unmarked rig anchor on the southern edge of the well pad.

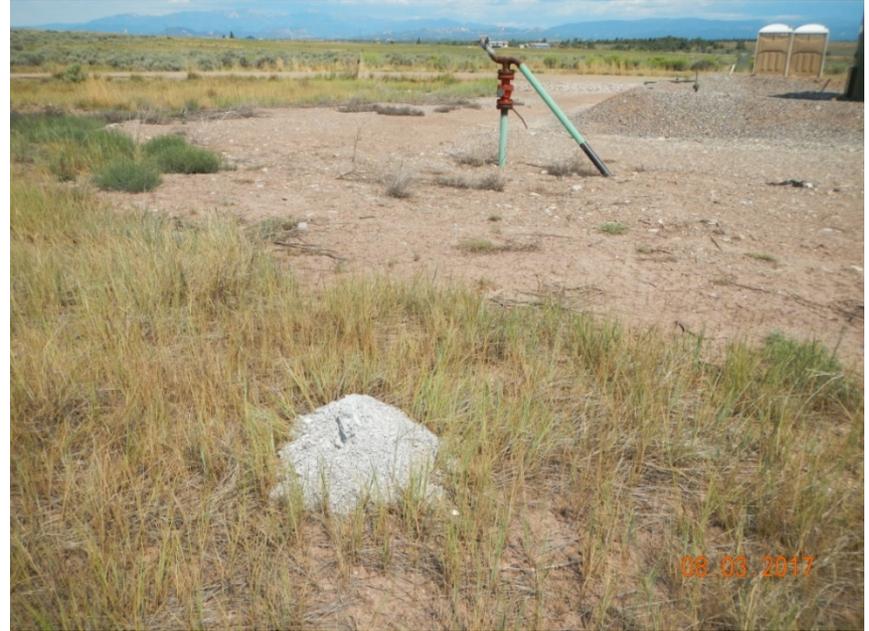
Photo 8: View of what appears to be cement debris or cuttings in the southern portion of the interim reclamation area.

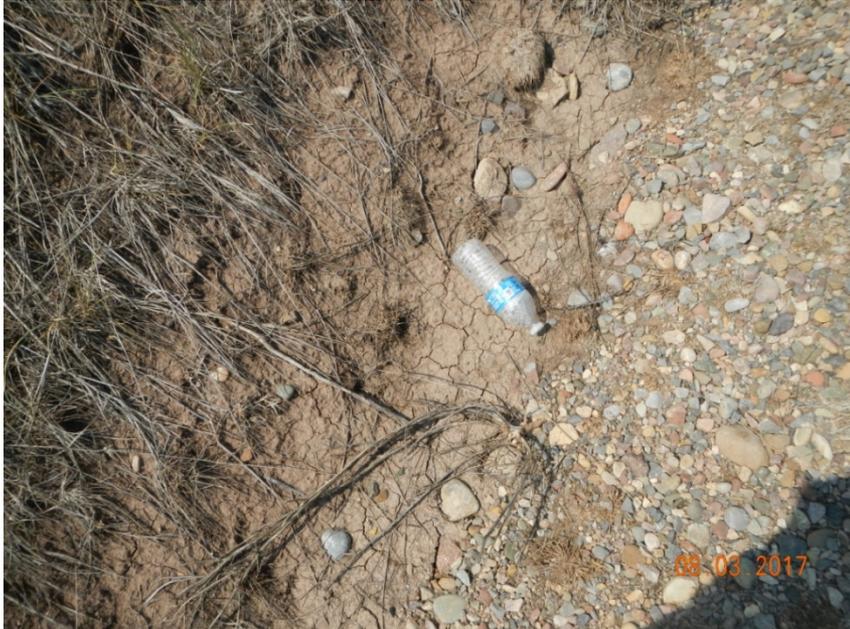
Photo 9: View of trash in the project area. Several of these water bottles are scattered around the project area.

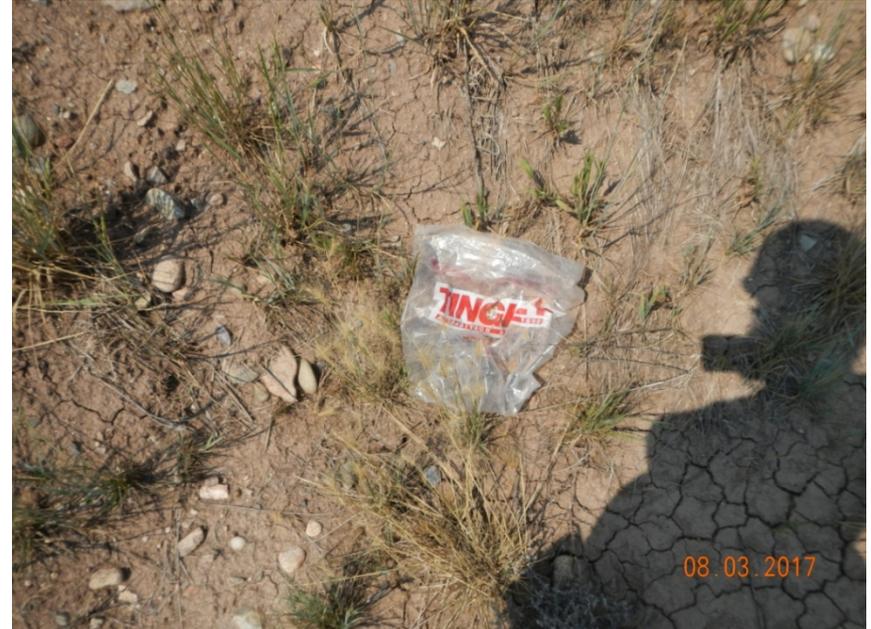
Photo 10: Another view of trash within the project area.

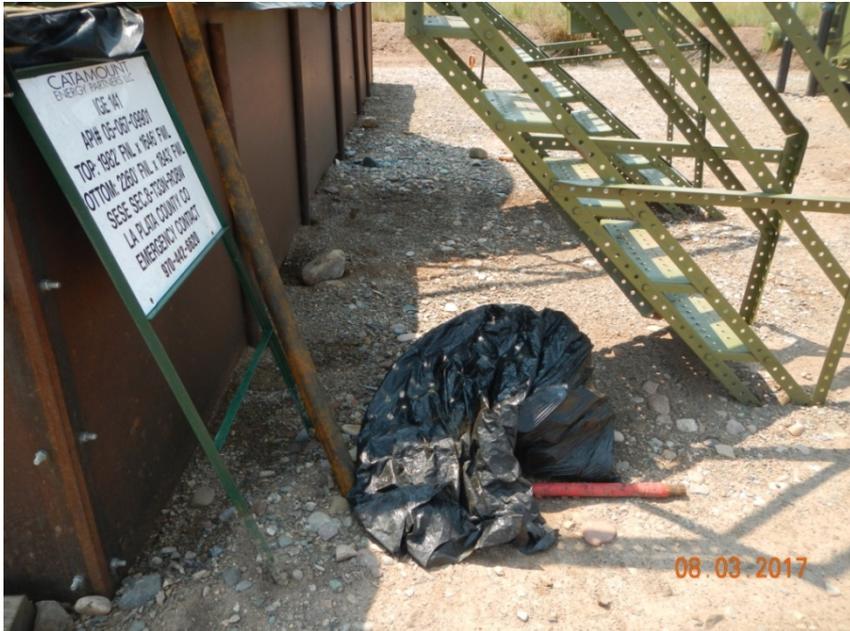
Photo 11: View of unsecured trash bag within the project area.

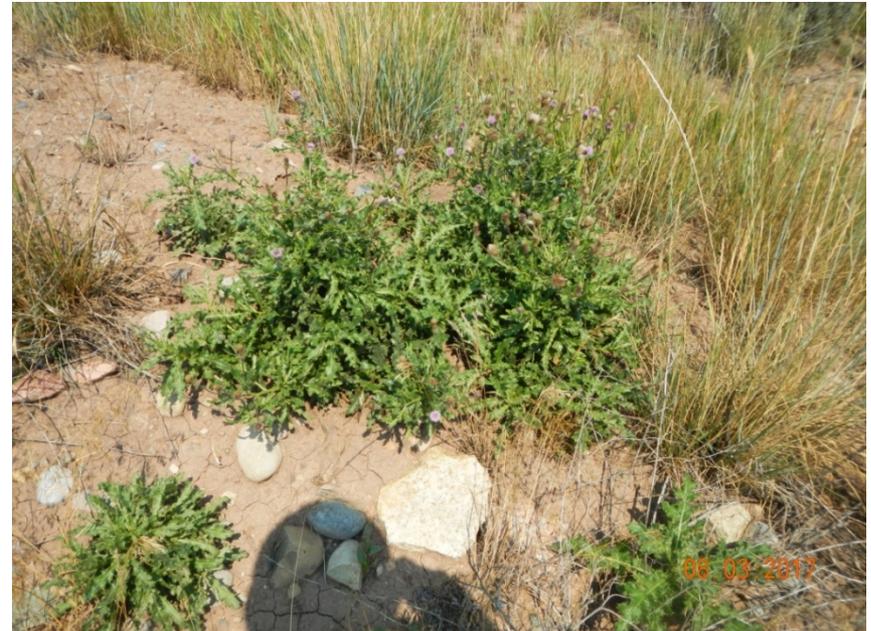
Photo 12: View of Canada thistles (*Cirsium arvense*) within the project area.
