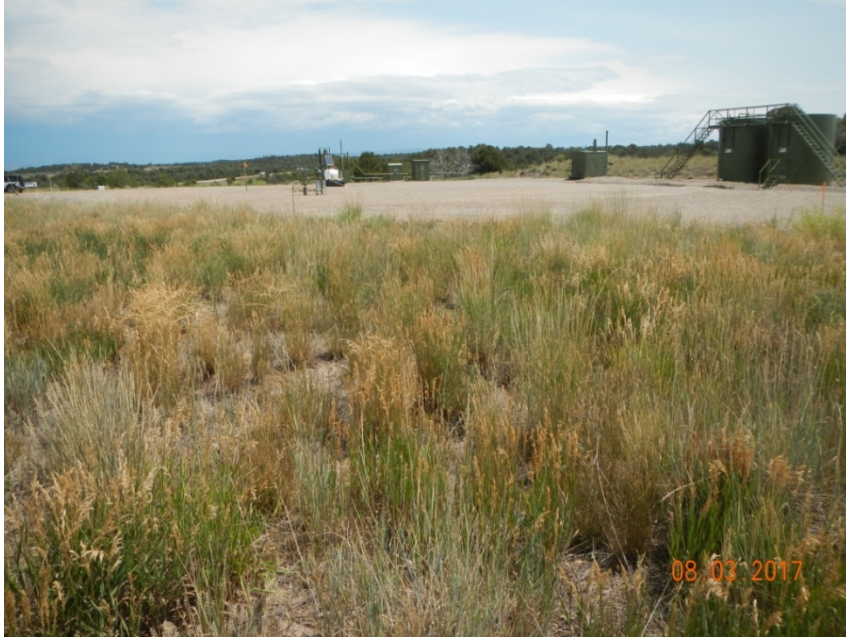
**Photo 1: View of the project area from the southwestern corner facing center.**

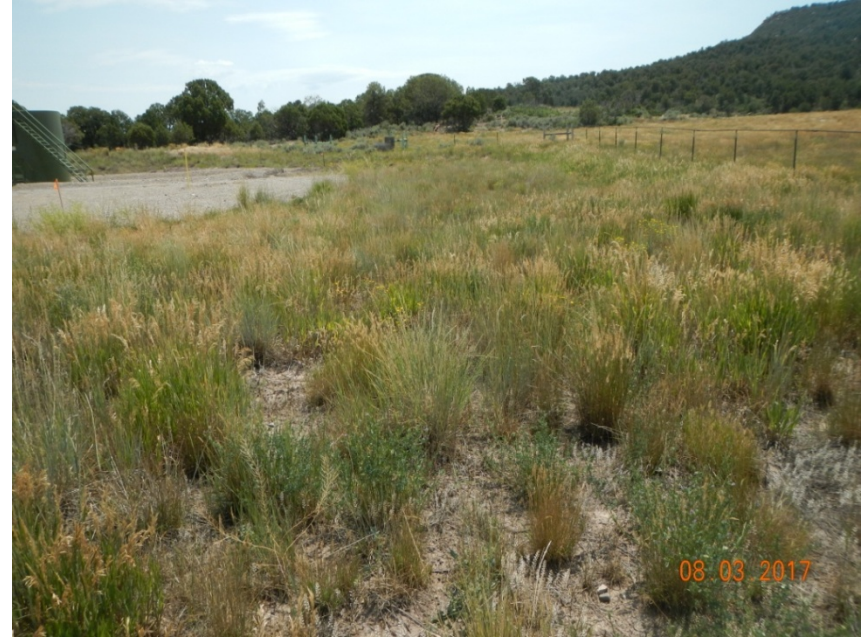
**Photo 2: View of the southern portion of the project area from the southwestern corner of the well pad facing southeastward. Revegetation is progressing with grasses such as crested wheatgrass (*Agropyron cristatum*), western wheatgrass (*Pascoyprum smithii*), and smooth brome (*Bromus inermis*).**

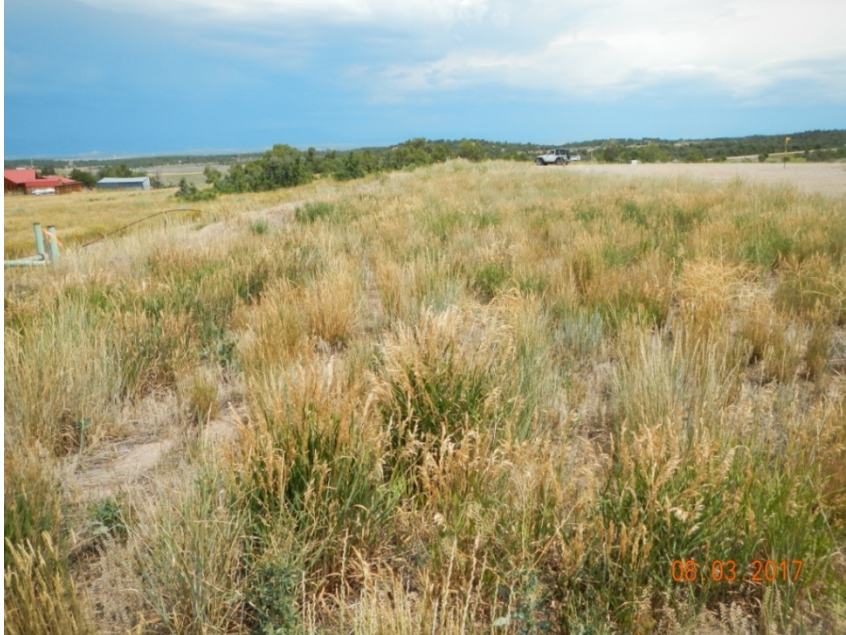
**Photo 3: View of the western portion of the project area from the southwestern corner of the well pad facing northeastward.**

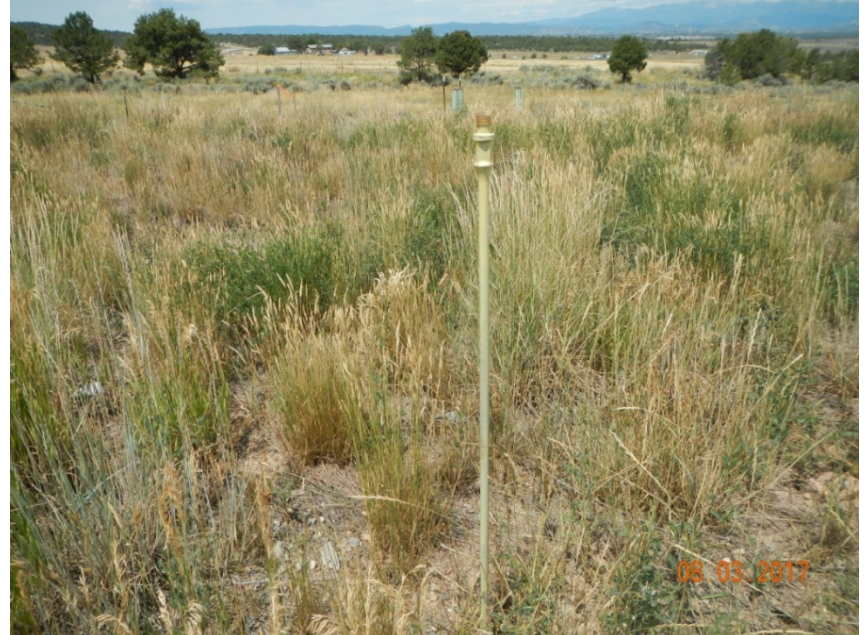
**Photo 4: View of unknown riser at approximately 37.093632, -107.726581 at the edge of the western portion of the project area.**

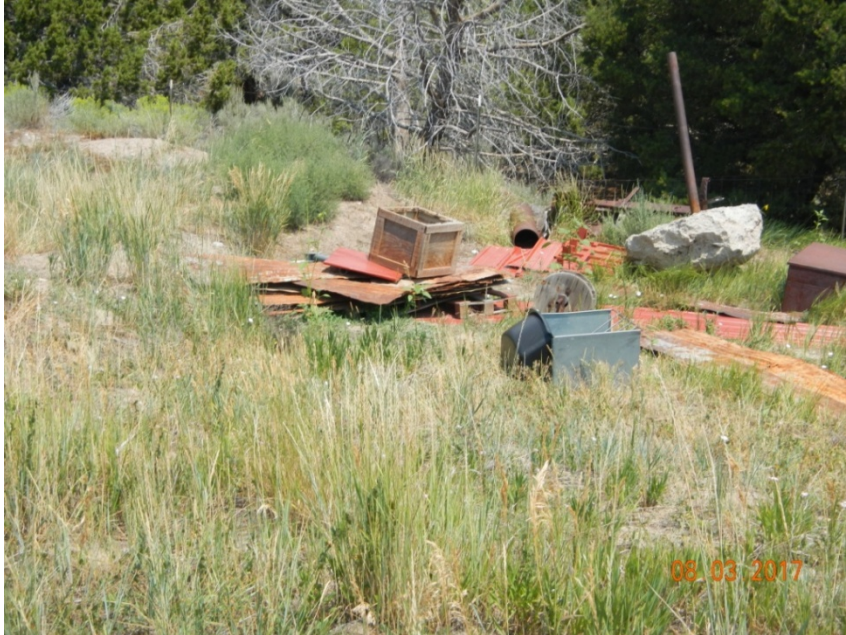
**Photo 5: View of what appears to be surface owner debris in the northeastern portion of the project area.**

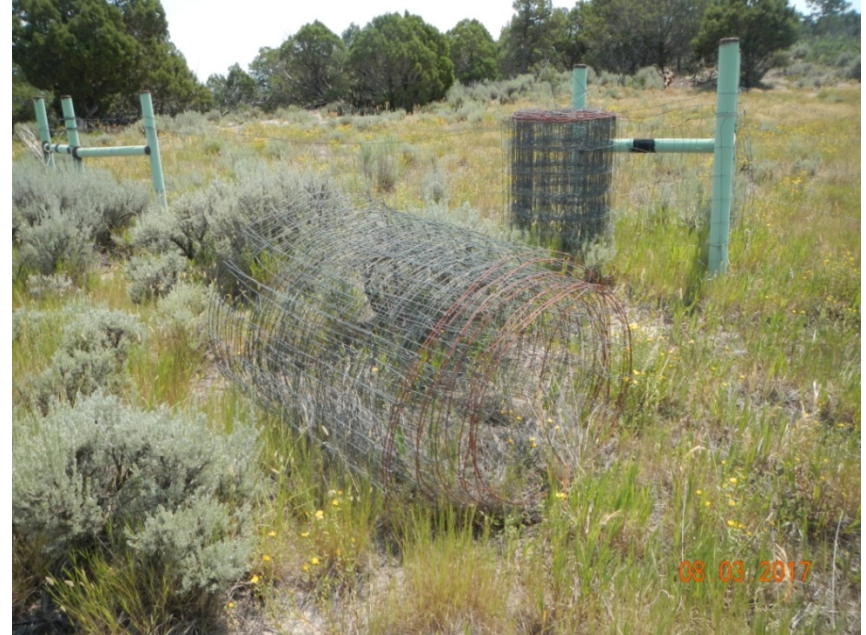
**Photo 6: View of fence debris in the southern portion of the project area.**

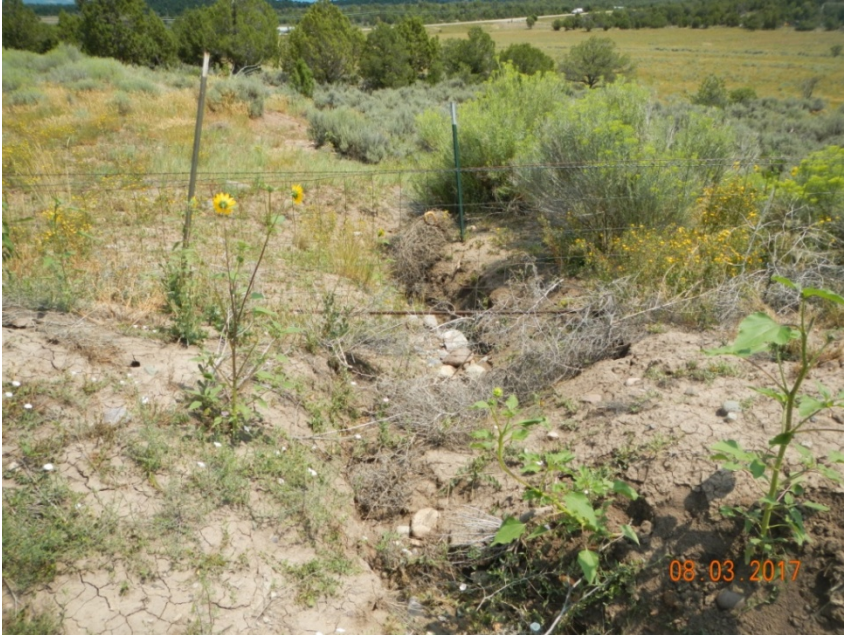
**Photo 7: View of erosional channel in the northern portion of the project area needing stabilization measures.**
