Inspection Photos
Location Name: Wagner 11-65 9-1H
API: 05-123-33345

COLORADO
Oil & Gas Conservation
Commission
Department of Natural Resources

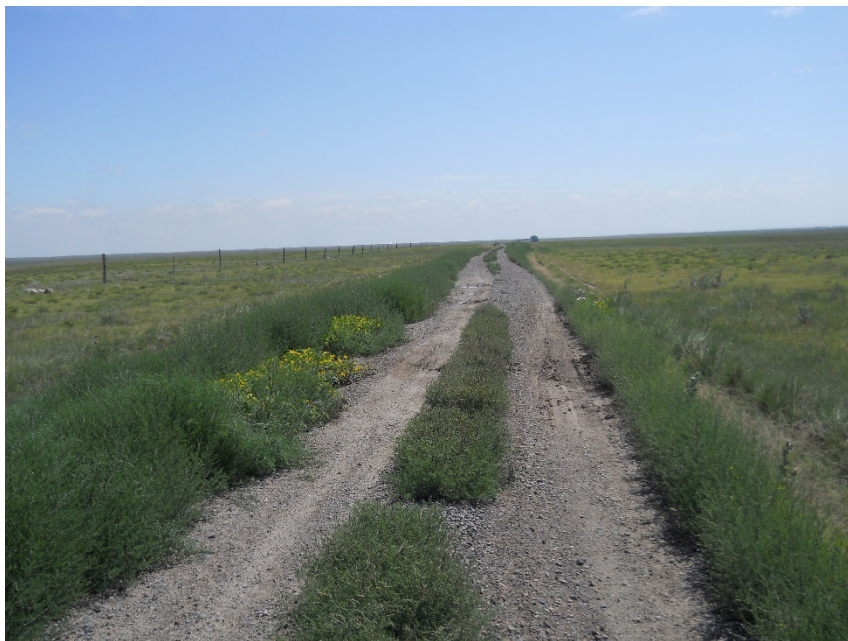
Access road looking east, weeds need controlled

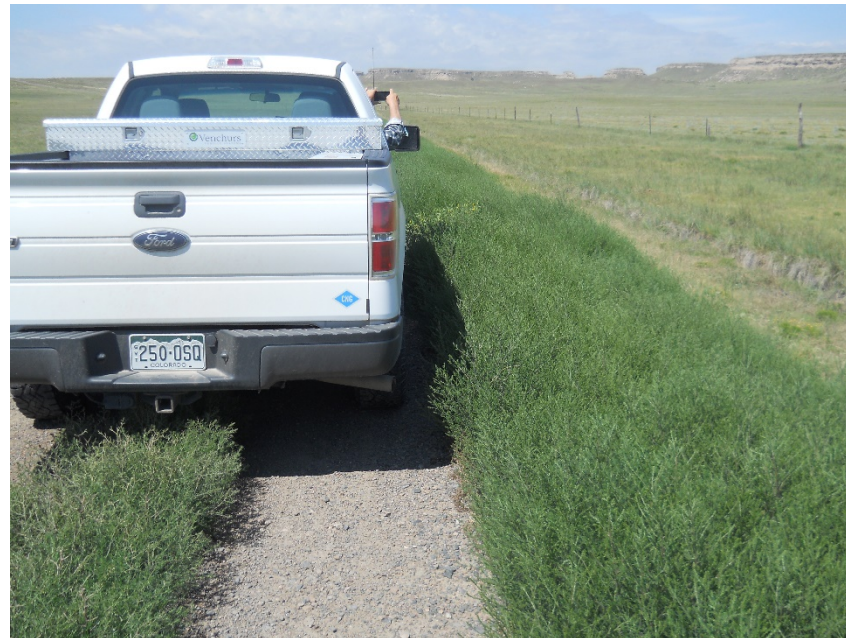
Access road heading west, weeds need controlled. Truck shown as reference to height

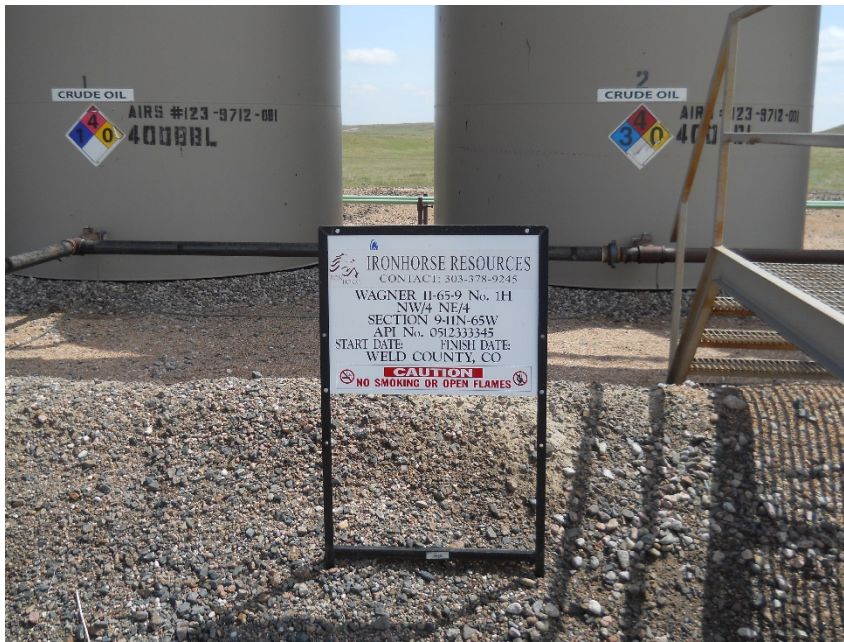
Battery sign looking east at production tanks

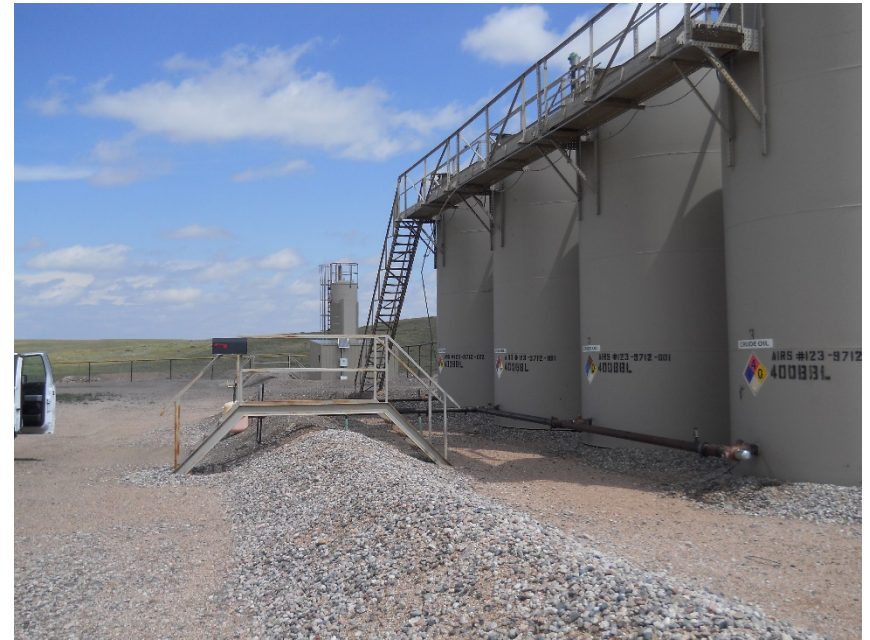
Tanks and heater treater from south side of tanks looking north

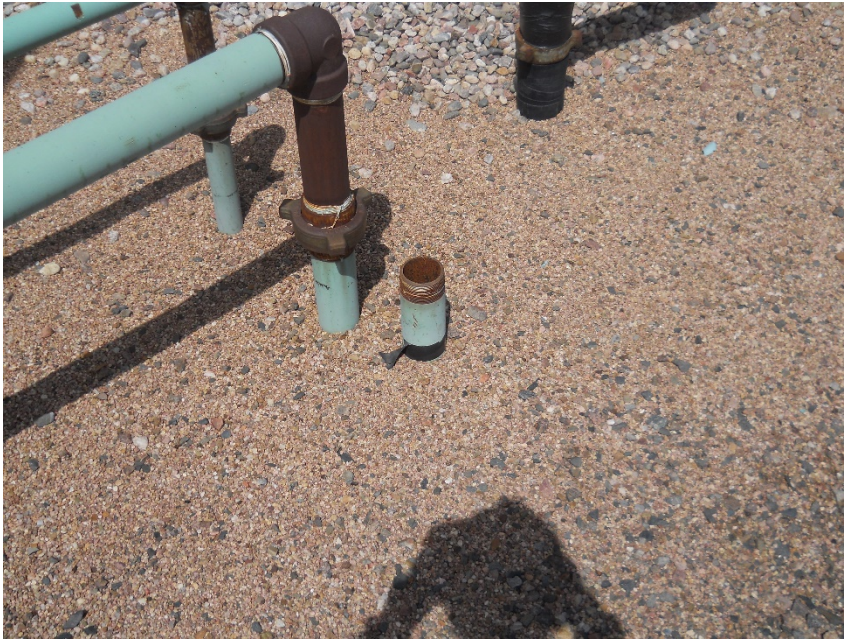
Unused/unmarked 3" riser on east side of north crude tank

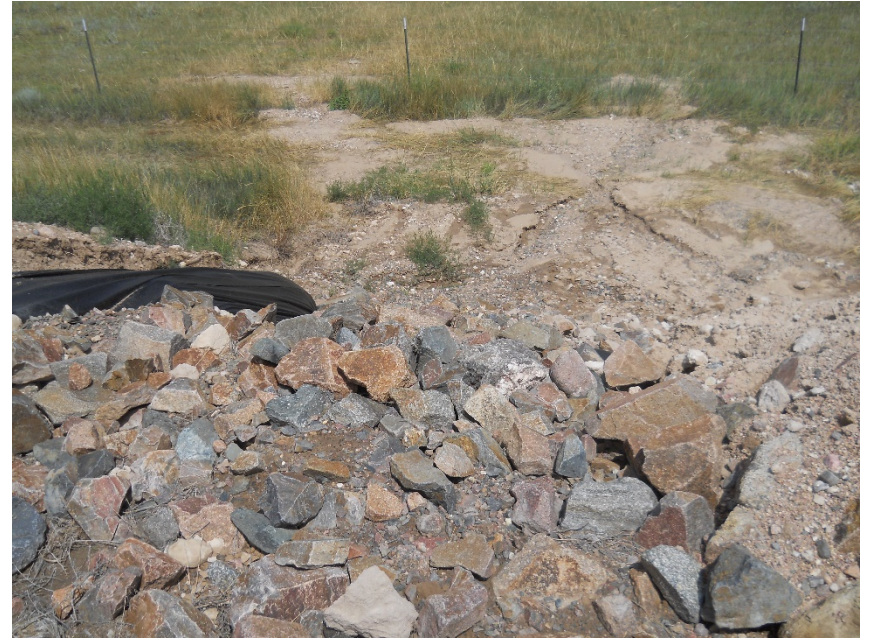
Erosion at discharge run down on north side of battery

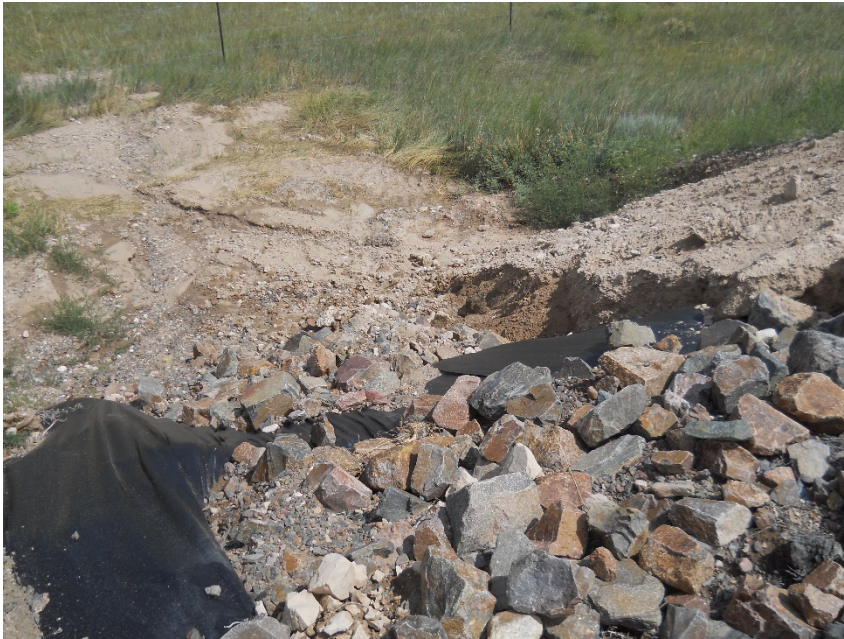
Erosion at discharge run down on north side of battery

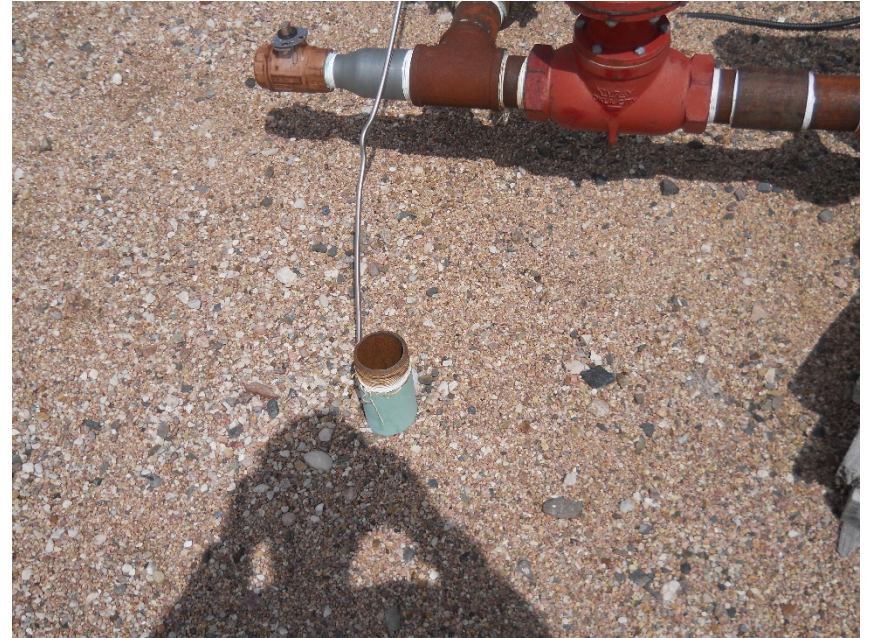
Unused/unmarked 3" riser on south side of ECD

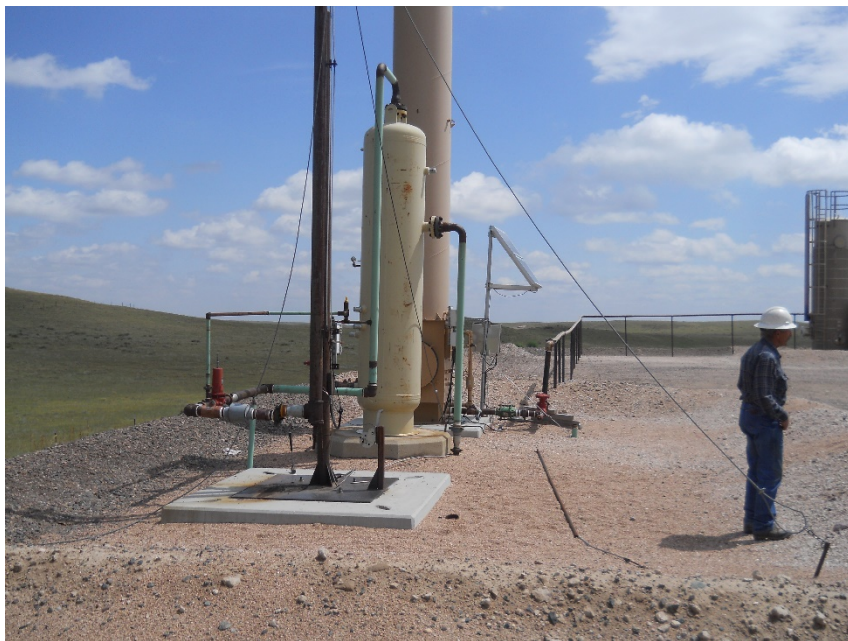
West side of ECD and flare looking east

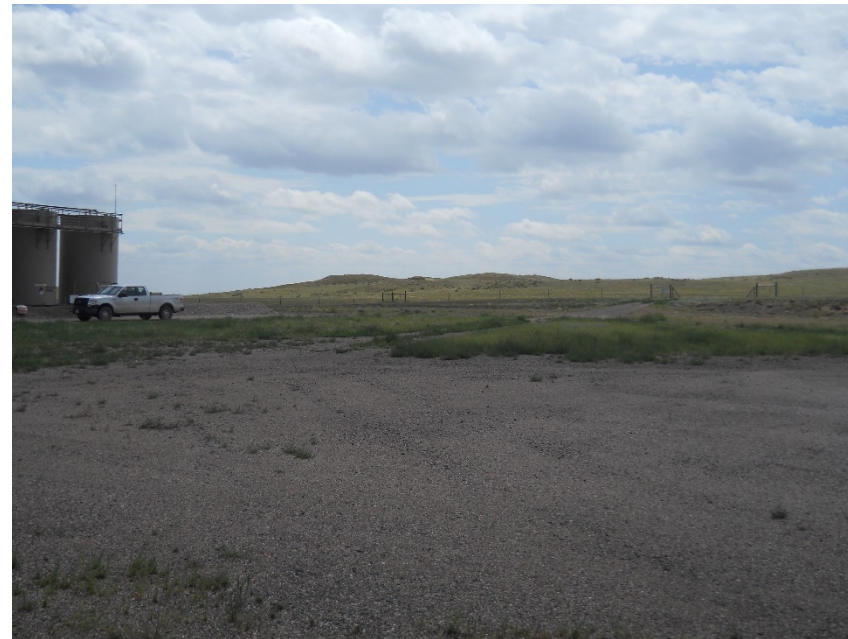
Weeds need to be controlled on location

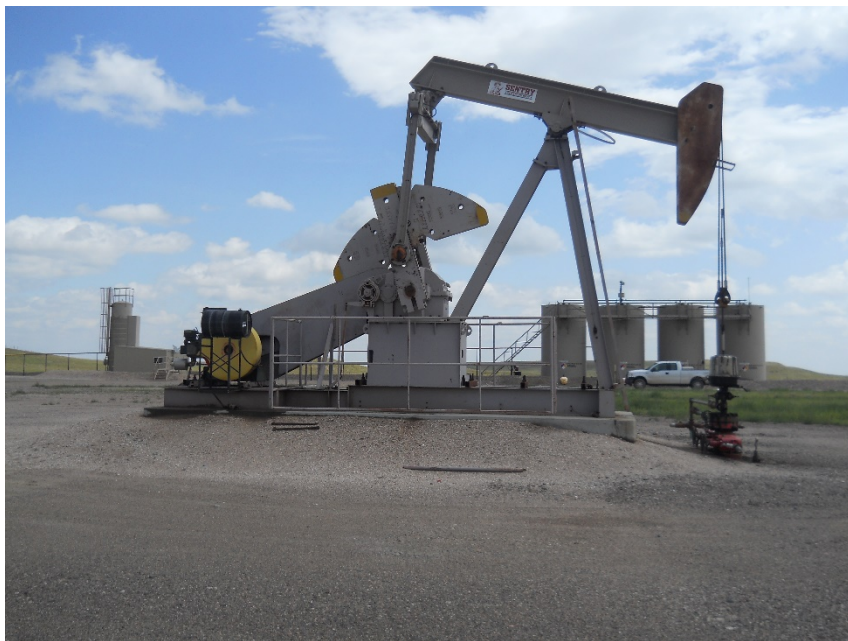
West side of pump jack looking east

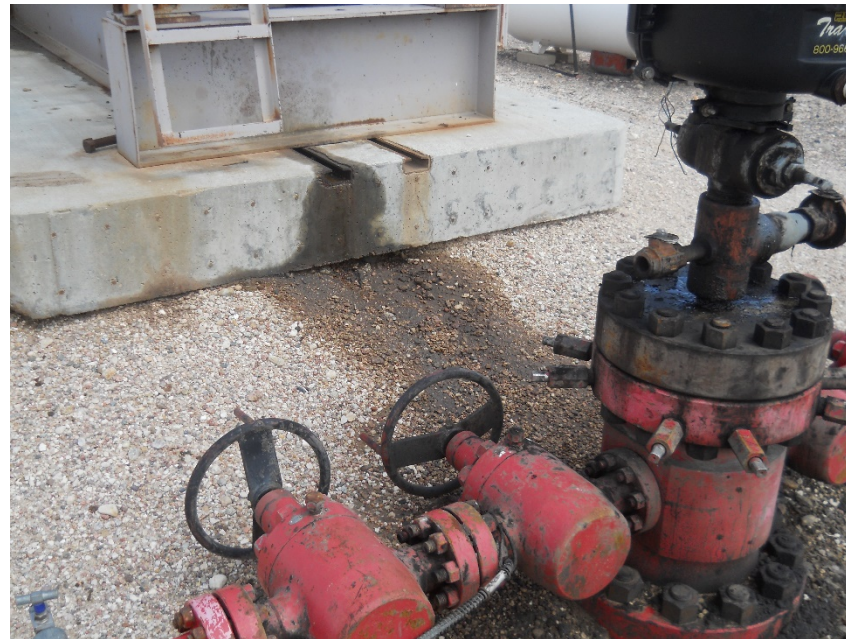
Stained soil at wellhead and pump jack skid

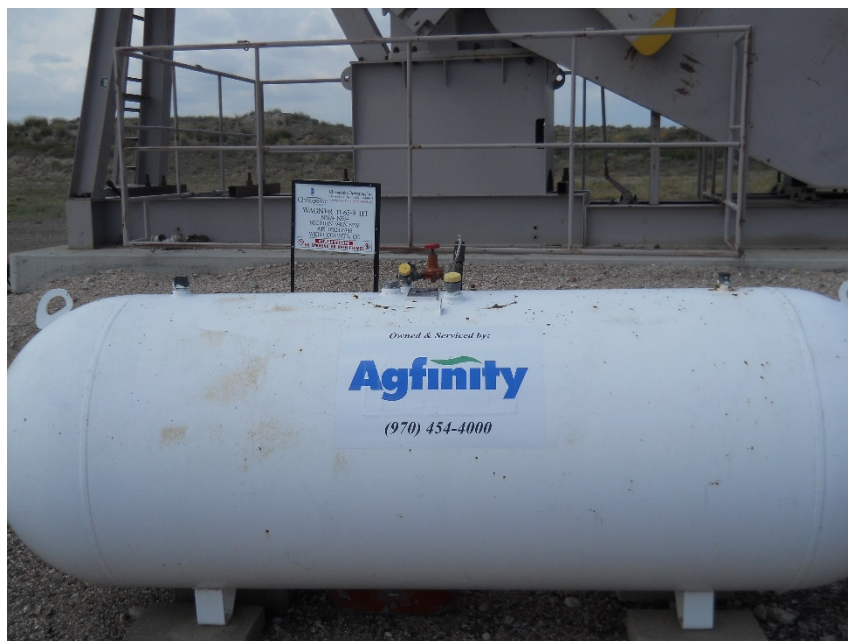
Propane tank on east side of pump jack with no labeling

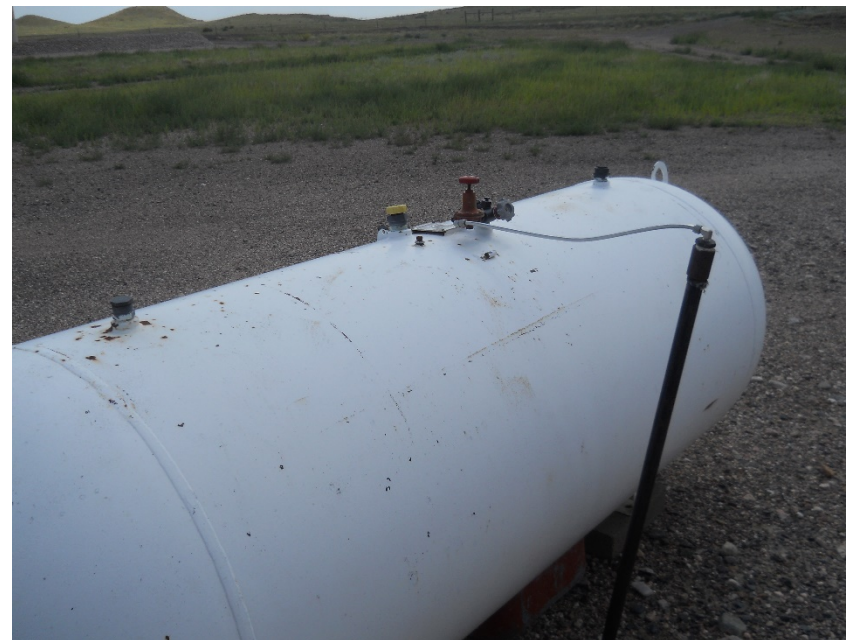
Propane tank on east side of pump jack with no labeling

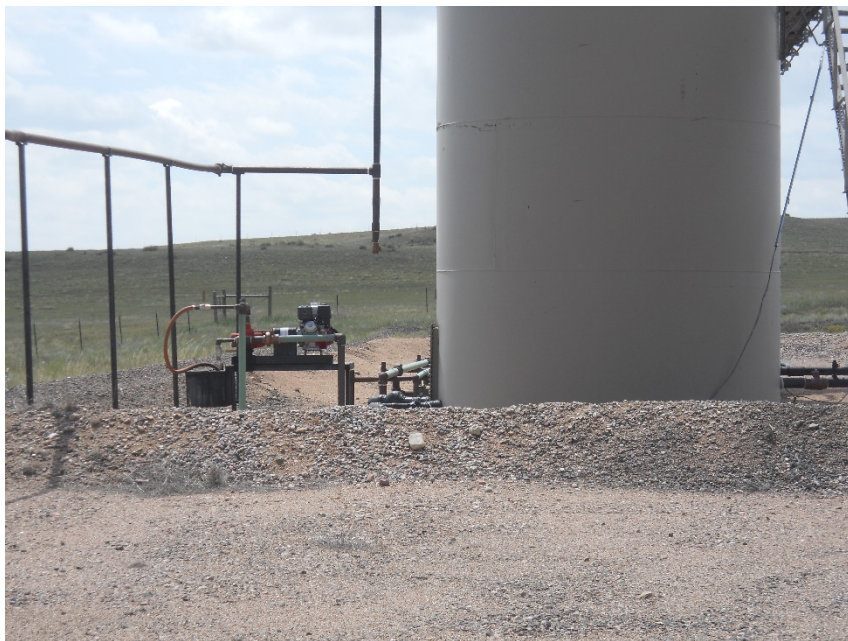
North of production tanks looking east, recirculating pump

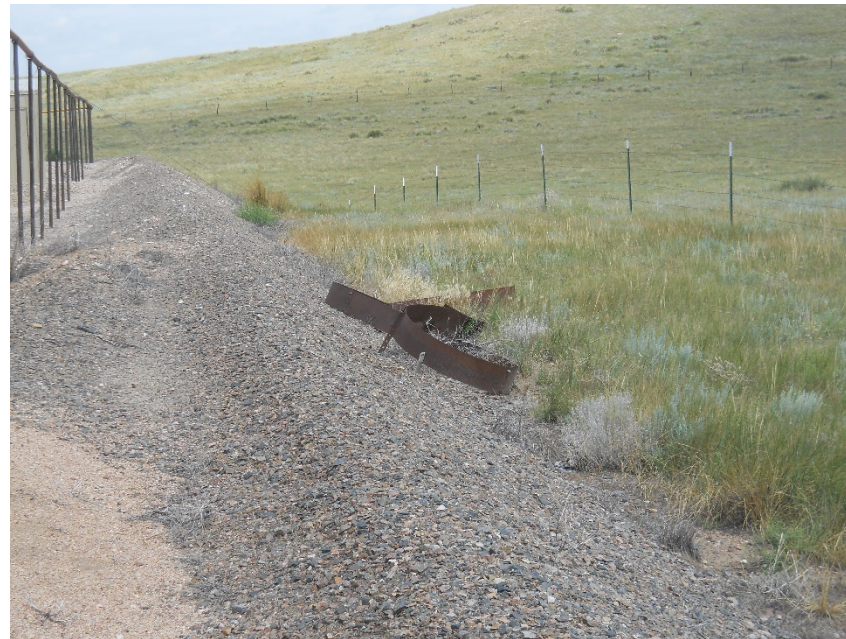
Trash on east side of production tanks

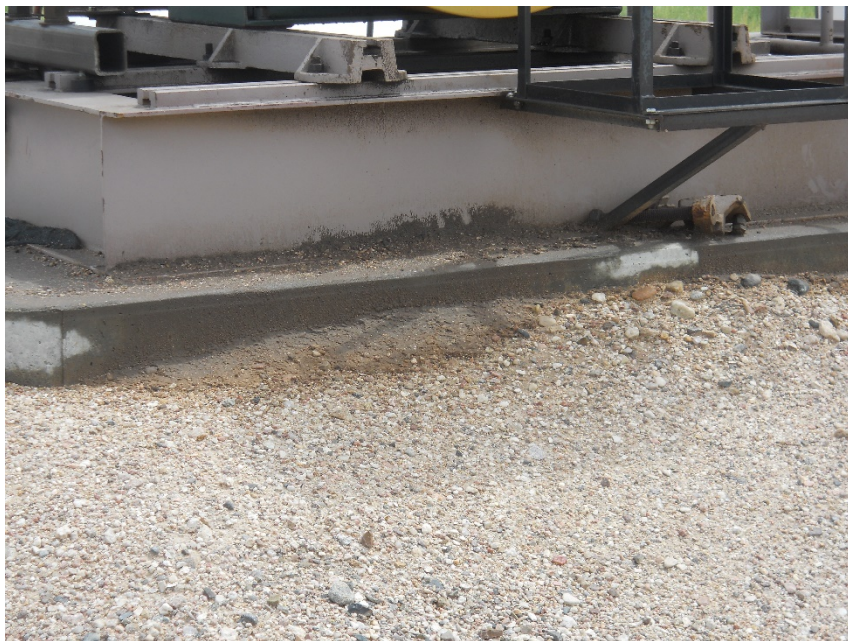
Stained soil on northwest side of pump jack motor

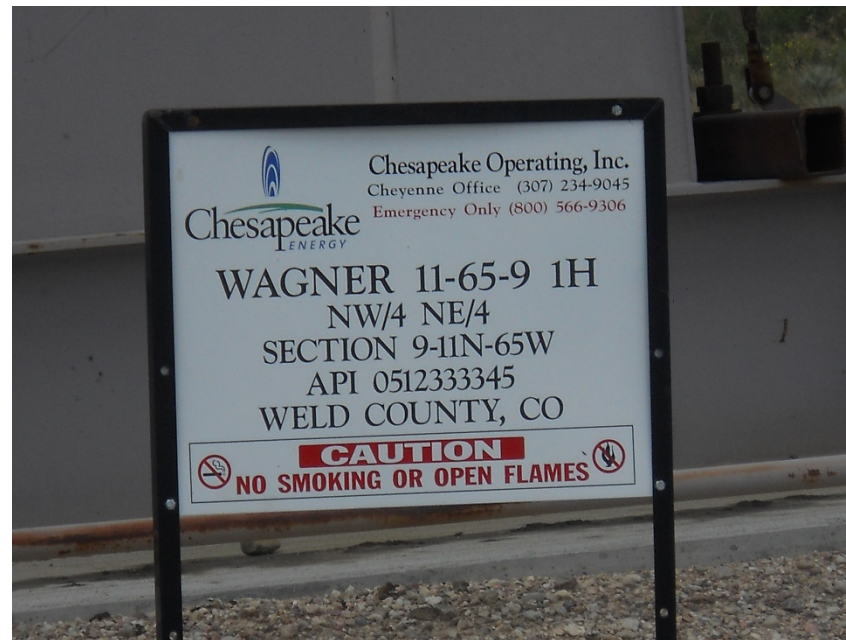
Incorrect operator and emergency contact information on wellhead sign

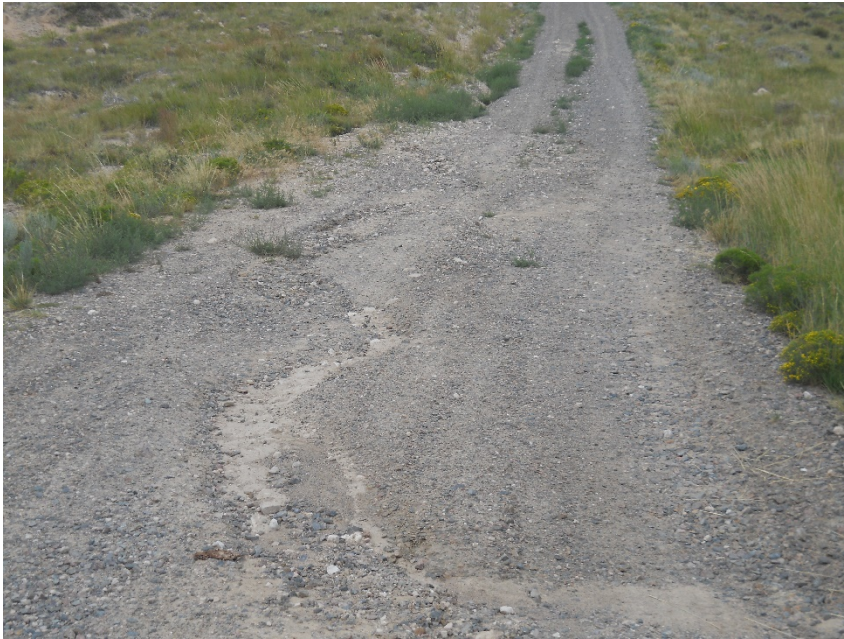
Erosion on lease road hill looking south

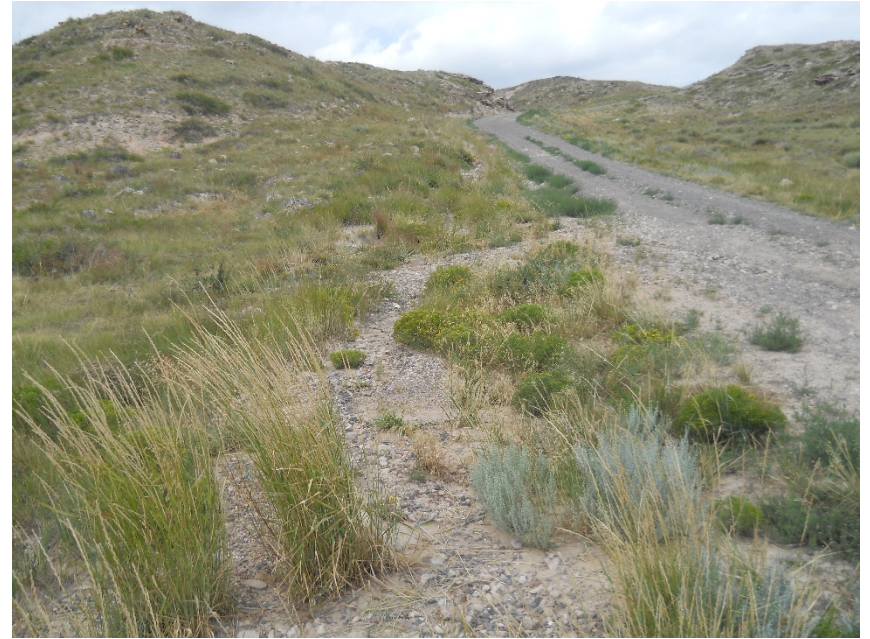
Lease road on hill washing out, sediment is carrying of road

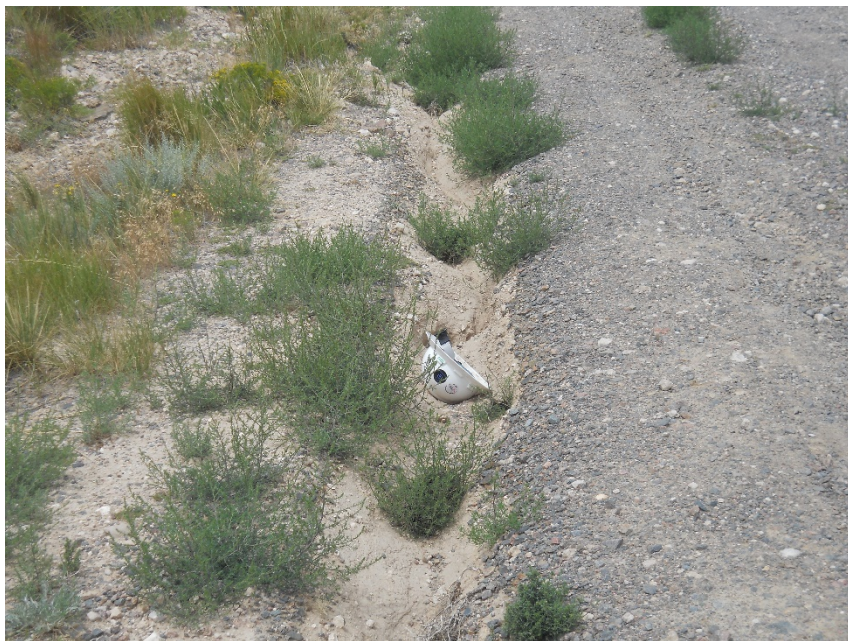
Lease road on hill erosion, hard hat used as reference
