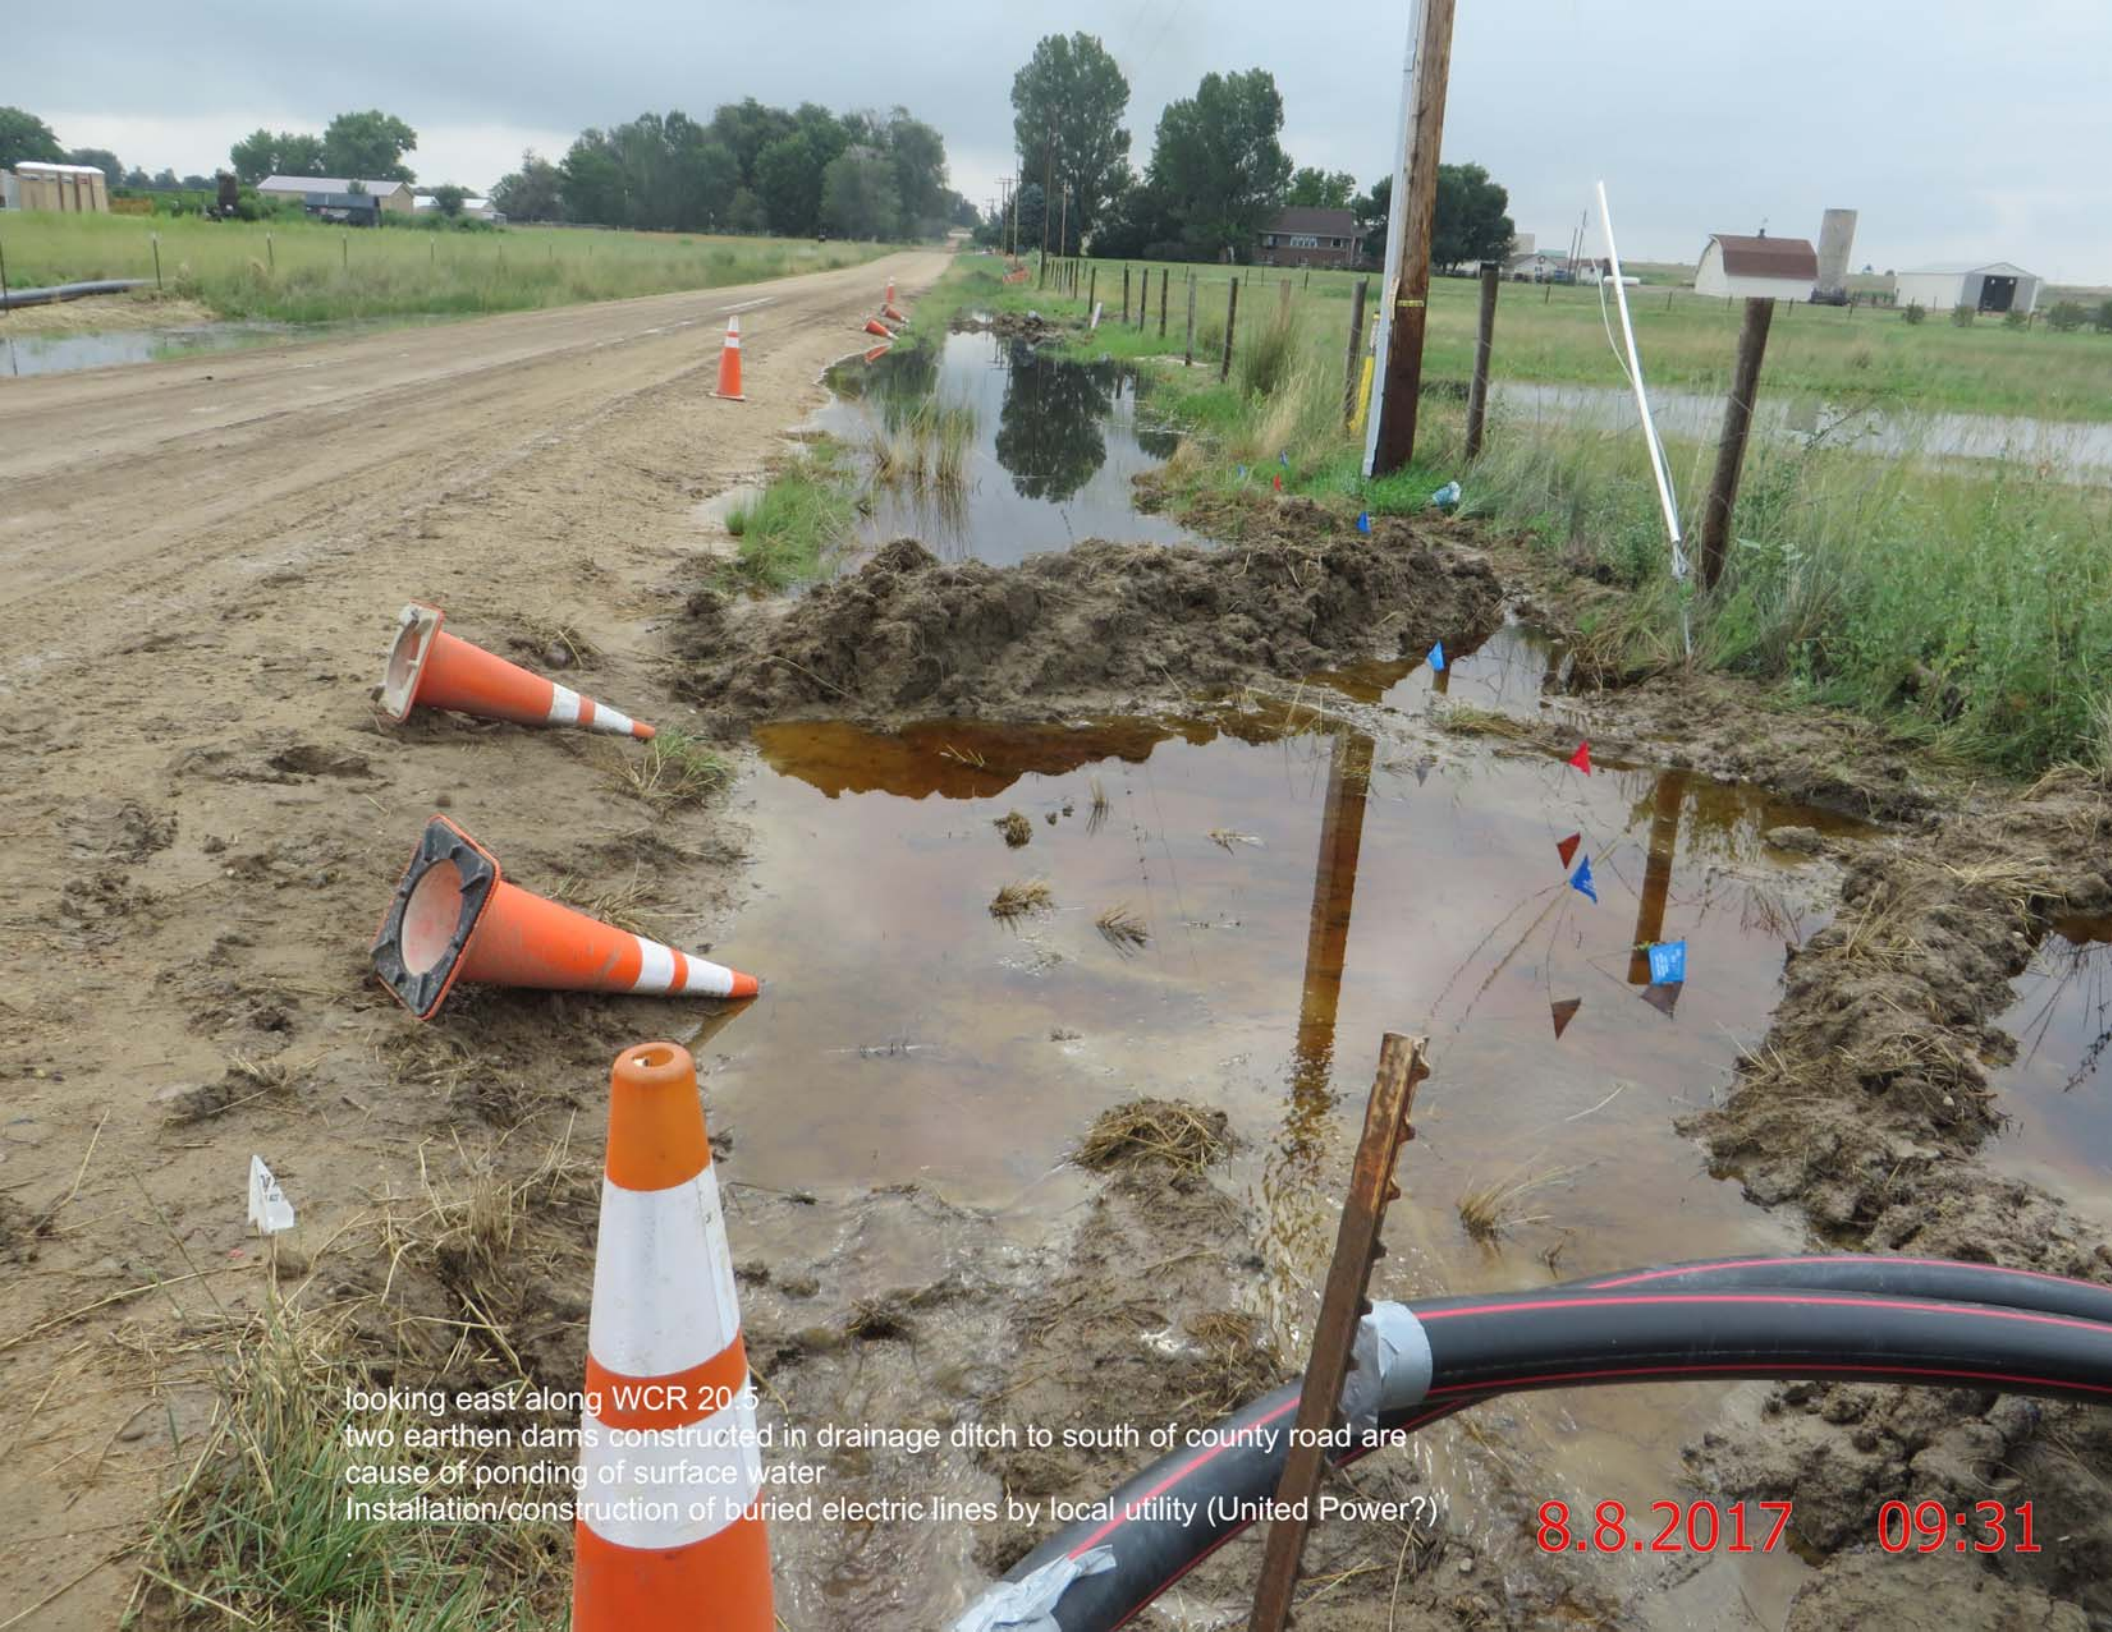
looking east along WCR 20.5
two earthen dams constructed in drainage ditch to south of county road are
cause of ponding of surface water
Installation/construction of buried electric lines by local utility (United Power?)
