Inspection Photos
Location Name: Josey 12-8 (1)
API: 05-123-10206

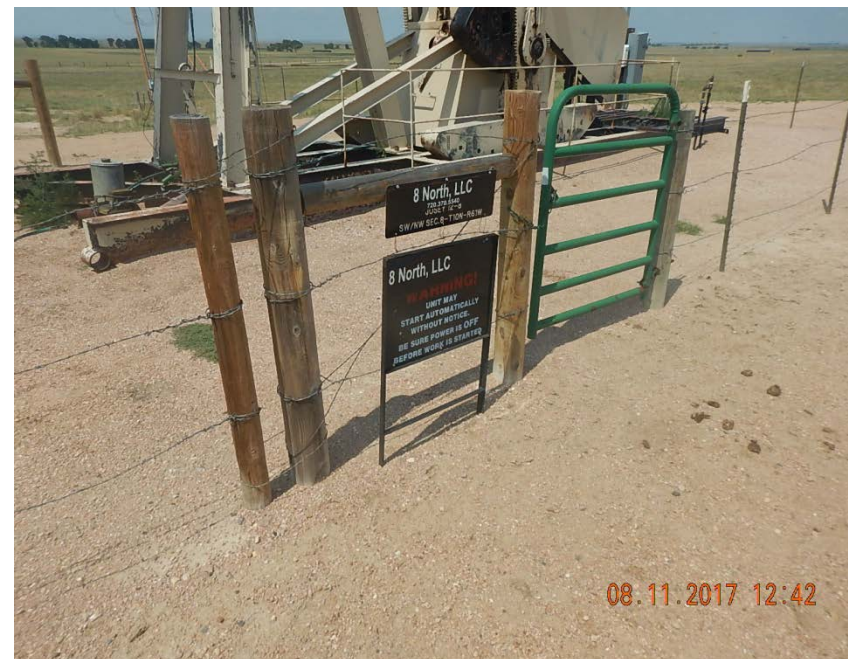
Photo 1: Signage reflects current operator

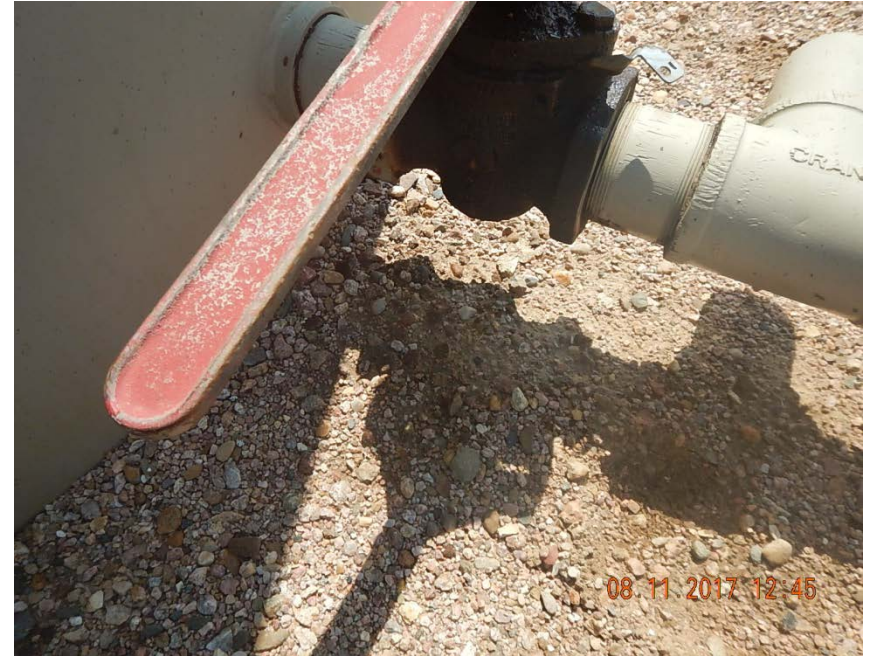
Photo 2: Soil has been removed or remediated

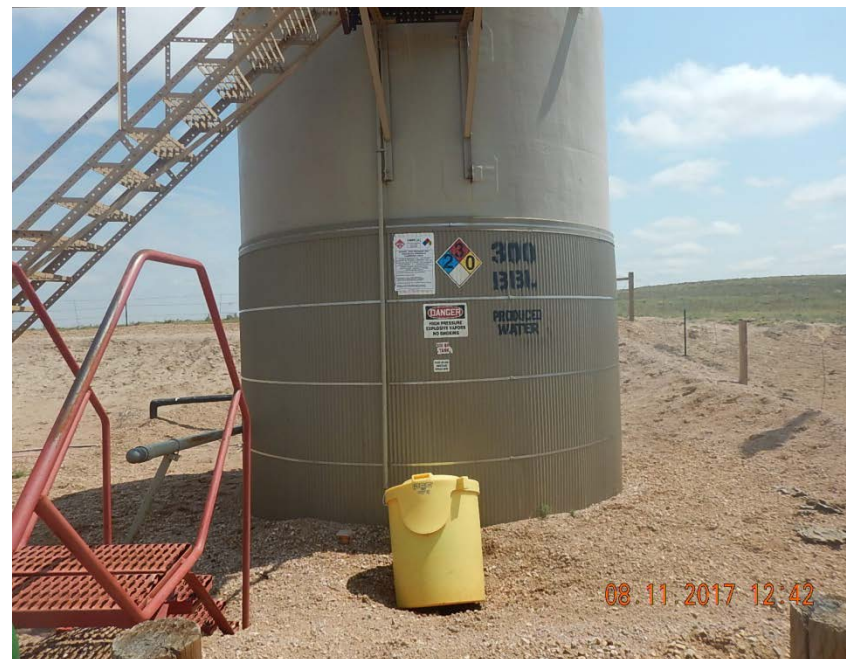
Photo 3: Tank has contents and capacity

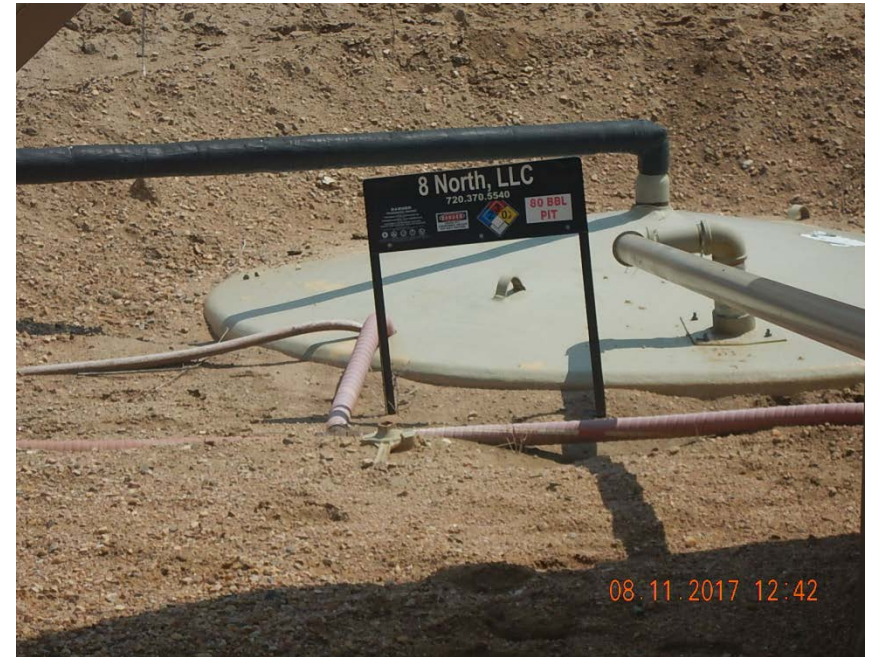
Photo 4: Signage is for current operator.
