Inspection Photos
Location Name: URSA
API: 05-045-12475

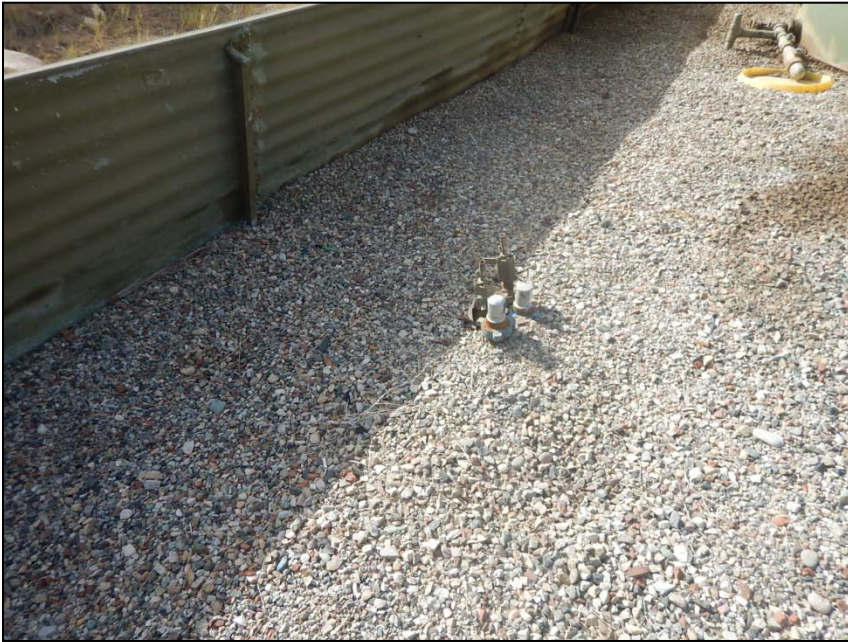
Photo 1. Overview of the project area from the southeastern corner facing center.

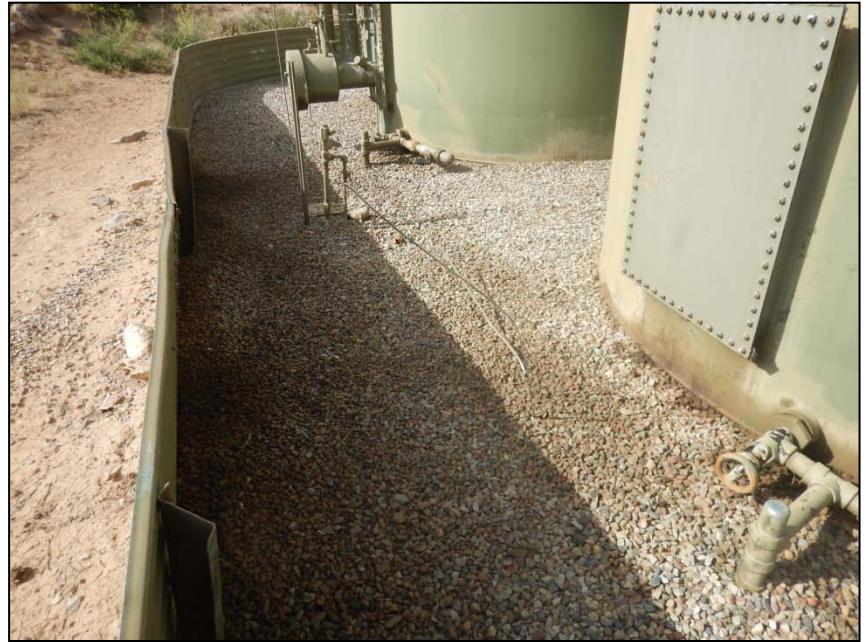
Photo 2. View of berm and cobble run-downs in the eastern portion of the project area from the southeastern corner facing northward.
