COGCC Environmental Field Inspection Report Photo Attachment

Inspection Date: **August 10, 2017**

Steven J. Arauza, P.G.

COGCC Environmental Protection Specialist

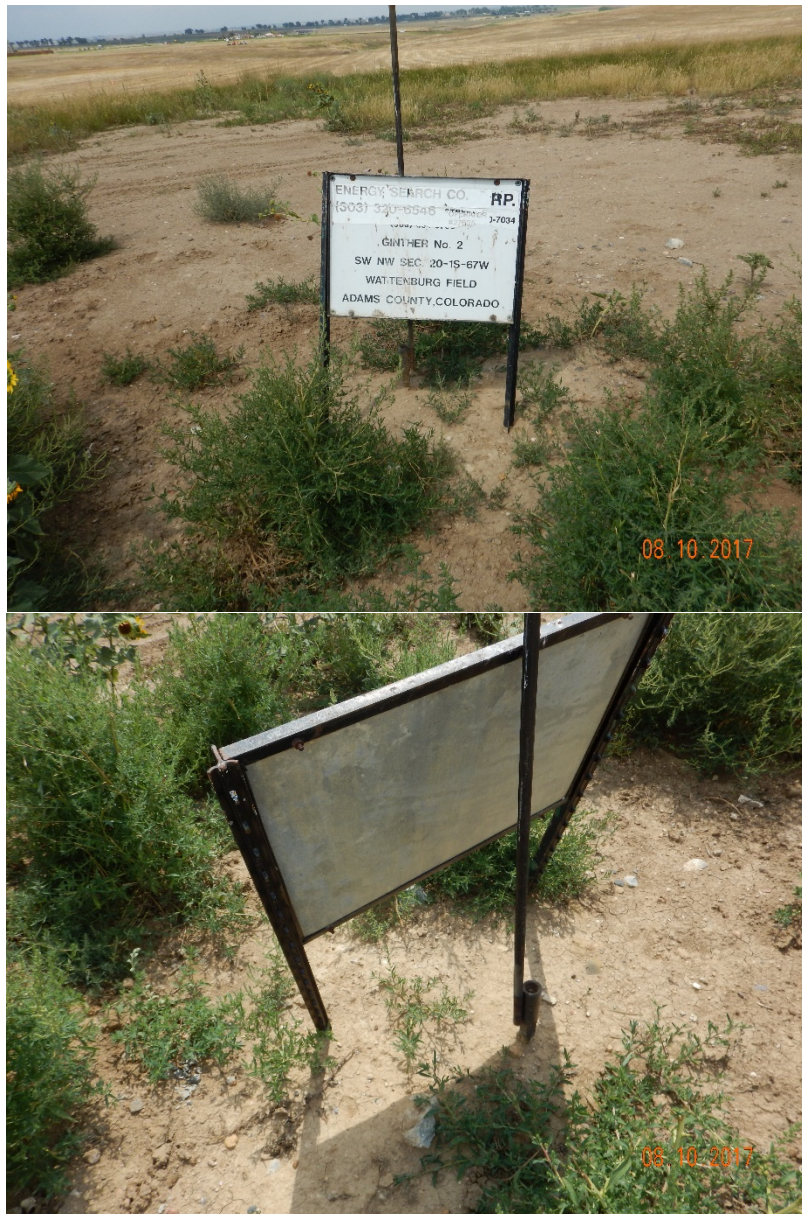
*Figure 1 - Well sign at former well location is supported by buried polished rod.*

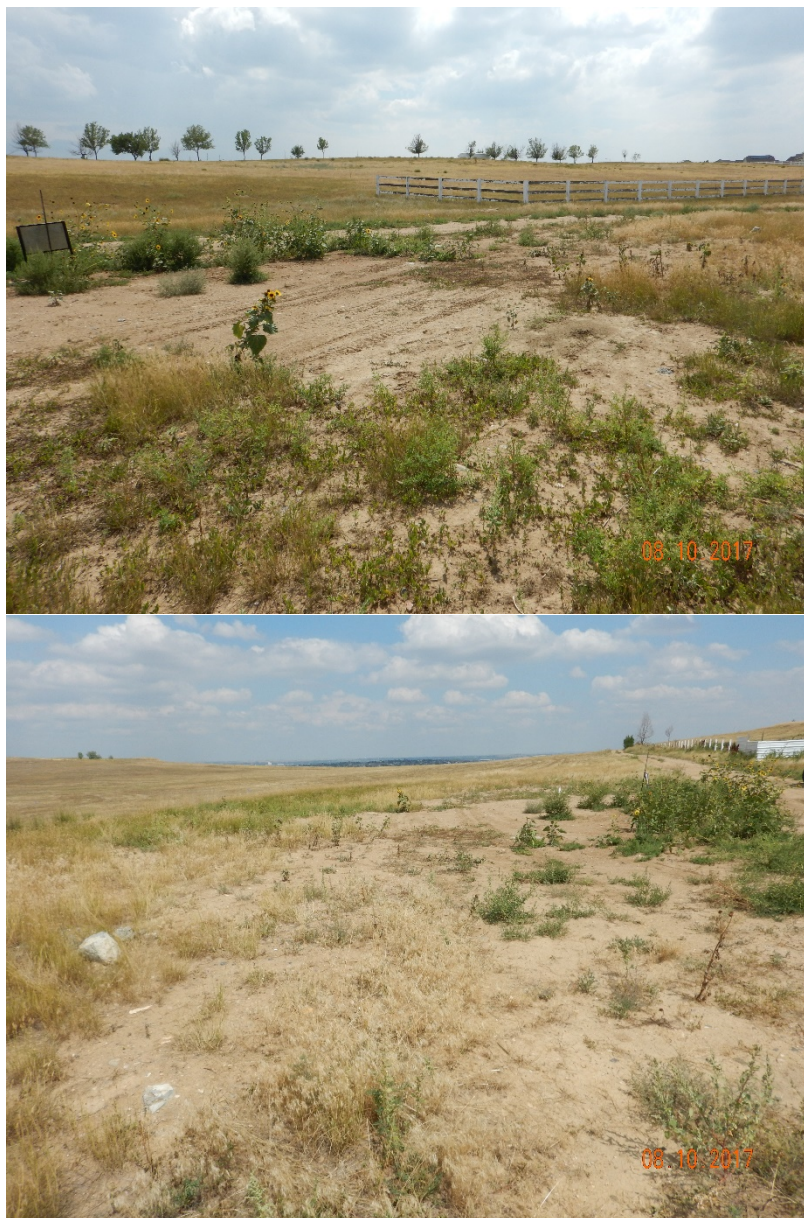
*Figure 2 - Distressed vegetation and concrete debris at former well pad.*

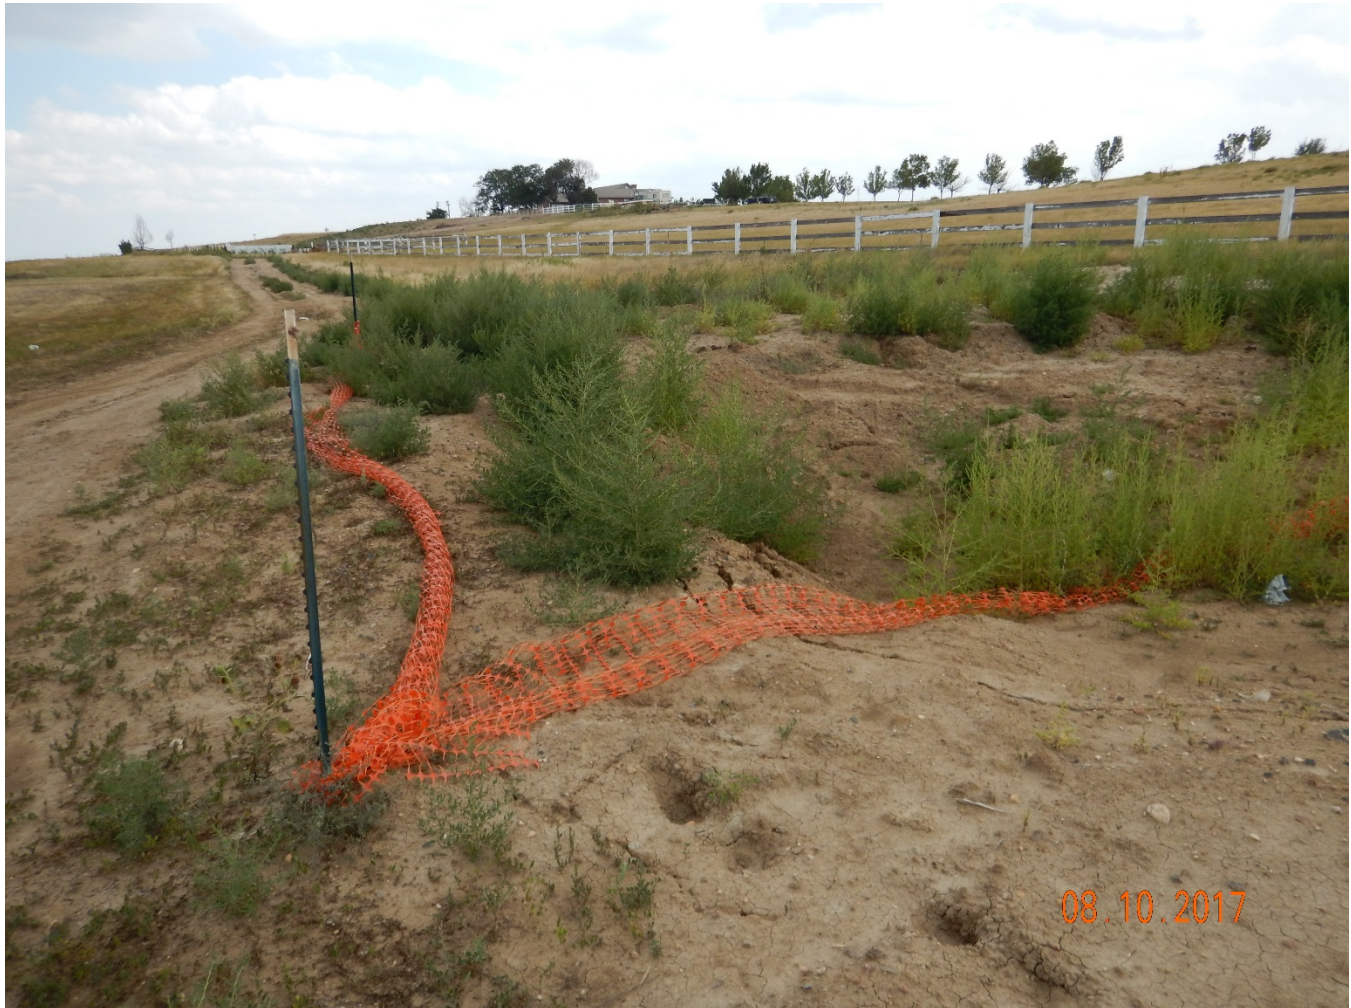
*Figure 3 - View of backfilled excavation associated with Remediation Project #10065 from NW corner. Note: abundance of weeds and subsidence inside of damaged safety fence.*

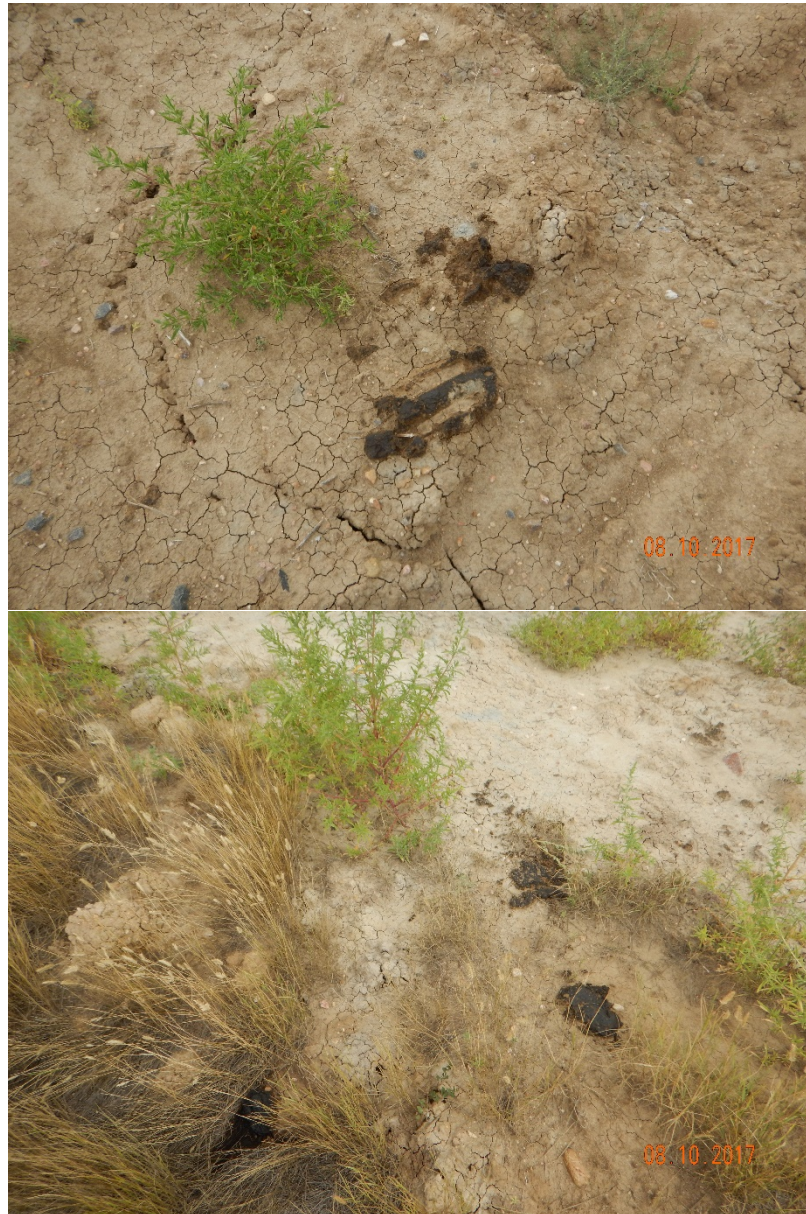
*Figure 4 - Localized, oil-stained soil and apparent drilling mud on east side of former excavation.*

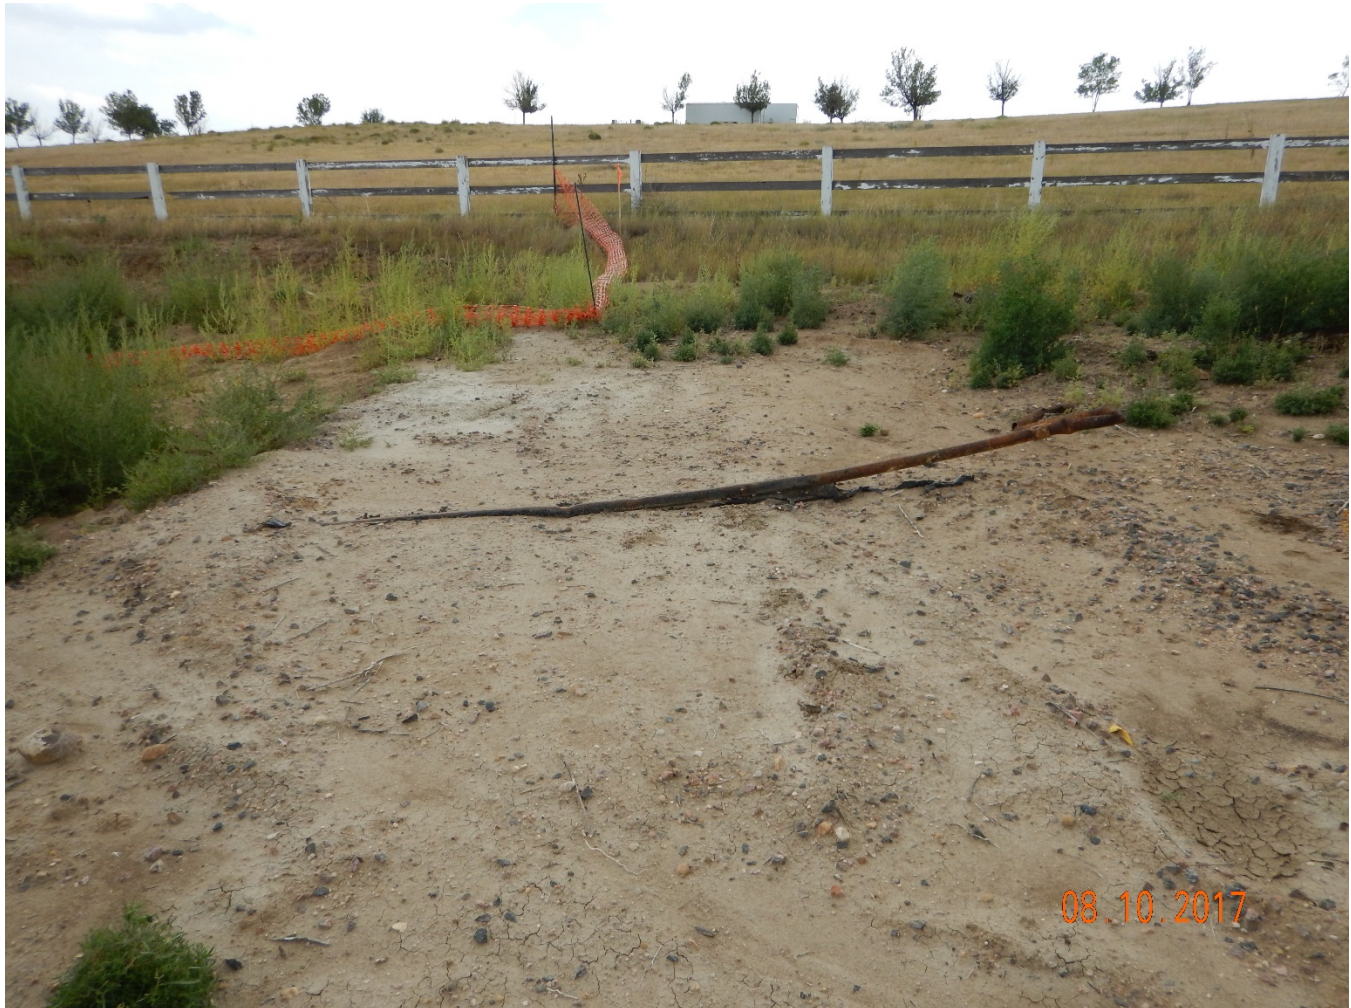
*Figure 5 - Rusted, abandoned 2" steel flowline daylighting west of former excavation.*

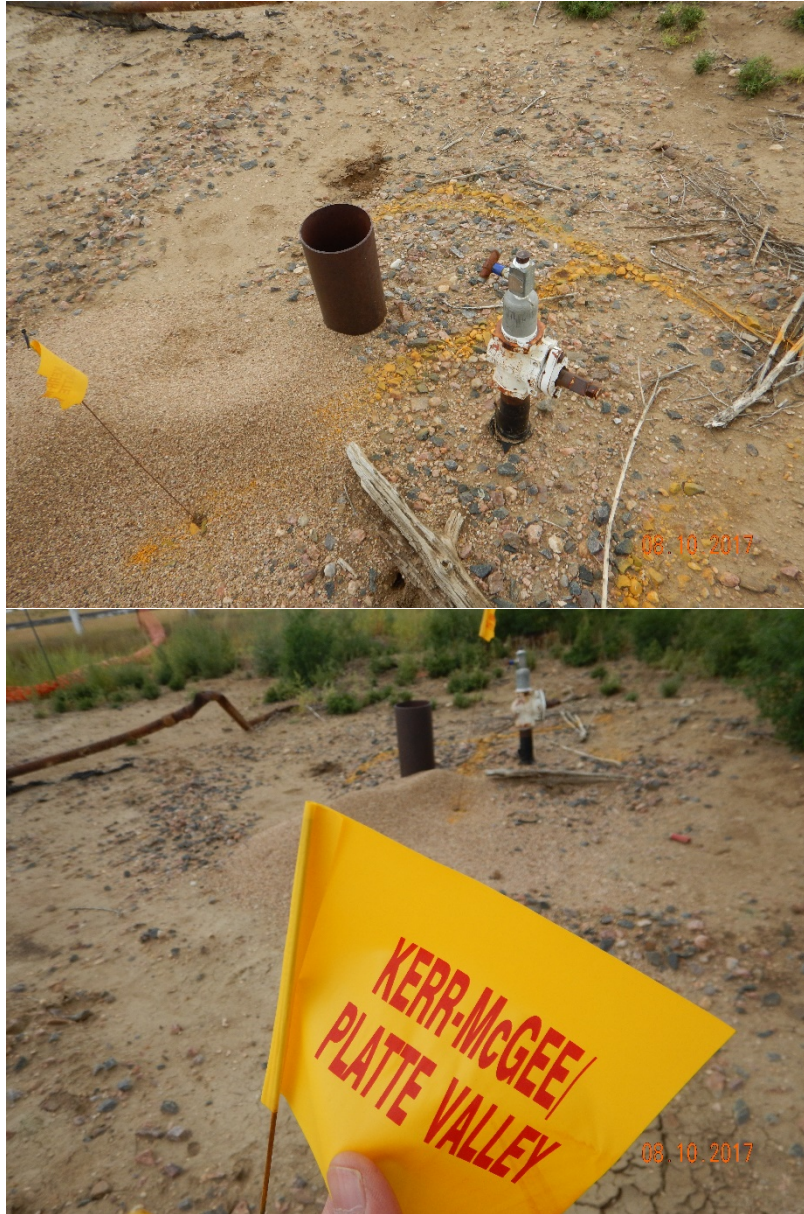
*Figure 6 - 2" steel flowline riser and ~6" pipe riser on west side of former excavation. Yellow flags and markings suggest that the flowline is operated by Kerr-McGee/Platte Valley.*

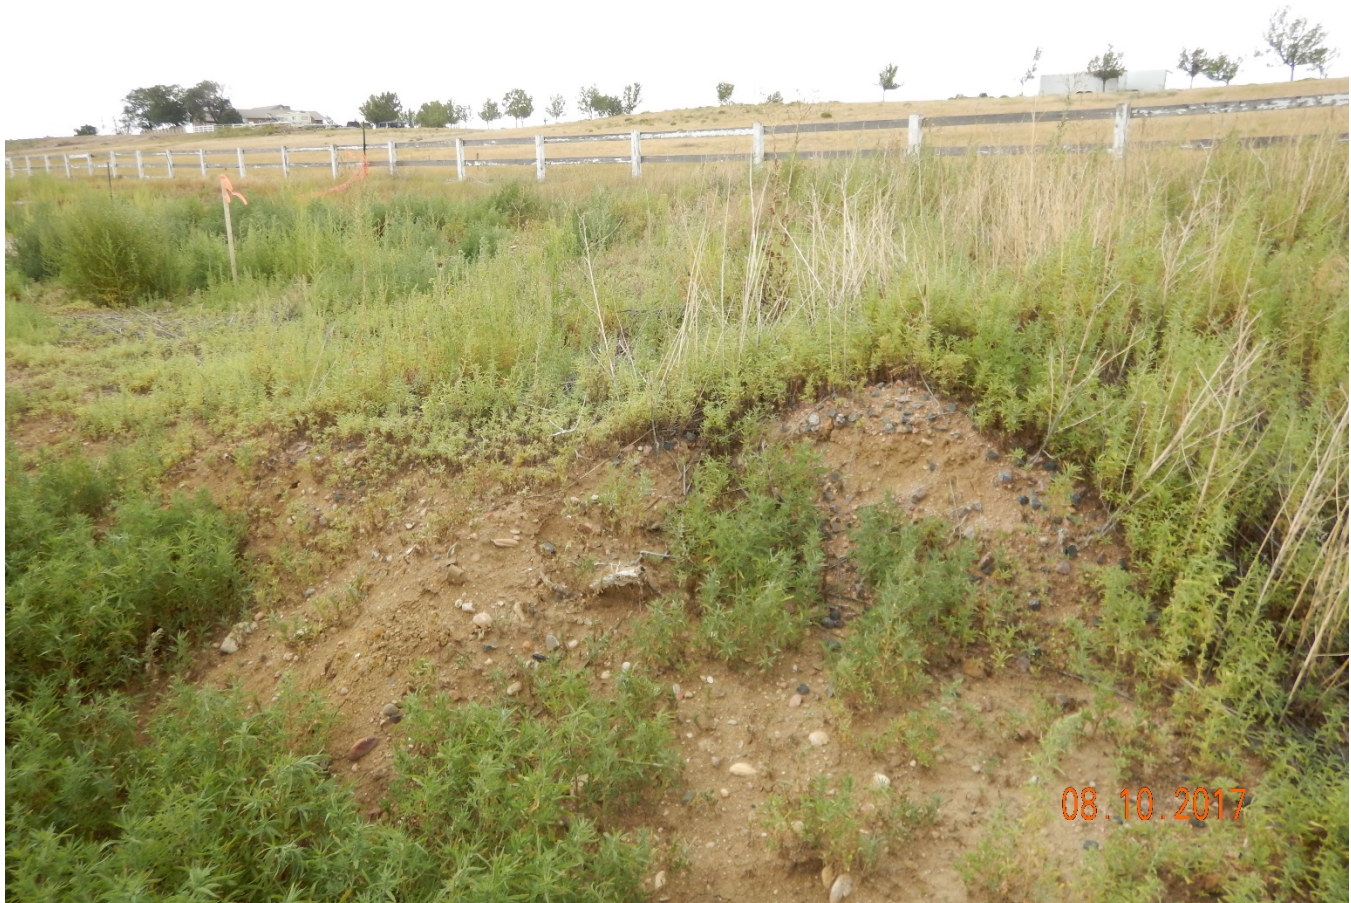
*Figure 7 - Cross-sectional view of former vertical treater berm that remains on location (west of former excavation). Grade has not been restored to preexisting conditions. Uncontrolled weeds and gravel remain on-site.*

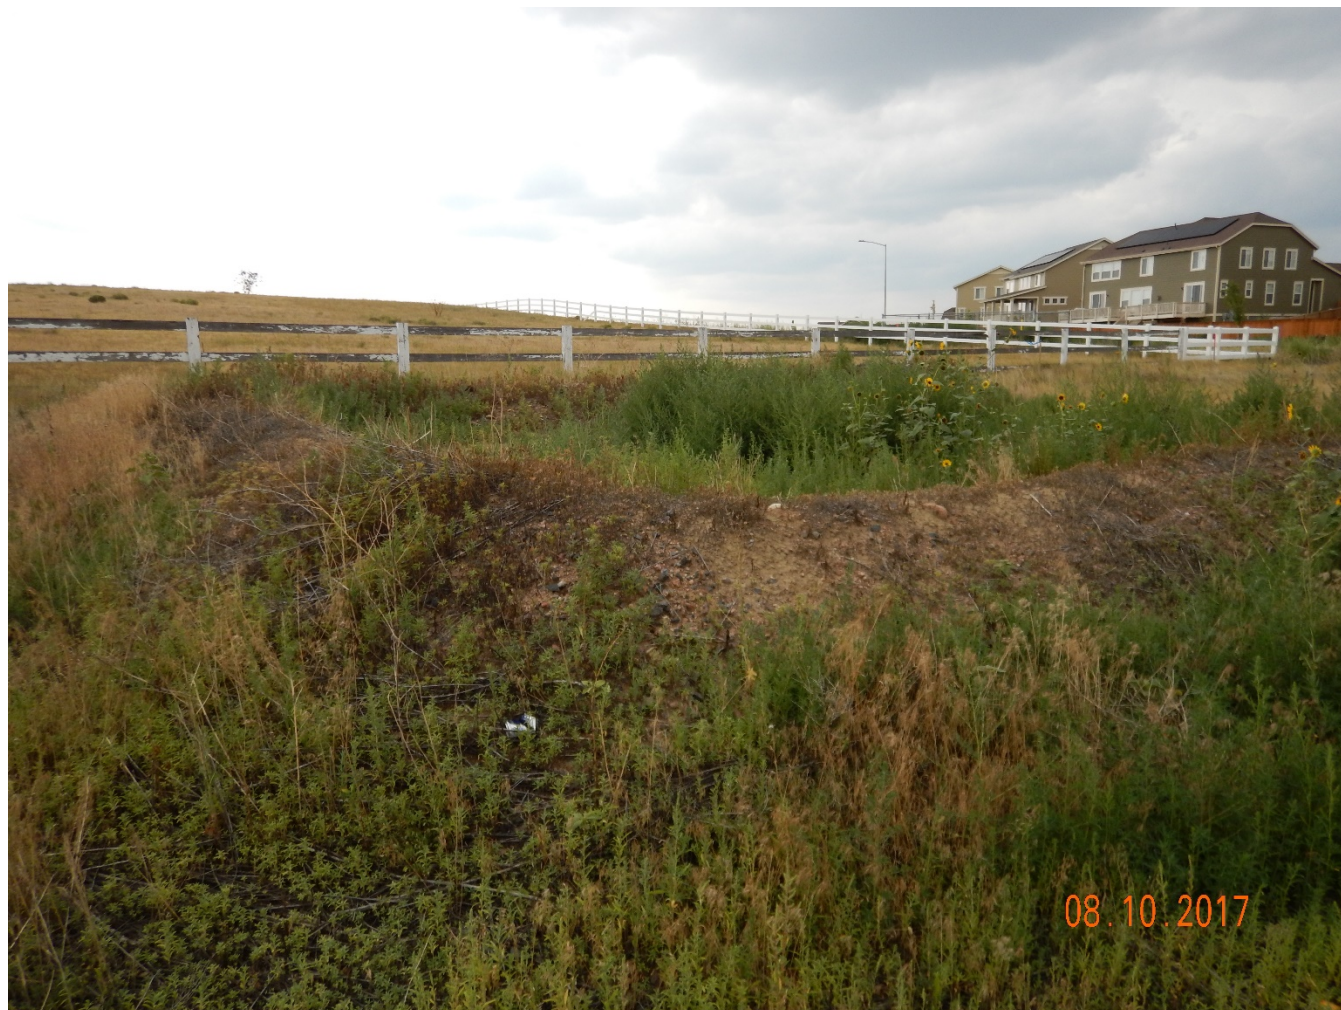
*Figure 8 - Former tank berm remains on west side of location (~30'x30').*

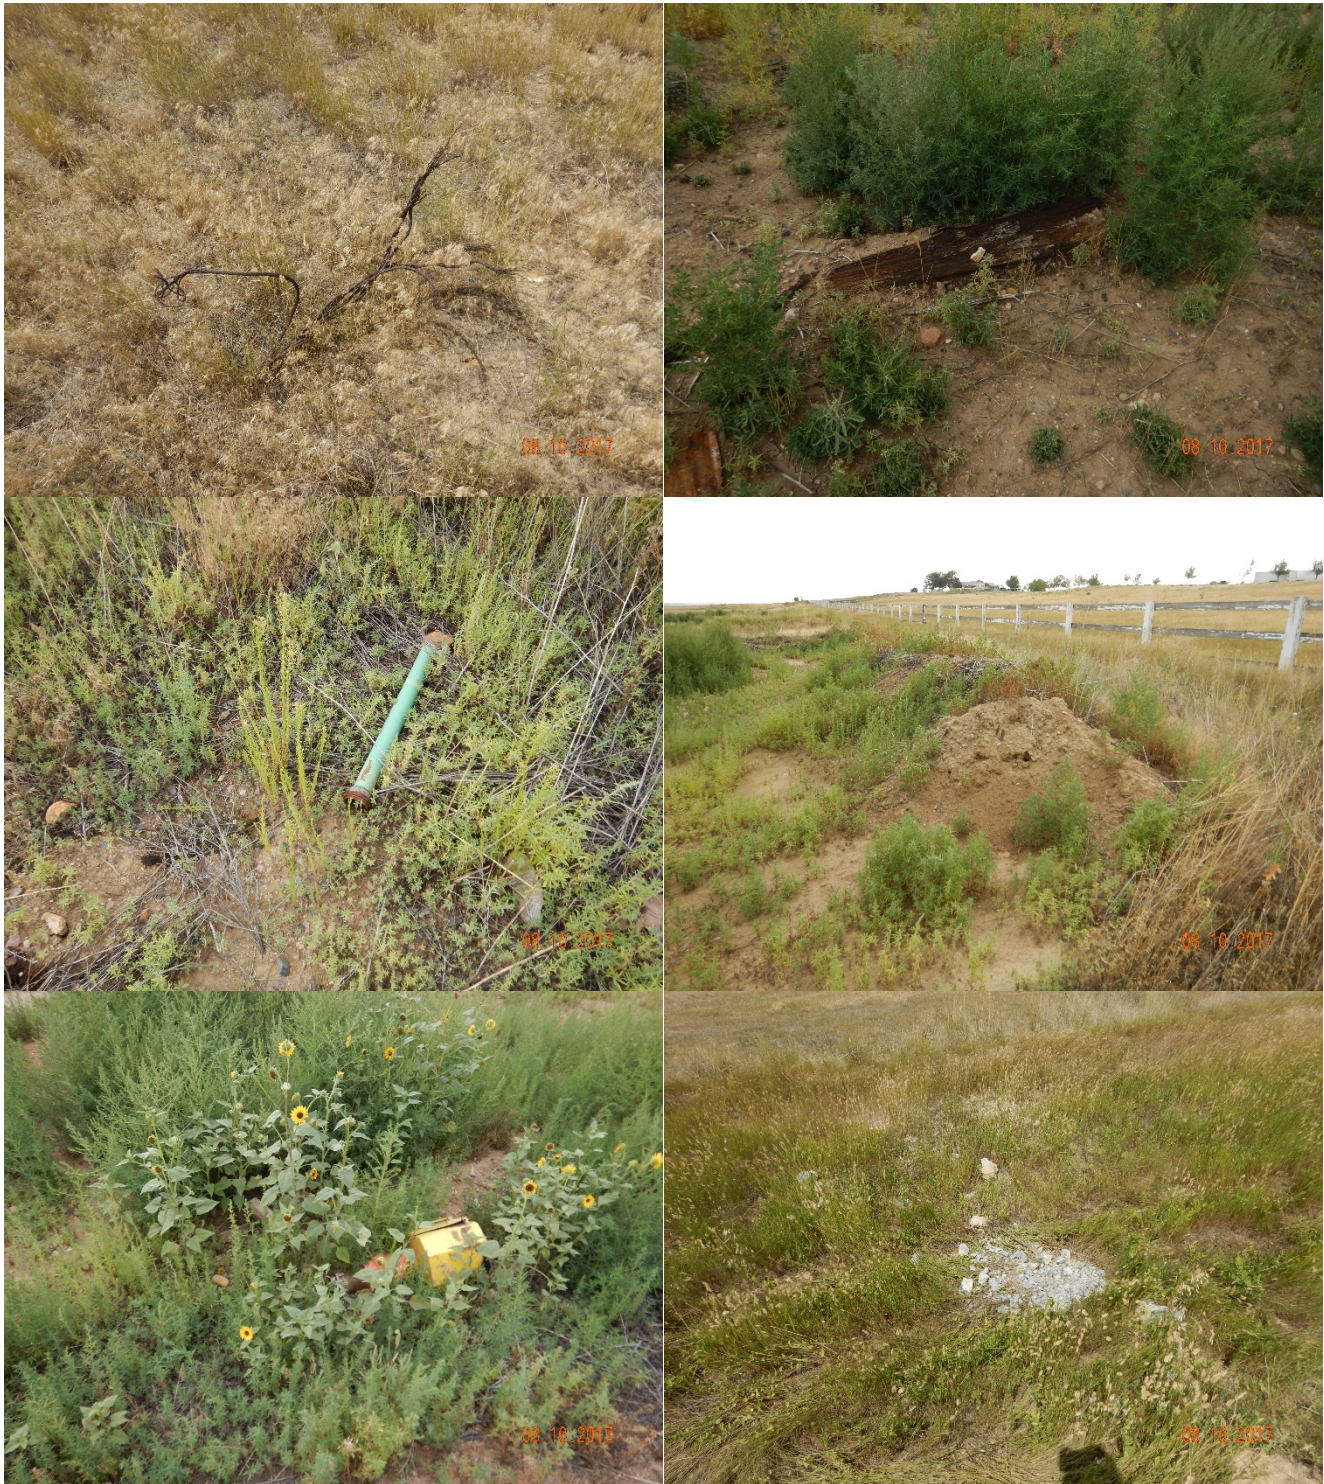
*Figure 9 - Site-wide junk and debris on location.*

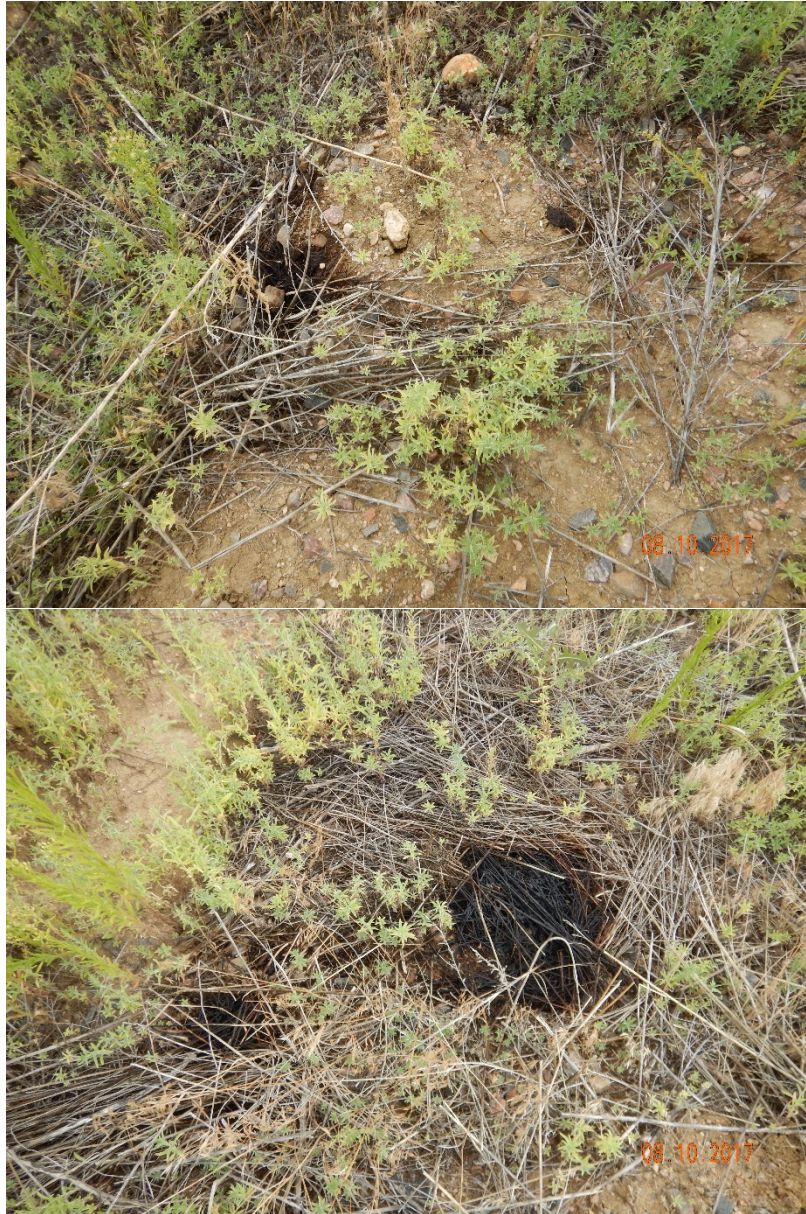
*Figure 10 - Localized, oil-stained soil associated with earthen berms at former tank battery.*

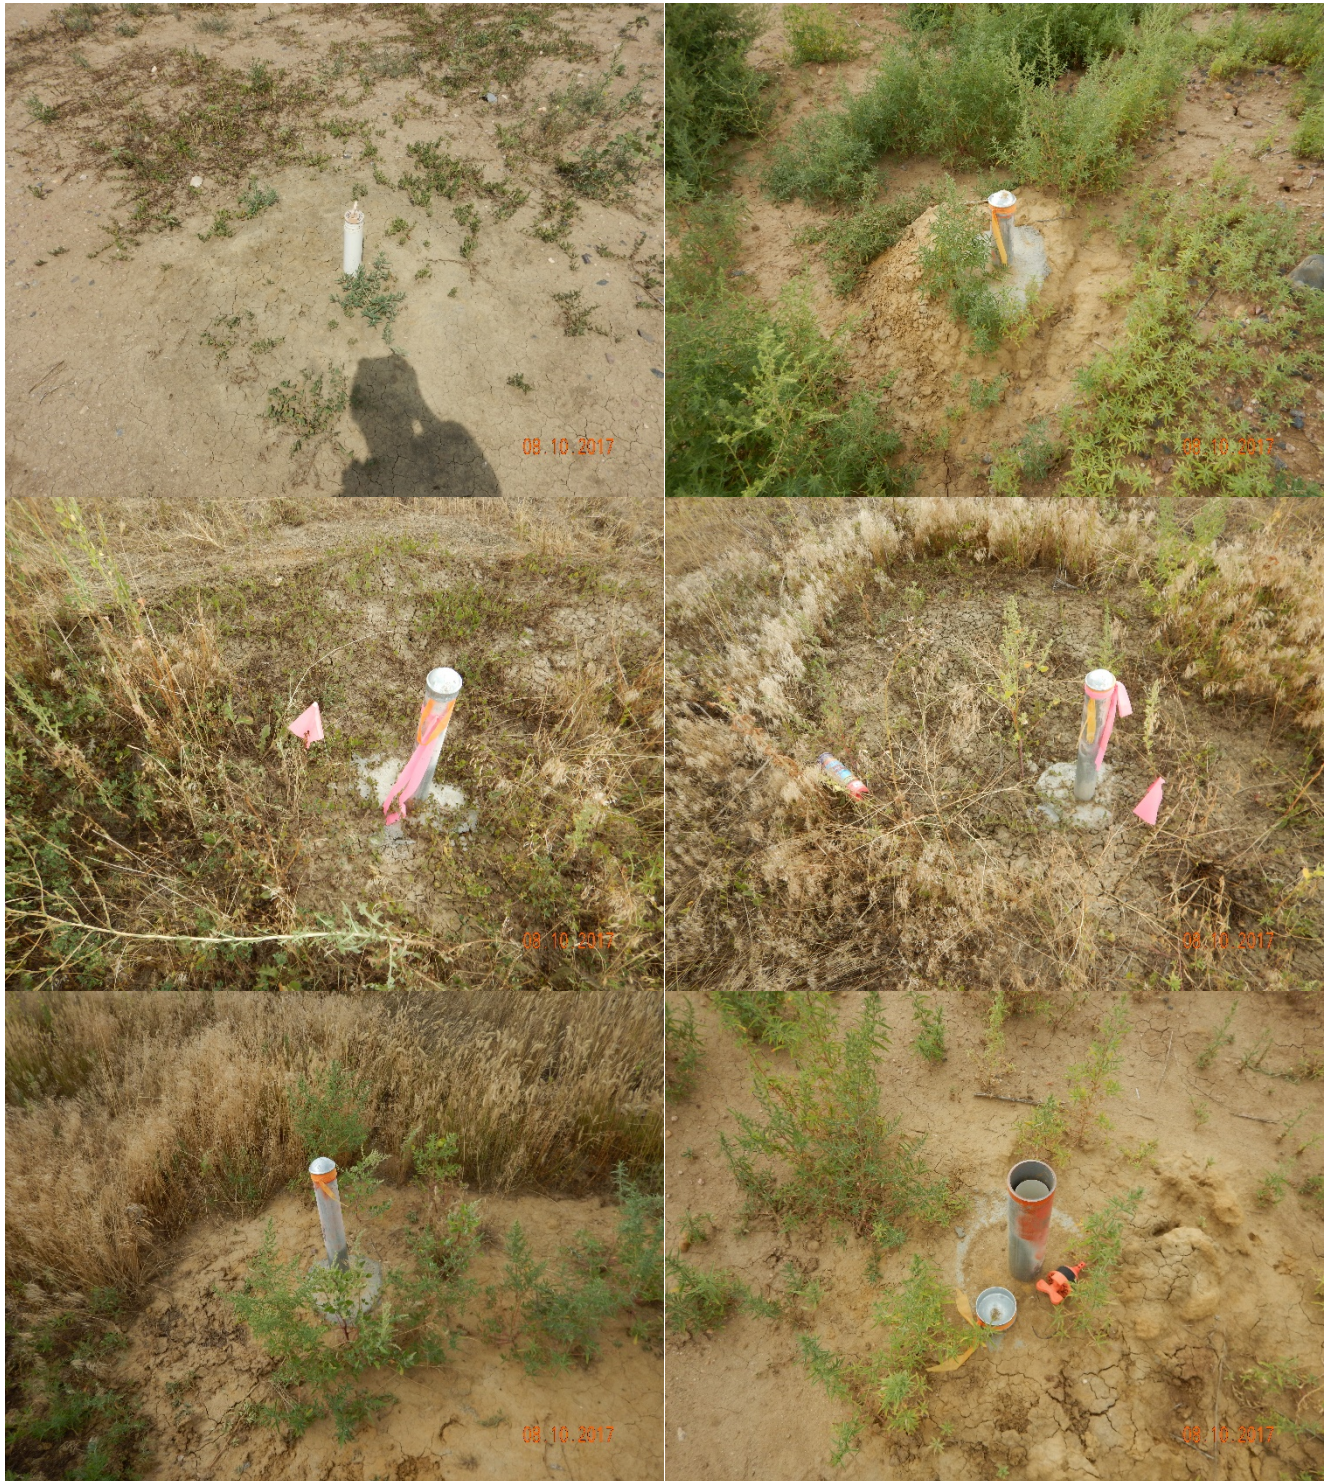
*Figure 11 - Assorted pictures of monitoring wells installed at location under Remediation Project #10065.*

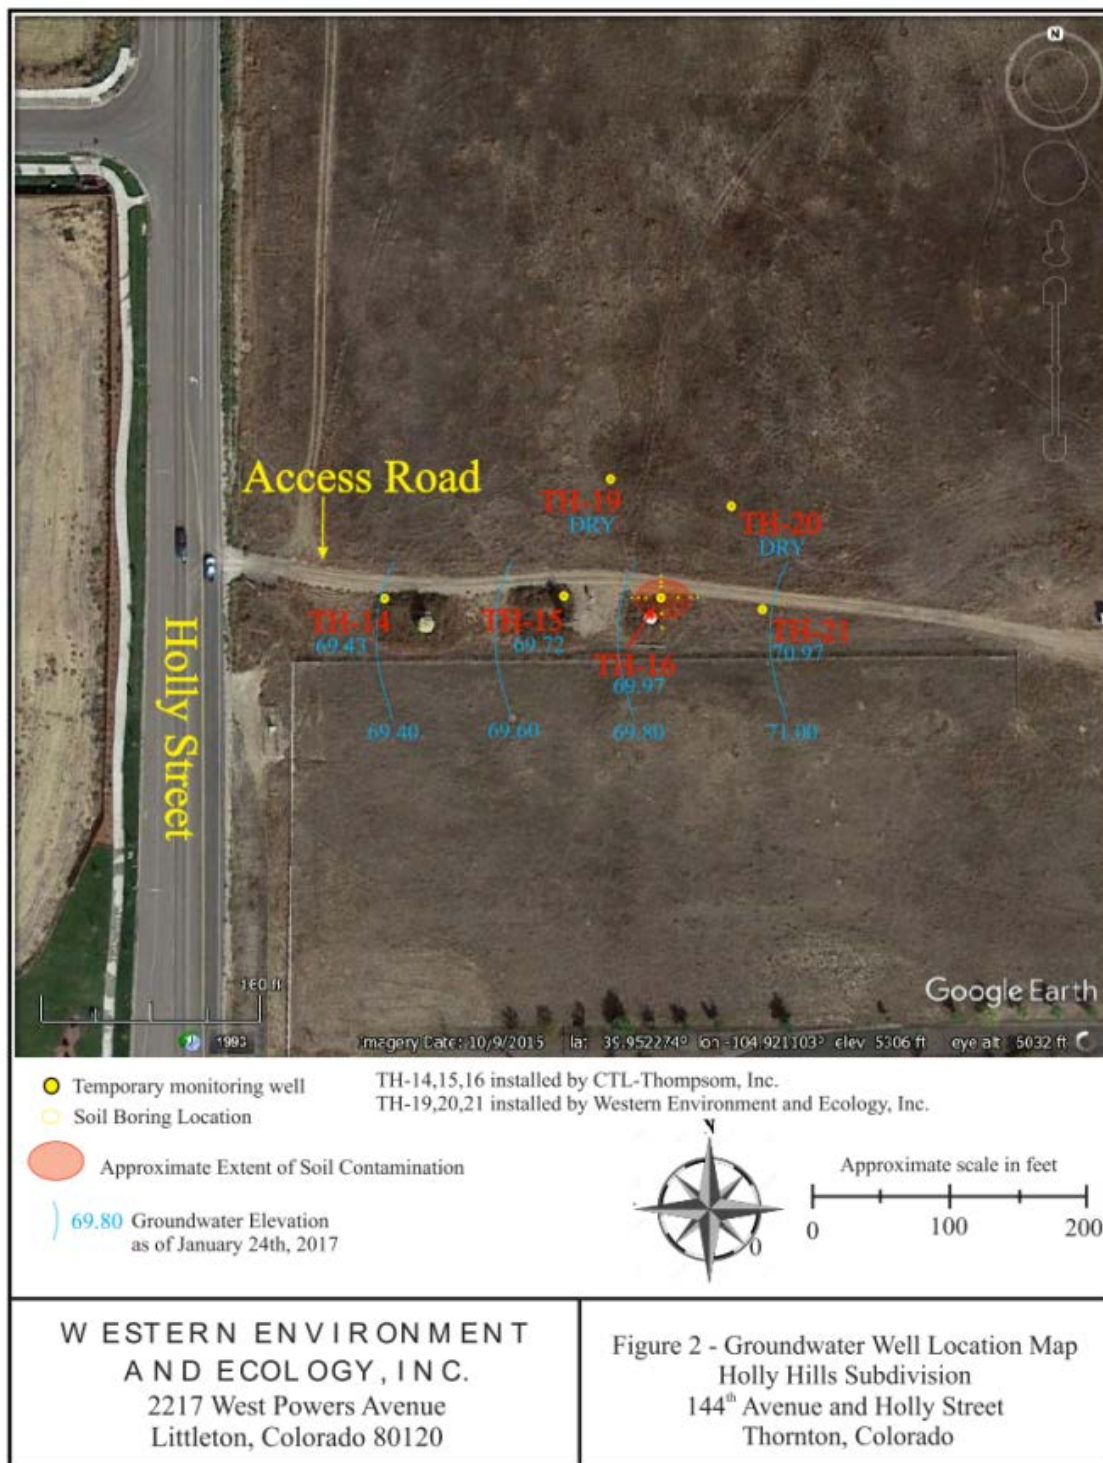
Figure 12 - Figure 2 from 2/7/2017 report prepared for Kent Carlson by Western Environment and Ecology, Inc. (COGCC doc #401217998) illustrating monitoring well locations at former tank battery. On date of this inspection report, TH-16 could not be located.
