**Inspection Photos**  
**Location Name: Flatiron 10-36**  
**API: 05-123-12686**

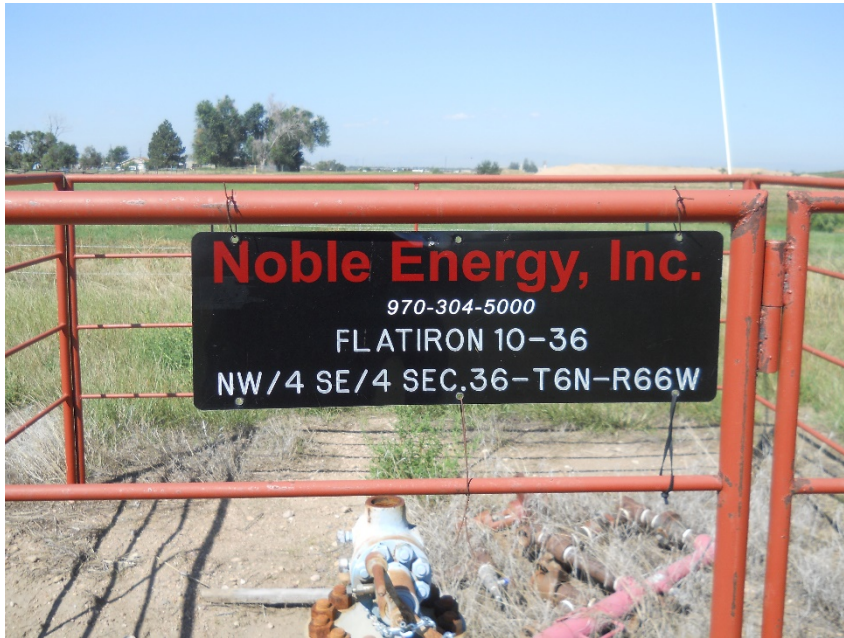
**Wellhead sign looking west**

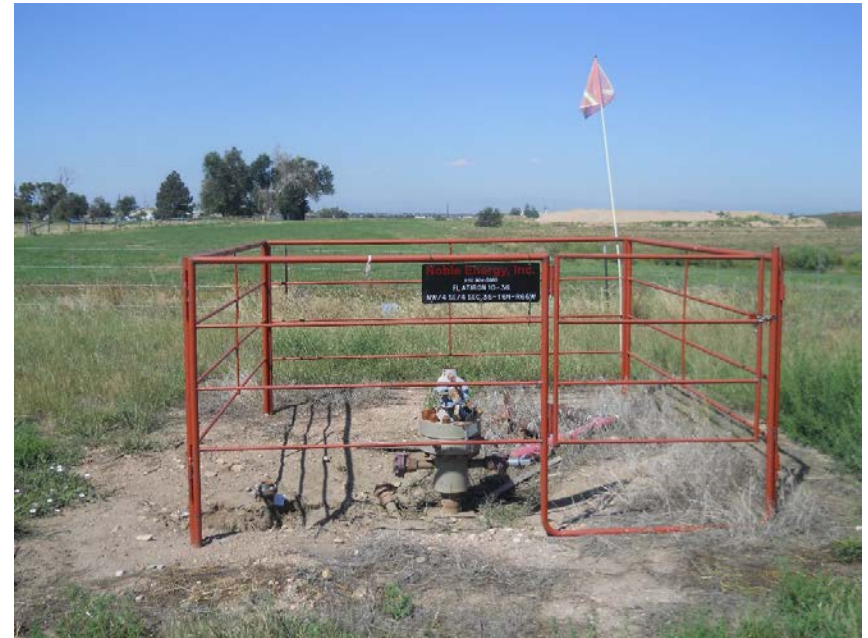
**Wellhead looking west. Well is TA, no MIT records**

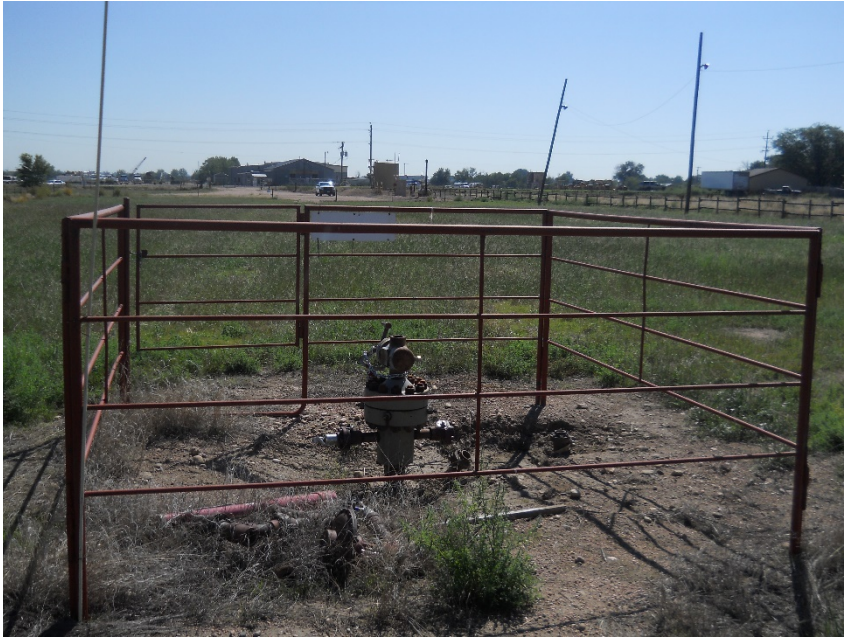
**Wellhead looking east at tank battery**

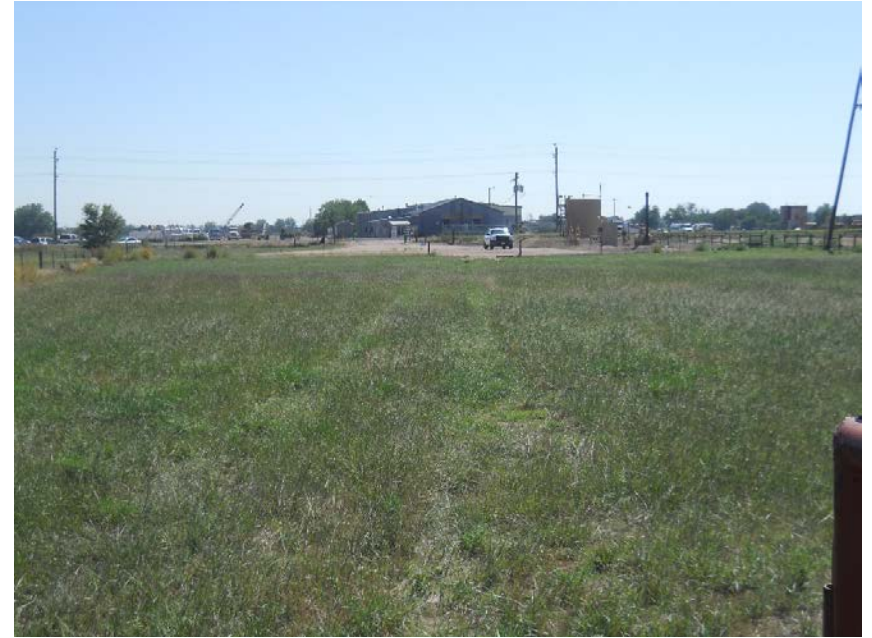
**Lease road looking east from wellhead to tank battery.  
Weeds need to be controlled**

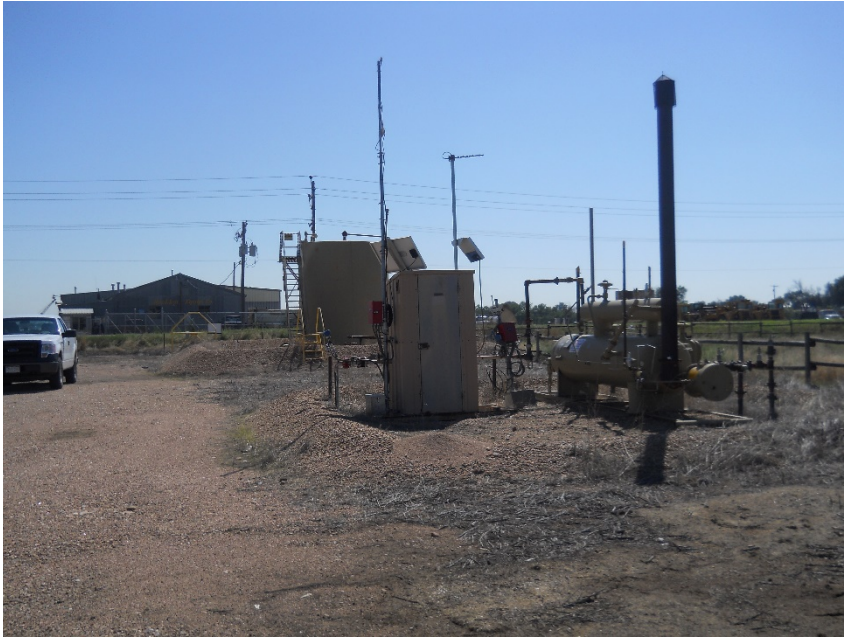
**West edge of location looking east at battery**

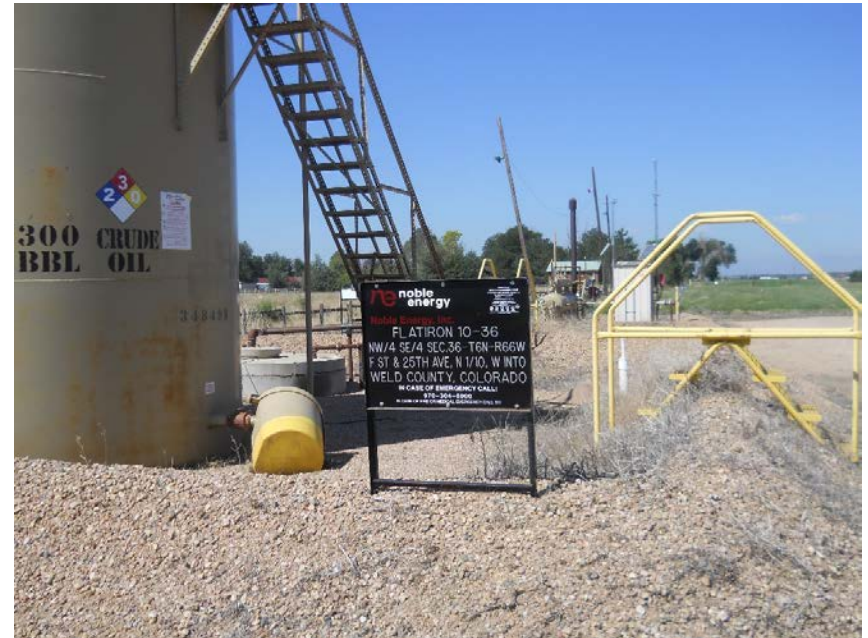
**Tank battery sign looking west at battery**

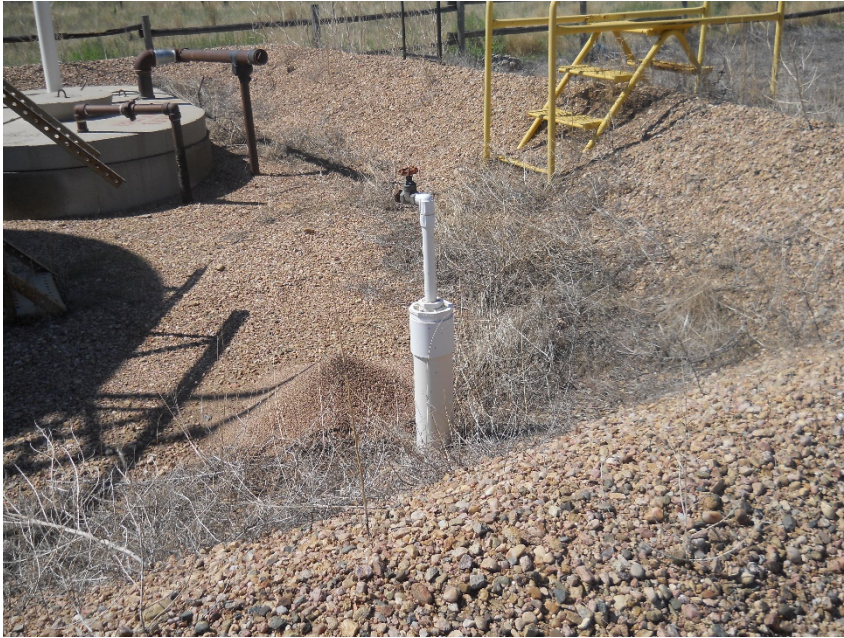
**Unused/unmarked riser inside of tank berm on northwest corner**

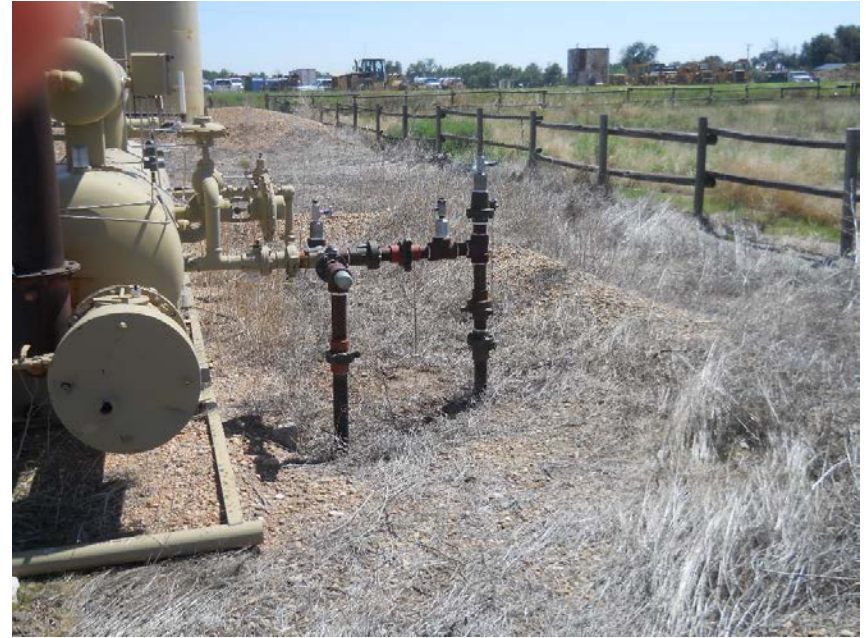
**Flowline at separator is still in place. Dead weeds on south side of location pose a fire risk. Needs to be controlled.**
