Inspection Photos
Location Name: North Platte J-F-28HZ
API: 05-123-36024

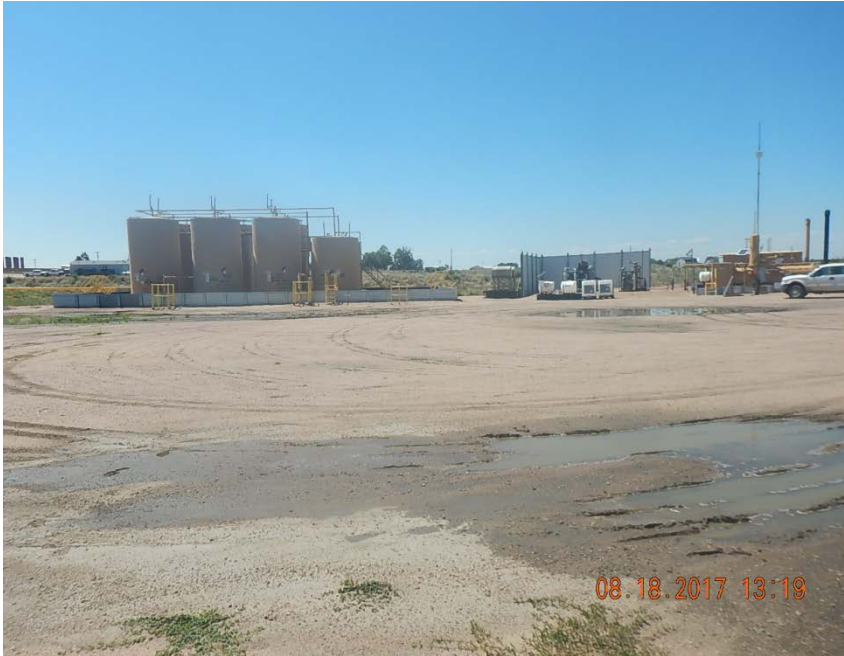
Photo 1: Location, looking SE

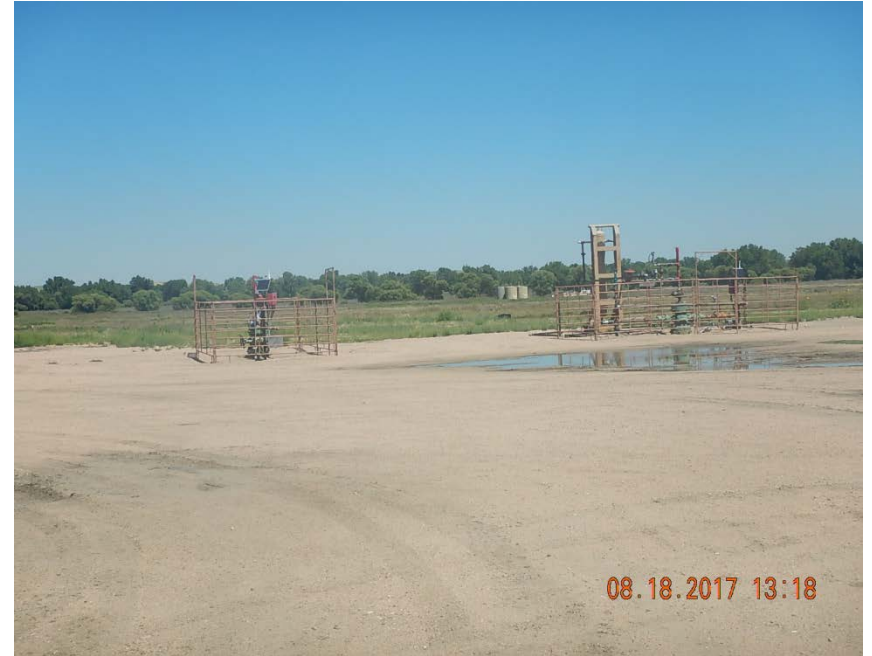
Photo 2: Wellhead, looking NE

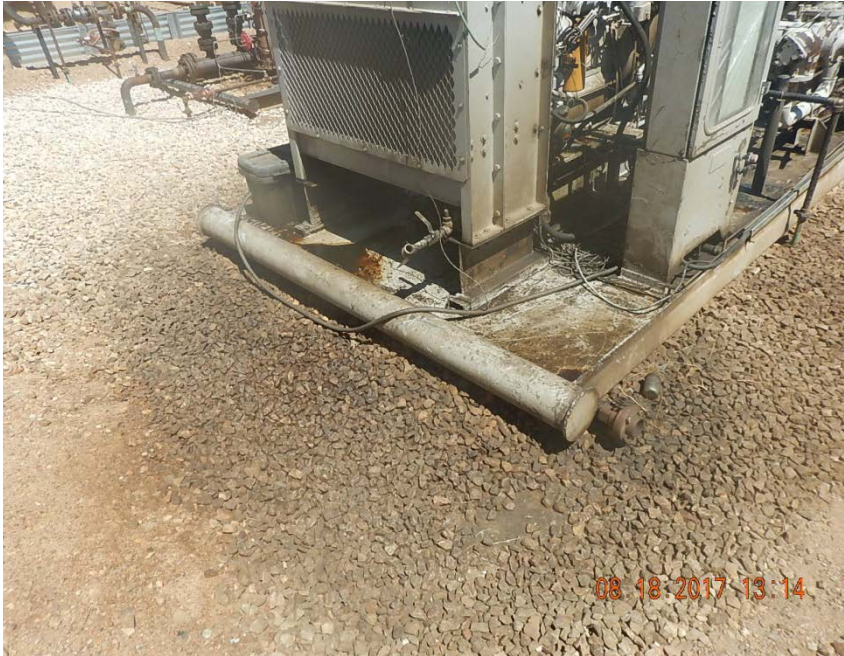
Photo 3: Stained soil at compressor

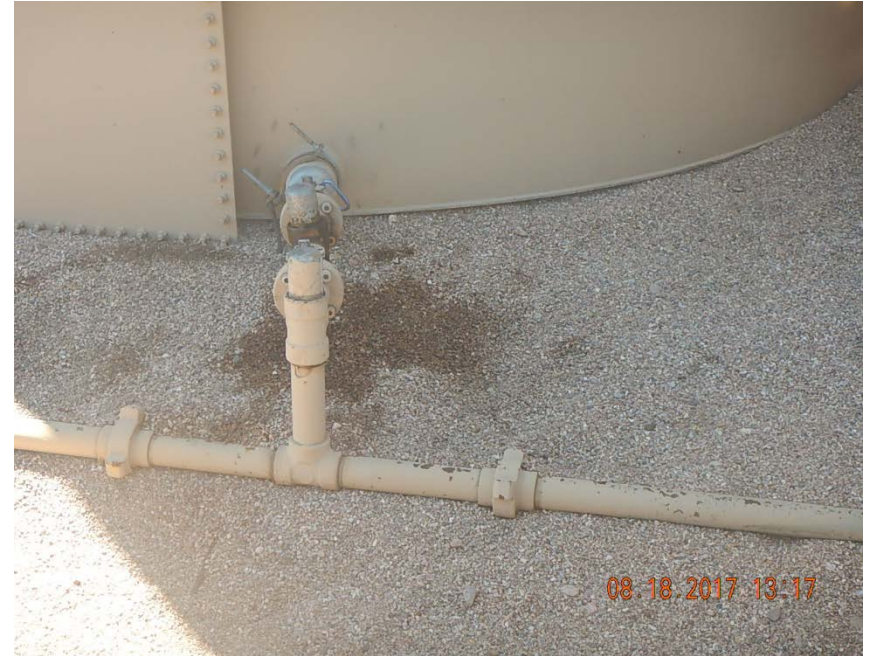
Photo 4: Stained soil at loadout valve

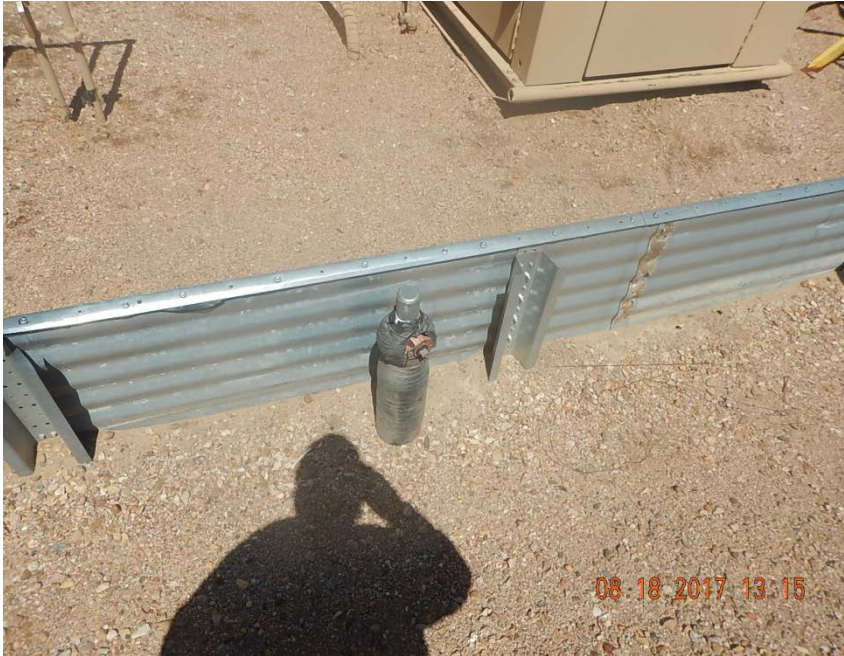
Photo 5: Riser at separator

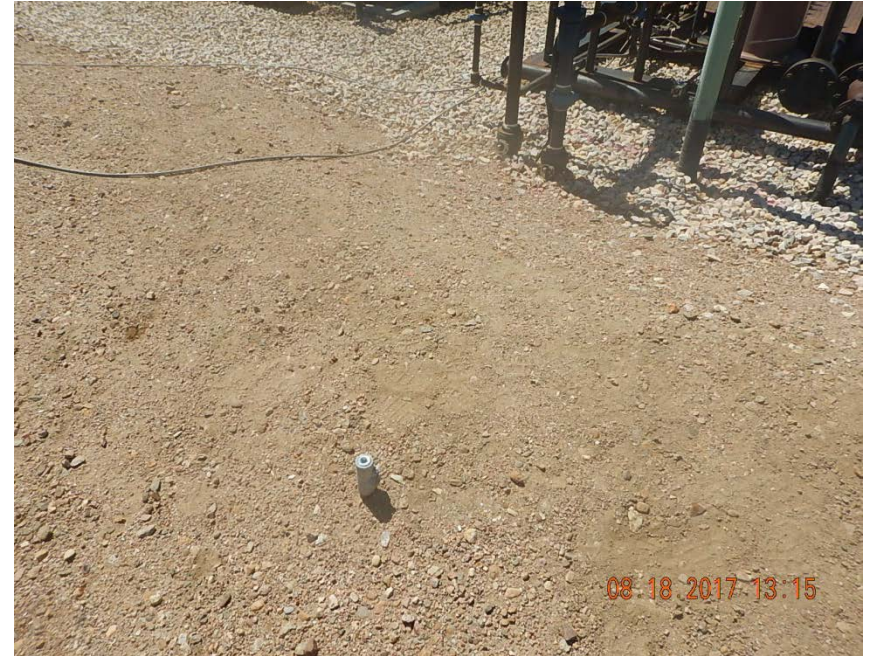
Photo 6: Riser at engine

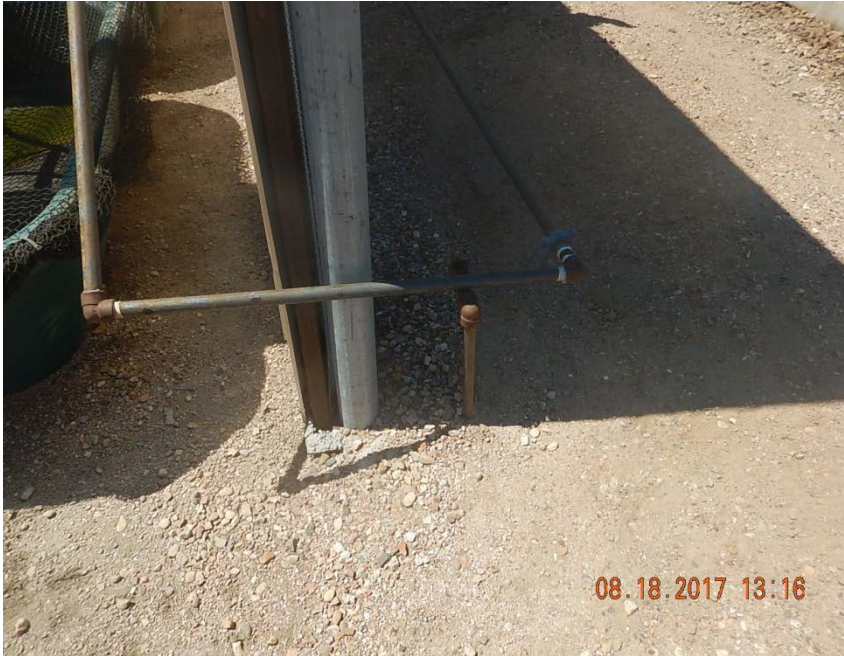
Photo 7: Riser at engine
