Inspection Photos
Location Name: Dolan Ranches #13-27
API: 05-123-07364

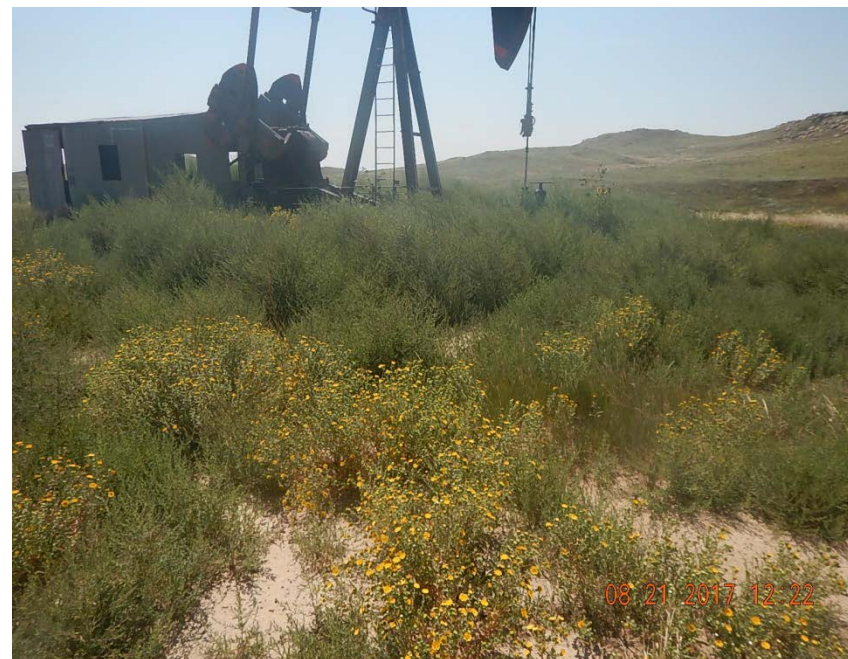
Photo 1: Weeds at wellhead

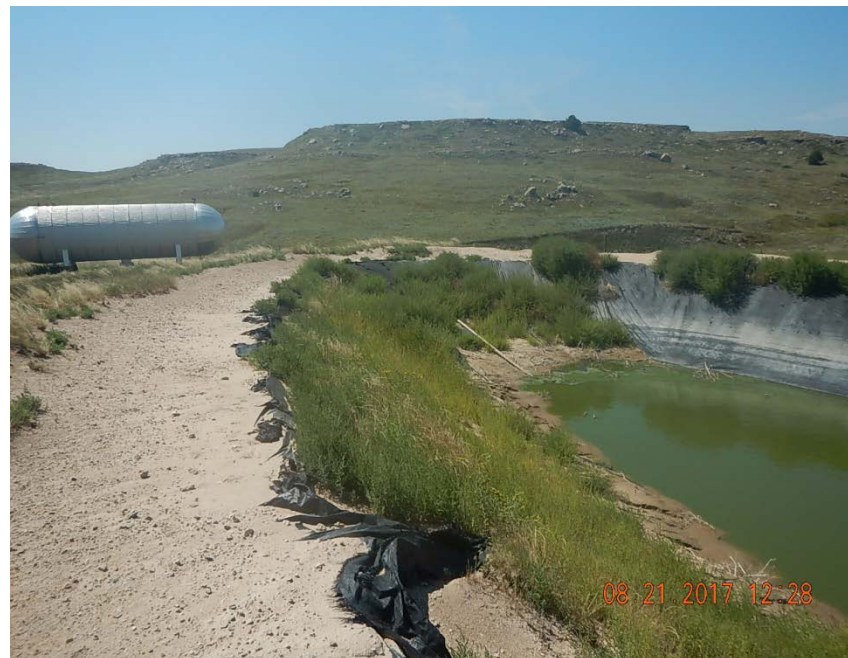
Photo 2: Liner compromised by vegetation

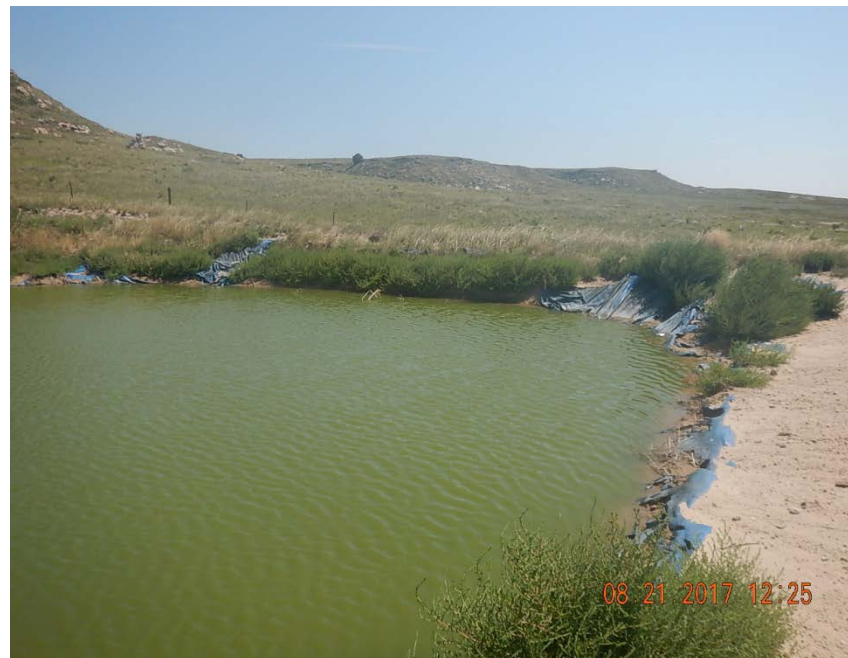
Photo 3: Liner compromised

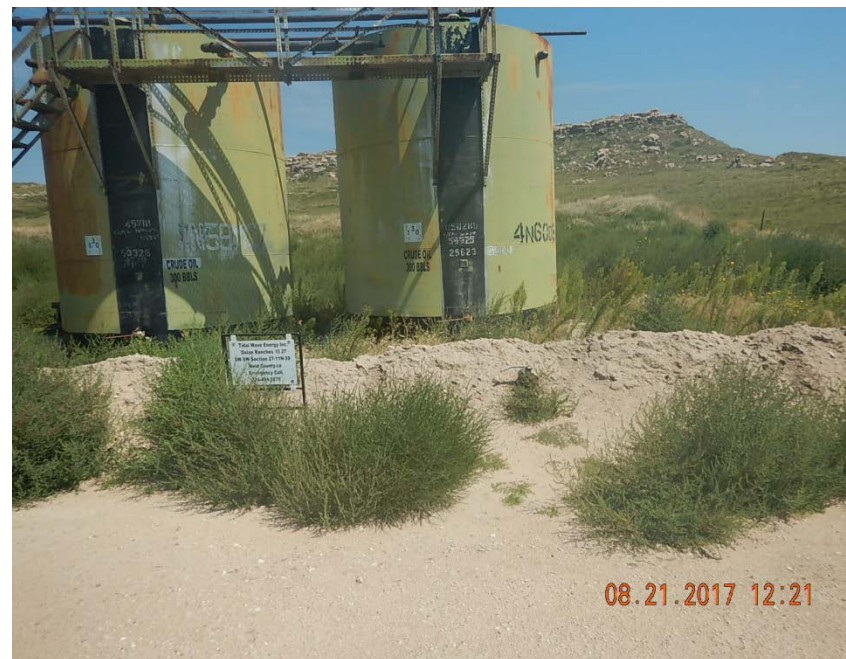
Photo 4: Weeds in tank battery

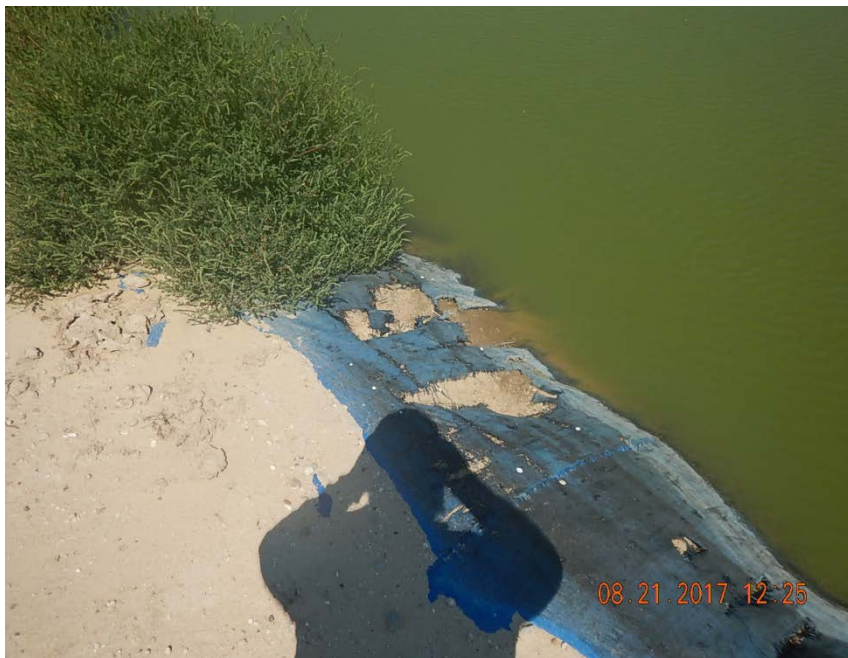
Photo 5: Tear in liner

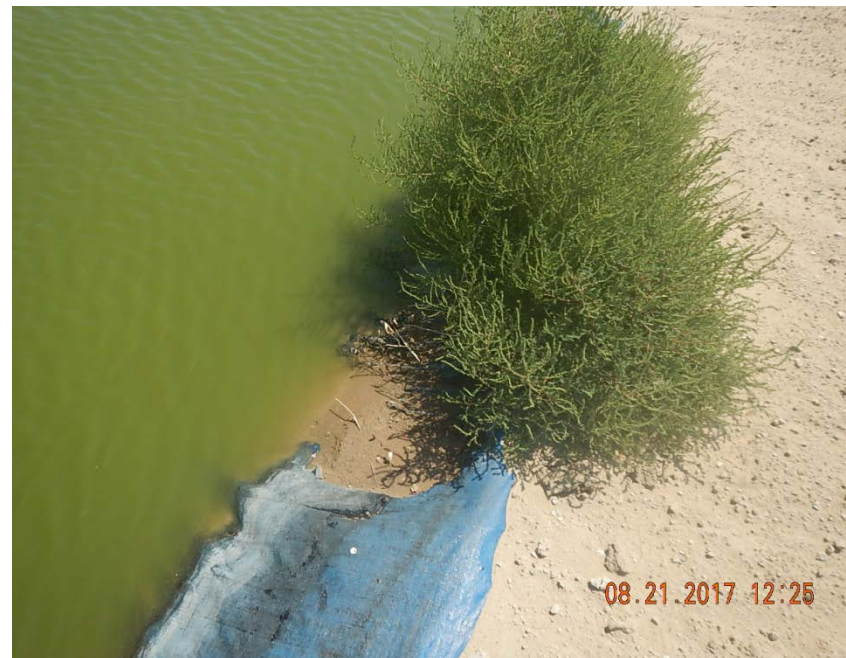
Photo 6: Weed in liner

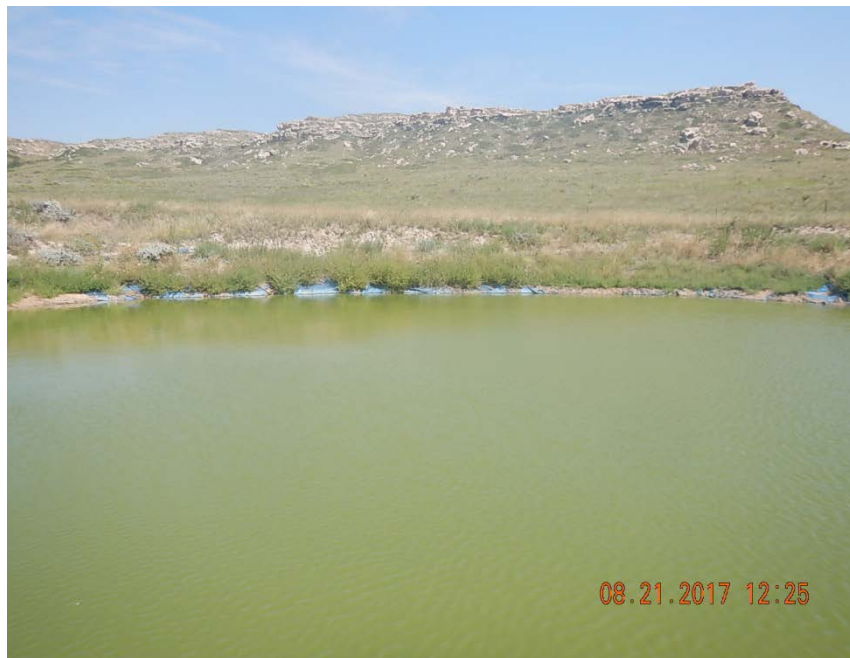
Photo 7: Weeds along liner

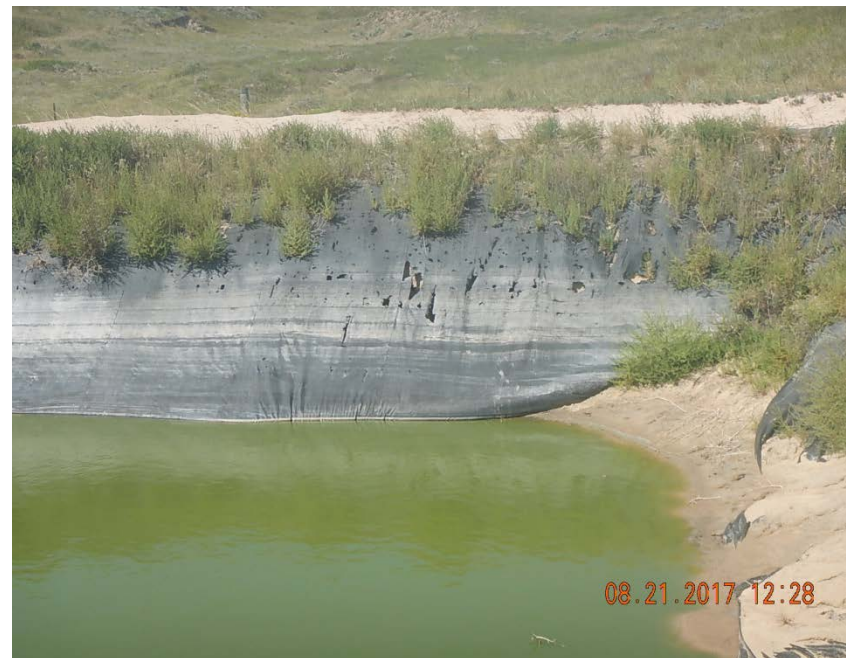
Photo 8: Tears in liner, vegetation in liner
