COGCC Environmental Field Inspection Report Photo Attachment

Inspection Date: **August 16, 2017**

COGCC Environmental Protection Specialist

**Oil & Gas Conservation
Commission**

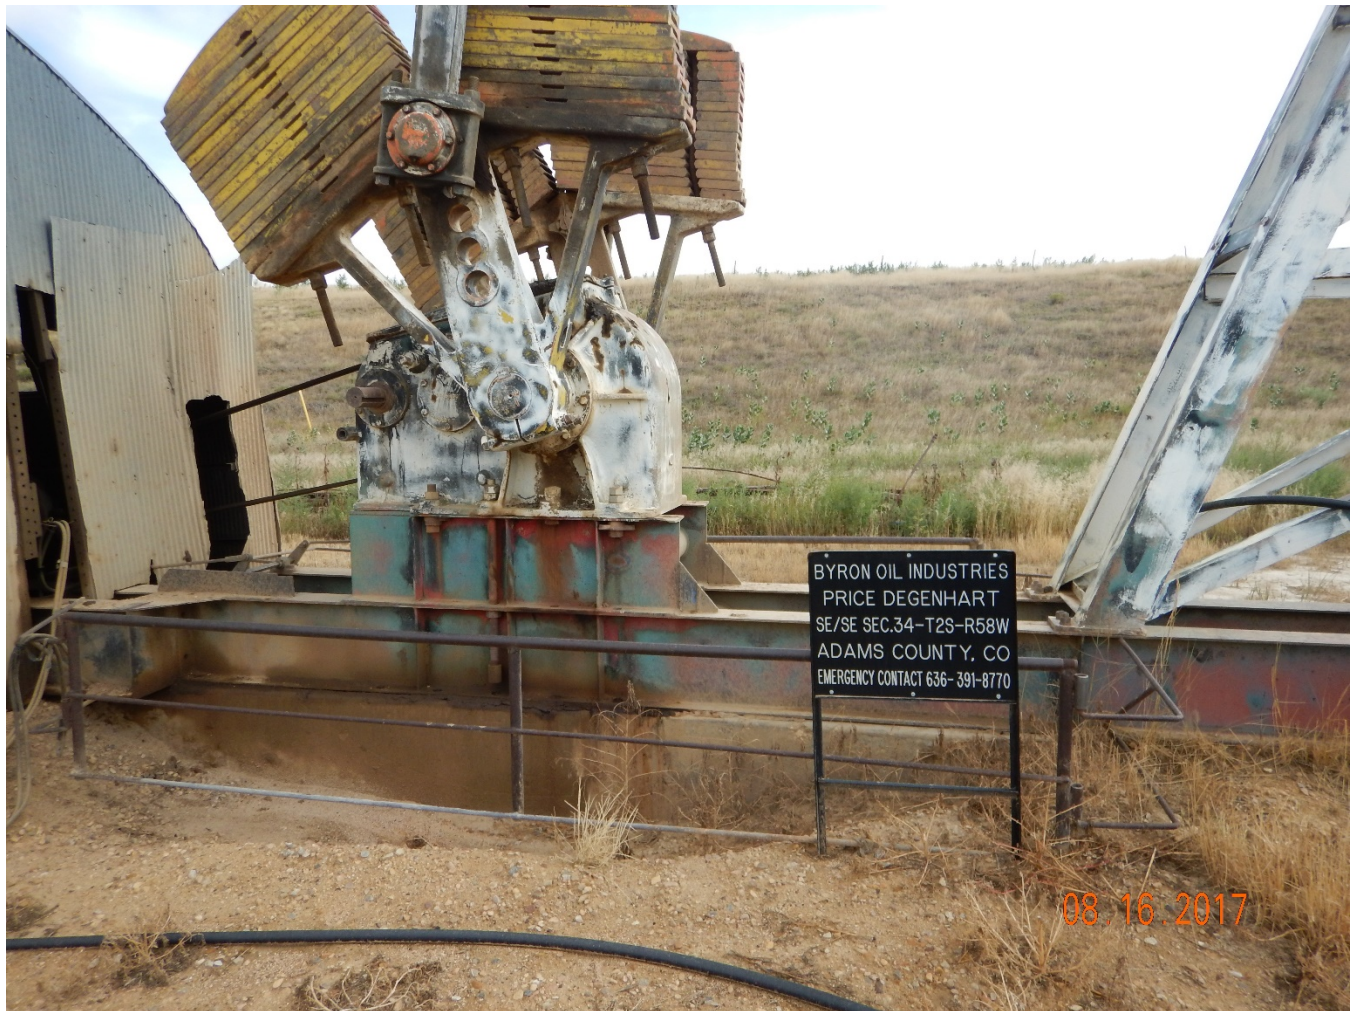
Figure 1 - Well sign at pump jack.

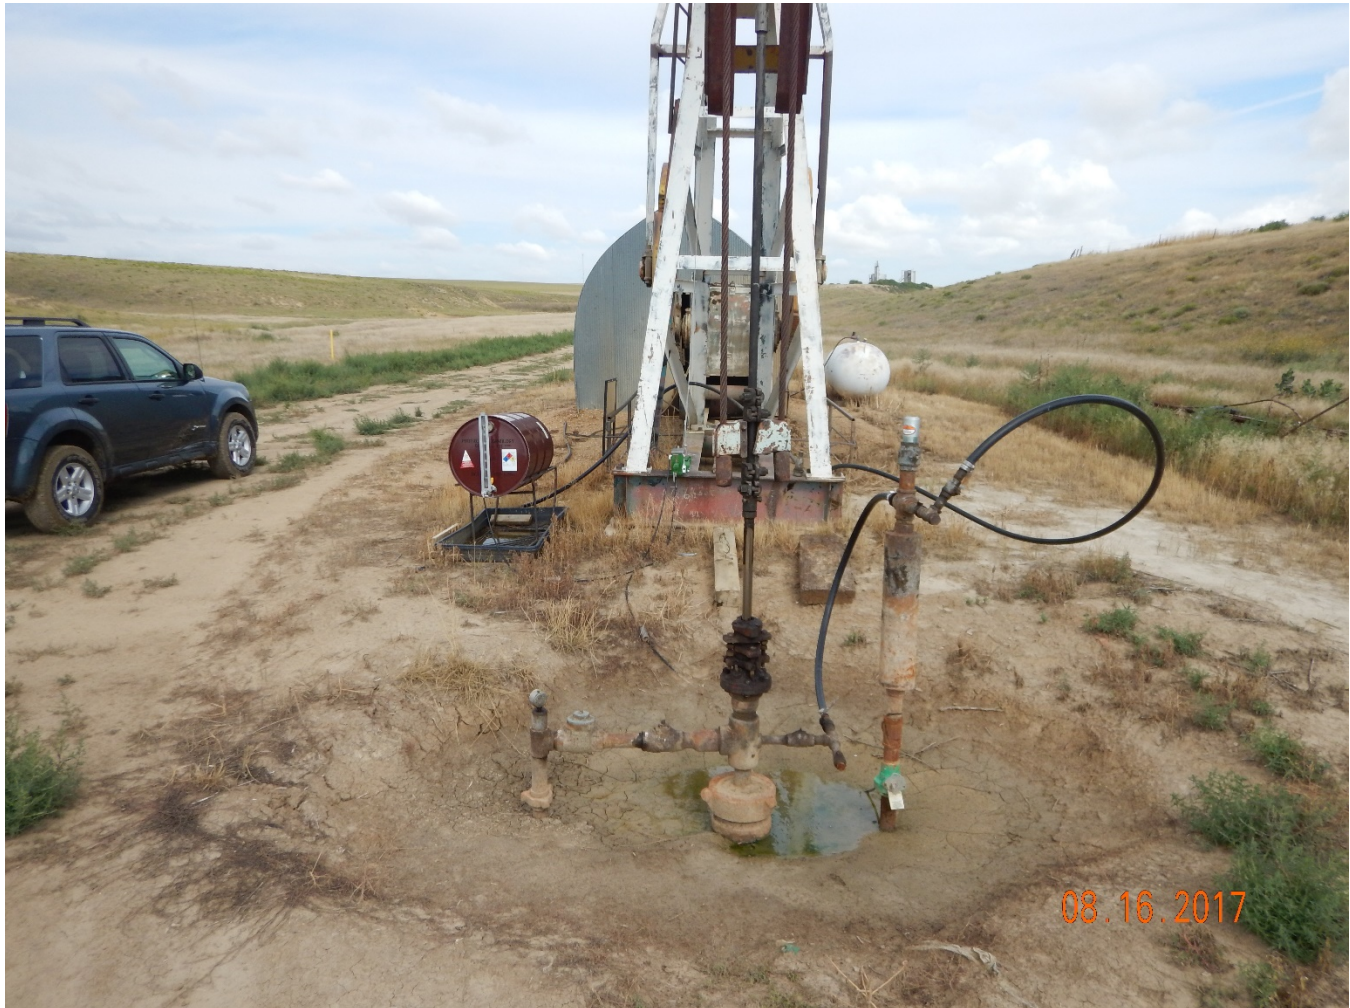
Figure 2 - Wellhead, pumping unit, 55-gallon storage drum, and propane tank. Note: wellhead remains surrounded by water.

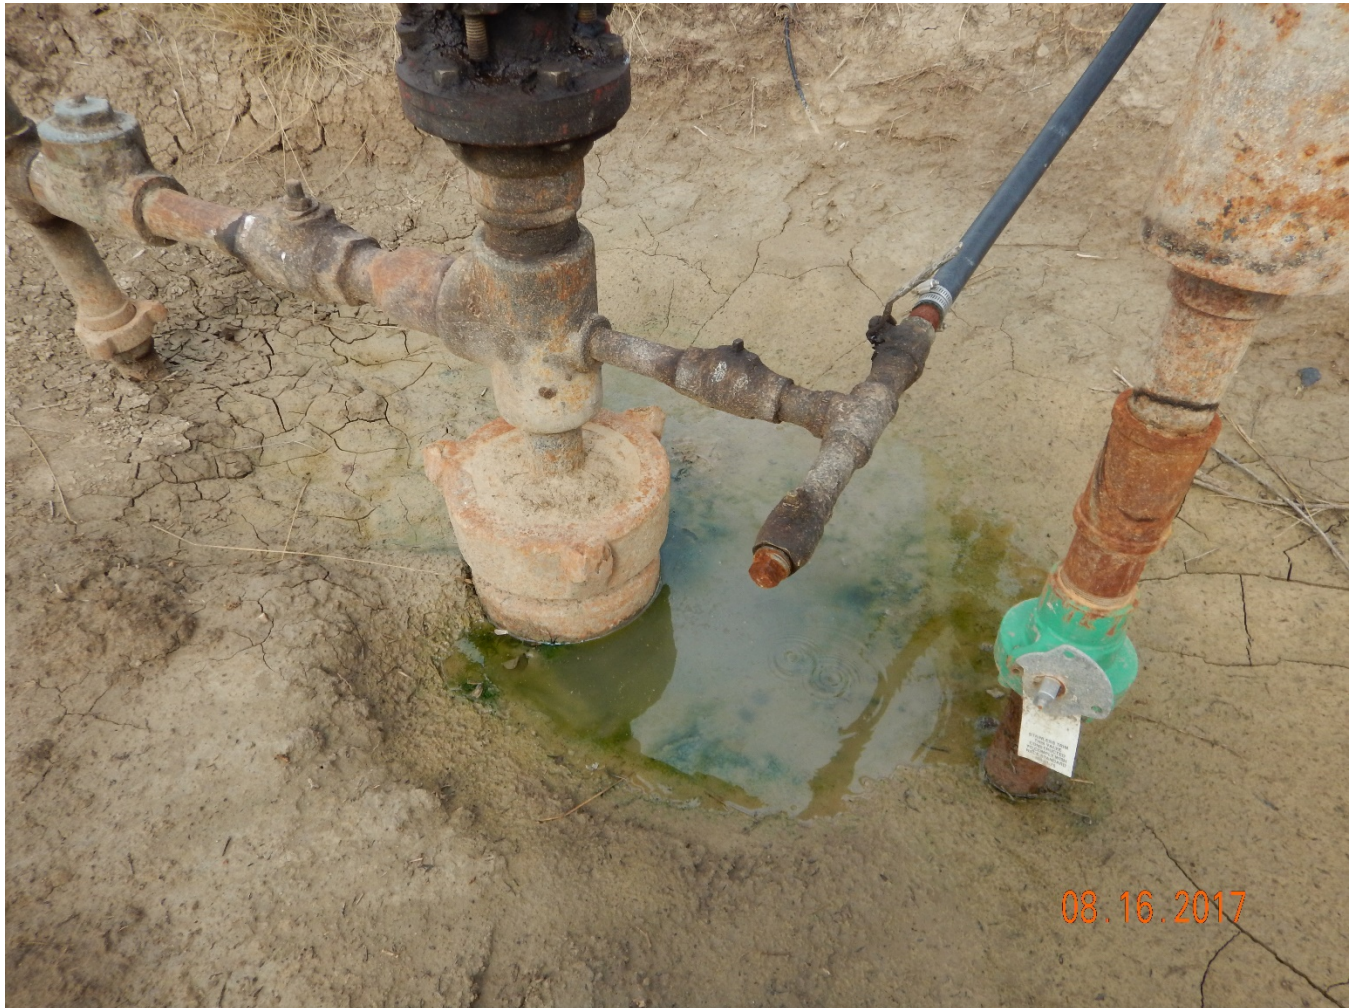
Figure 3 - Puddle surrounding wellhead. A steady release of bubbles into puddle was observed at wellhead, indicating possible integrity issue.

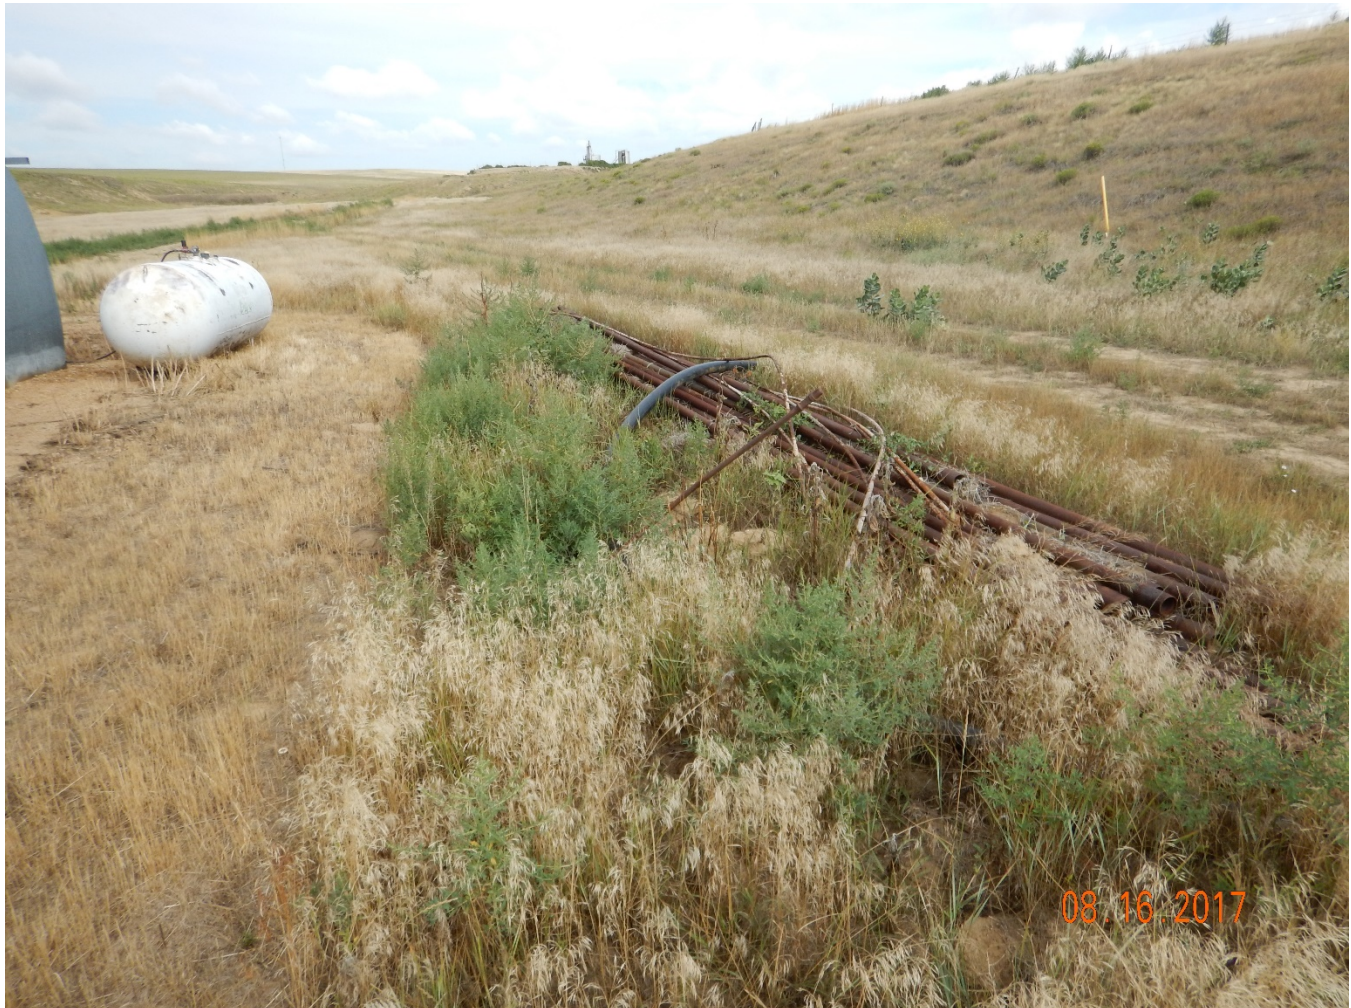
Figure 4 - Unused equipment remaining at wellhead.

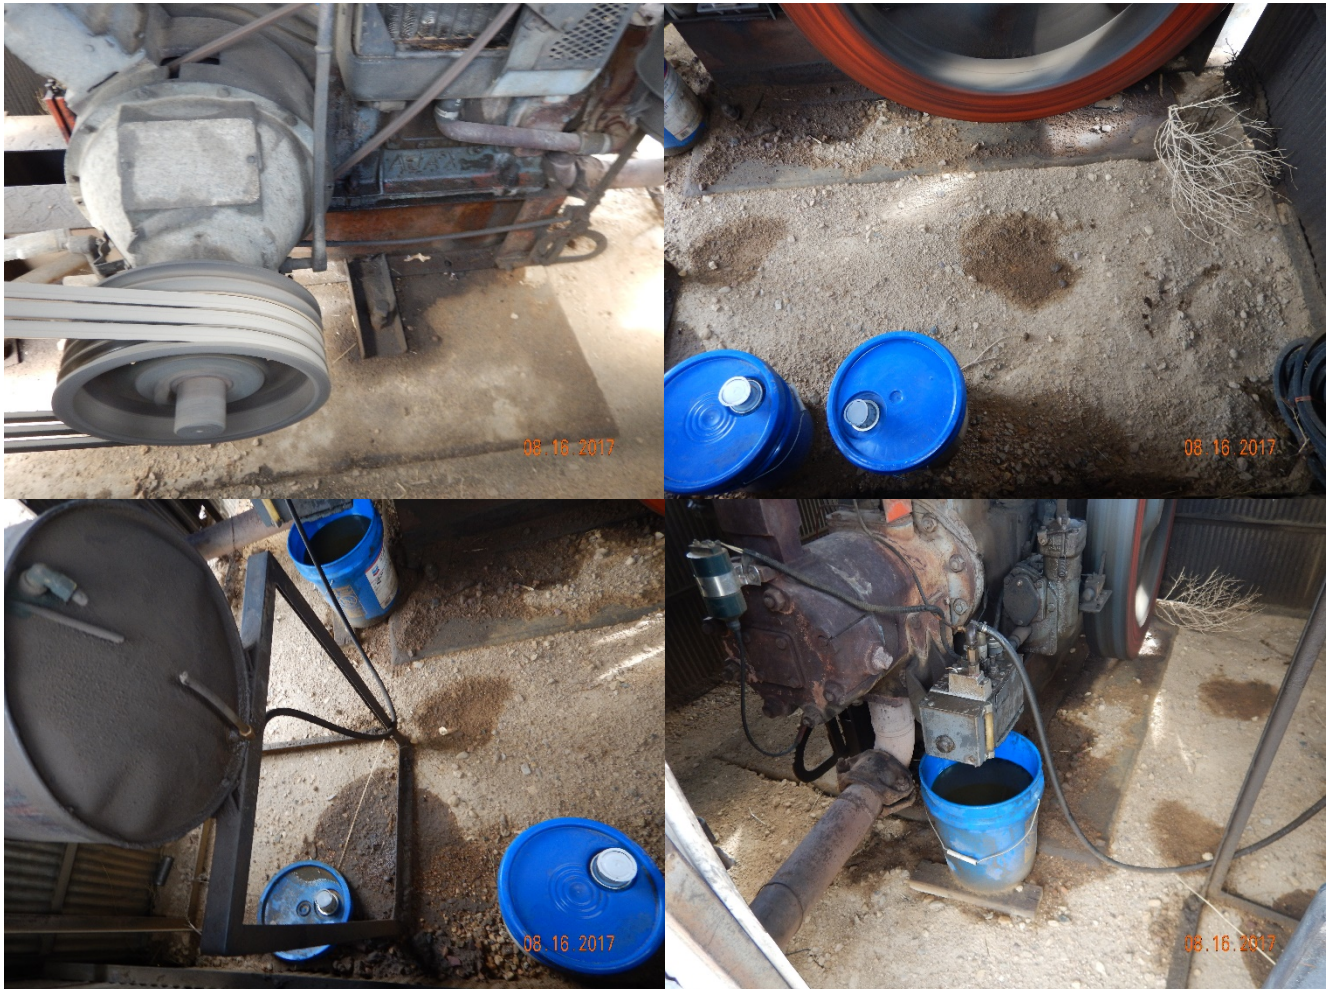
Figure 5 - Localized oil staining and bucket of oily waste observed inside of pump jack shed.

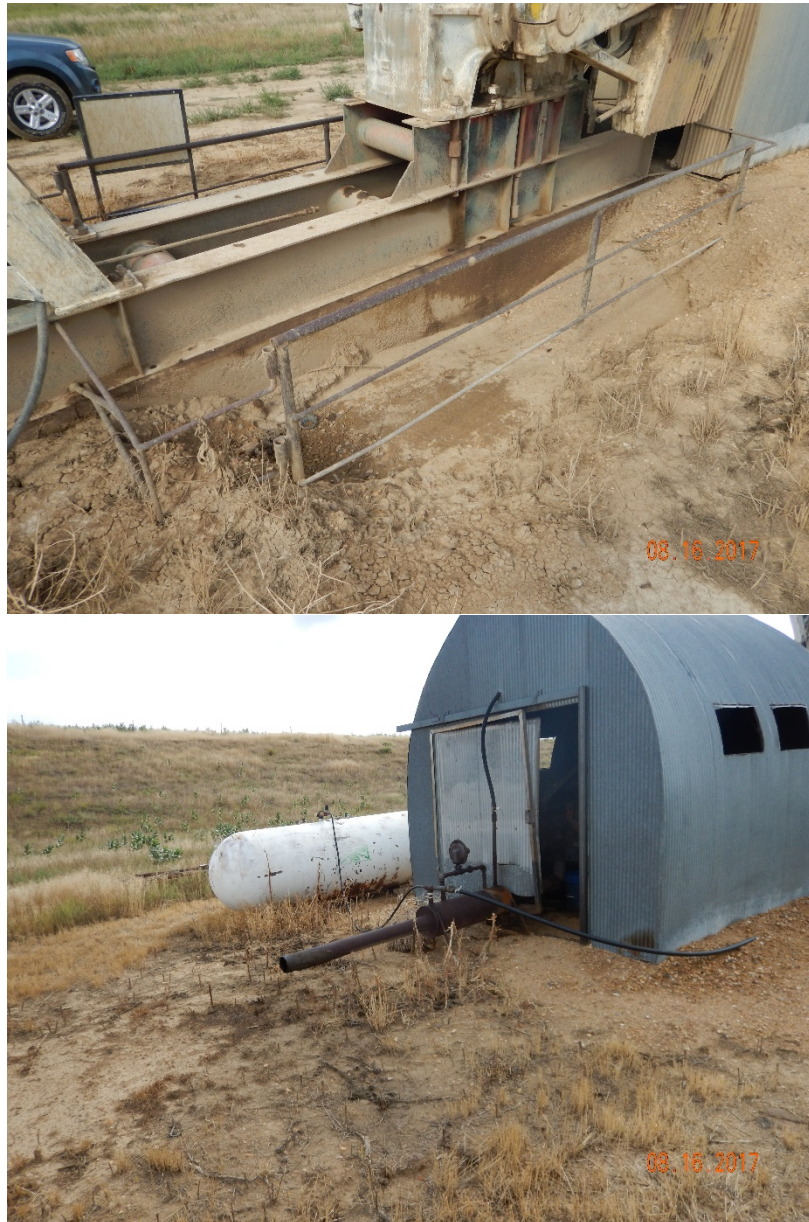
Figure 6 - Localized, oil-stained soil observed on north side of pumping unit (top photo) and beneath pumping unit exhaust (bottom photo).

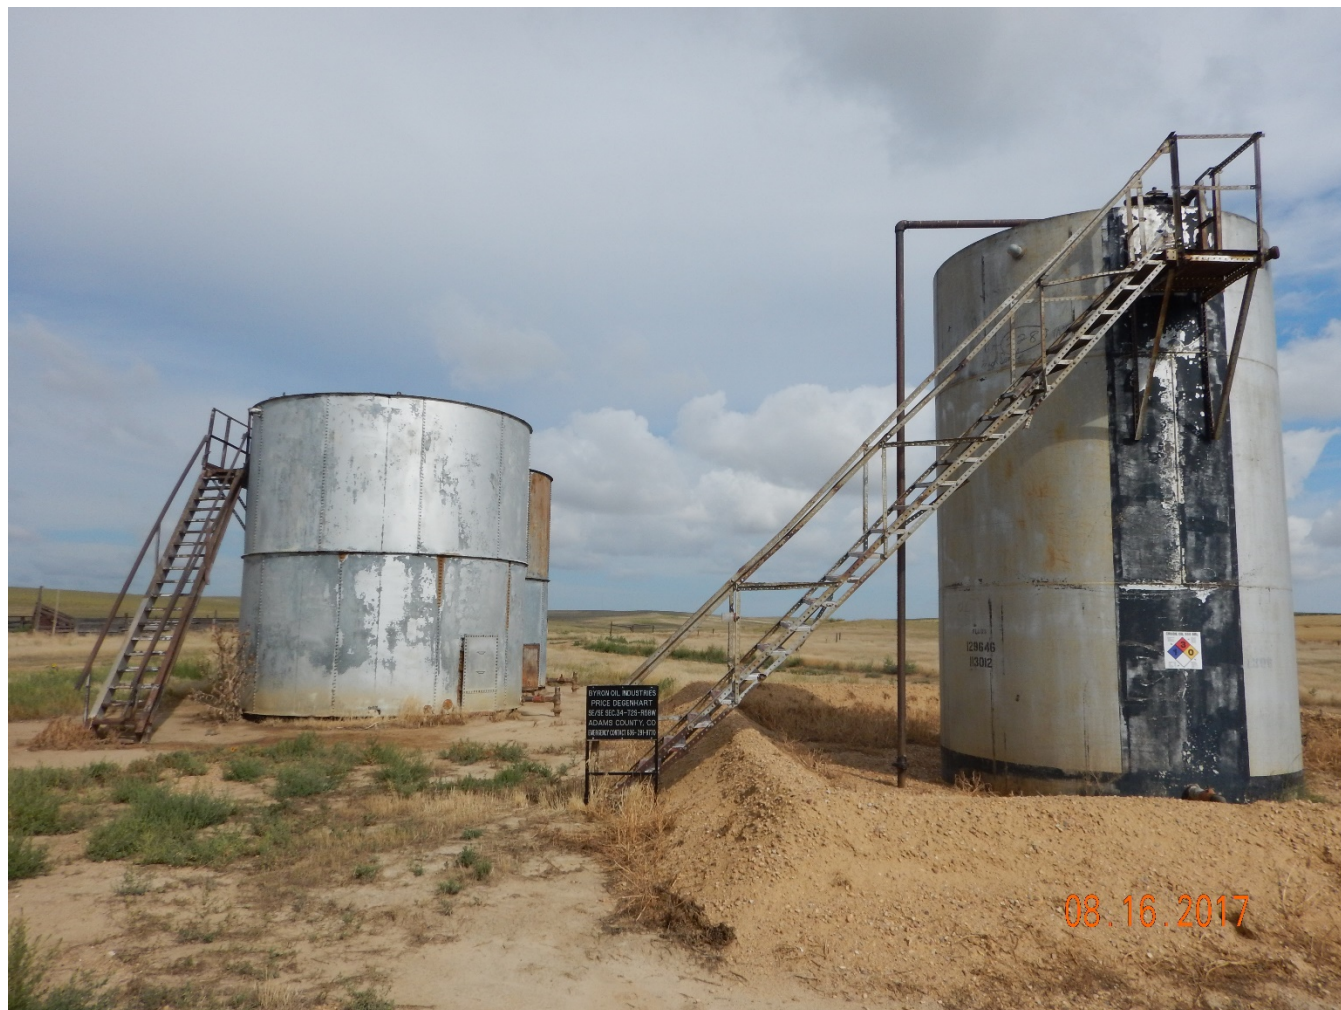
Figure 7 - Tank Battery sign, unidentified panel tanks, and crude oil AST.

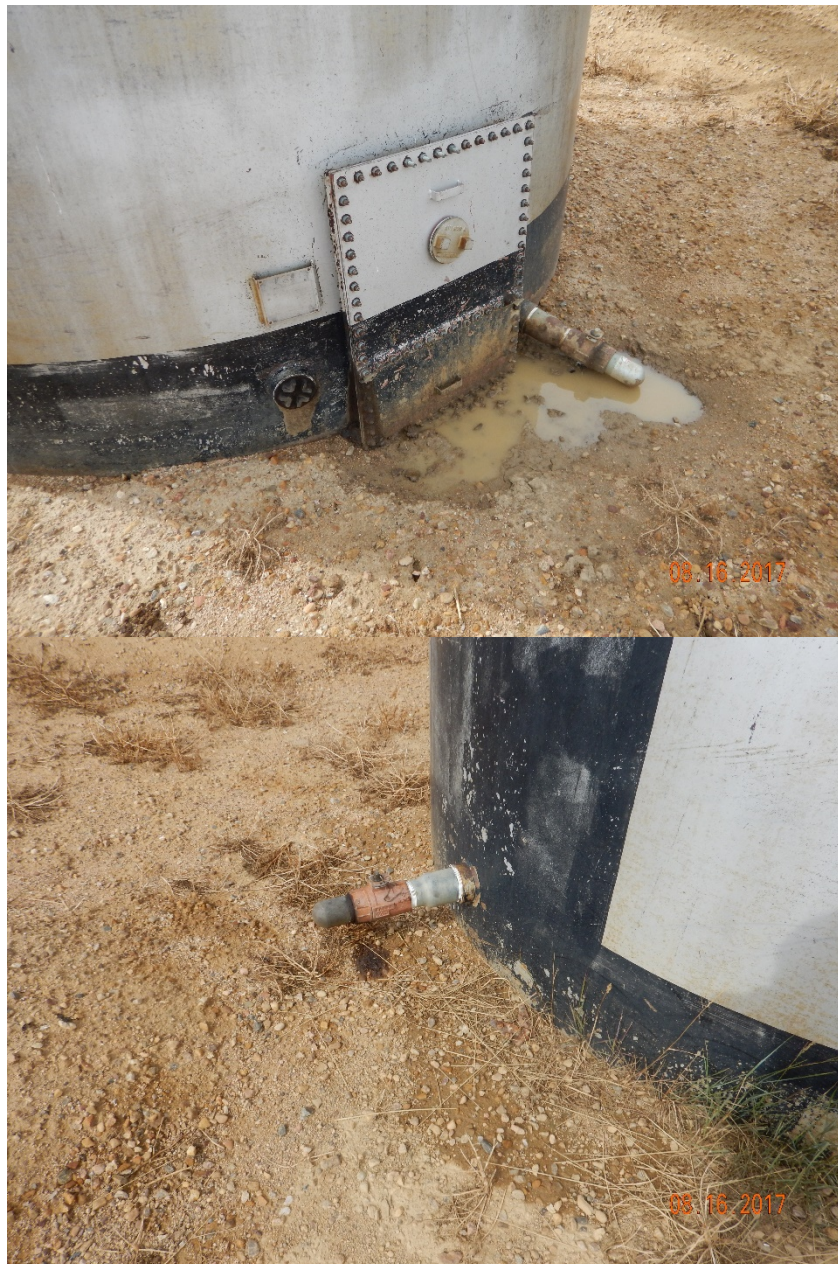
Figure 8 – Watery puddle beneath valve and panel on north side of crude oil AST (top photo). Oil-stained soil (oily waste) beneath valve on south side of crude oil AST (bottom photo).

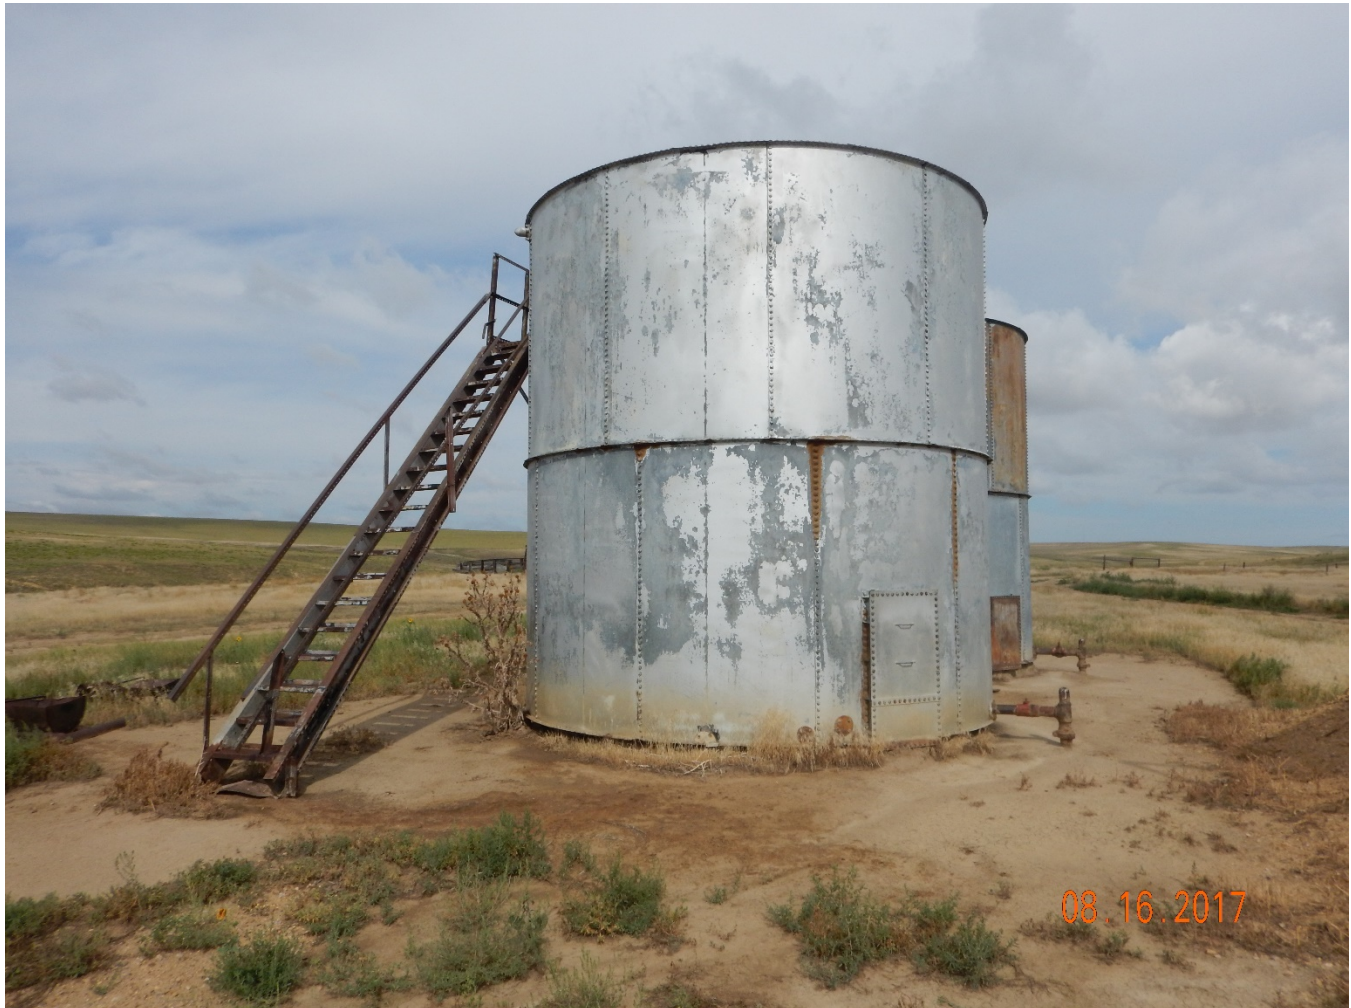
Figure 9 - View of unidentified, steel panel ASTs from the south. Operator confirmed that these tanks are inoperable and thereby subject to Rule 603.f for removal of unused equipment. Note asphaltic material (oily waste) immediately south of tank (in foreground) and tanks lack secondary containment.

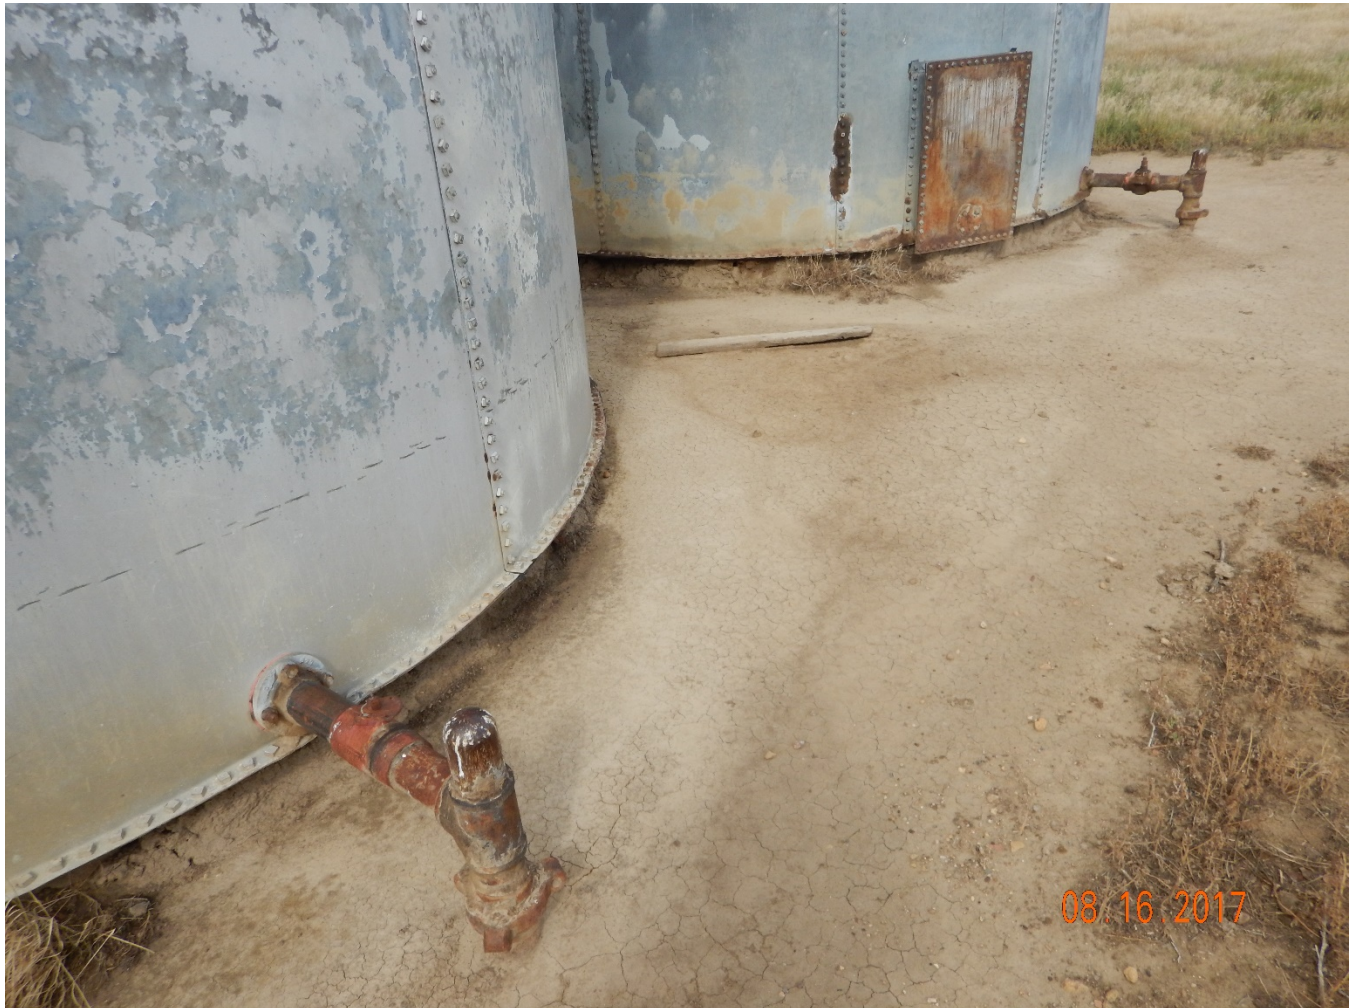
Figure 10 - Historical accumulation of oily waste beneath tanks and seeping from tank bolts. Tanks likely contain tank bottoms.

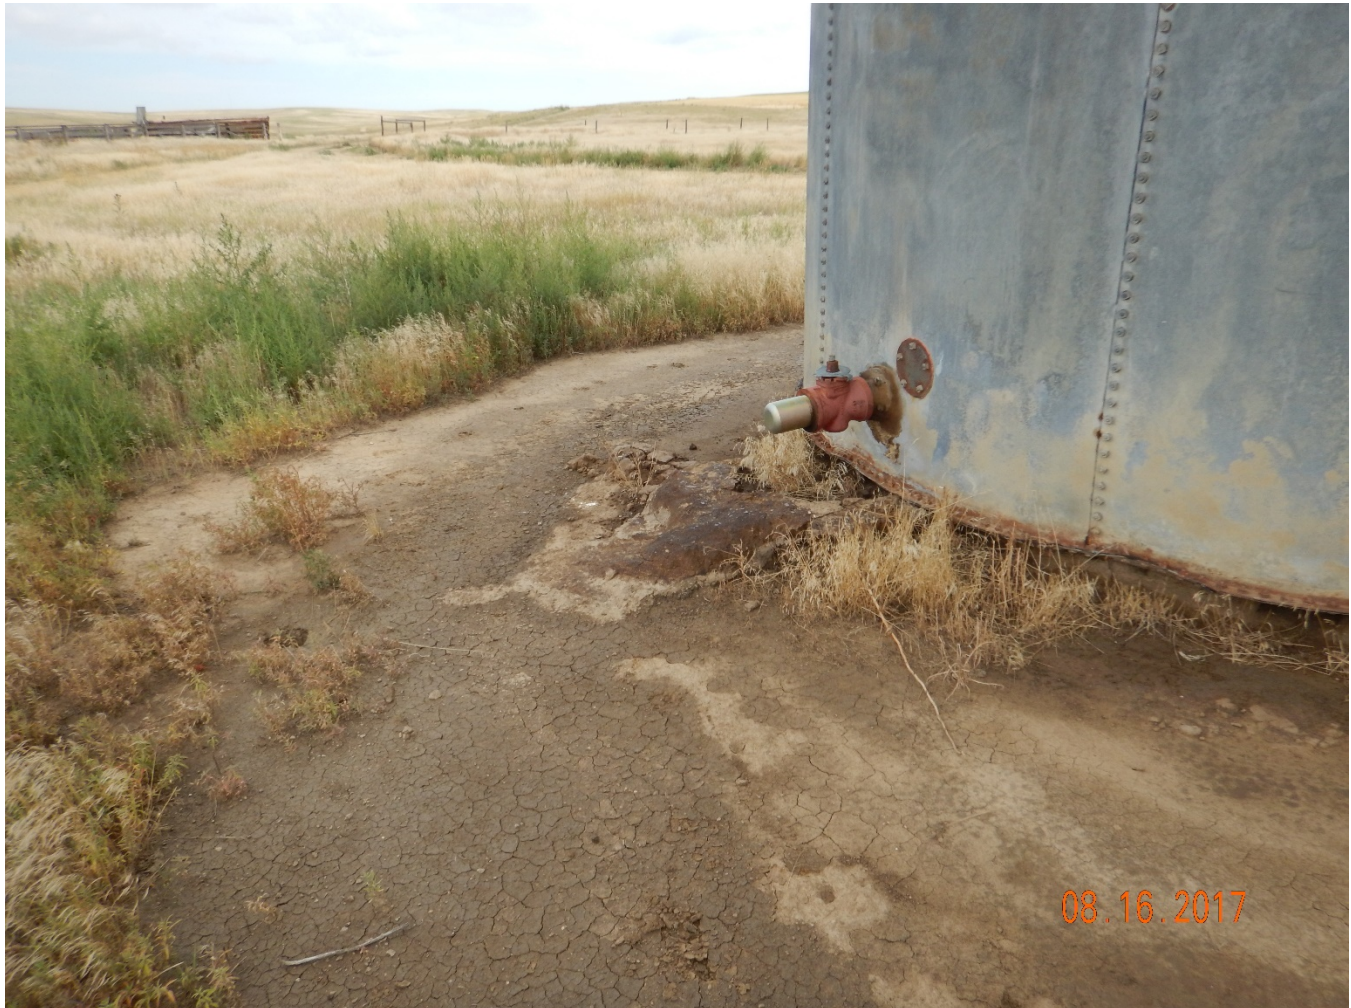
Figure 11 – Accumulation of oily waste beneath valve on west side of northern panel tank.

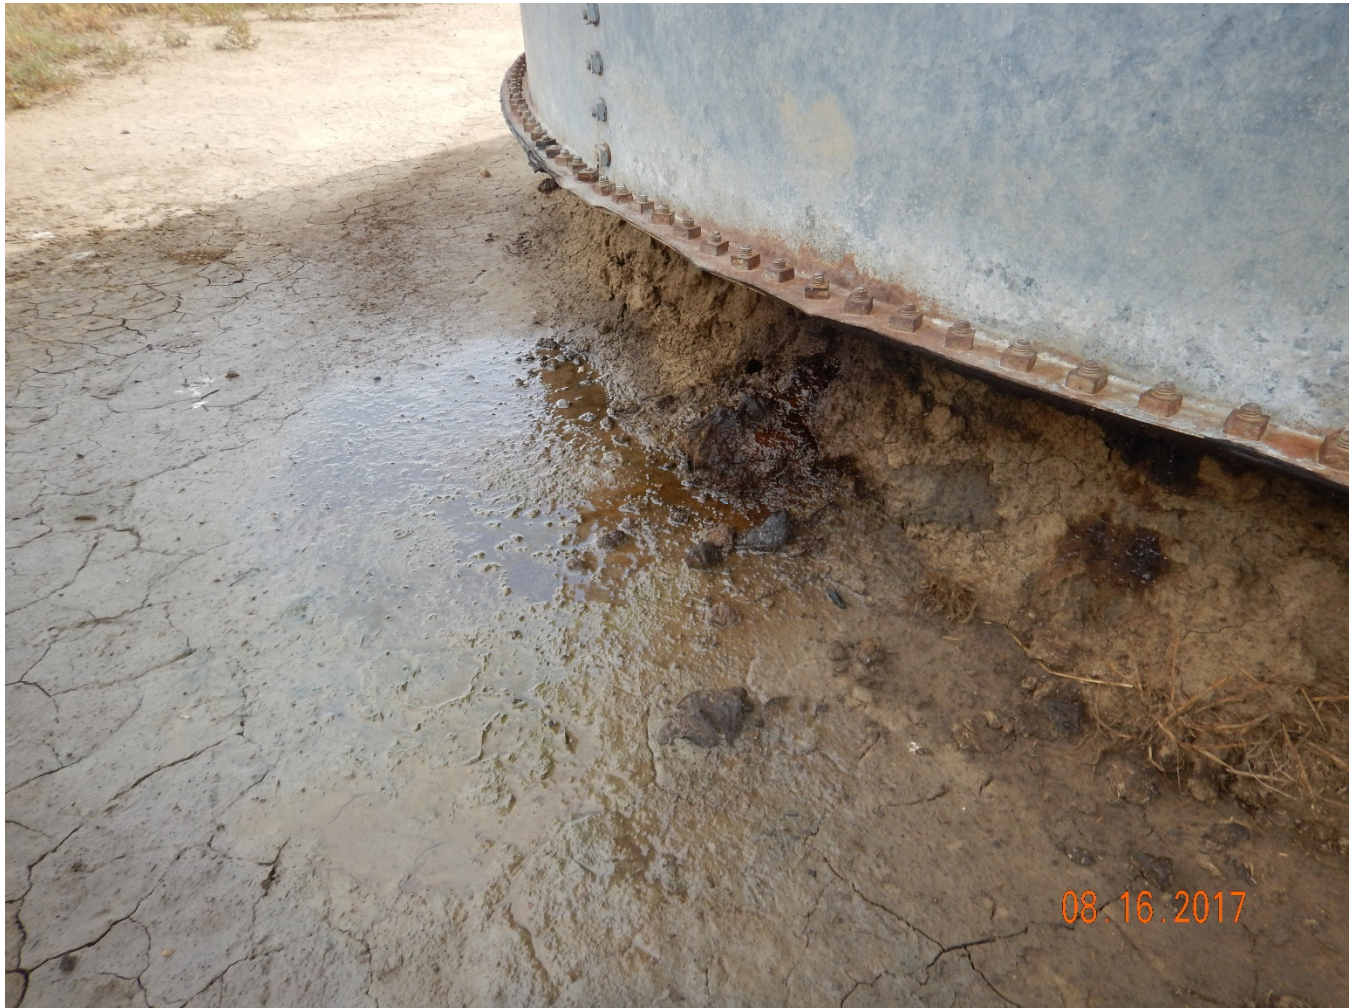
Figure 12 - Puddle was observed on north side of northern steel panel tank Note: oil in puddle.

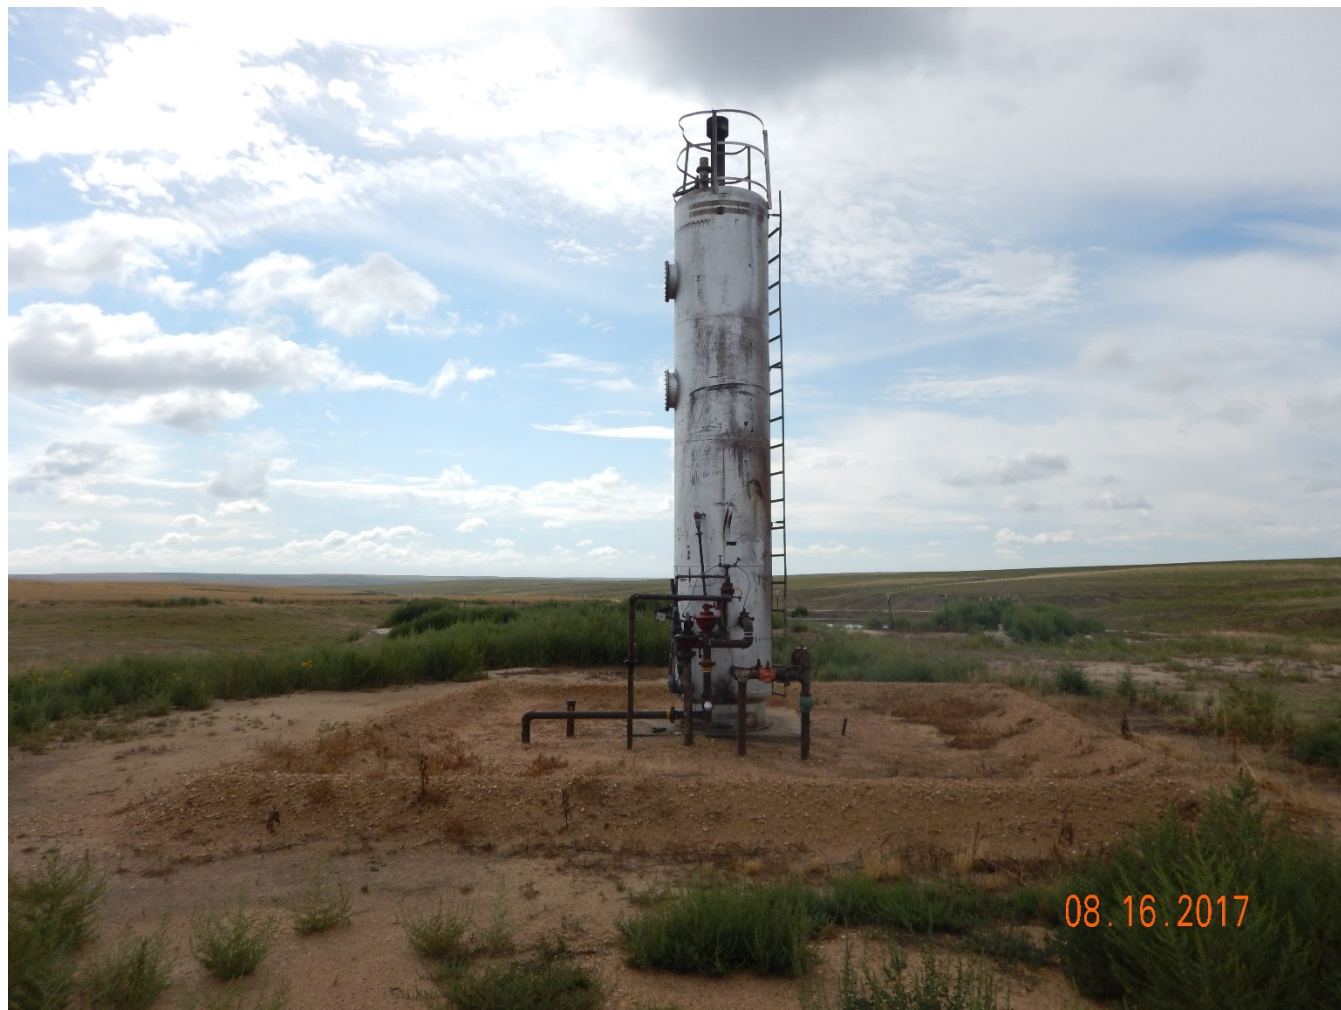
Figure 13 - Vertical heater treater with earthen berm and adequate bird protection.

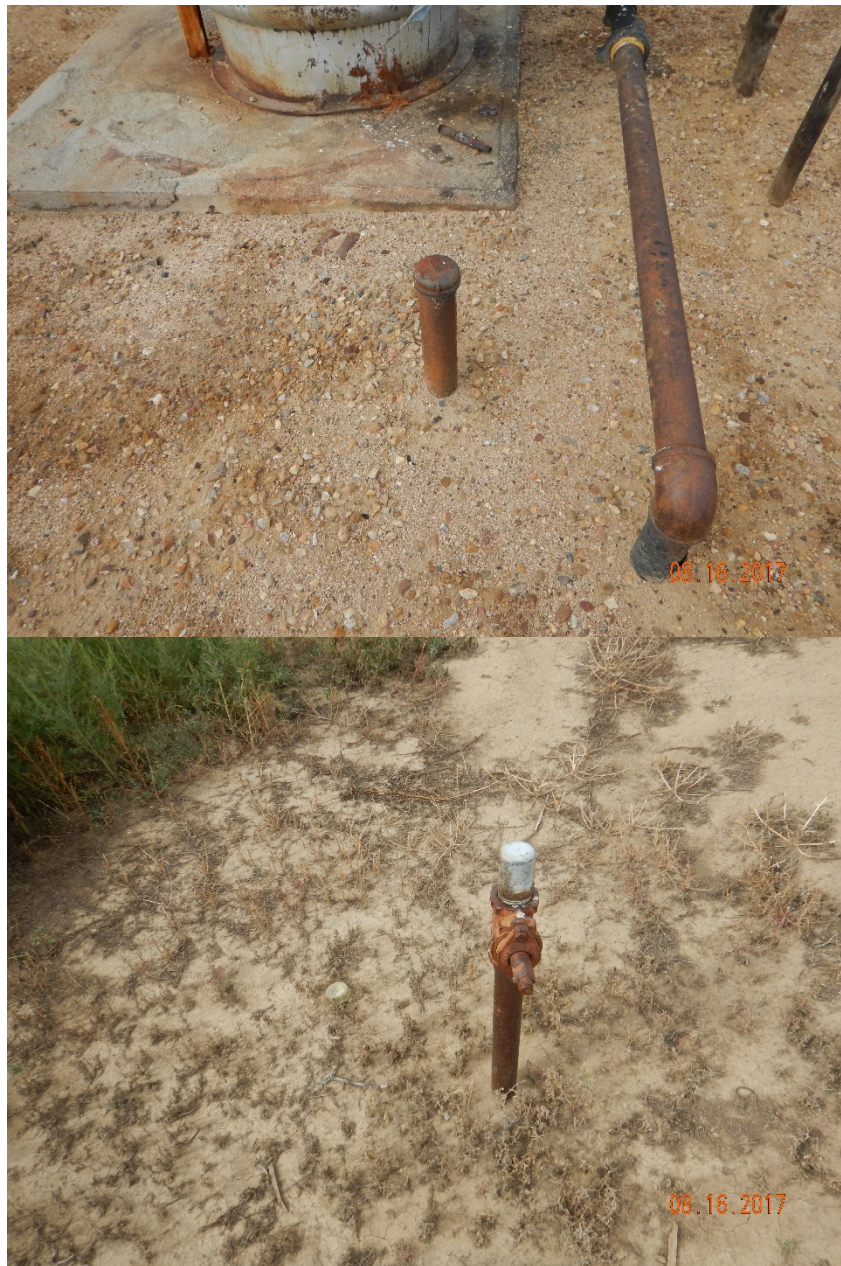
Figure 14 - Abandoned flowline risers at heater treater (top) and south of heater treater (bottom) had not been marked or tagged to comply with 2017 Flowline NTO as of inspection date.

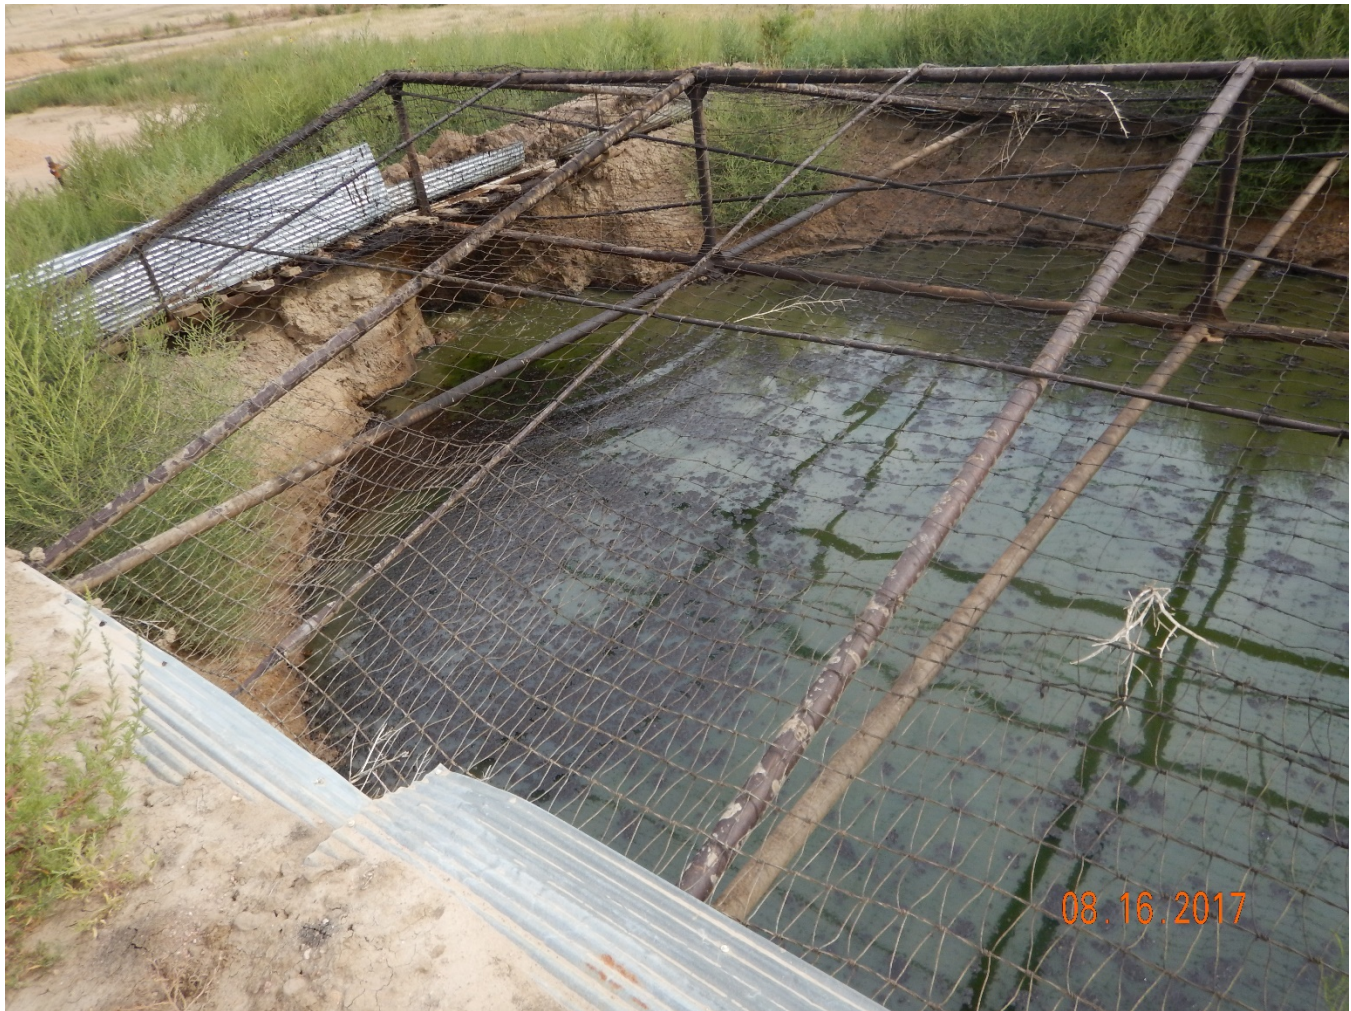
Figure 15 – View of unlined skim pit, COGCC Facility ID #104647, from SW corner. Note oil remaining on pit and berms. Continued operation of an unlined skim pit is a violation of Rule 904.a.(4), presence of oil on the pit is a violation of Rule 902.c and Rule 323.

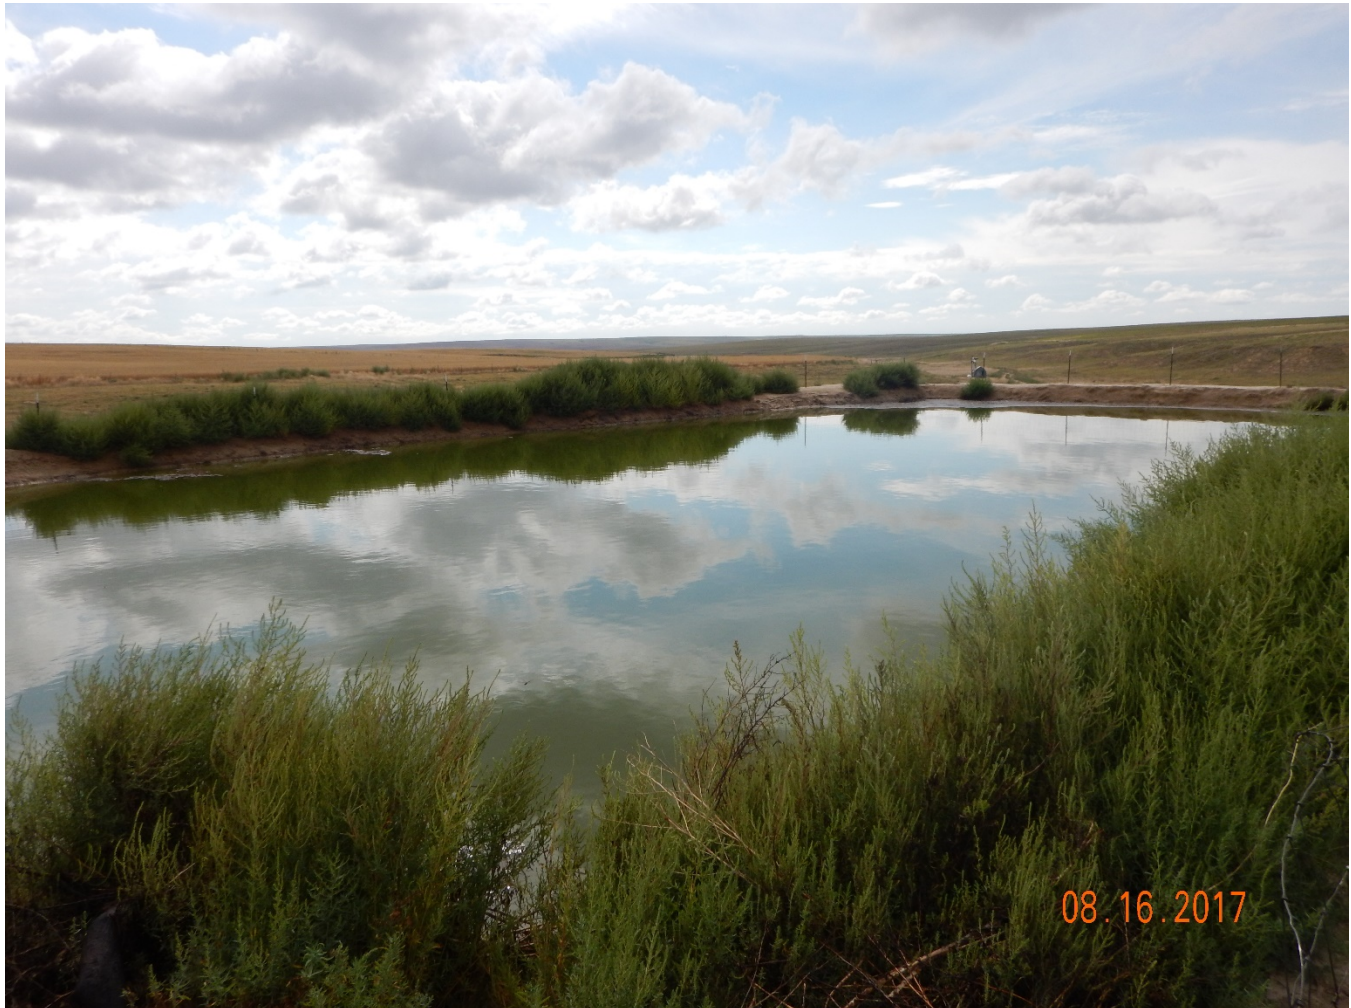
Figure 16 - View of unlined produced water pit, COGCC Facility ID #114378, from NW corner. Note: weeds growing into berms. Operator had made an attempt to remove oil that was reported to be on top of pit in previous FIRs. Oil remained covering 5-10% of pit on south side.

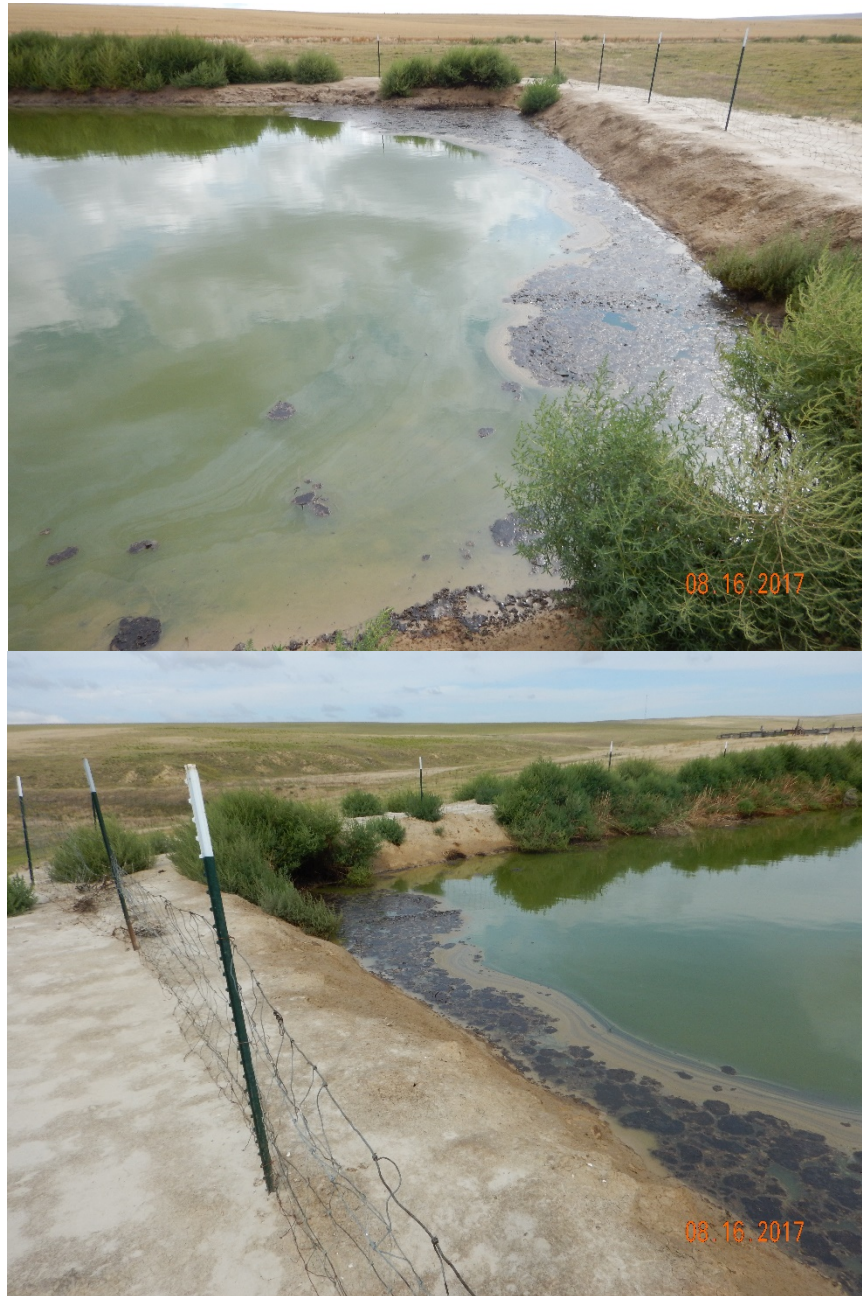
Figure 17 – Oily residue remains on produced water pit, primarily along southern berm and around perimeter. Continued presence of oil on pit, in violation of Rule 902.c and Rule 323.
