COGCC Environmental Field Inspection Report Photo Attachment

Inspection Date: **August 16, 2017**

COGCC Environmental Protection Specialist

**Oil & Gas Conservation
Commission**

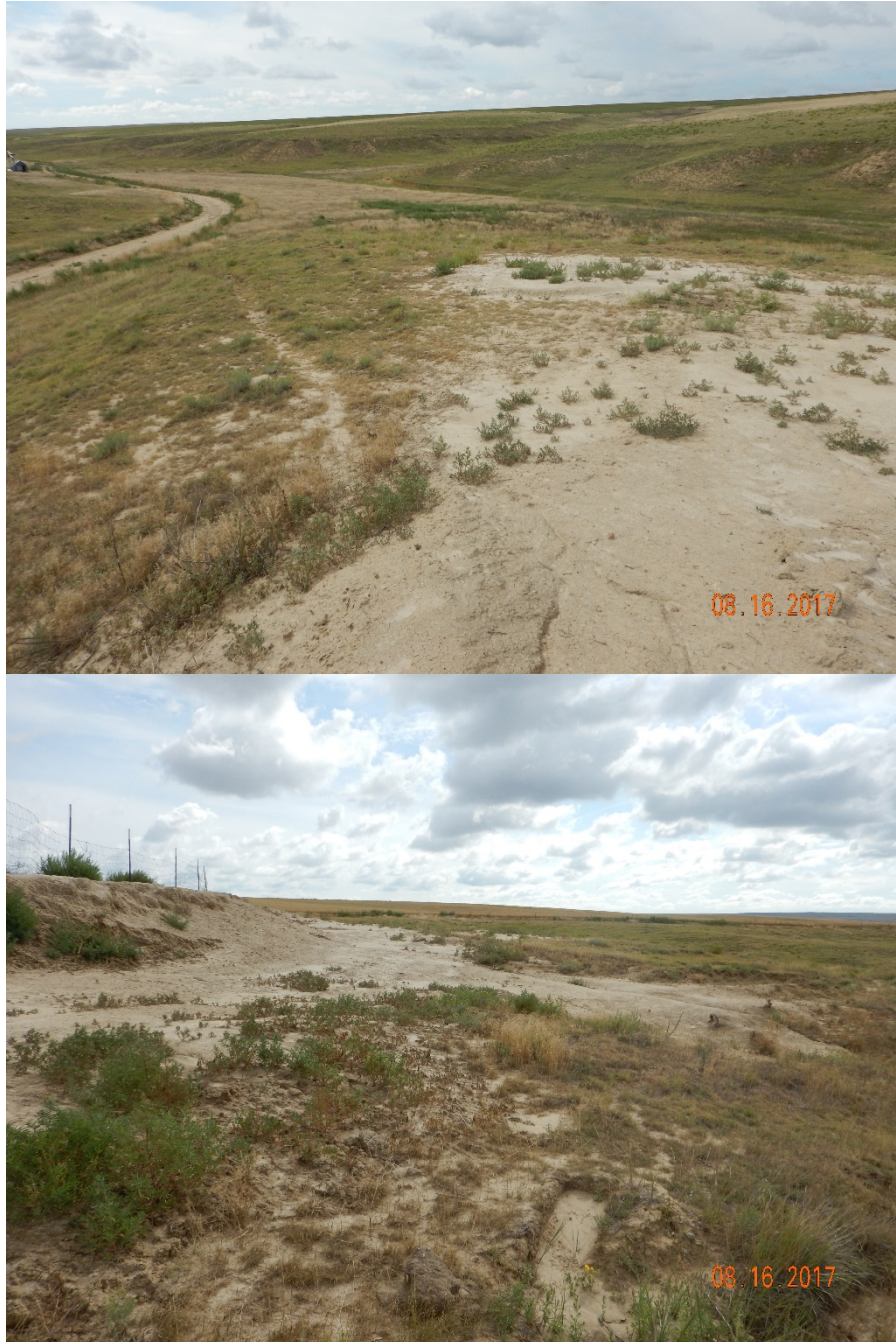
Figure 18 - Evidence of erosion, sediment migration, and possible impacted vegetation to south and west of produced water pit.

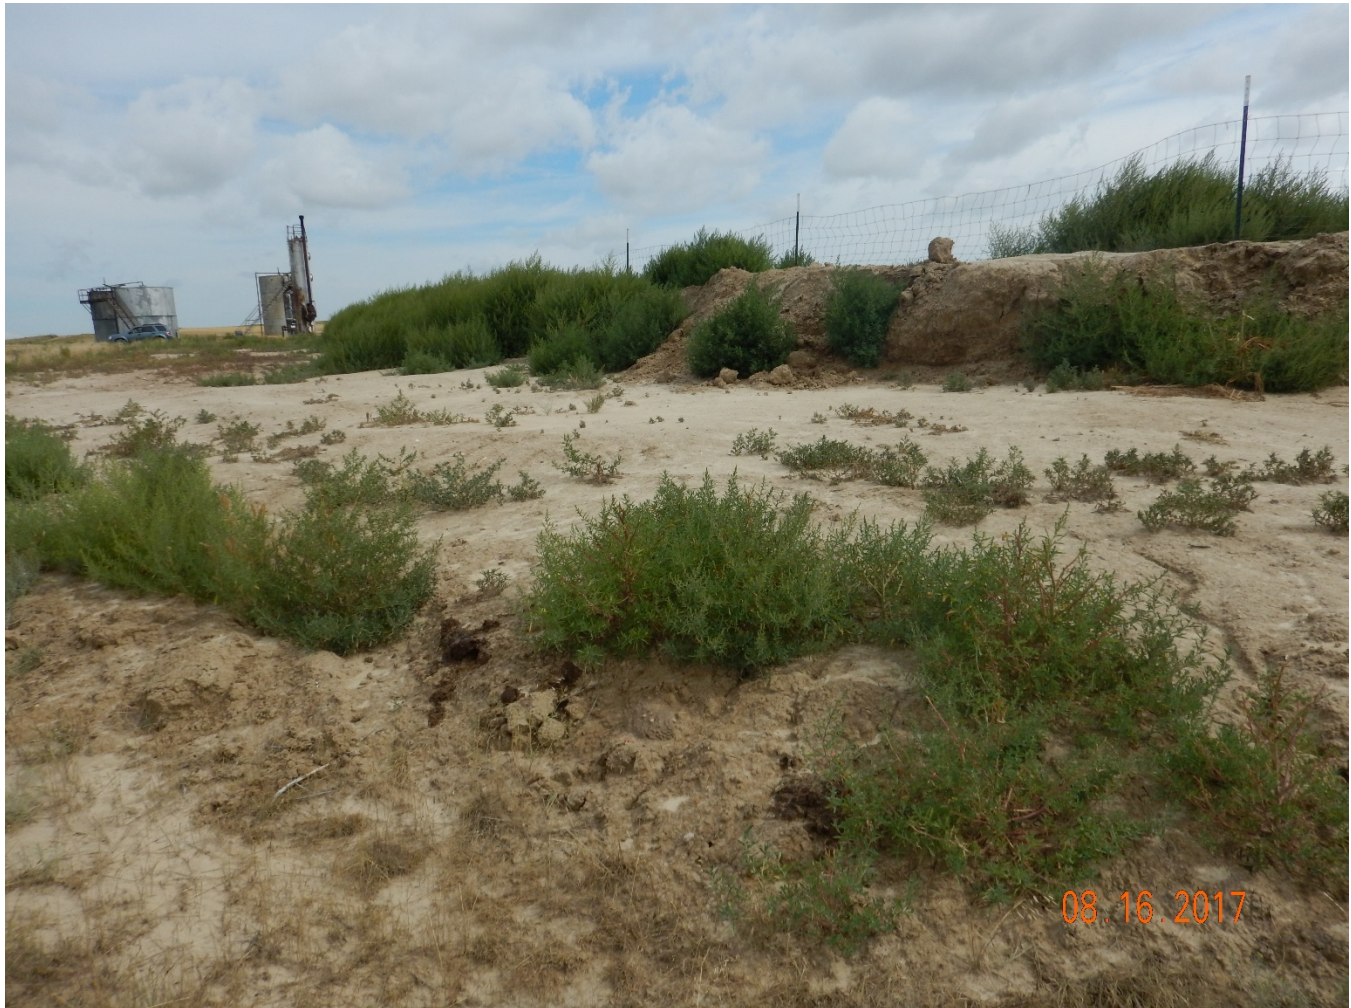
Figure 19 – Localized, oil-stained soil west of produced water pit.
