Inspection Photos
Location Name: Dilka 6-12
API: 05-123-23783

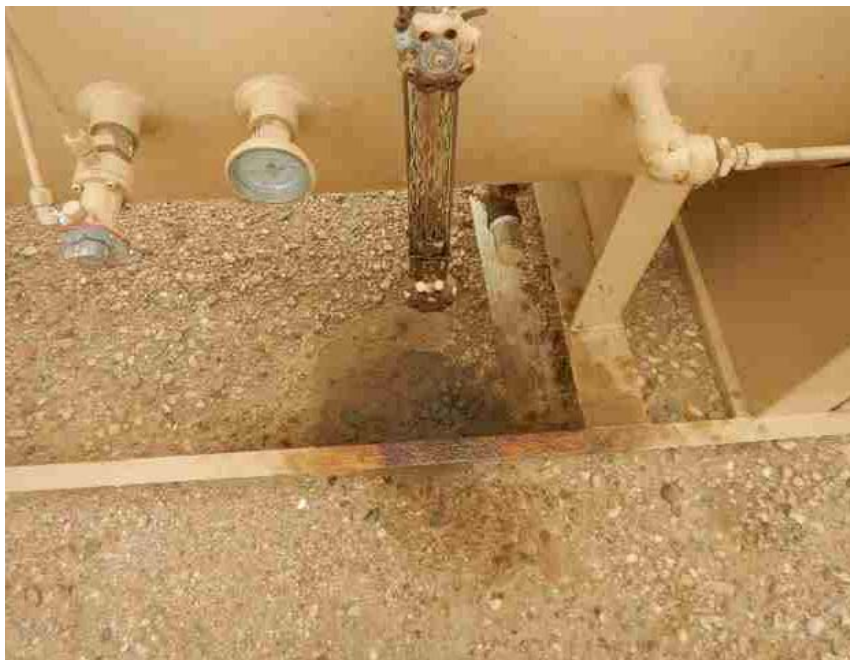
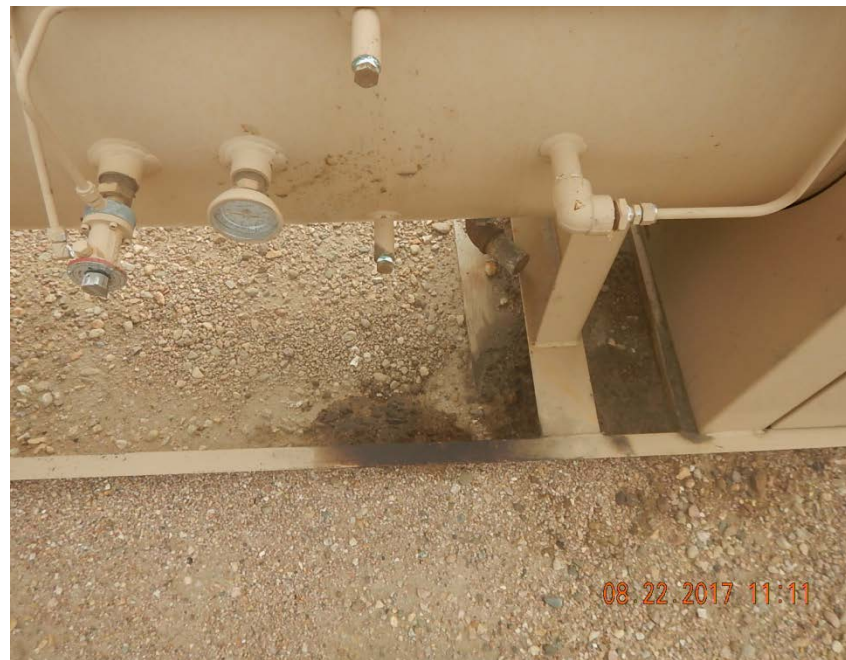
Photo from prior inspection for comparison

Photo 1: Stained soil outside of separator

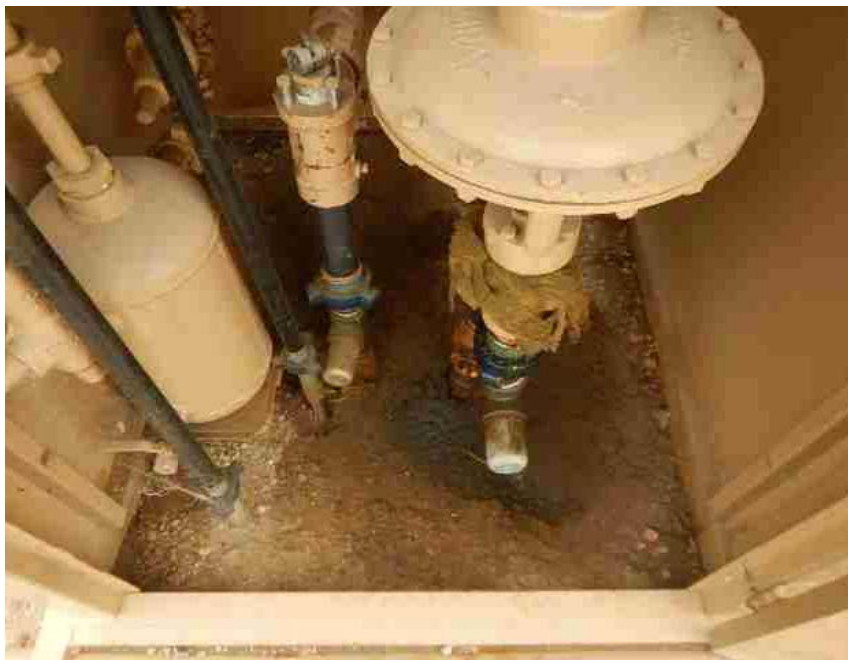
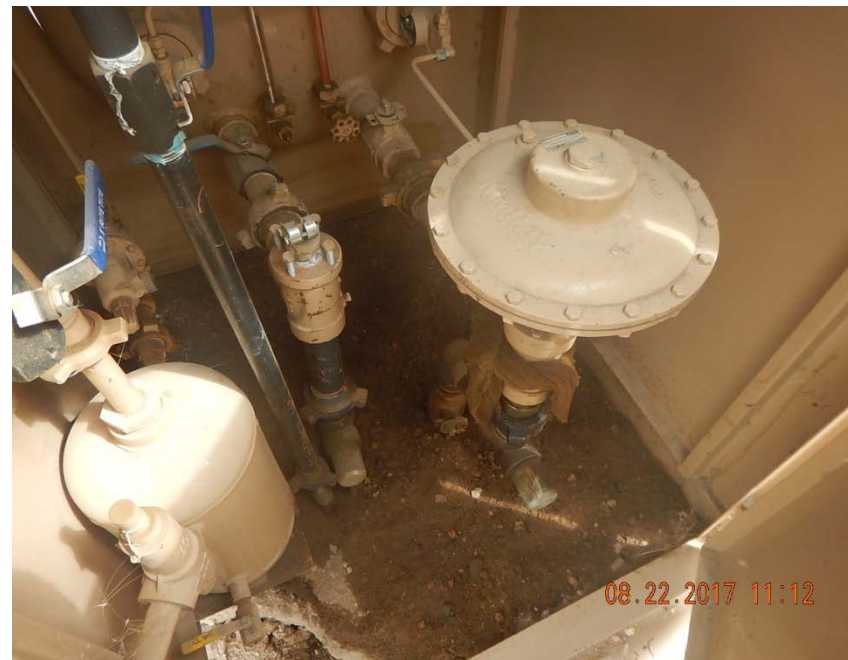
Photo from prior inspection for comparison

Photo 2: Stained soil in separator

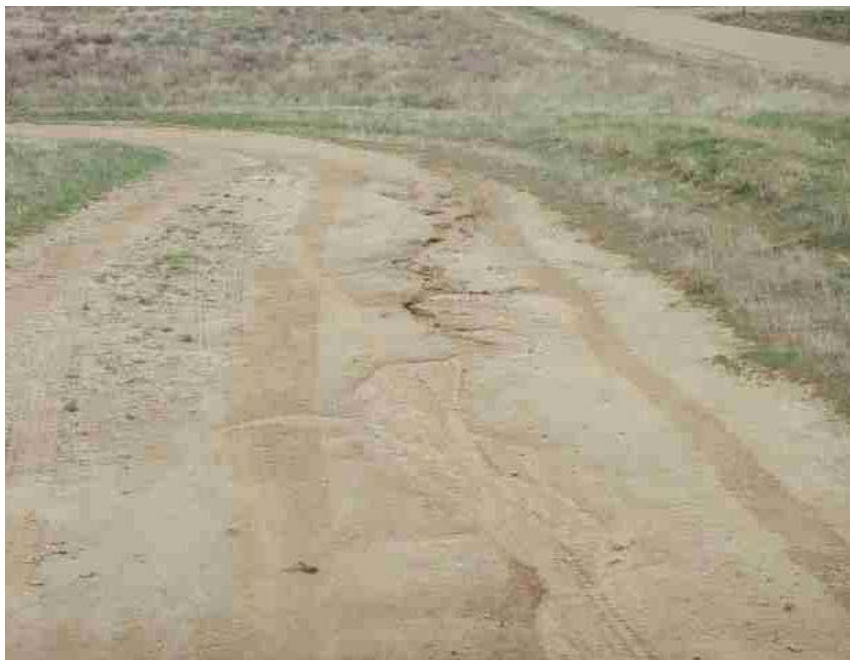
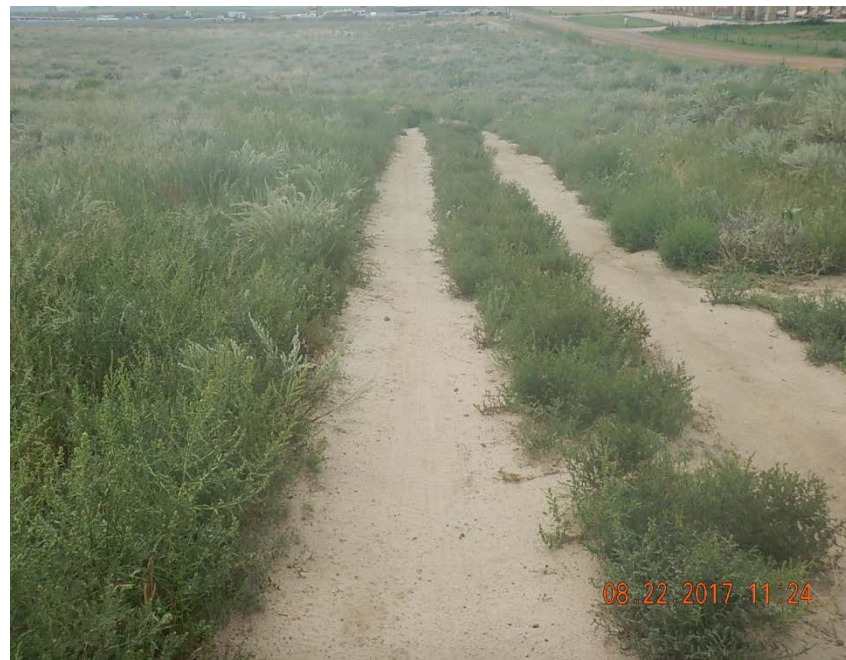
Photo from prior inspection for comparison

Photo 3: Stormwater erosion mitigated
