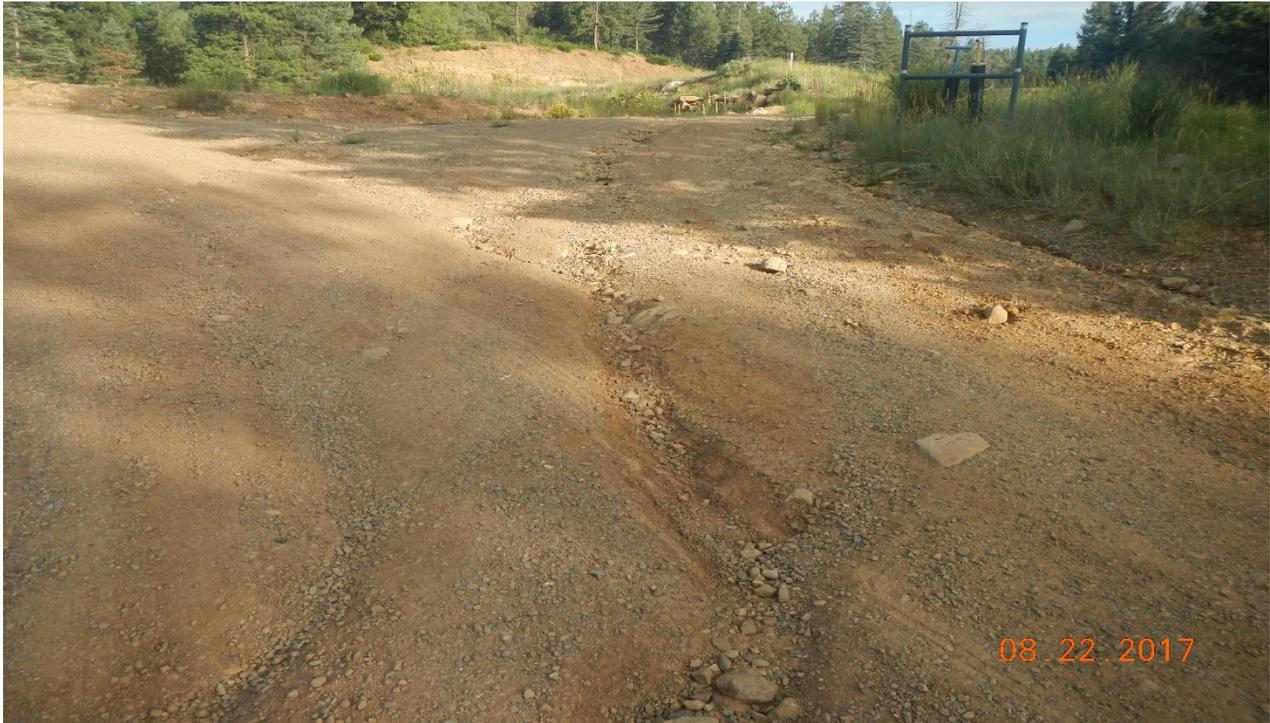
photo 1: Facing west along the main road. There is signs of erosion along the road. Stormwater water is flowing down the road and is not being properly diverted. Road base material has eroded away.

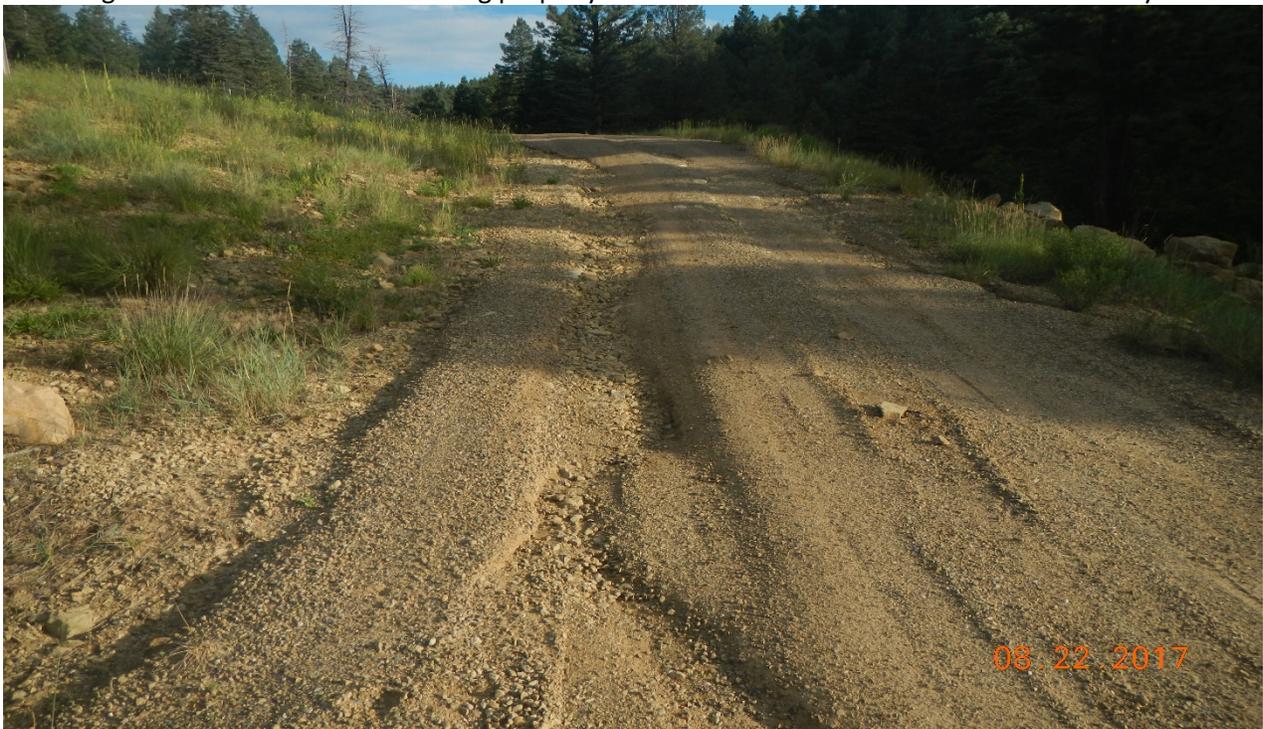
photo 2: Facing northwest at the access road. Signs of erosion indicates stormwater is flowing down towards the main road. A culvert may be needed at this point.

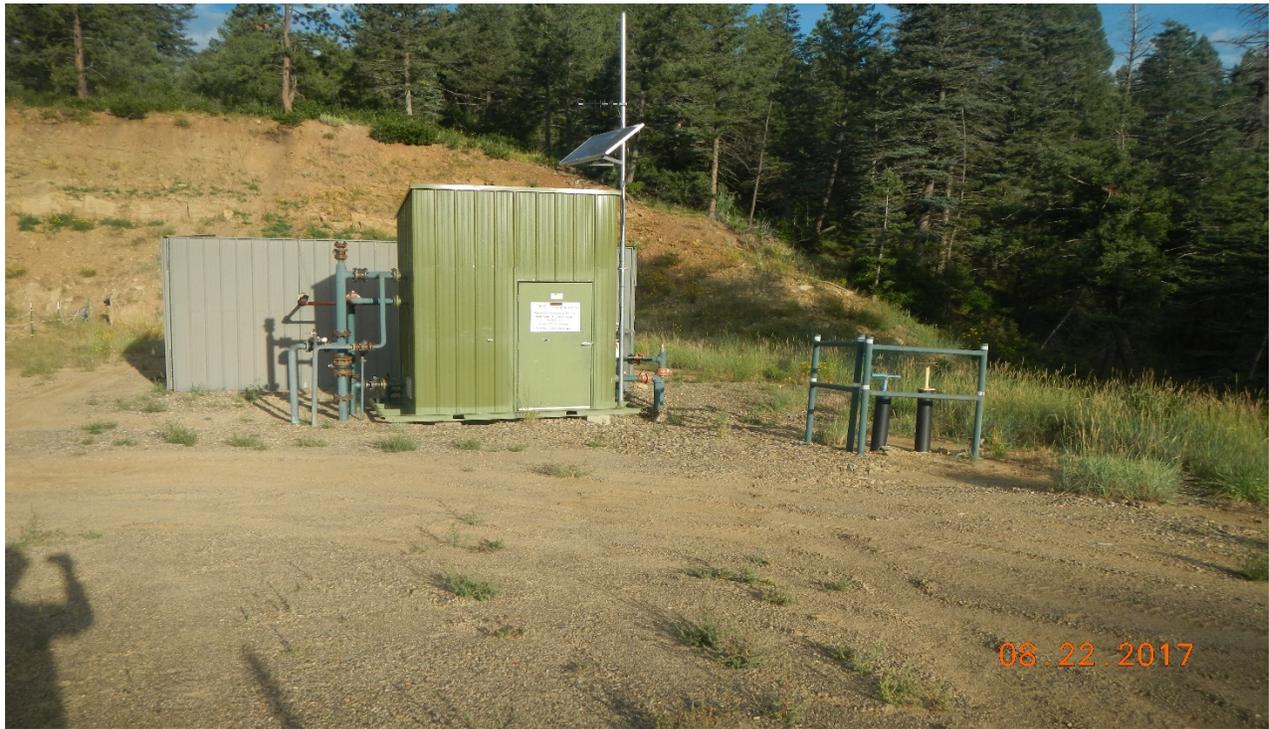
photo 3: Facing west towards the location.

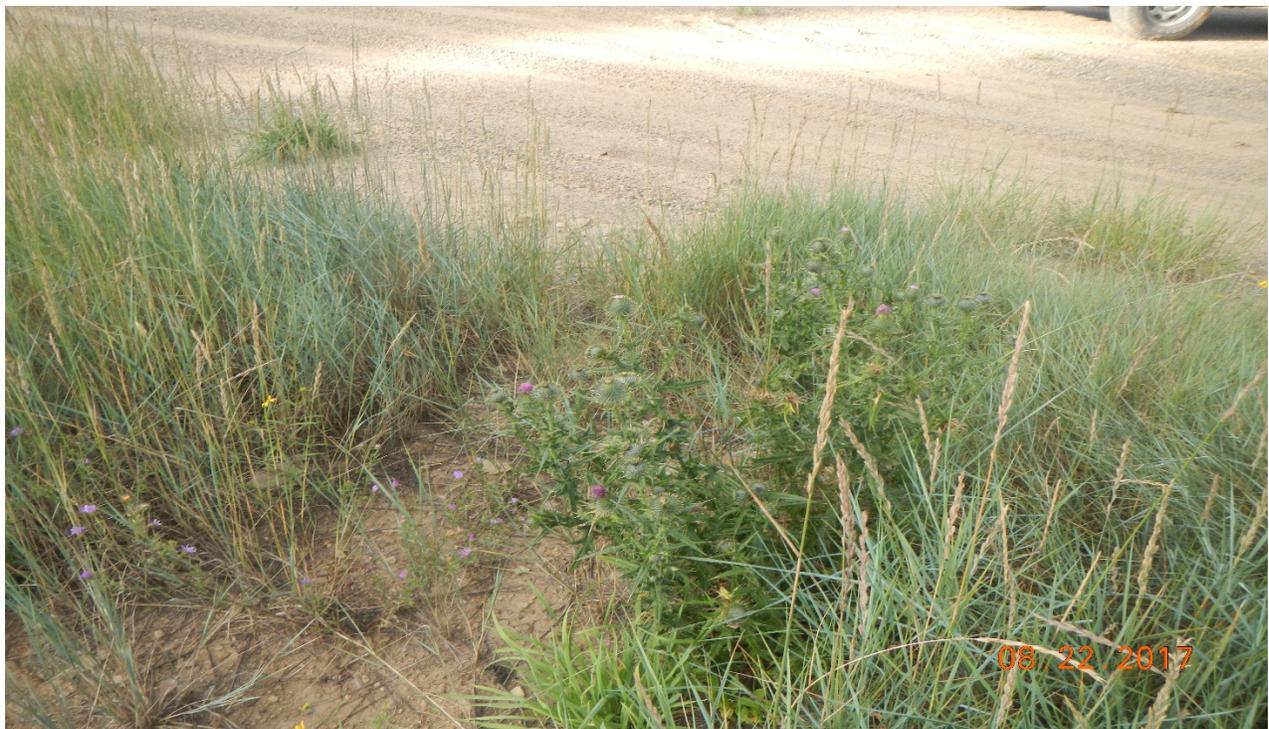
photo 4: There are noxious weeds (Bull thistle) growing around the location.
