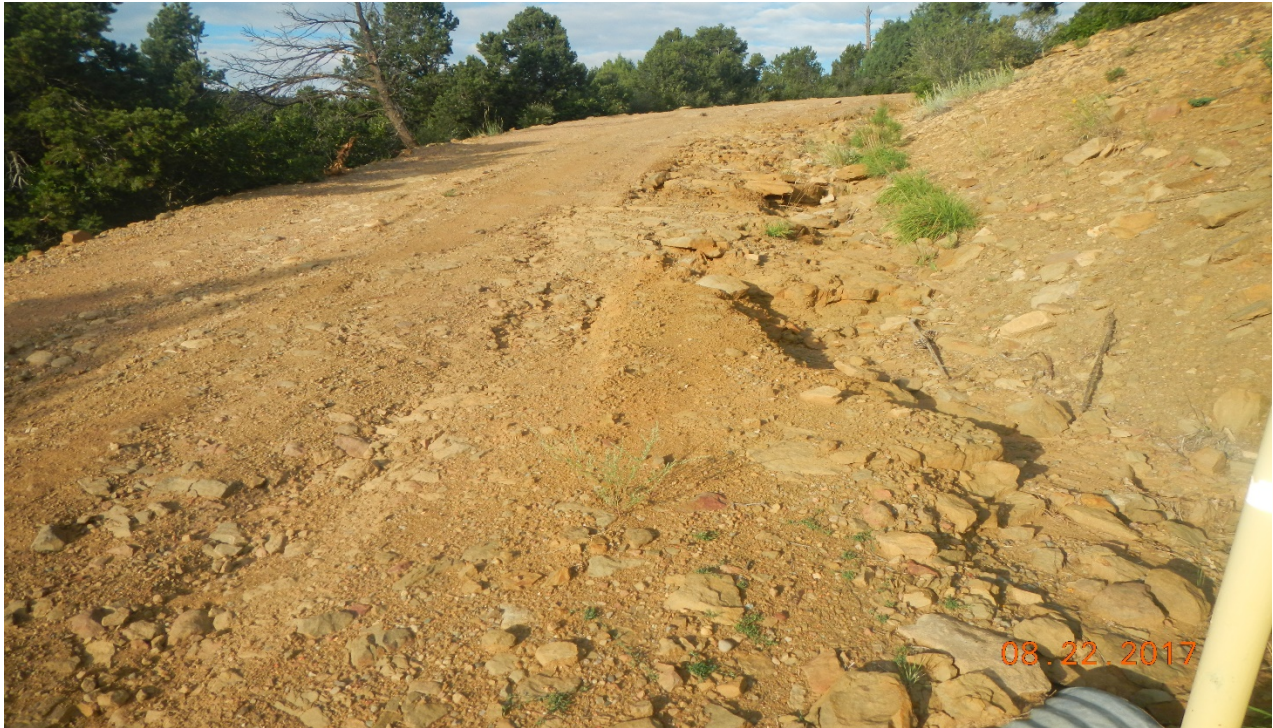
photo 1: Facing west along the main road. There is signs of erosion along the road. Stormwater water is flowing down the road and is not being properly diverted. Road base material has eroded away.

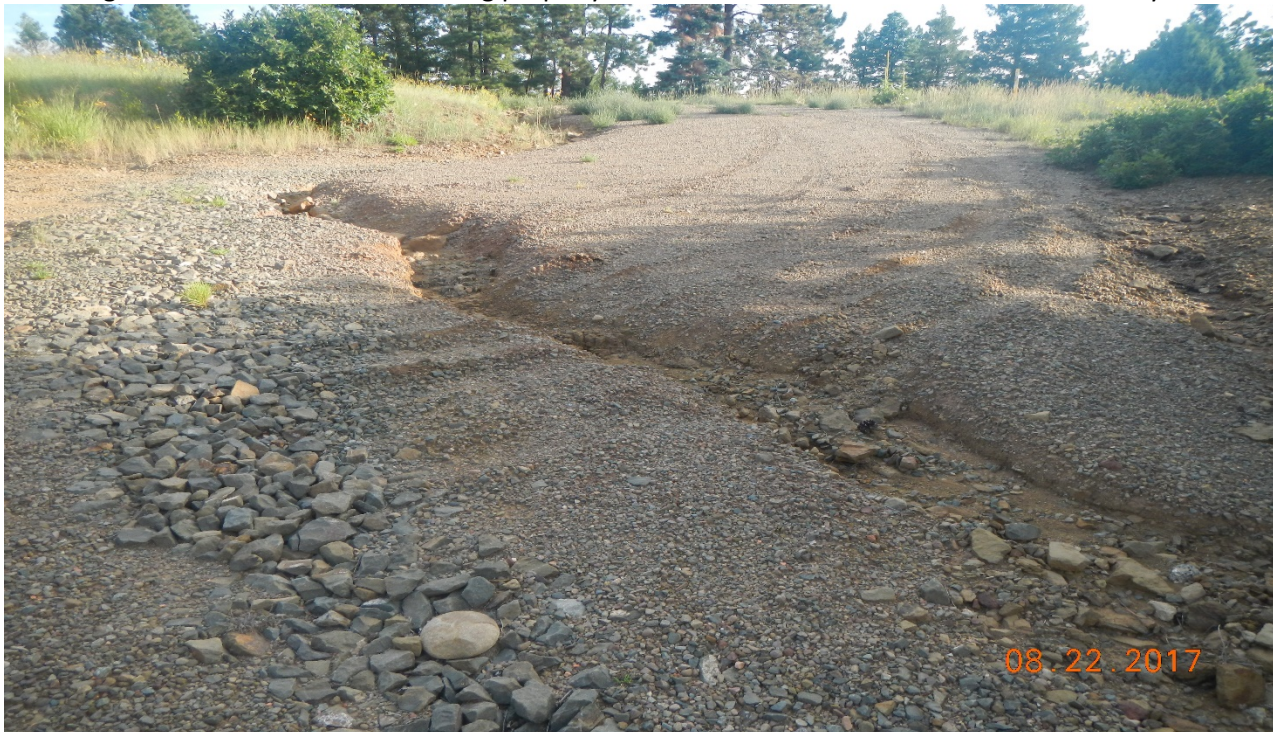
photo 2: Facing northwest at the access road. Signs of erosion indicates stormwater is flowing down towards the main road. A culvert may be needed at this point.
