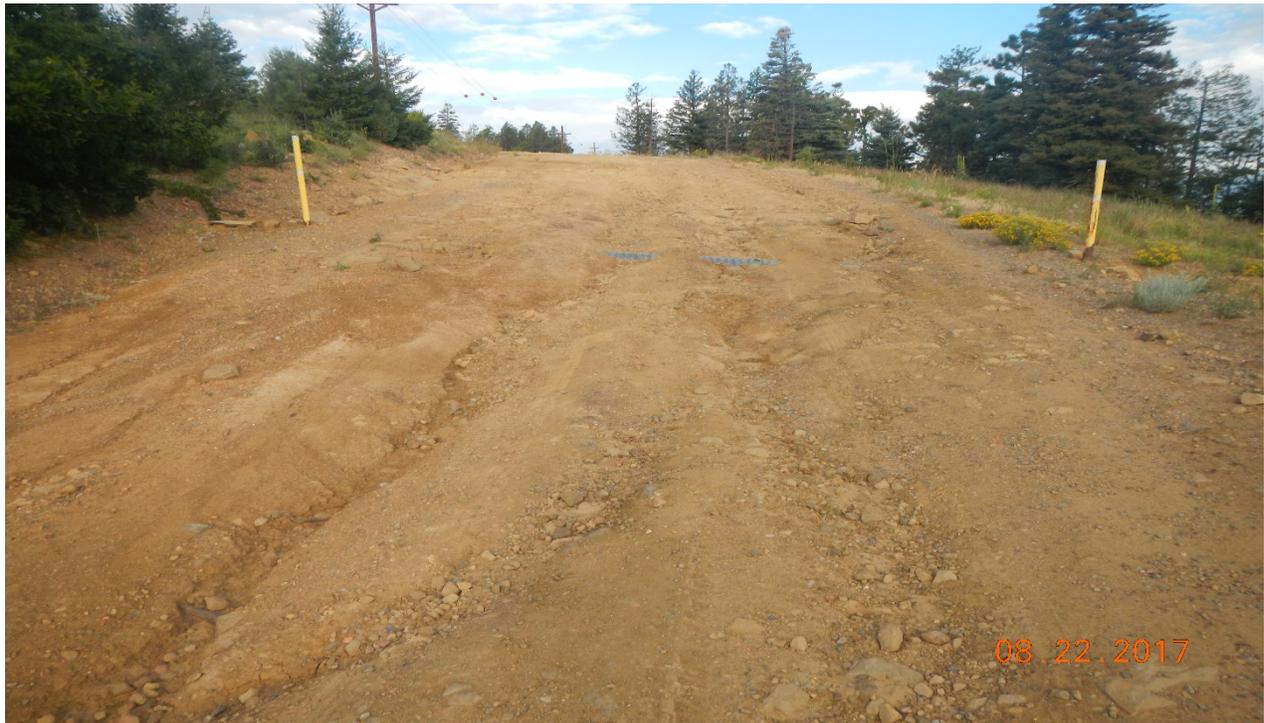
photo 1: Facing west along the main road. There is signs of erosion along the road. Stormwater water is flowing down the road and is not being properly diverted.

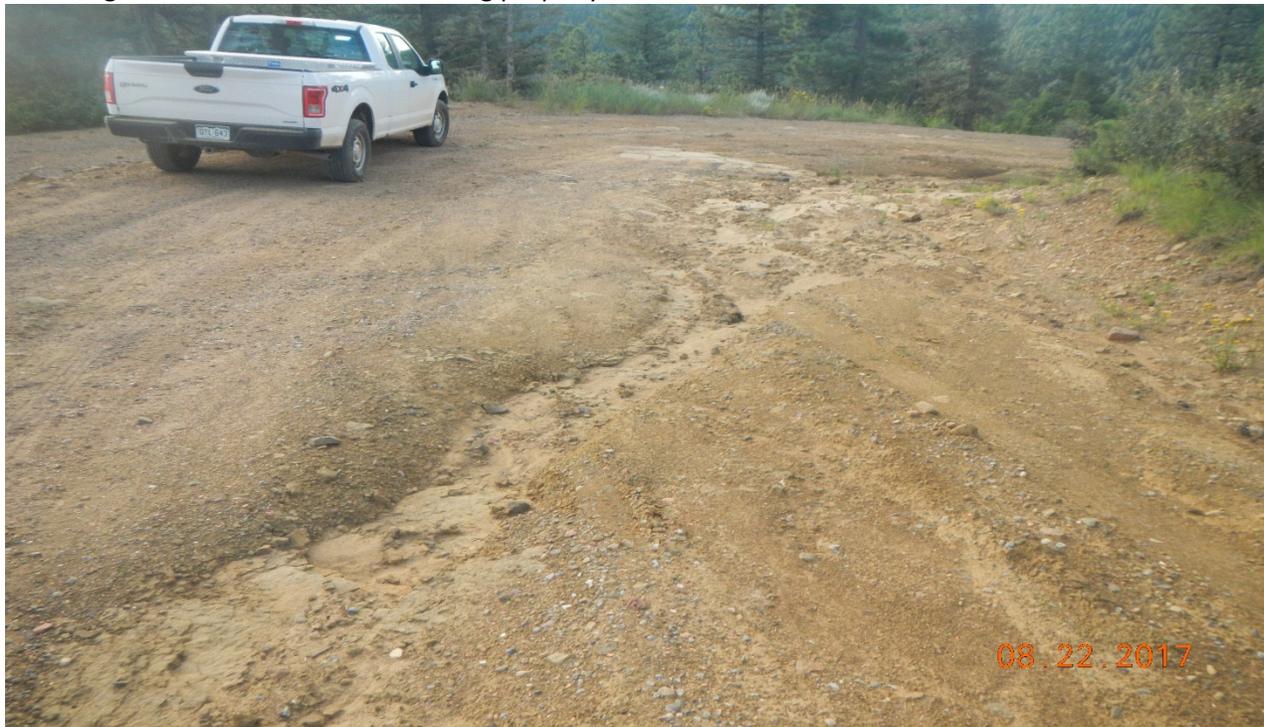
photo 2: Facing down the road Stormwater is flowing down the road causing erosion.

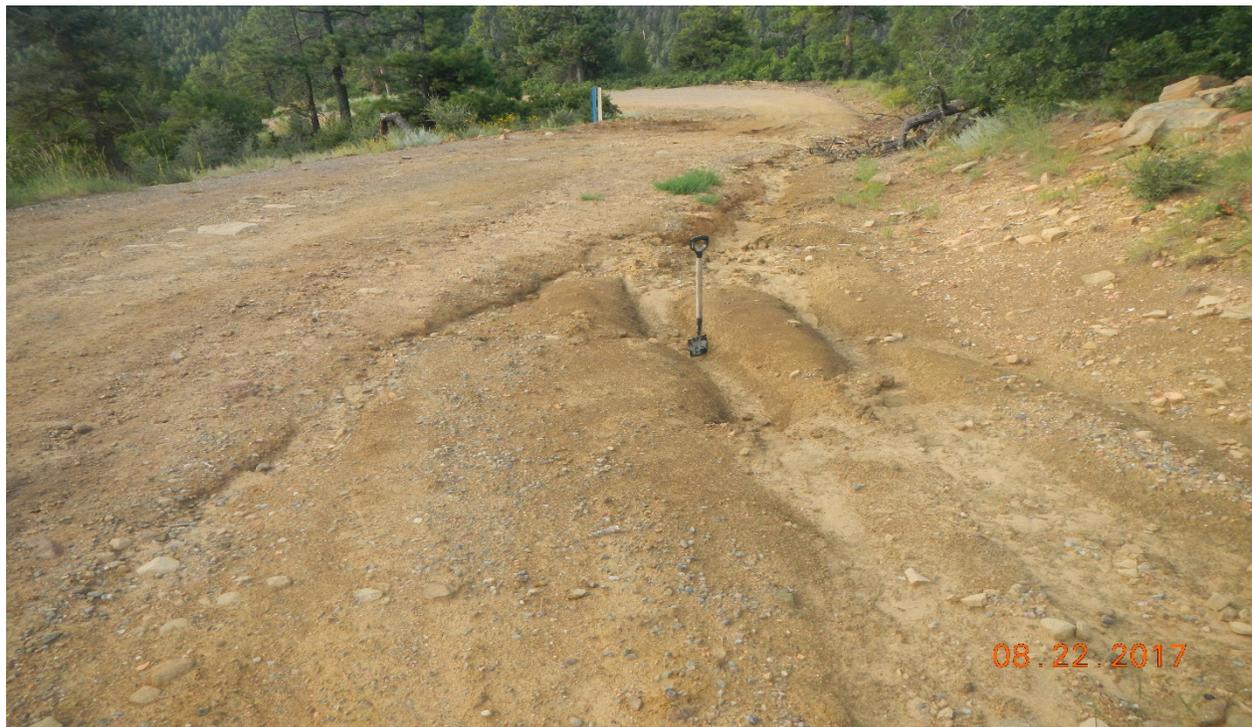
photo 3: Facing further down the road to the southeast.

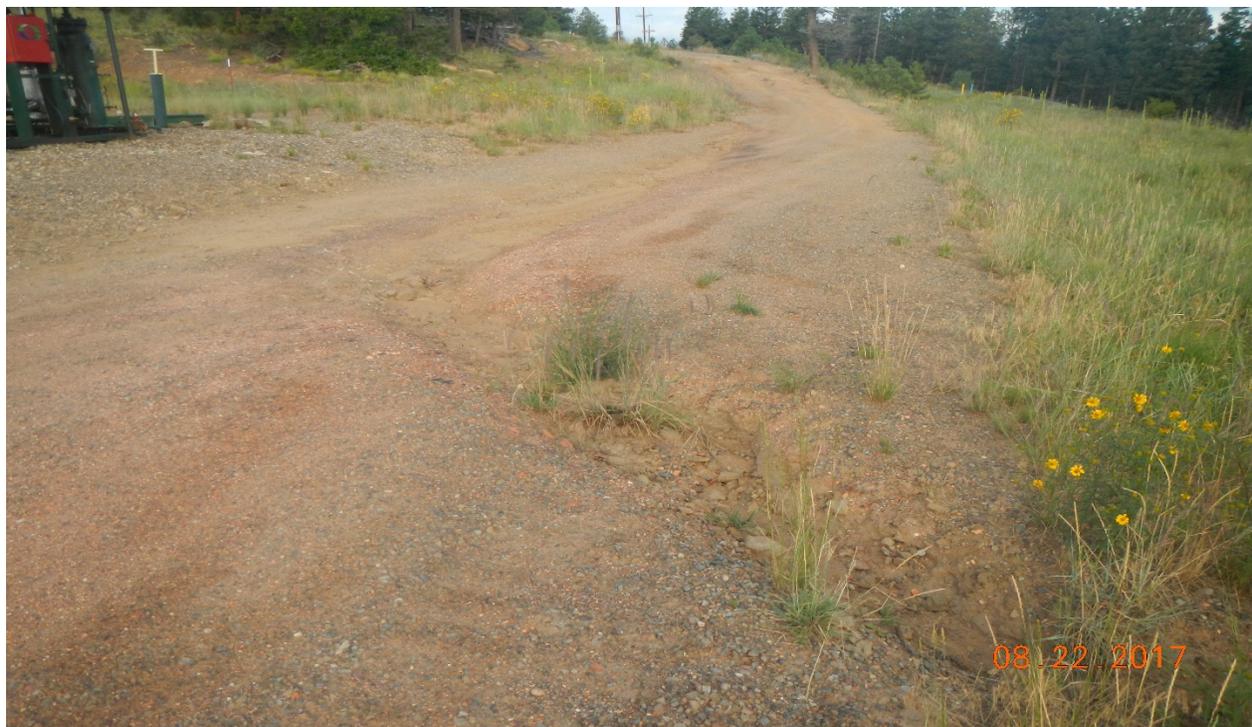
photo 4: There are signs of erosion occurring across the main road.

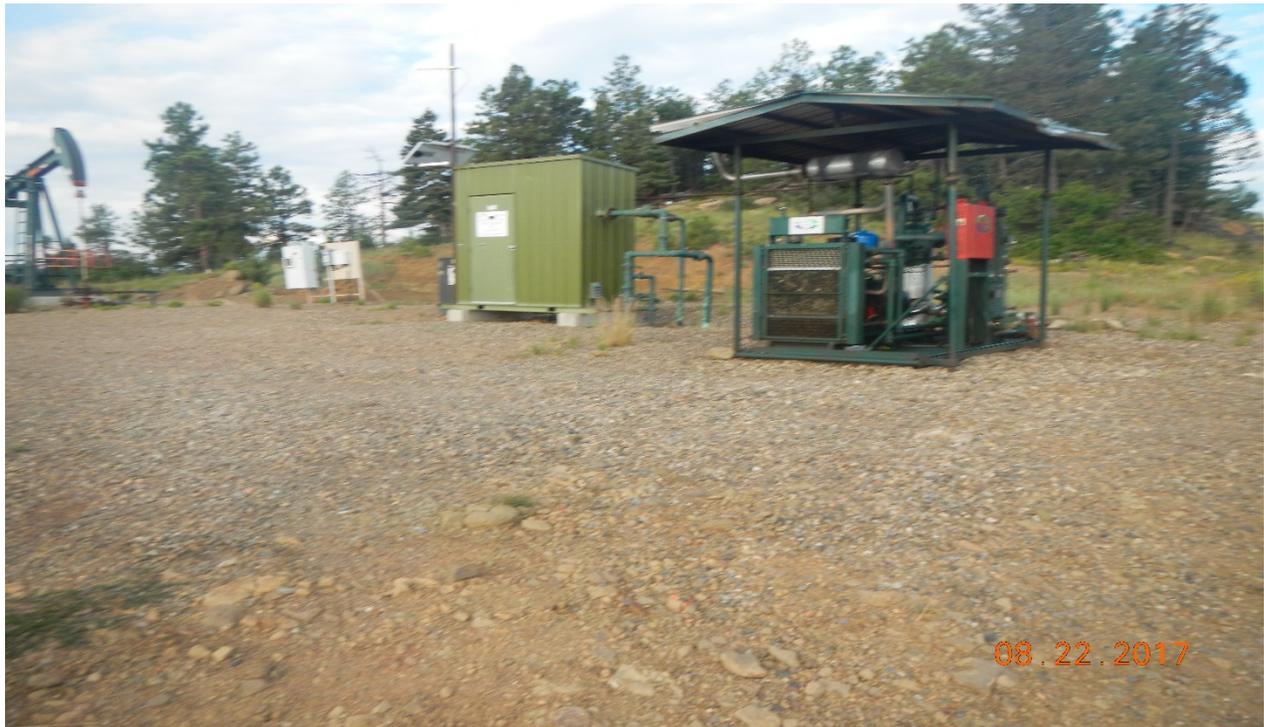
photo 5: Facing southwest toward the location.

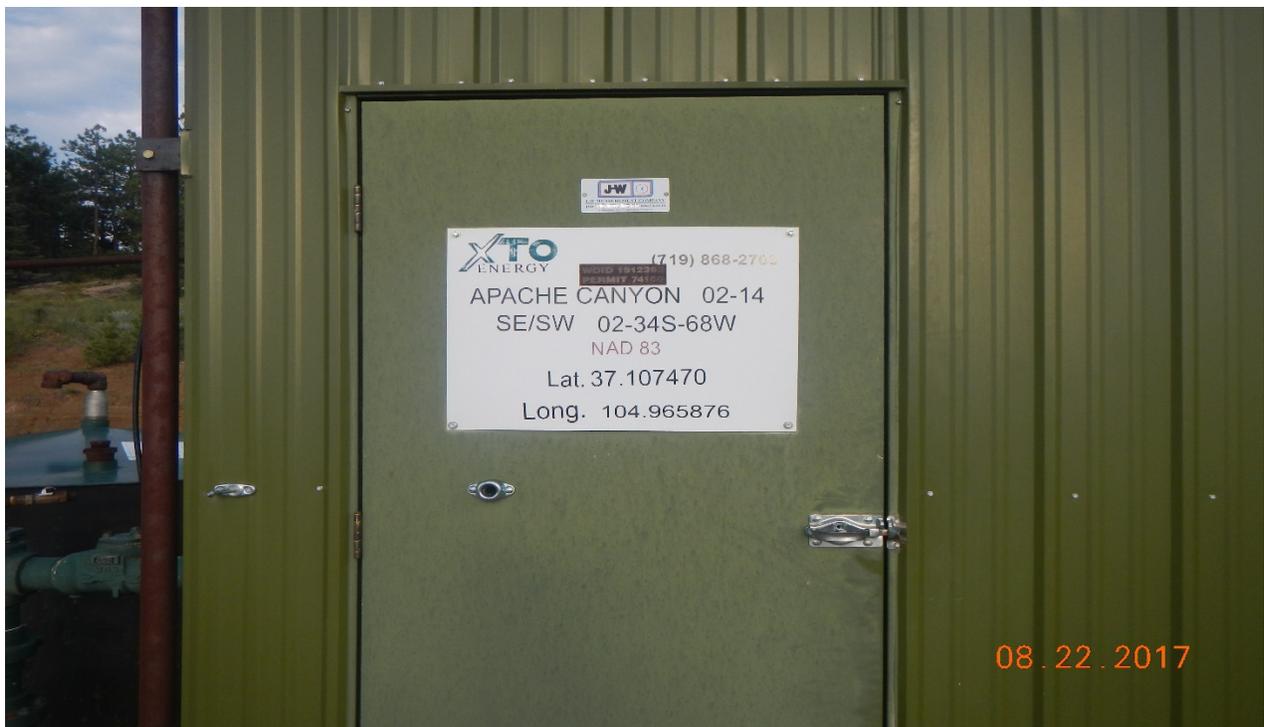
photo 6: Well sign at the location.
