- Archuleta-Dix 1 05-067-07038

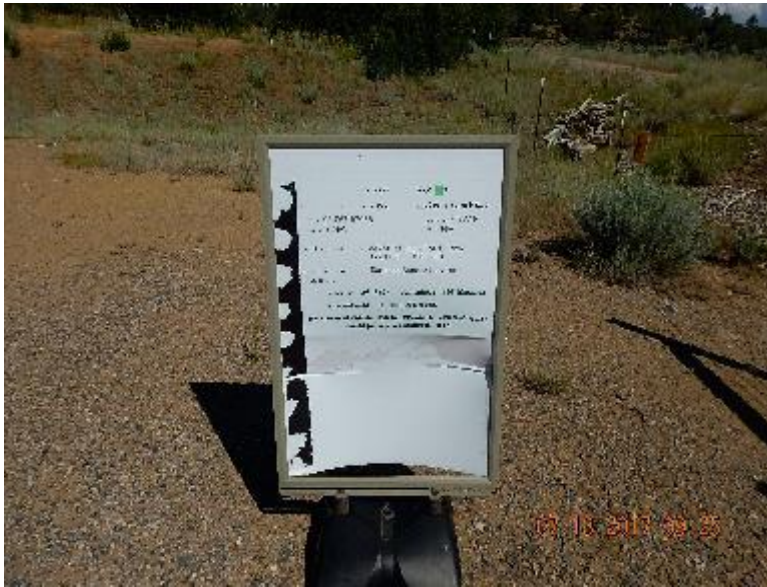
Photo 1: Wellhead sign previous inspection.

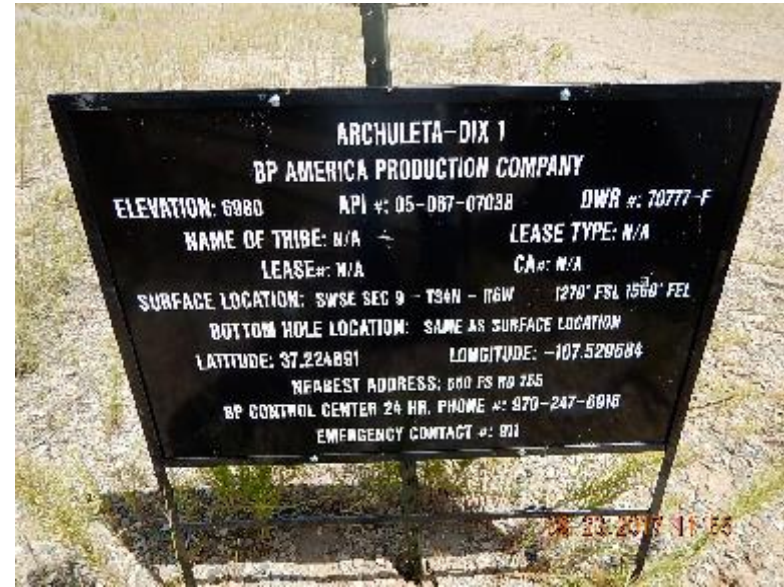
Photo 2: New wellhead sign.

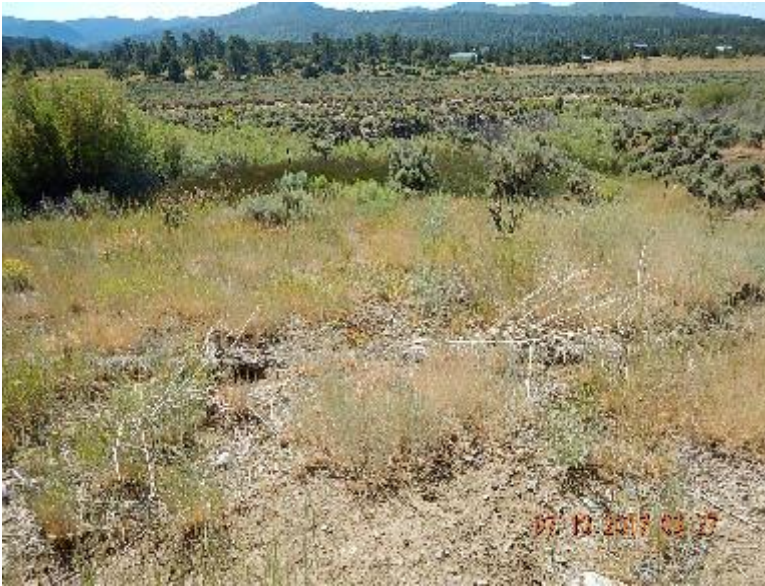
Photo 3: Failed waddle and erosion channel in SW corner previous inspection.

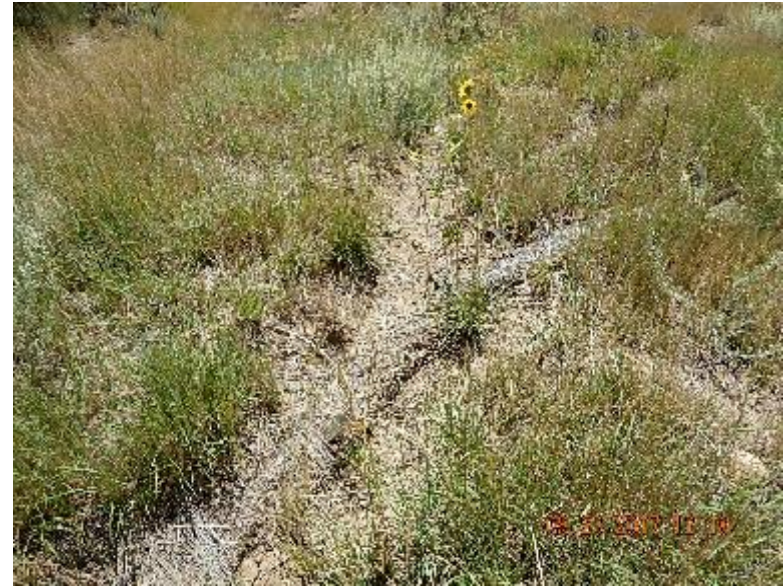
Photo 4: Failed waddle and erosion channel in SW corner current inspection.

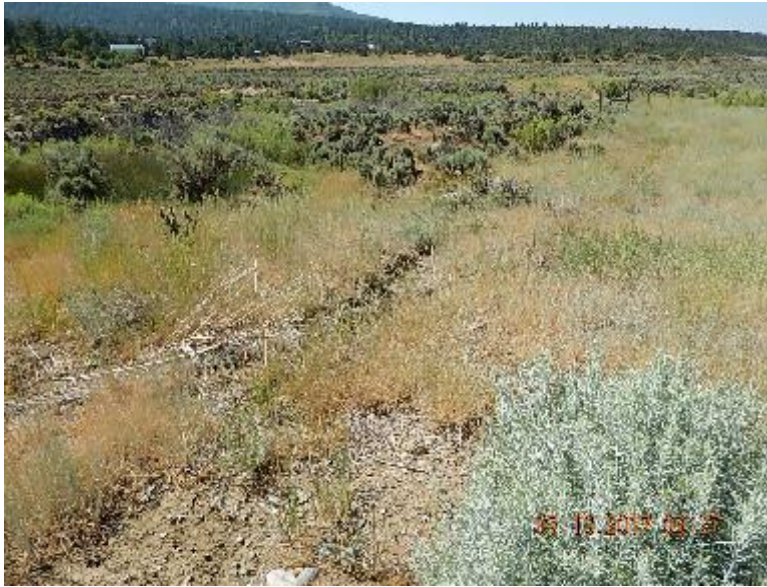
Photo 5: Erosion channel in SW corner previous inspection..

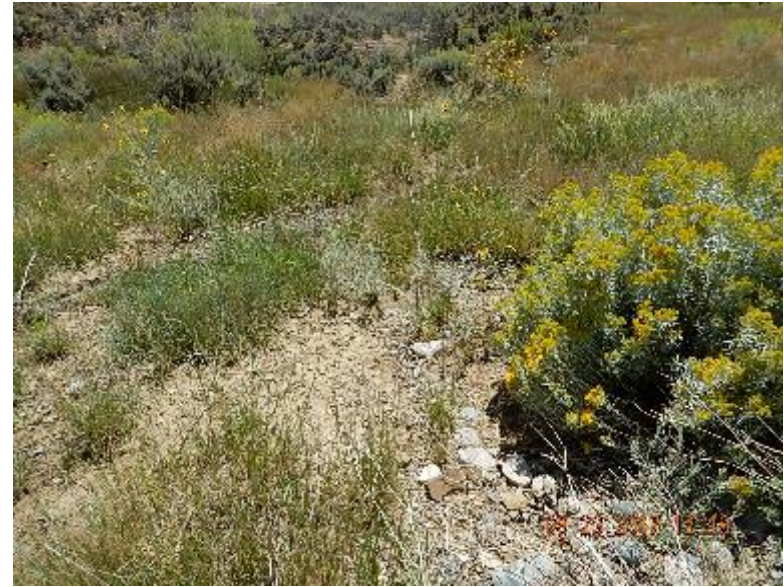
Photo 6: Erosion channel in SW corner current inspection.

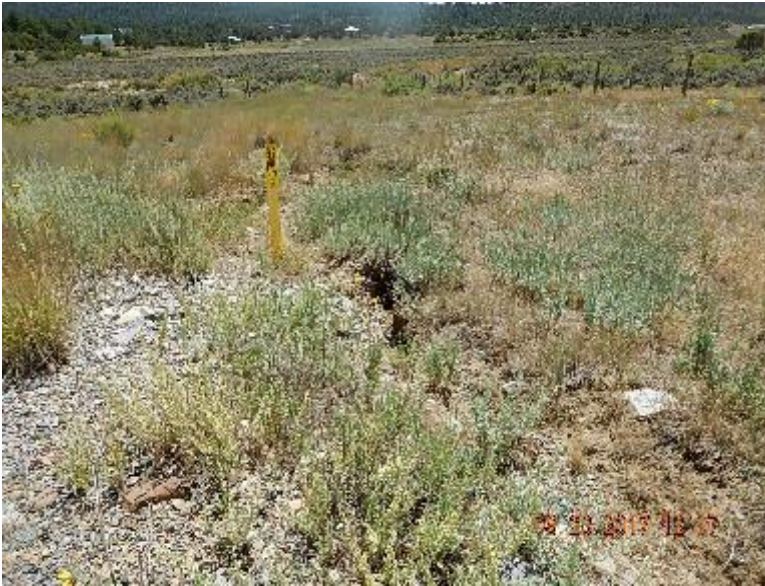
Photo 7: Erosion channel in SW corner of location.

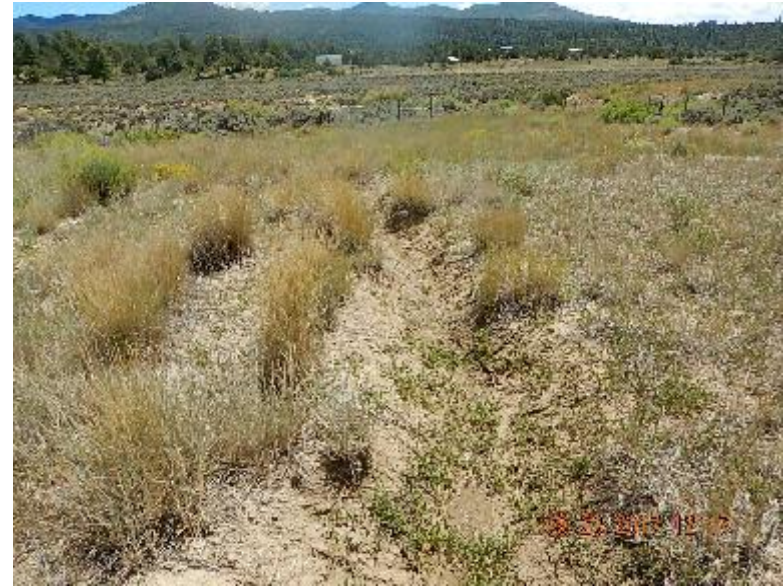
Photo 8: Same erosion channel as photo 7 in SW corner further down slope of location.
