# Inspection Photos

Operator: HRM RESOURCES II LLC - 10548

Location ID: 313925

Inspection Doc. Number: 675103907

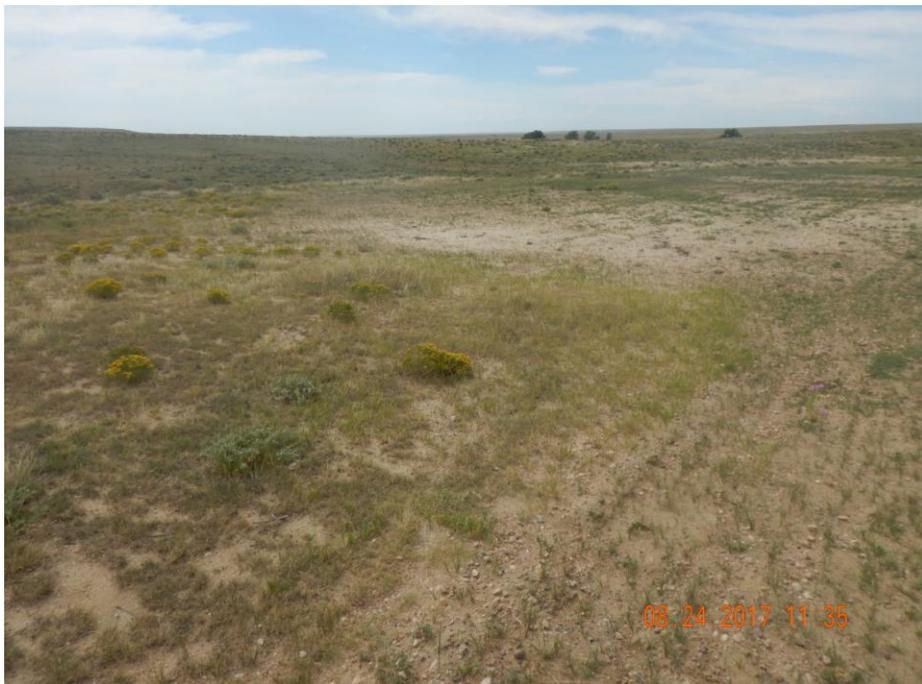
**Photo 1:** Photo taken from the north end of the pad, facing south. Photo shows overview of the pad and well location.

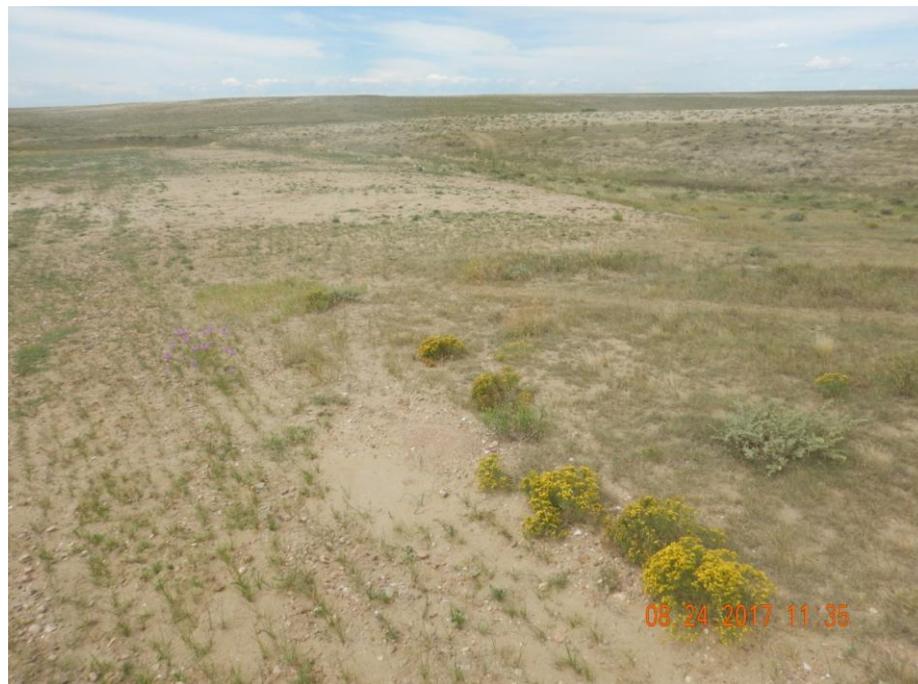
**Photo 2:** Photo taken from the north end of the pad, facing southwest. Photo shows overview of the pad and well location.

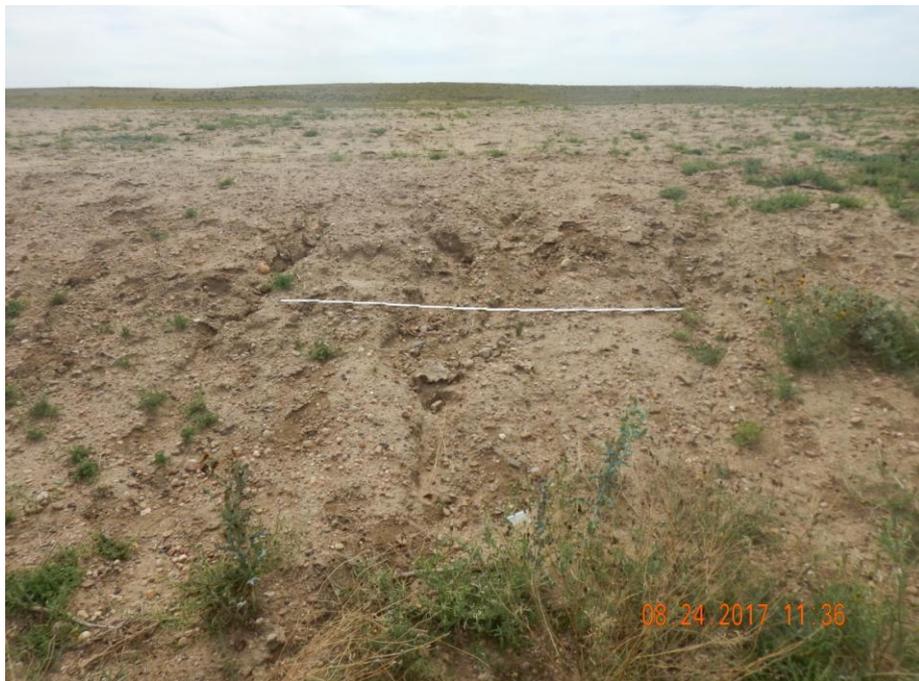
**Photo 3:** Photo taken from the west end of the location. Photo shows stormwater erosion. Previous inspections required operator to repair erosion and install controls to mitigate future stormwater erosion and degradation from occurring. Erosion was once repaired in this area, however no stormwater BMPs were installed or maintained and degradation has been allowed to persist. 6 foot measuring stick for reference.

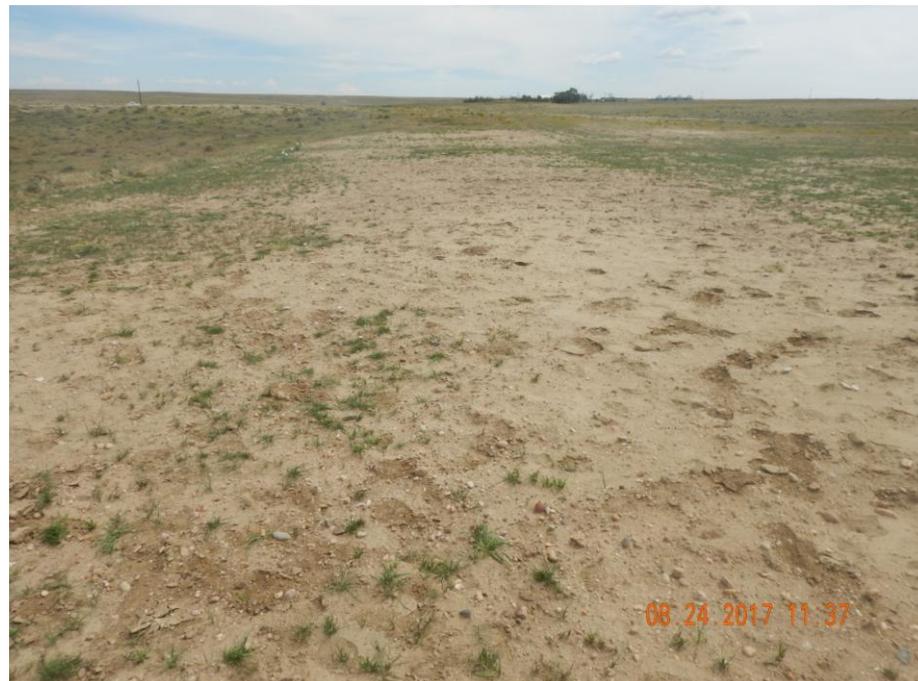
**Photo 4:** Photo taken from the southwest corner of the location, facing north. Photo shows large portions of the western half of the location where desirable perennial vegetation does not appear to be establishing.

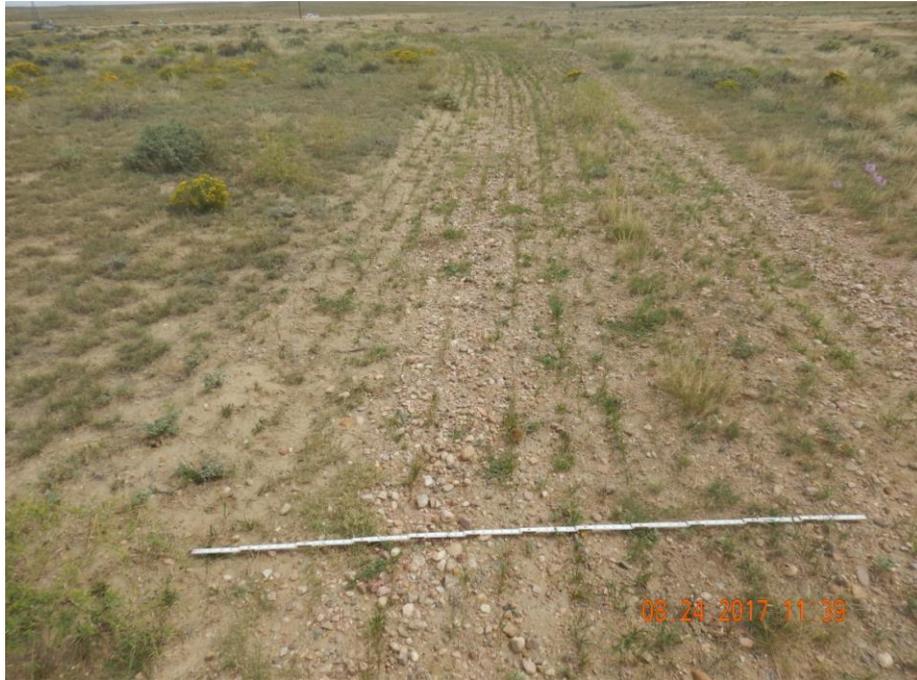
**Photo 5:** Photo taken from the from the access road, north of the location facing north. Previous inspection required operator to remove gravel/road base from the access road, perform compaction alleviation, re-contour/re-grade. Photo shows gravel/road base remains on access road. No additional reclamation activities per CA's have been conducted. 6 foot measuring stick for reference.

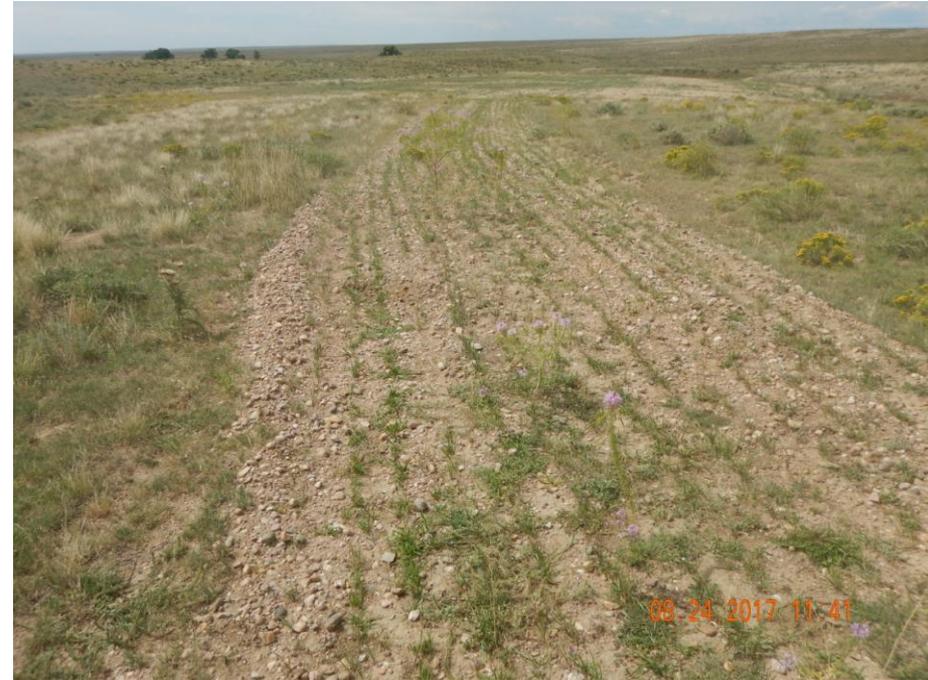
**Photo 6:** Photo taken from the from the access road, north of the location facing south. Previous inspection required operator to remove gravel/road base from the access road, perform compaction alleviation, re-contour/re-grade. Photo shows gravel/road base remains on access road. No additional reclamation activities per CA's have been conducted.

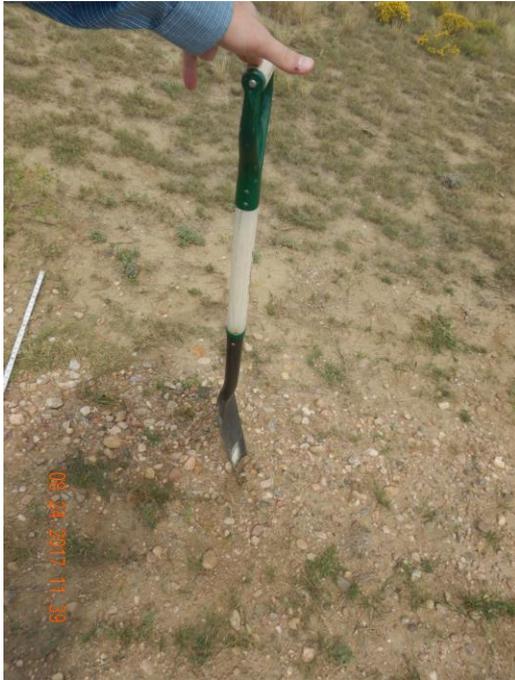
**Photo 7:** Photo taken from the access road. Photo shows gravel/road base remaining on location. Inspector had attempted to dig a soil pit to test access road for compaction. Inspector was unable to penetrate the soil more than a few inches; compaction alleviation has not been performed.

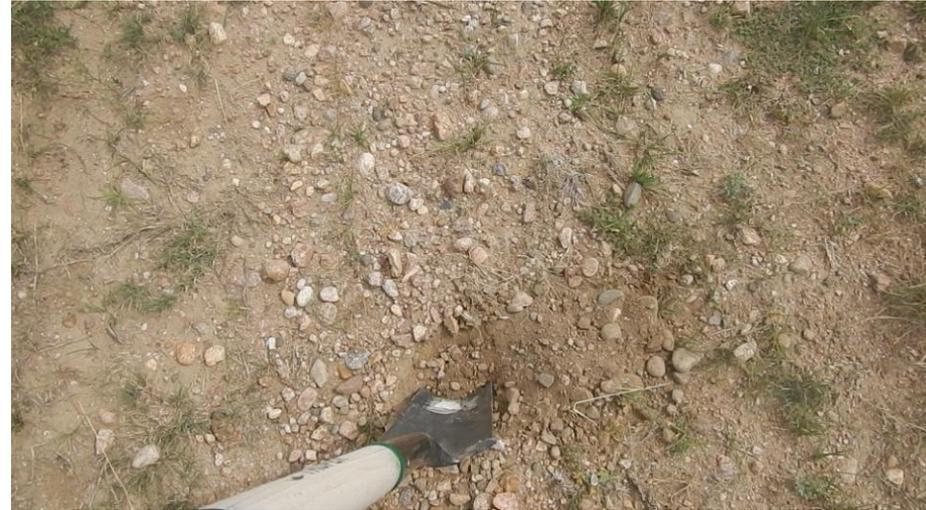
**Photo 8:** Photo taken from the access road. Photo shows gravel/road base remaining on location. Inspector had attempted to dig a second soil pit to test another area of the access road for compaction. Inspector was unable to penetrate the soil more than a few inches; compaction alleviation has not been performed.

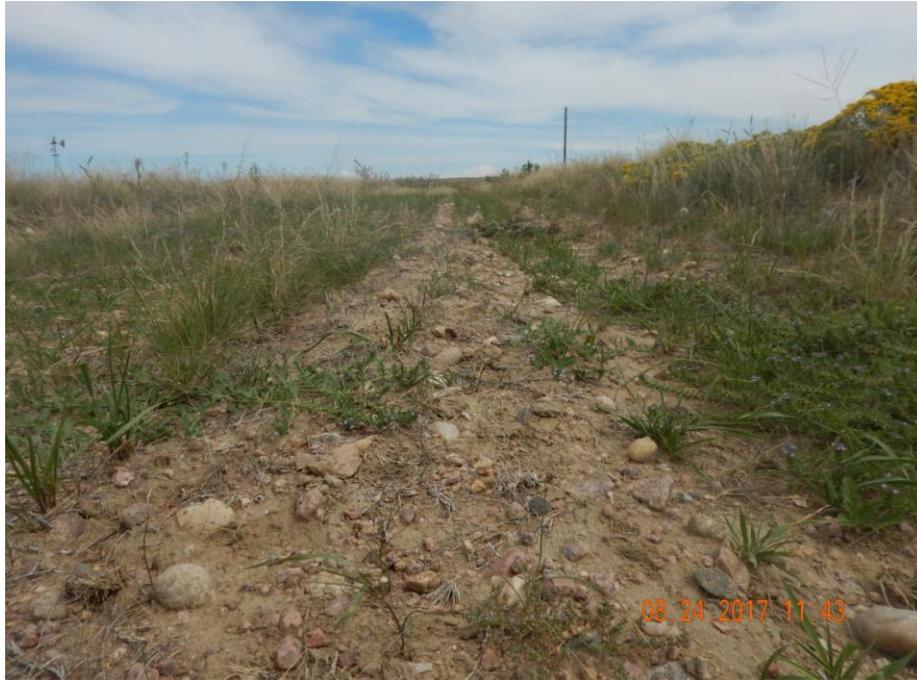
**Photo 9:** Photo taken from the access road, facing north. Photo shows gravel/road base remaining on location. Photo also shows access road had not been re-contoured or re-graded on large sections of the road to match the adjacent reference area.

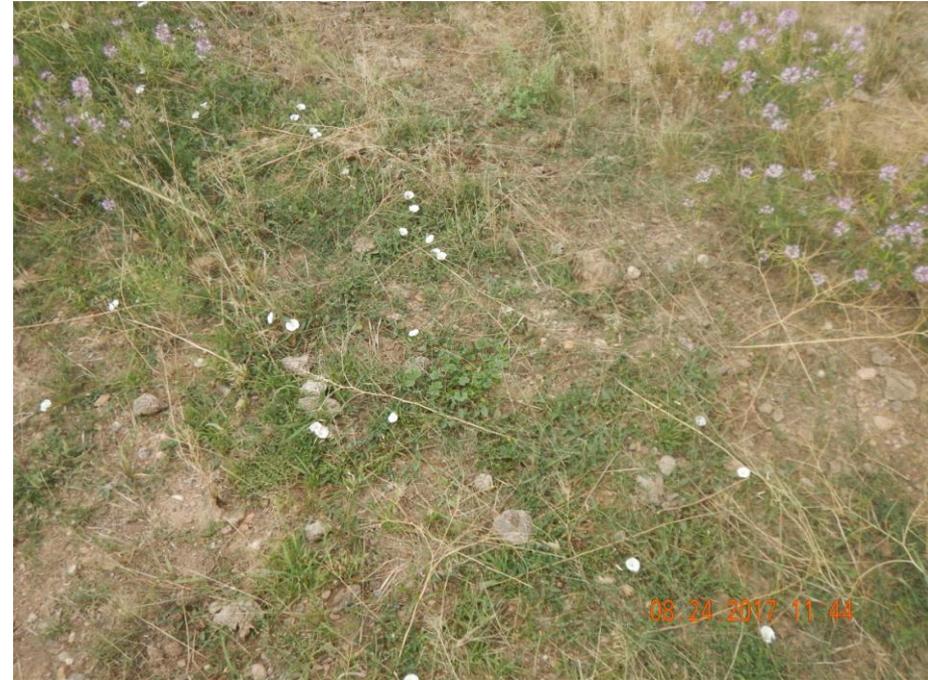
**Photo 10:** Photo taken from the access road. Photo shows bindweed. Bindweed has begun to establish over large areas of the access road. This is a Colorado State listed noxious weed and needs to be managed.

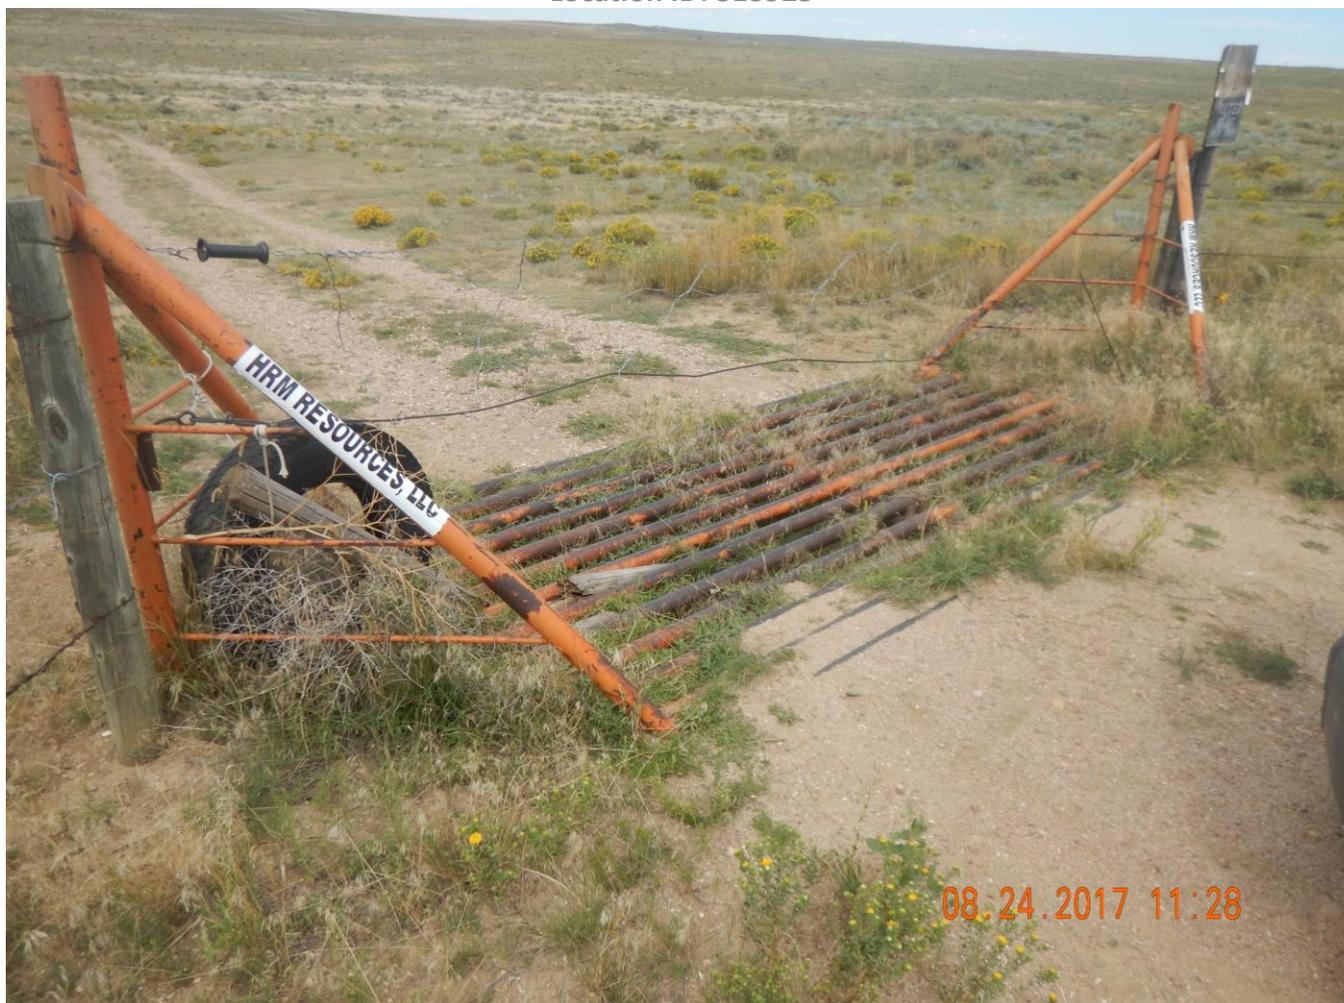
**Photo 11:** Photo taken from the access road entrance at the county road. Previous inspections required operator to remove/reclaim cattle guard. Cattle guard remains in place.
