Inspection Photos
Location Name: Wells Ranch USX BB 11-3
API: 05-123-25117

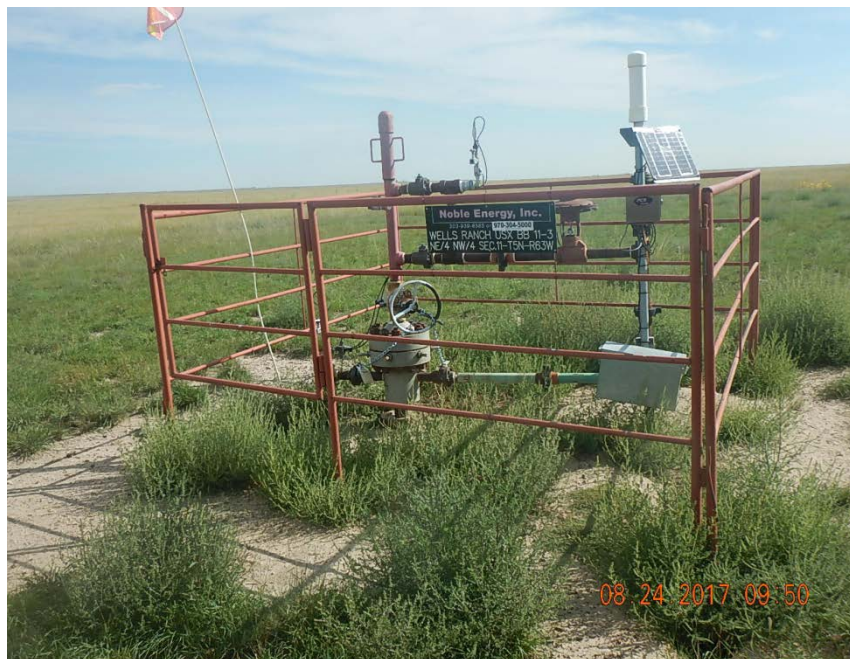
Photo 1: Wellhead, looking NE

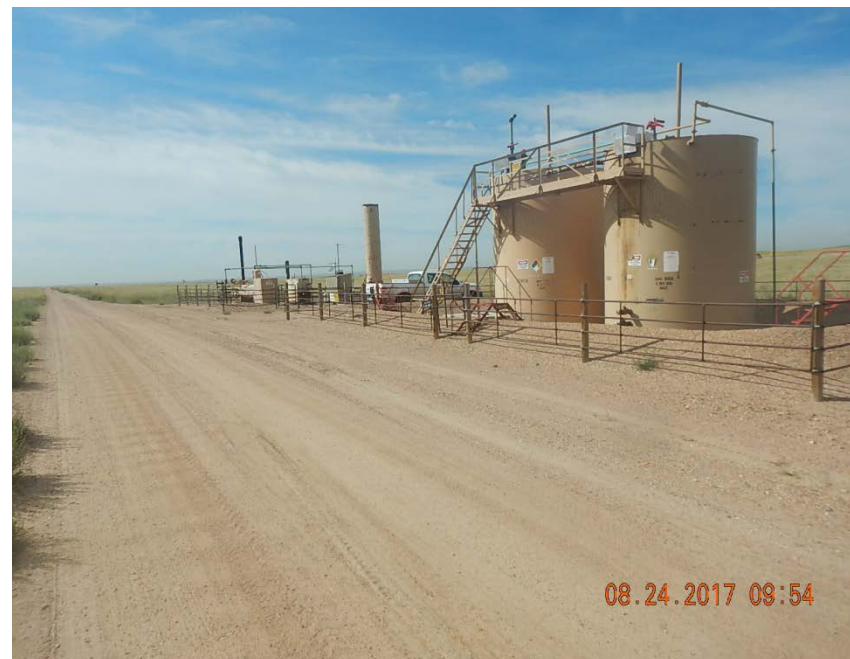
Photo 2: Location, looking SW

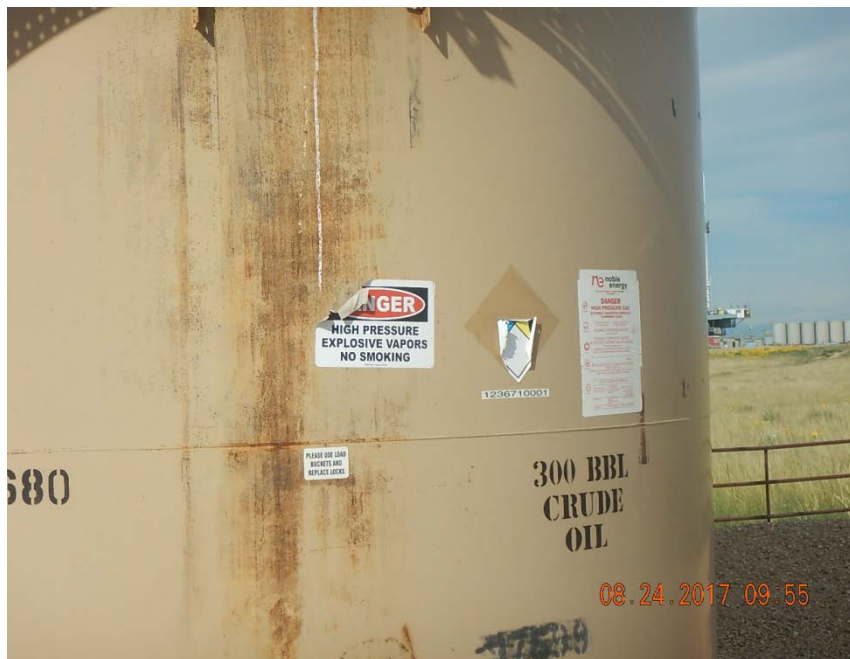
Photo 3: Decal damaged

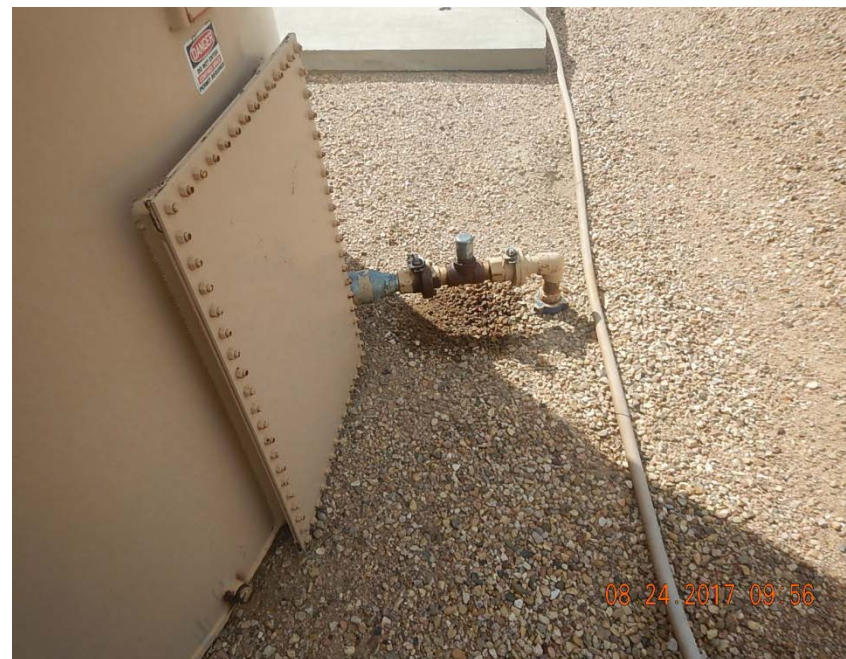
Photo 4: Stained soil at valve
