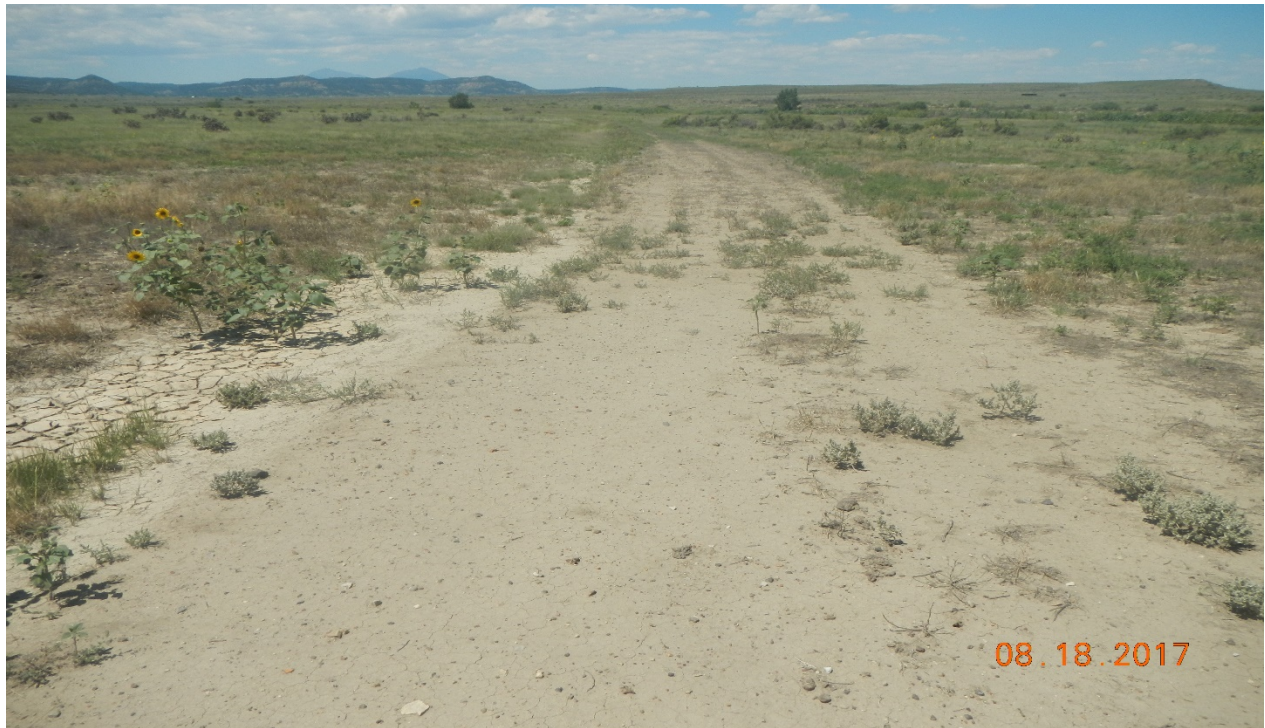
photo 1: Facing northwest along the access road which has not been reclaimed.

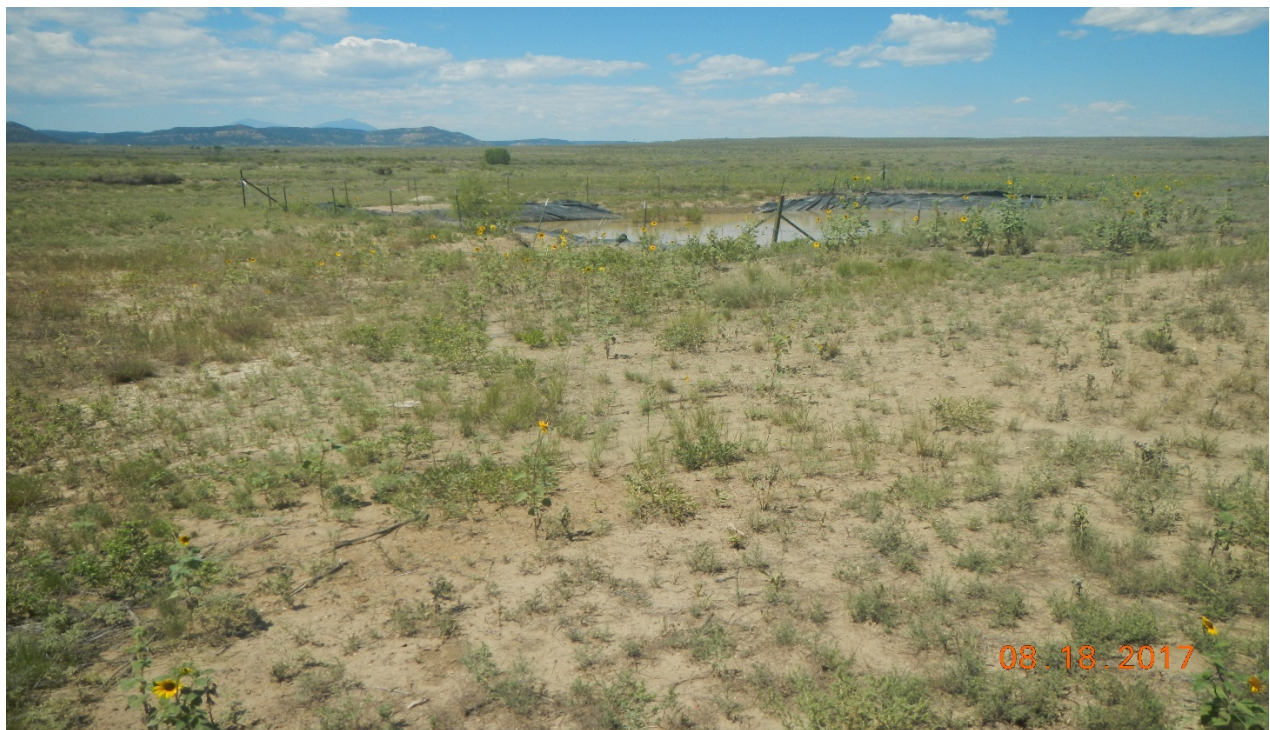
photo 2: Facing northwest toward the location. The location has not been reclaimed and a pit remains at the location.

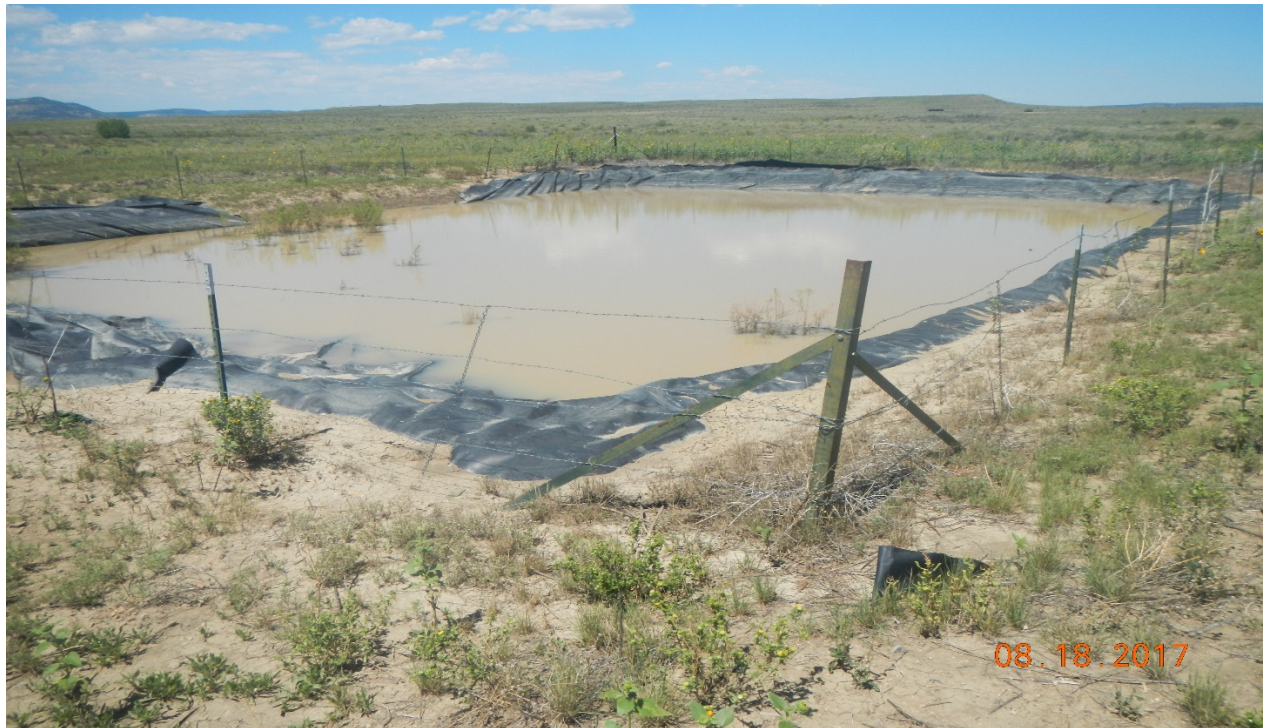
photo 3: The northeast toward the pit. The liner appears to be degraded and the fence around the pit is not maintained.

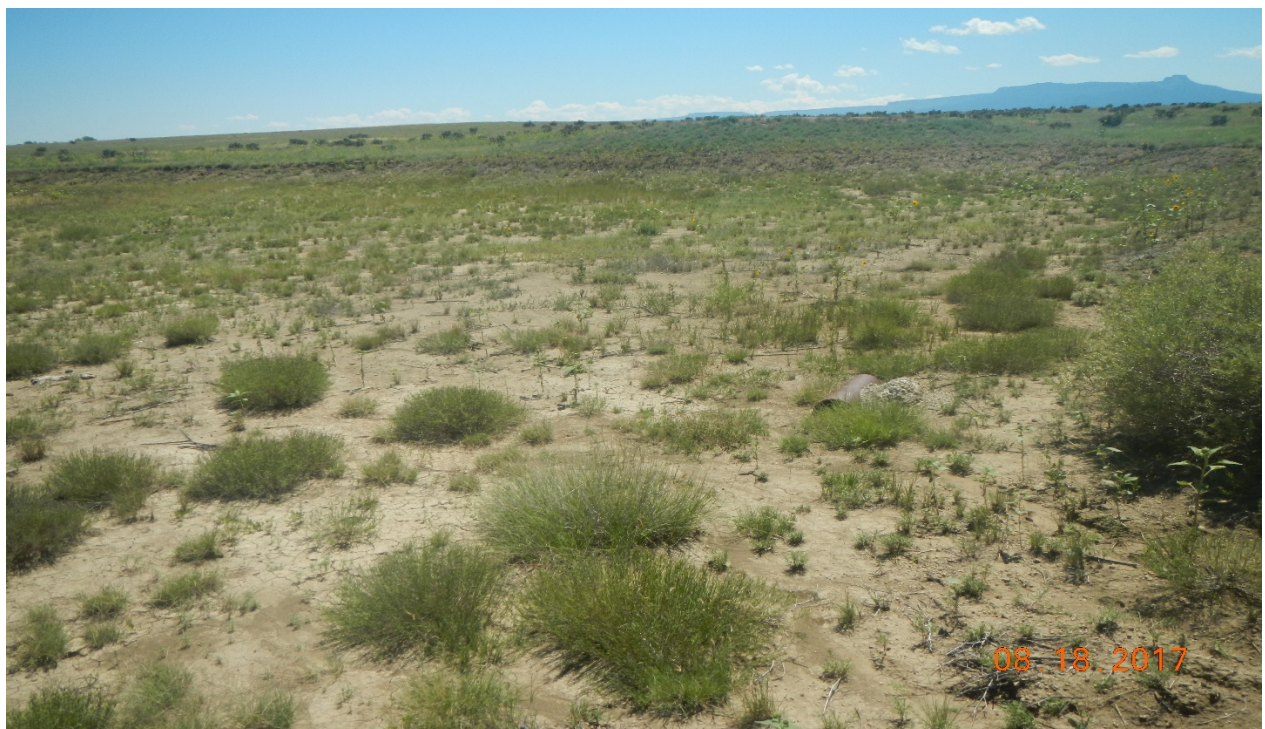
photo 4: Facing south toward the cut slope of the location.

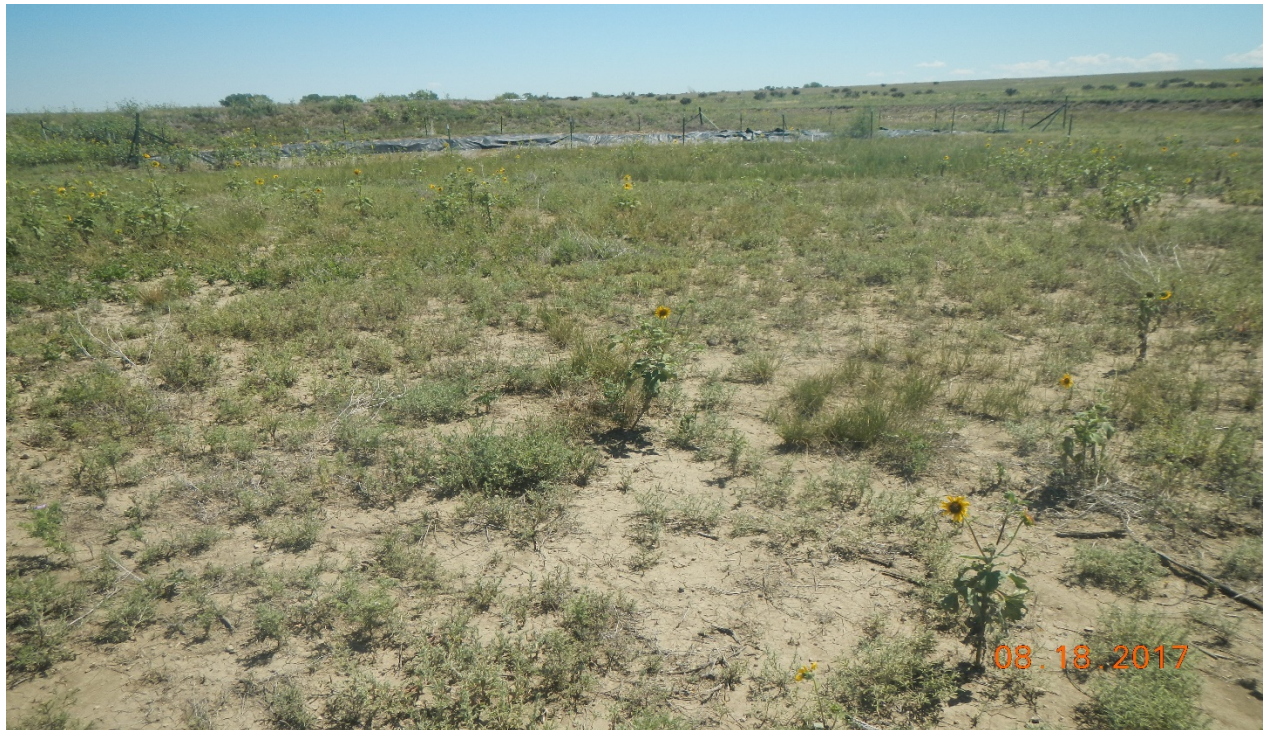
photo 5: Facing southeast toward the location.

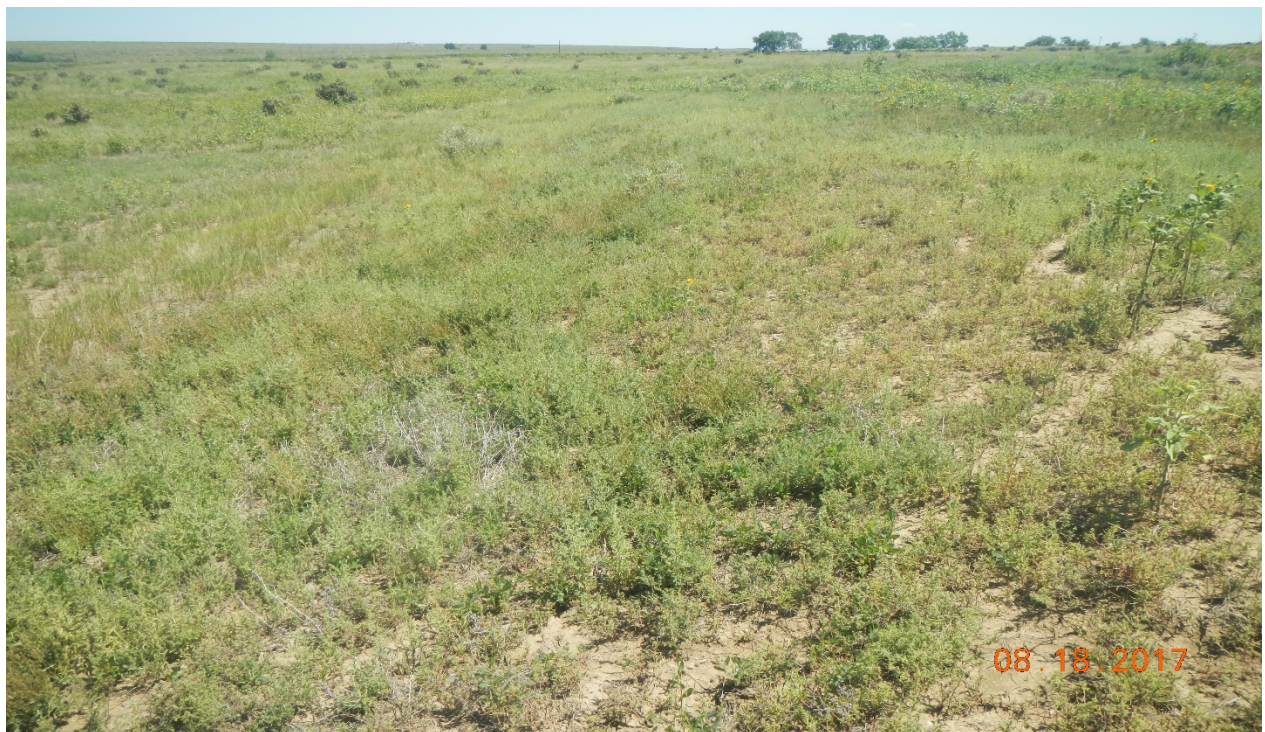
photo 6: Facing east along the north fill slope. There is predominately undesirable weeds (Russian thistle) throughout the location.

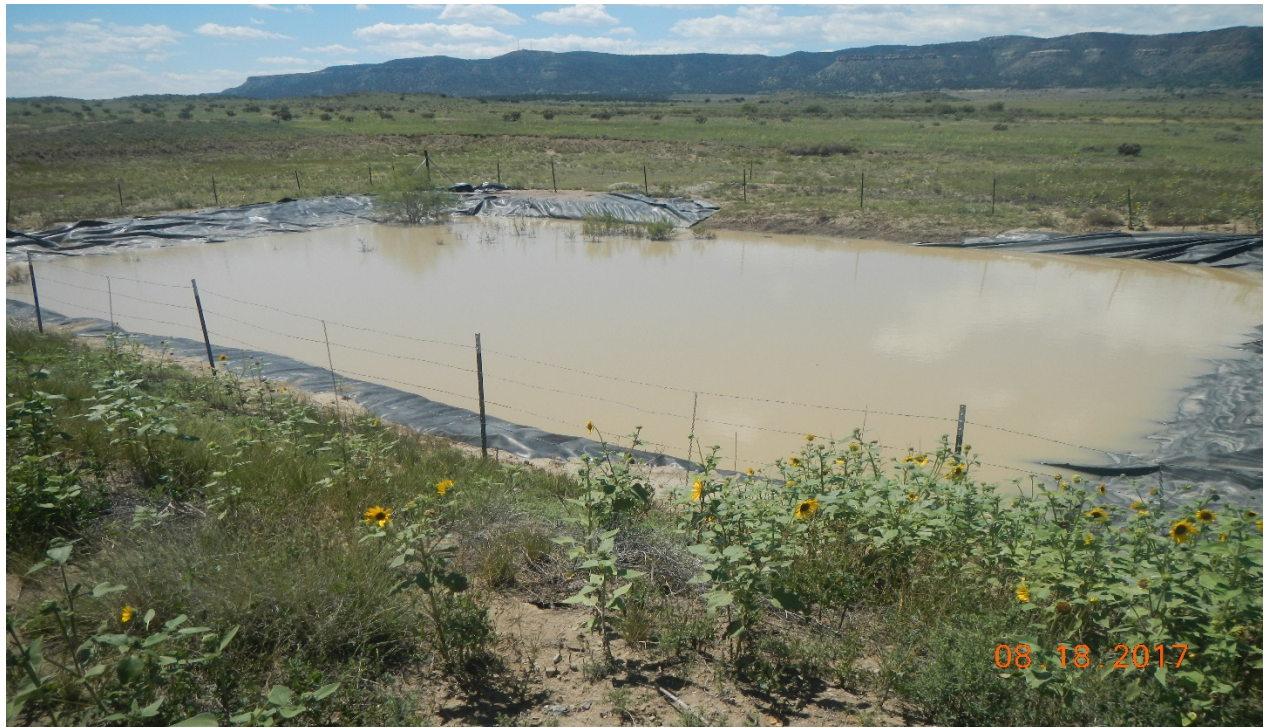
photo 7: Facing southwest toward the pit standing on top of the soil stockpile.

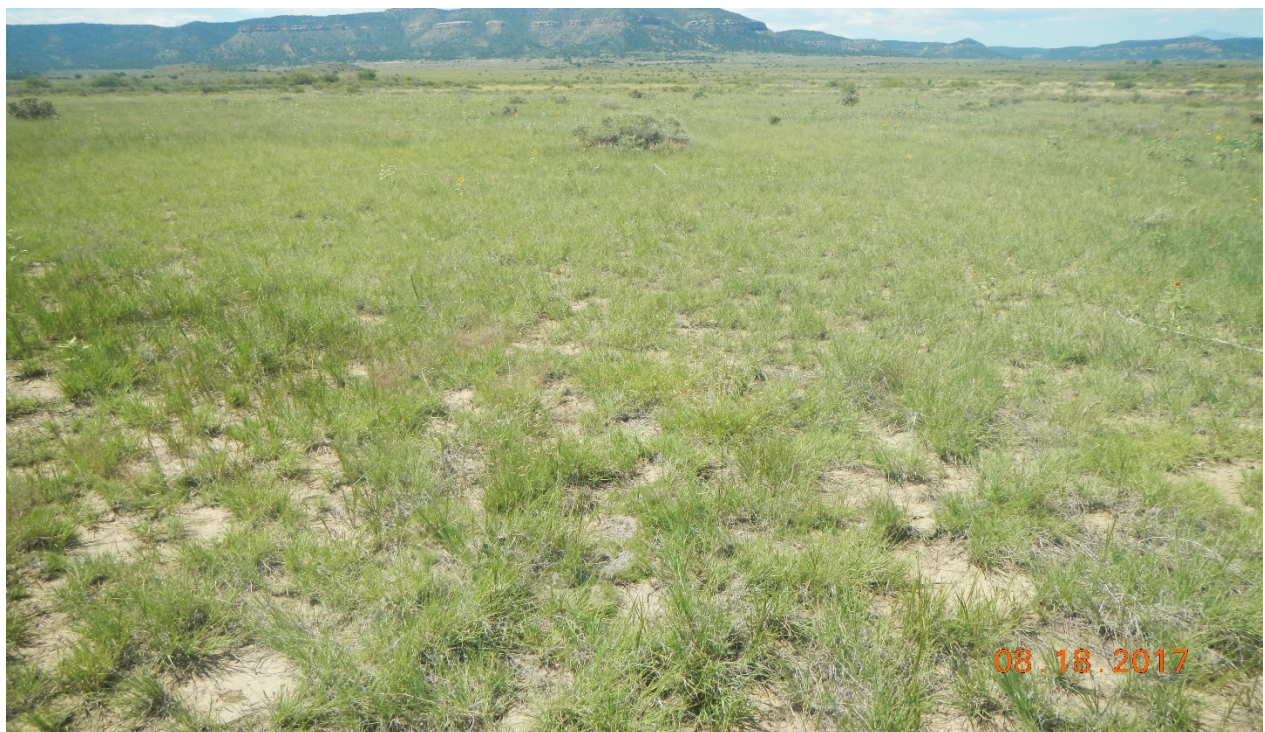
photo 8: Facing west toward the surrounding undisturbed pasture.
