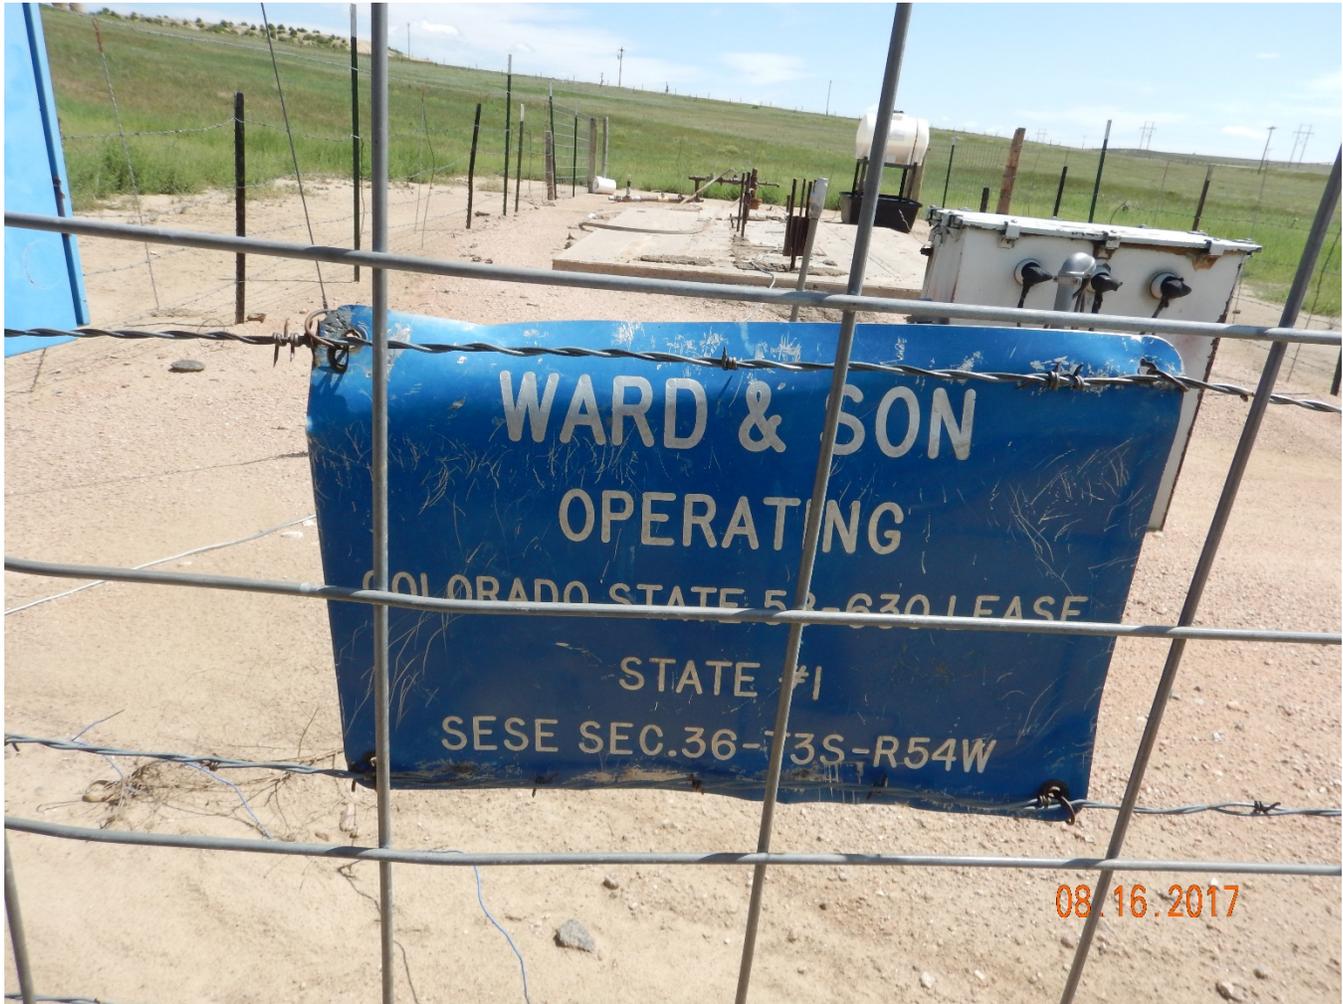
*Figure 1 - Well sign lacking operator emergency contact information.*

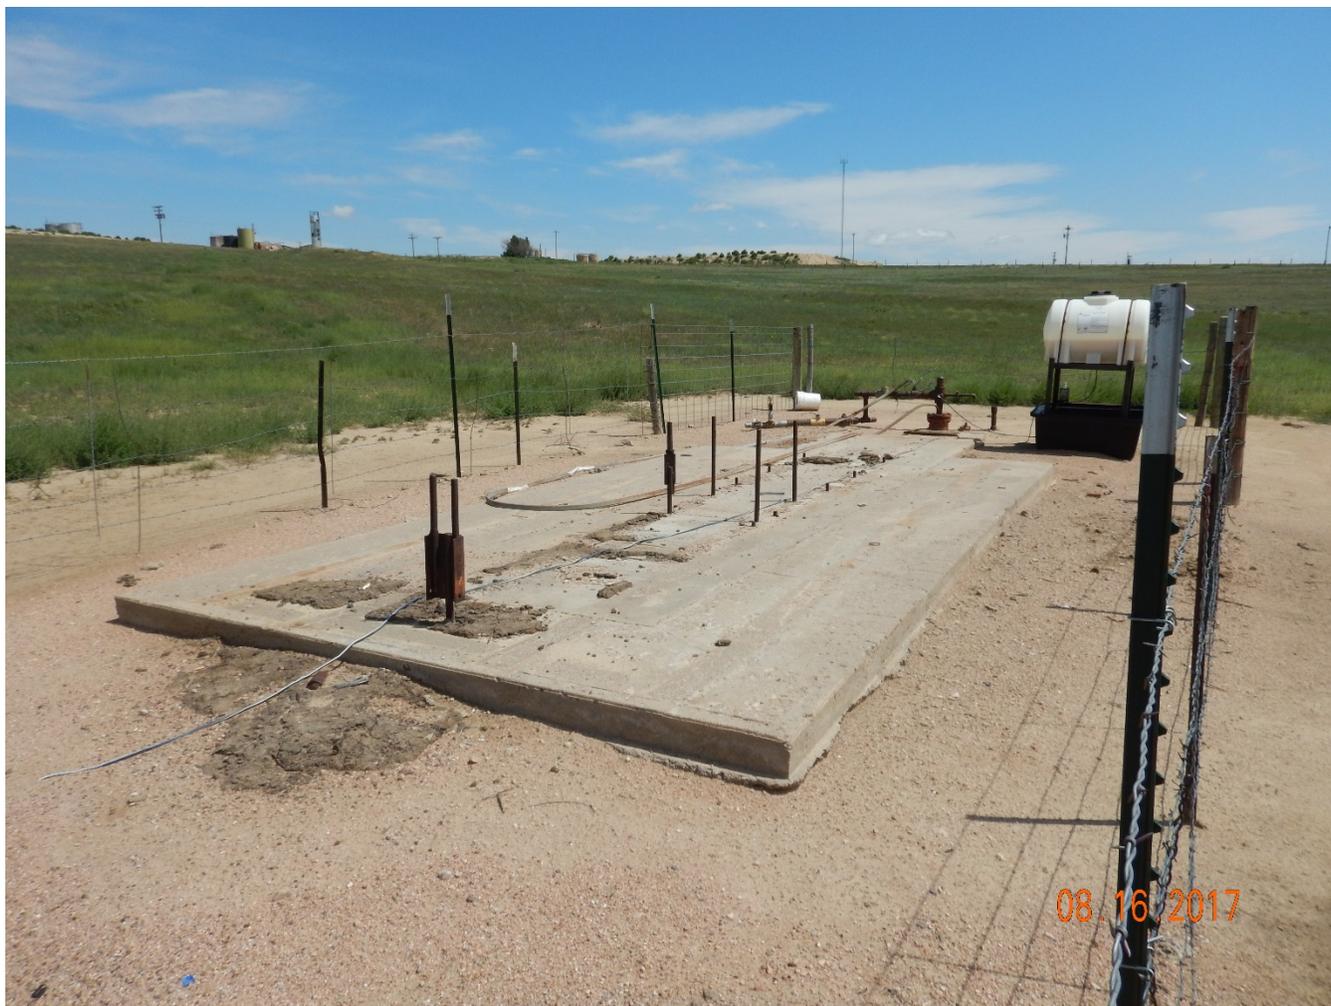
*Figure 2 - Pump jack foundation and wellhead. Note presence of oily waste associated with pump jack foundation.*

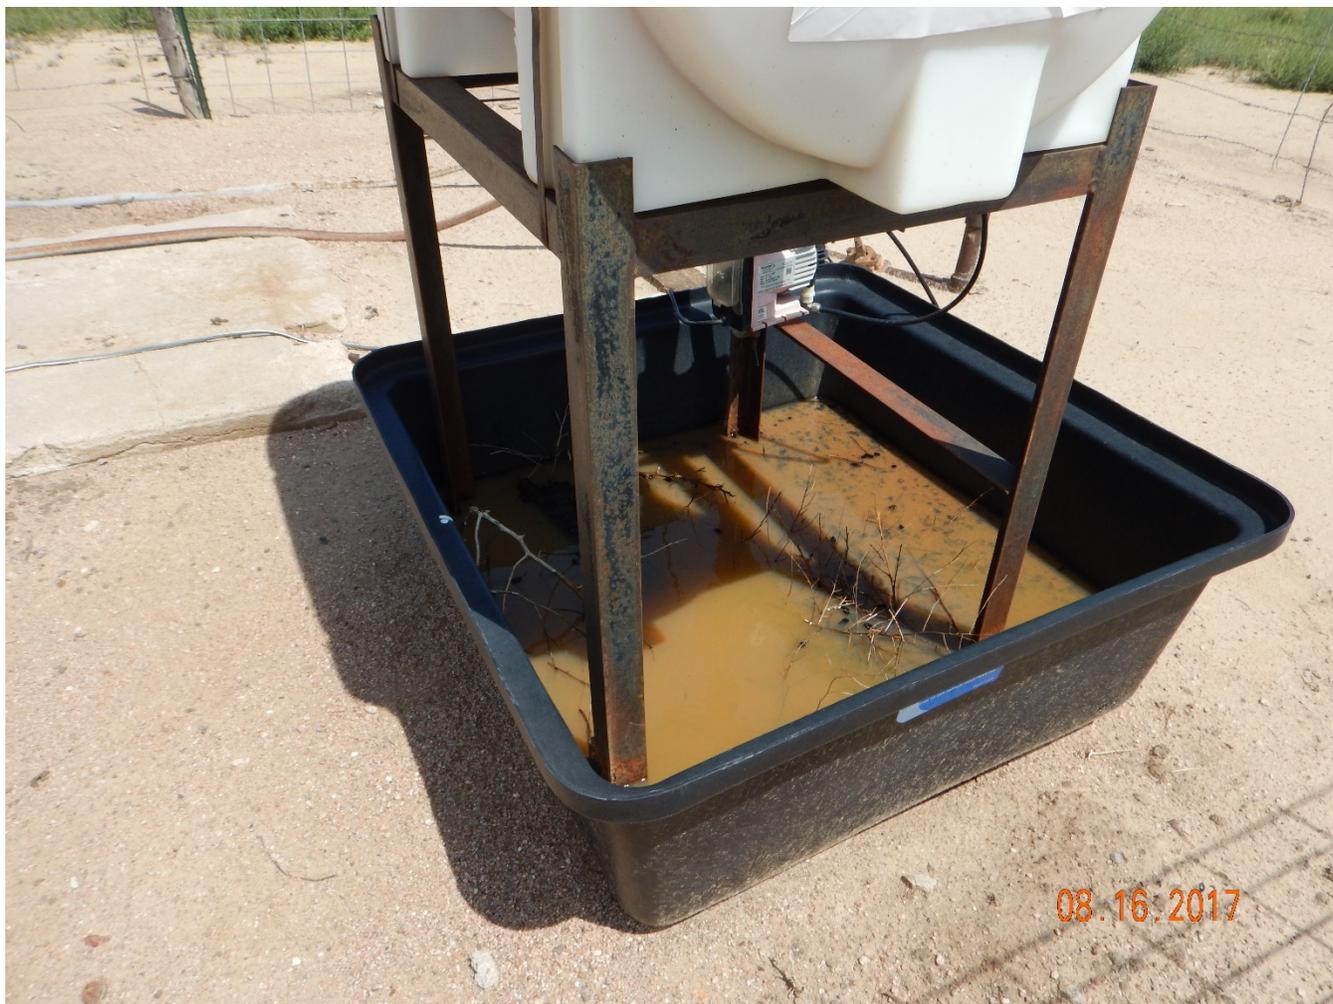
*Figure 3 - Day tank with secondary containment device at wellhead. Note presence of contaminated stormwater inside of containment device.*

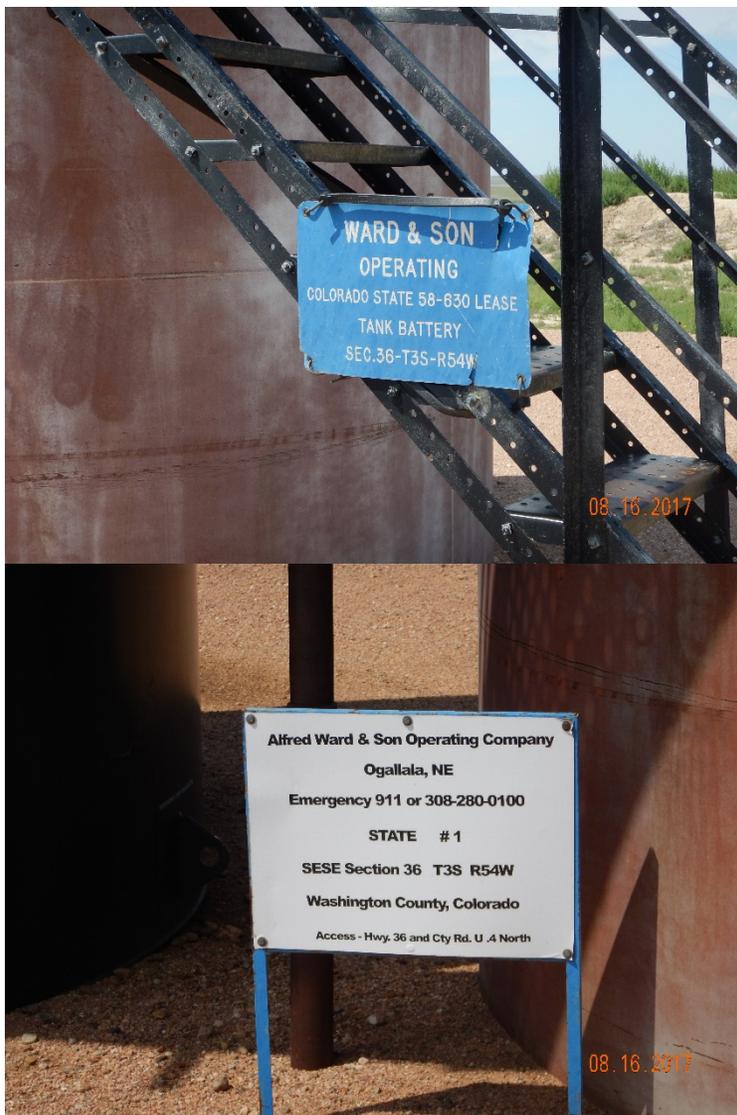
*Figure 4 - Battery signs located near crude oil ASTs.*

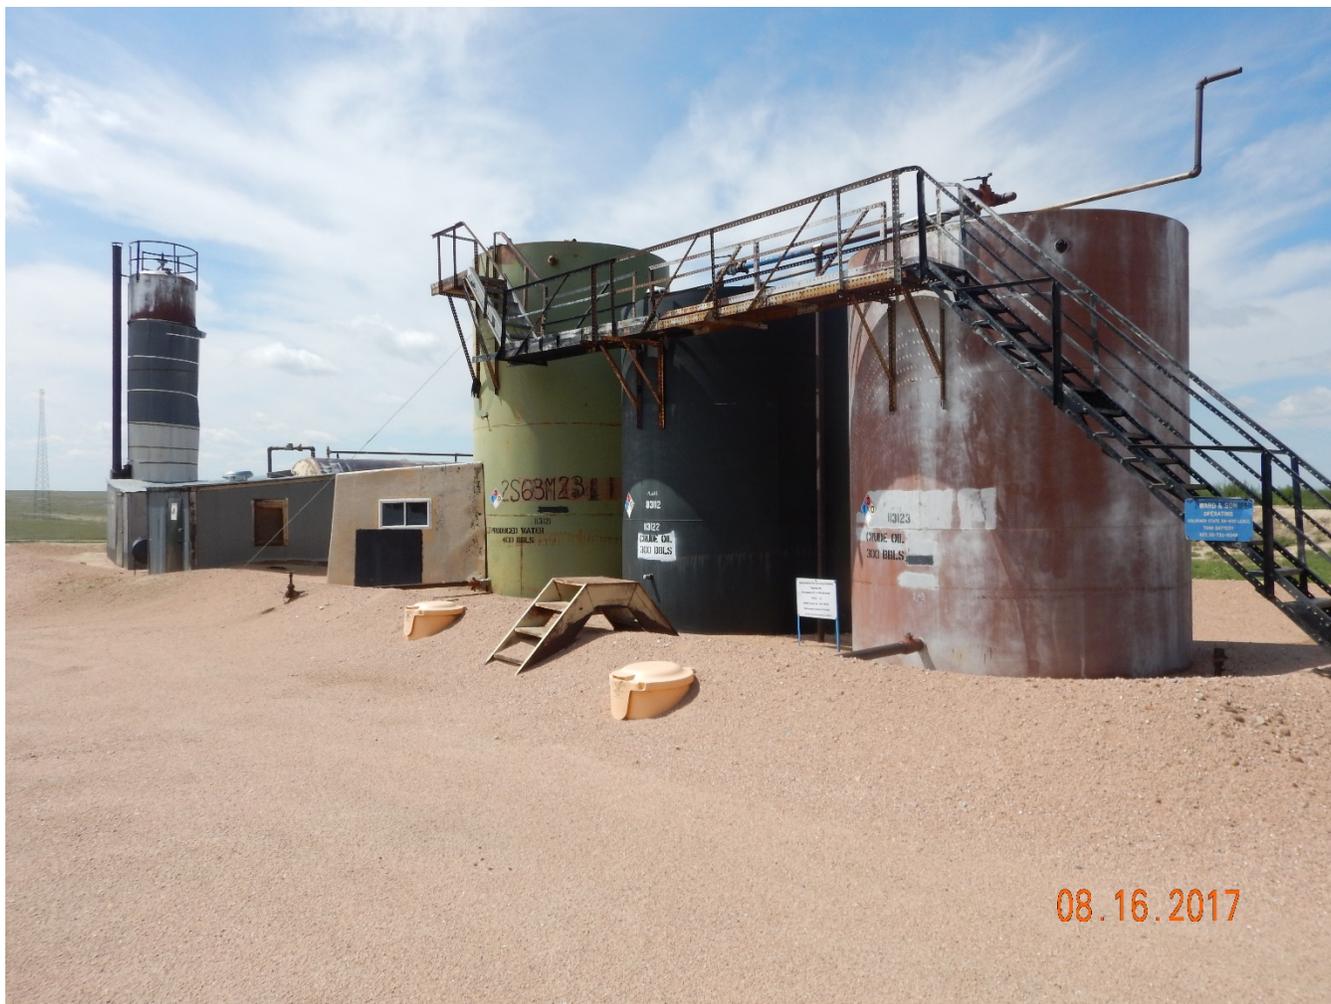
*Figure 5 - Crude oil battery with FWKO and VHT.*

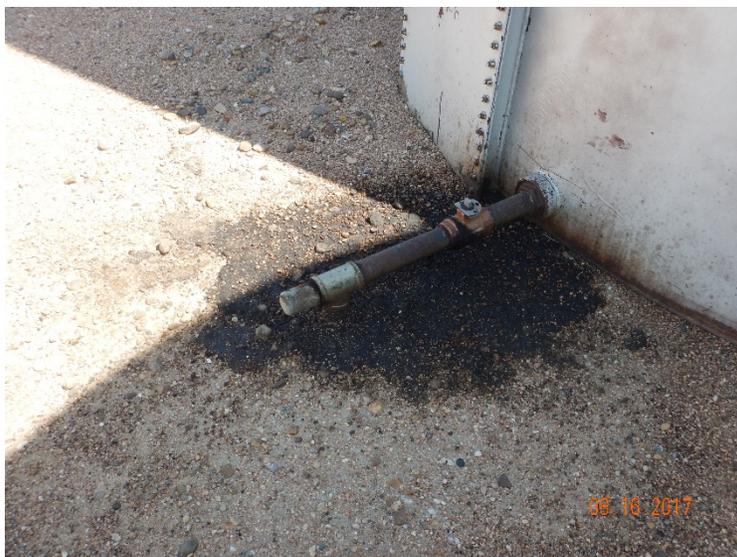
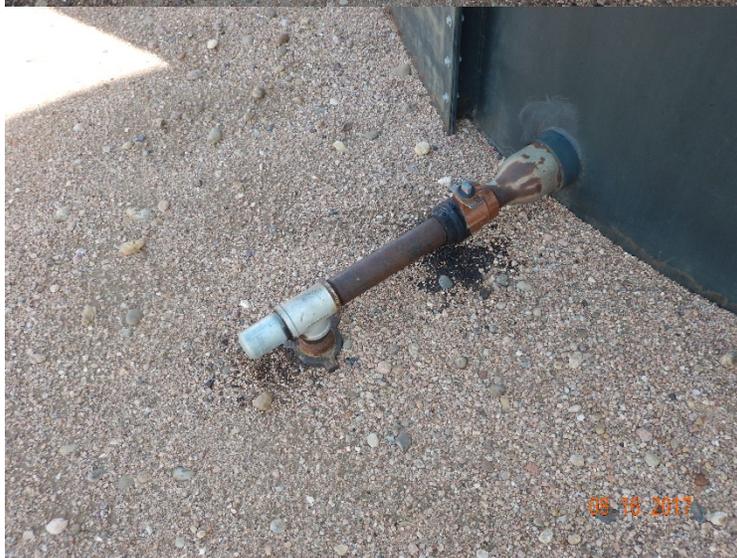
*Figure 6 - Oily waste underlying valves on west side of crude oil ASTs.*

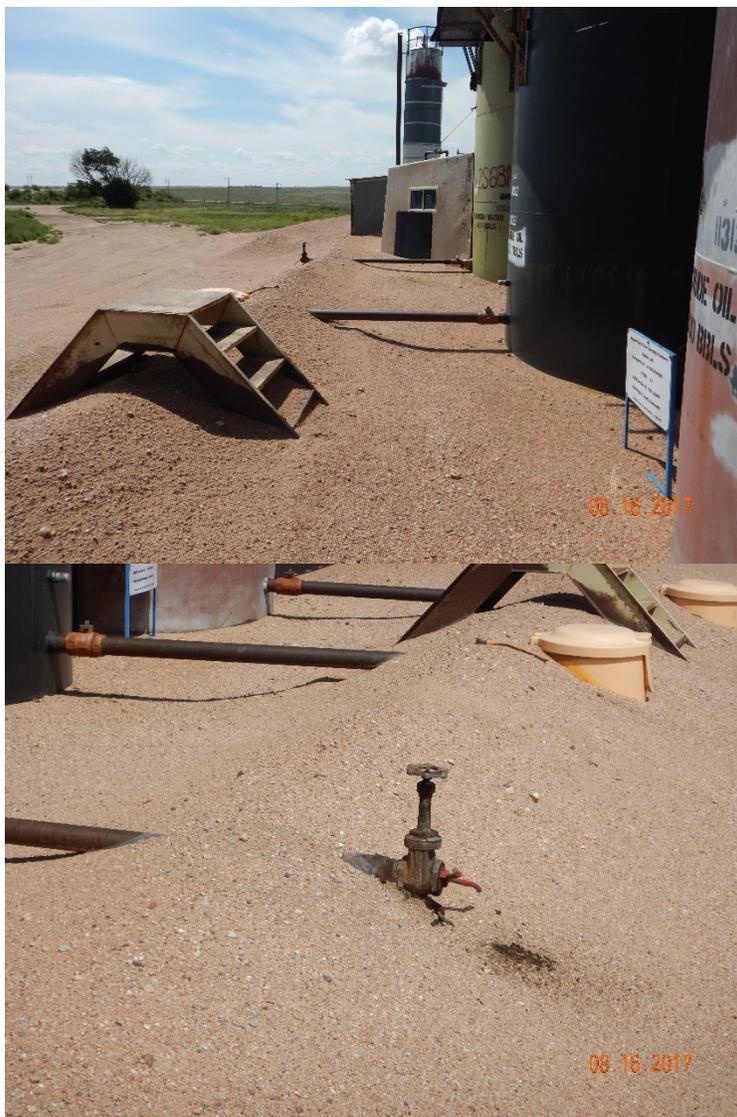
*Figure 7 - Shallow earthen berm (top photo) and oily waste at truck loadout (bottom photo).*

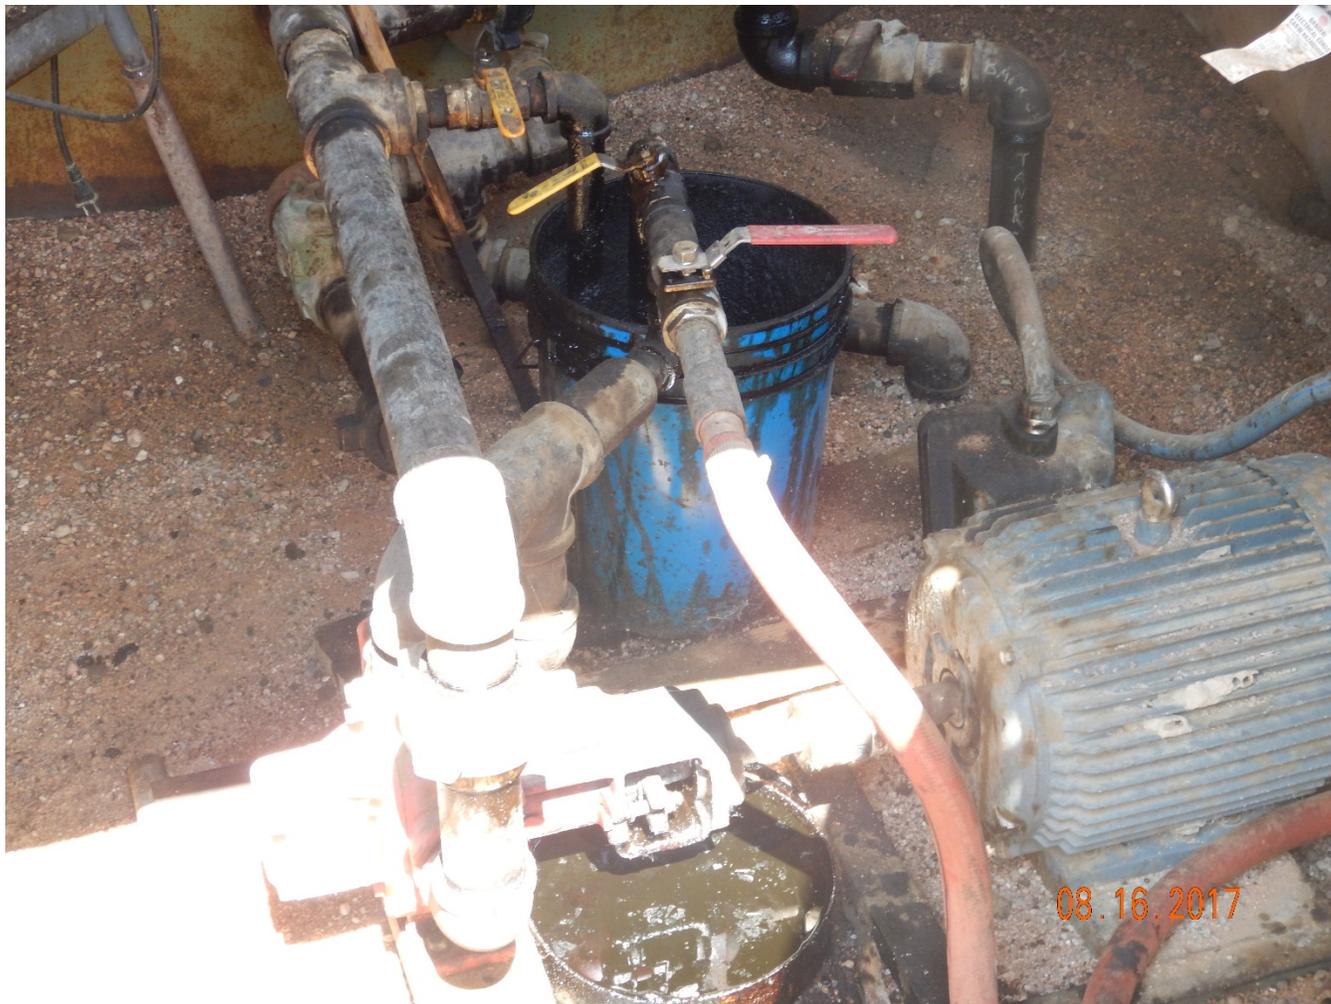
*Figure 8 - Open buckets of oily waste and oil-stained soil inside of shed attached to 400 bbl produced water AST.*

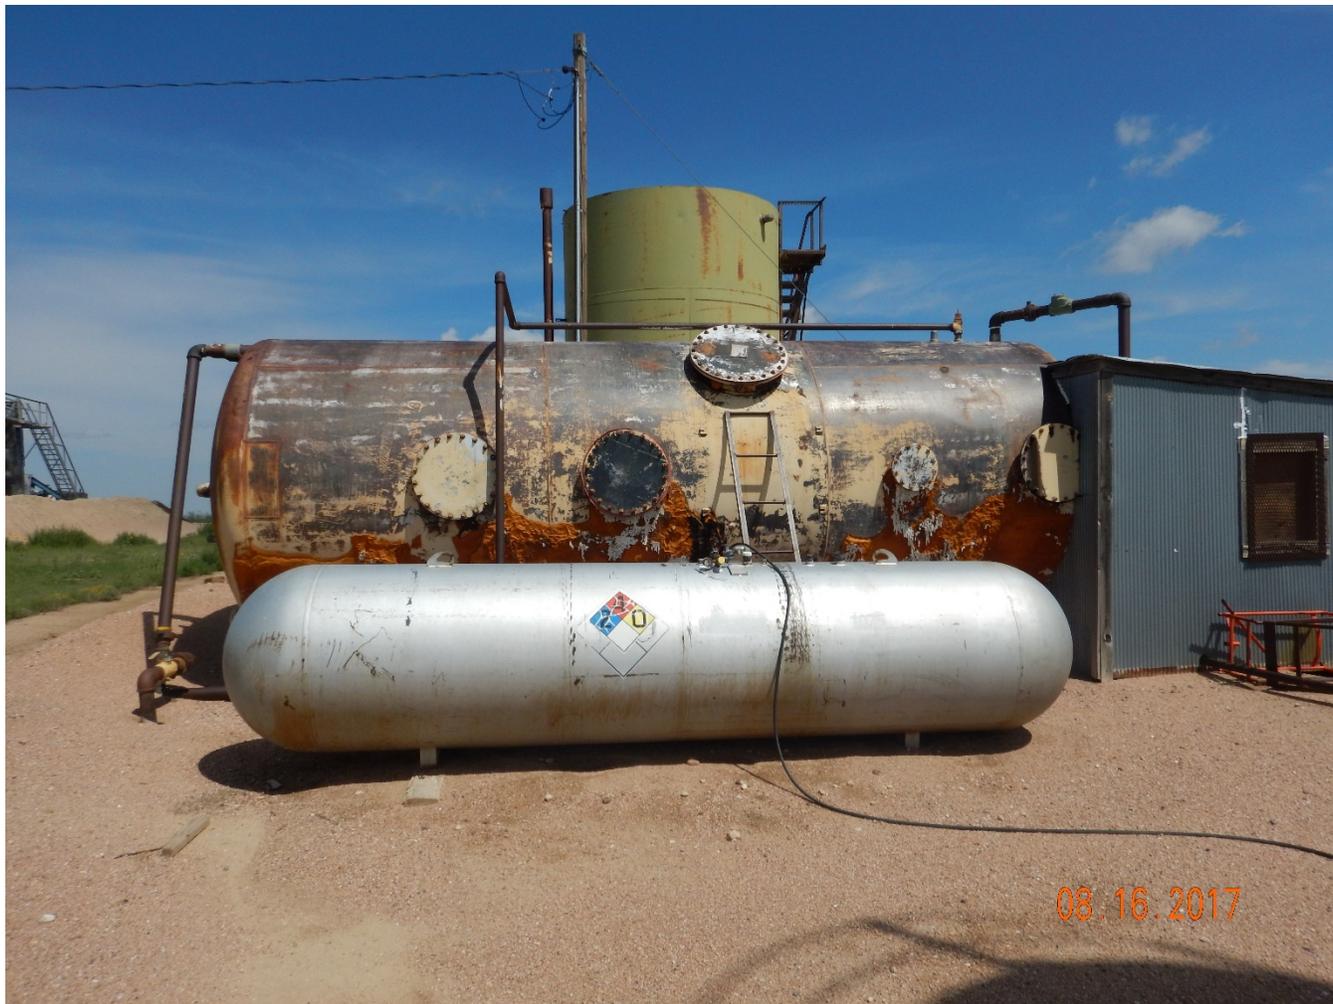
*Figure 9 - Unlabeled horizontal AST/FWKO and propane tank south of produced water AST.*

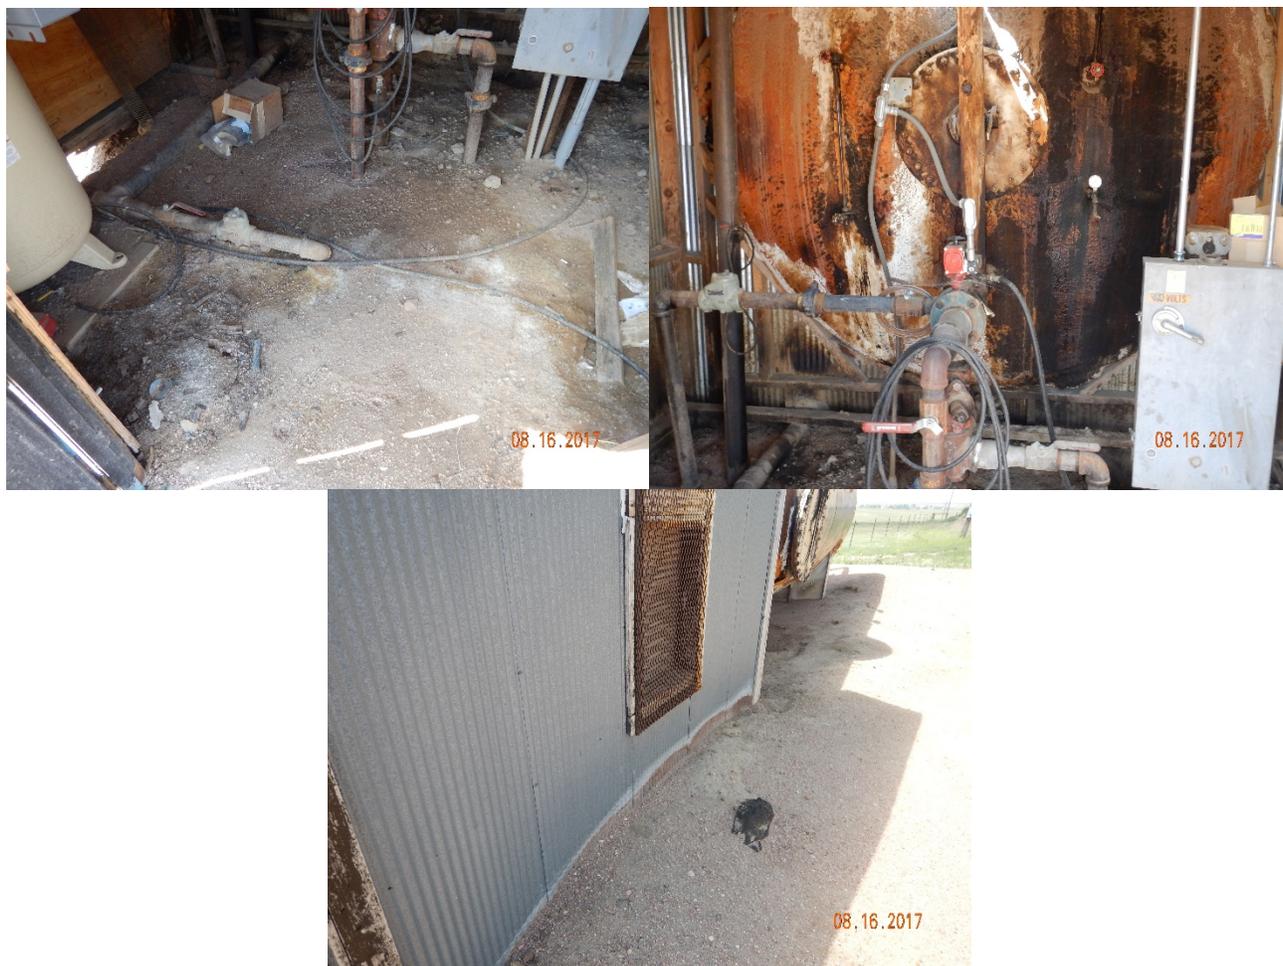
*Figure 10 - Oil-stained soil and equipment (top photos) inside of FWKO shed and oily rag outside of window on north side of shed (bottom photo).*

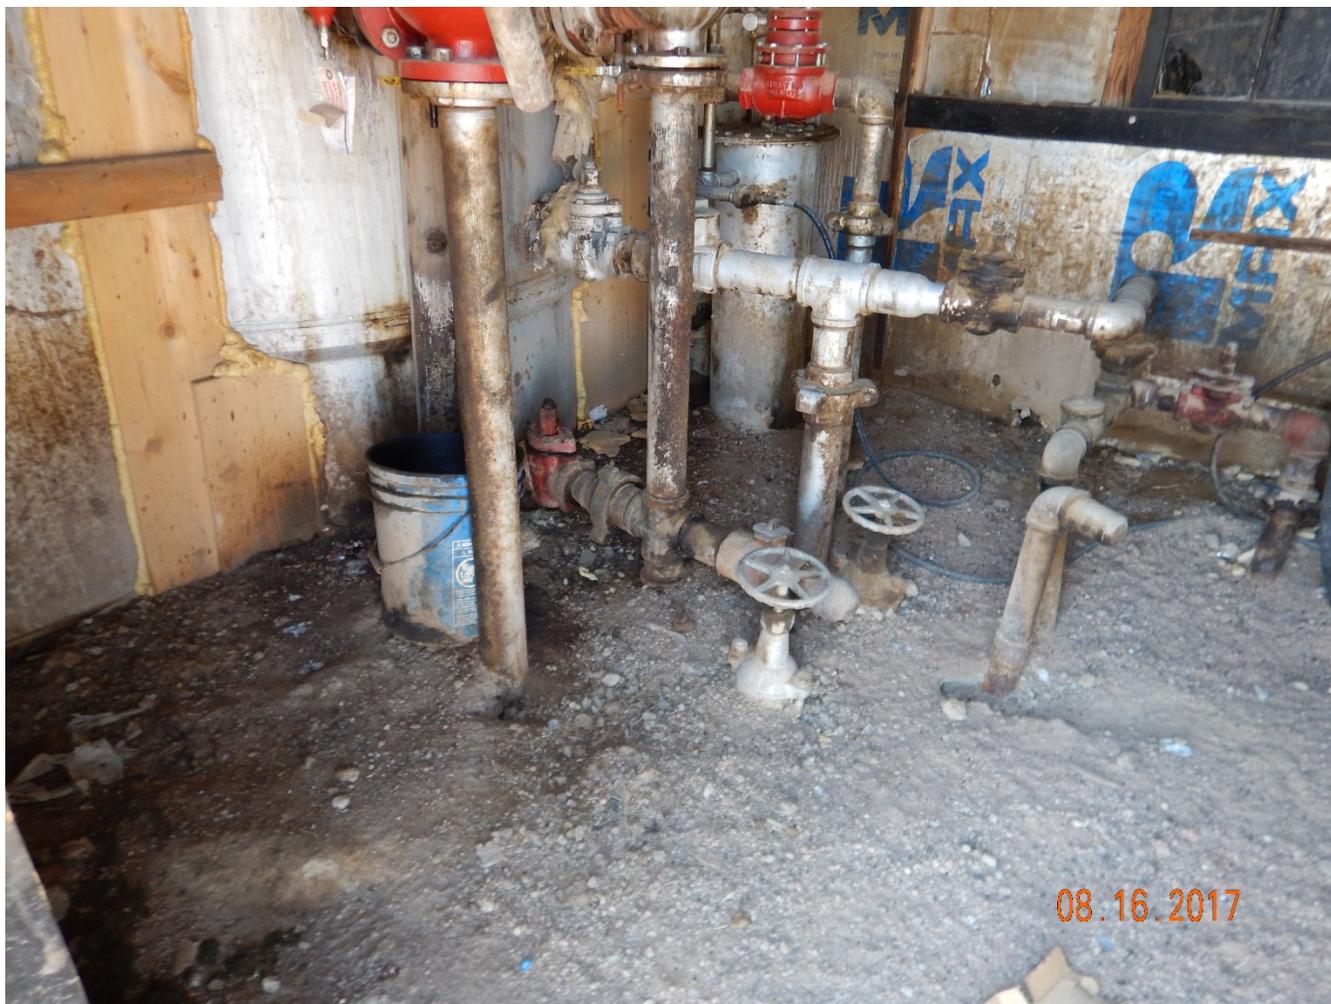
*Figure 11 - Localized, oil-stained soil and bucket of oily waste inside of VHT shed.*

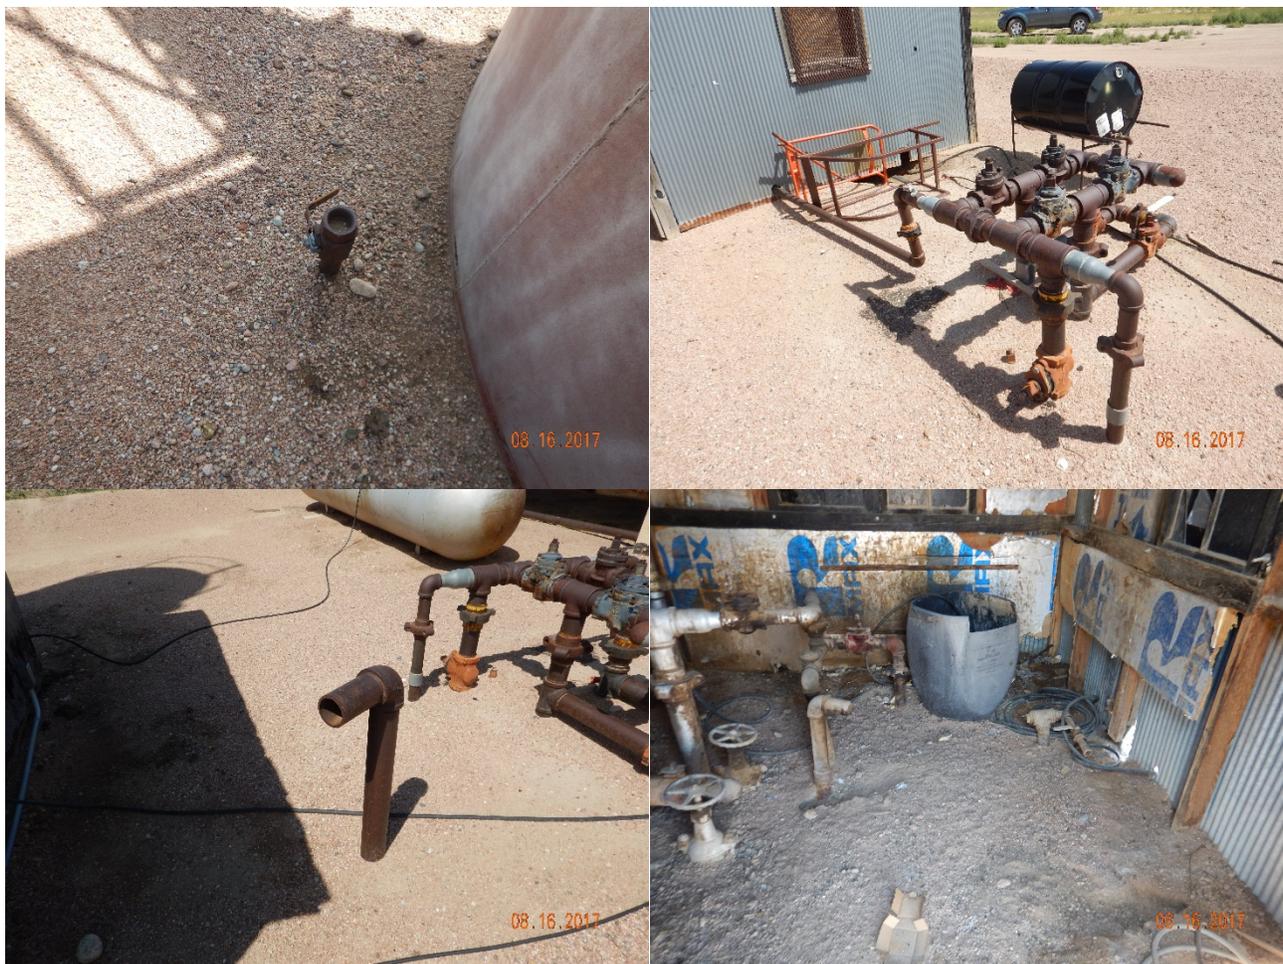
Figure 12 - Flowline risers around crude oil tank battery. Clockwise from top left: 2" uncapped line north of crude oil tanks, manifold and storage drum south of FWKO, two 2" risers inside of VHT shed and 4" riser with 90-degree angle south of manifold.

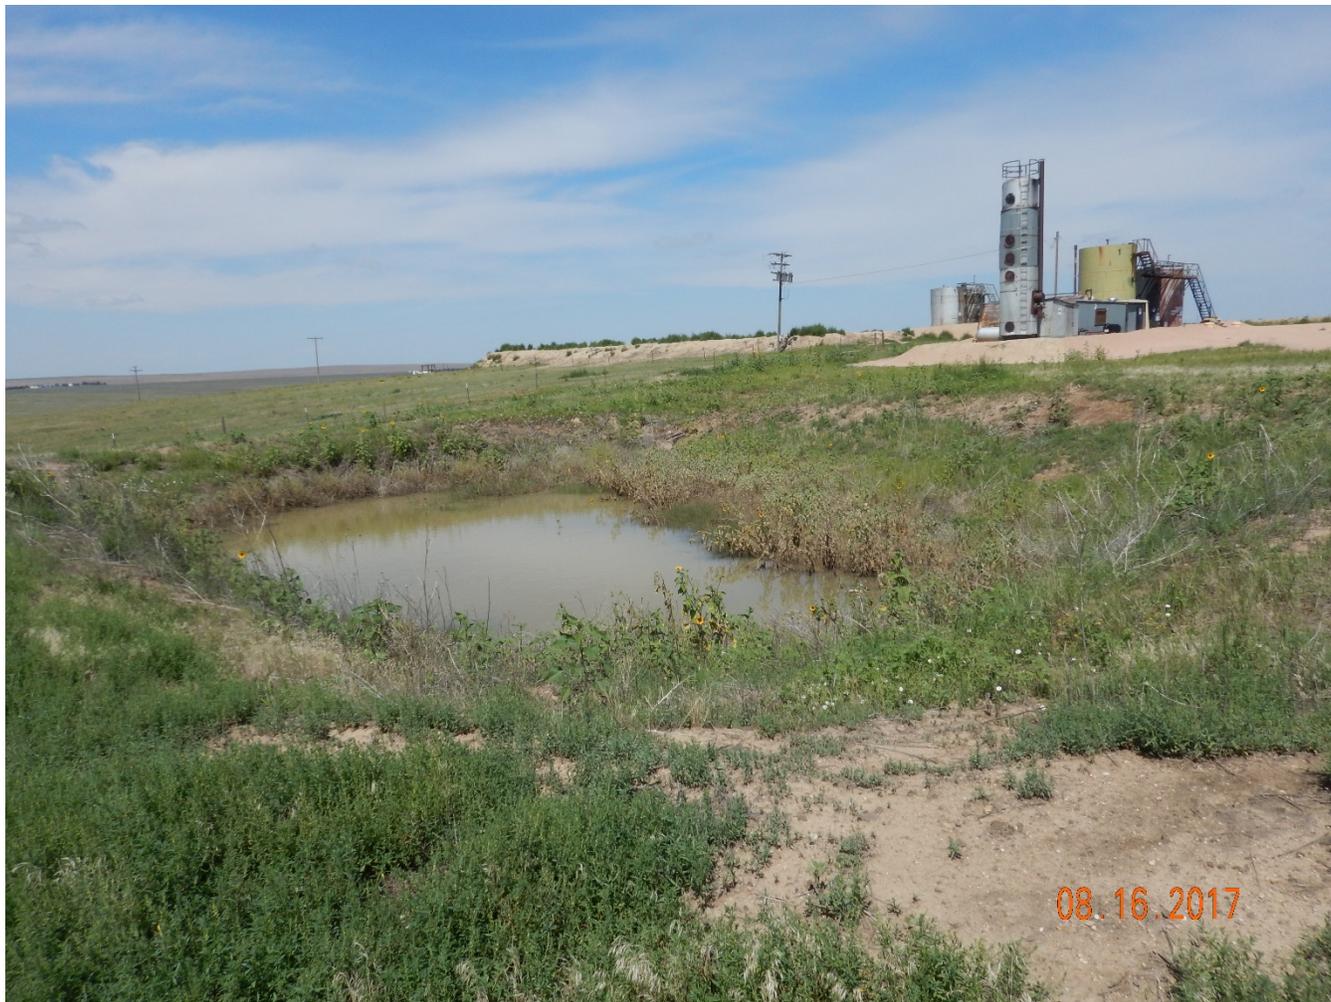
*Figure 13 - Pit facility #440212, located SE of crude oil ASTs. Operator was instructed via email on 12/4/2014 to submit a Form 27 for closure, remediation, and reclamation of this pit (doc #2313356). To date, the required Form 27 for pit closure has not been received by COGCC.*

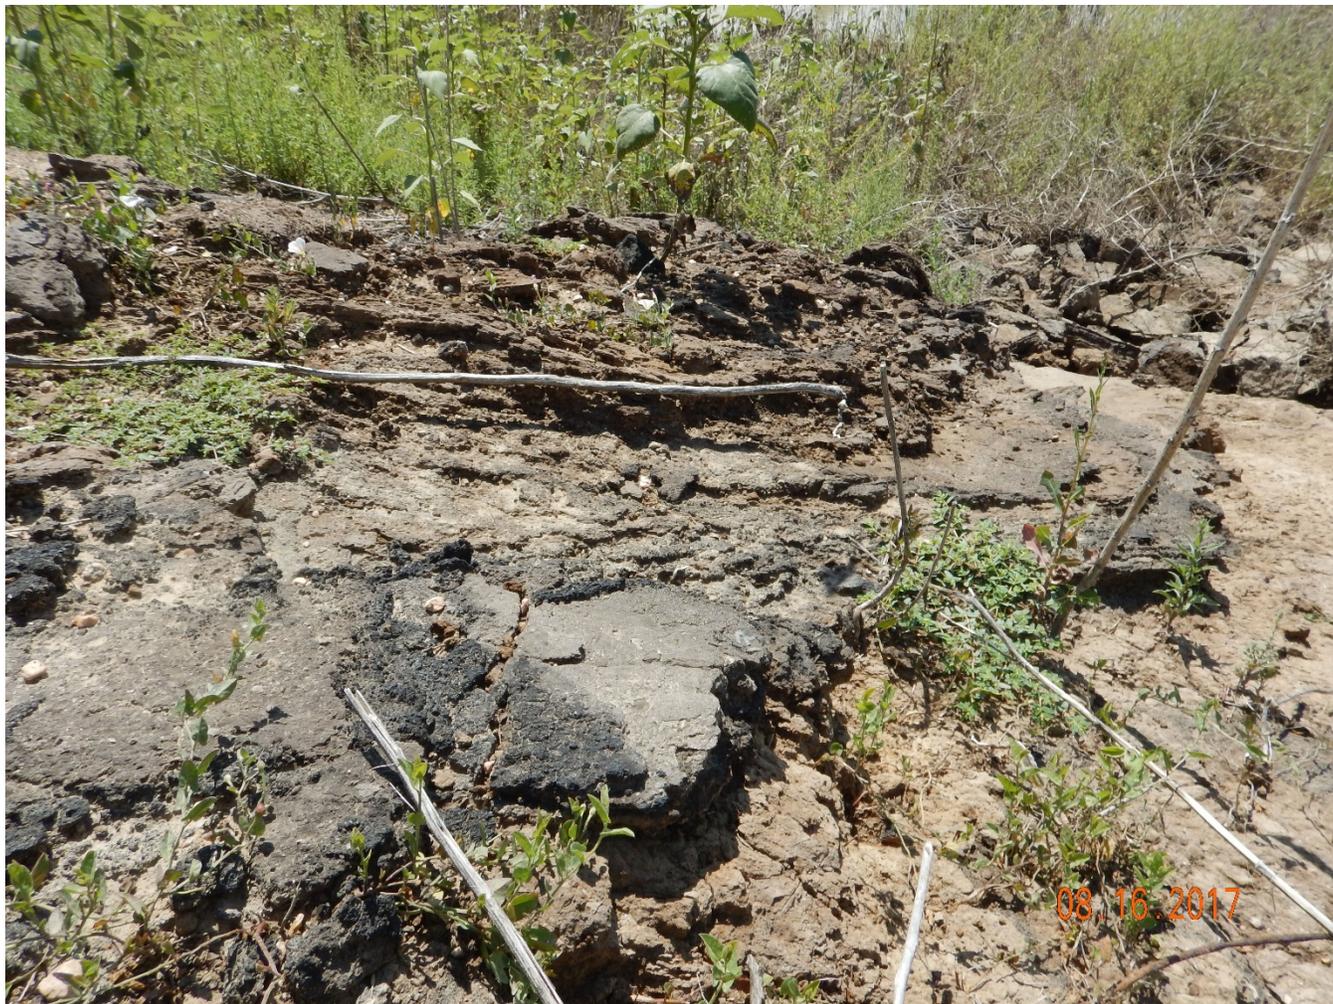
*Figure 14 - Impacted soil/asphalt material located on north berm of pit facility #440212.*

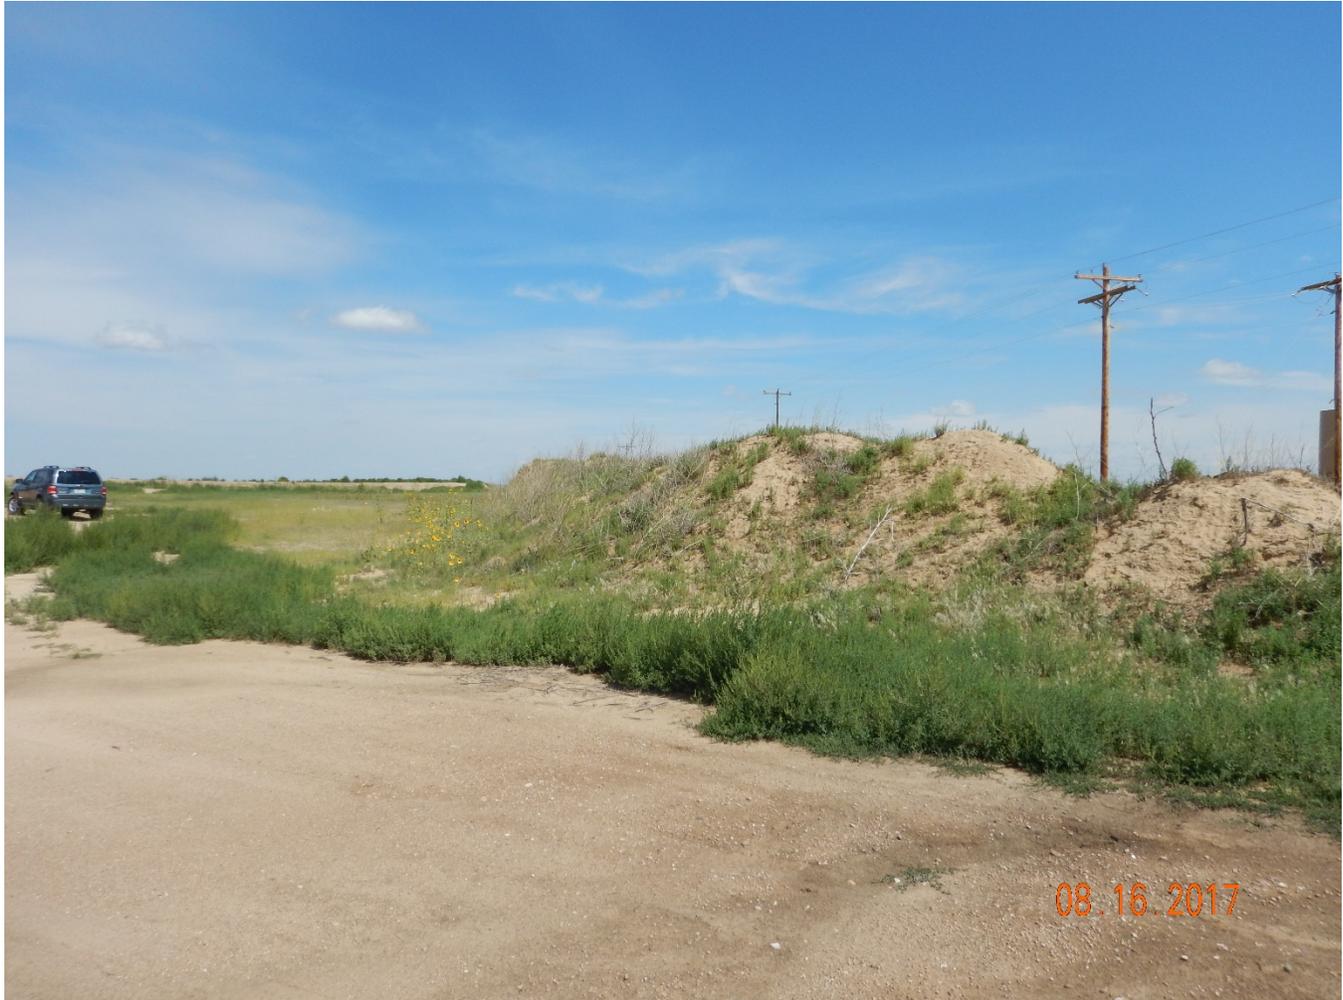
*Figure 15 - Unidentified soil stockpile east of crude oil ASTs.*

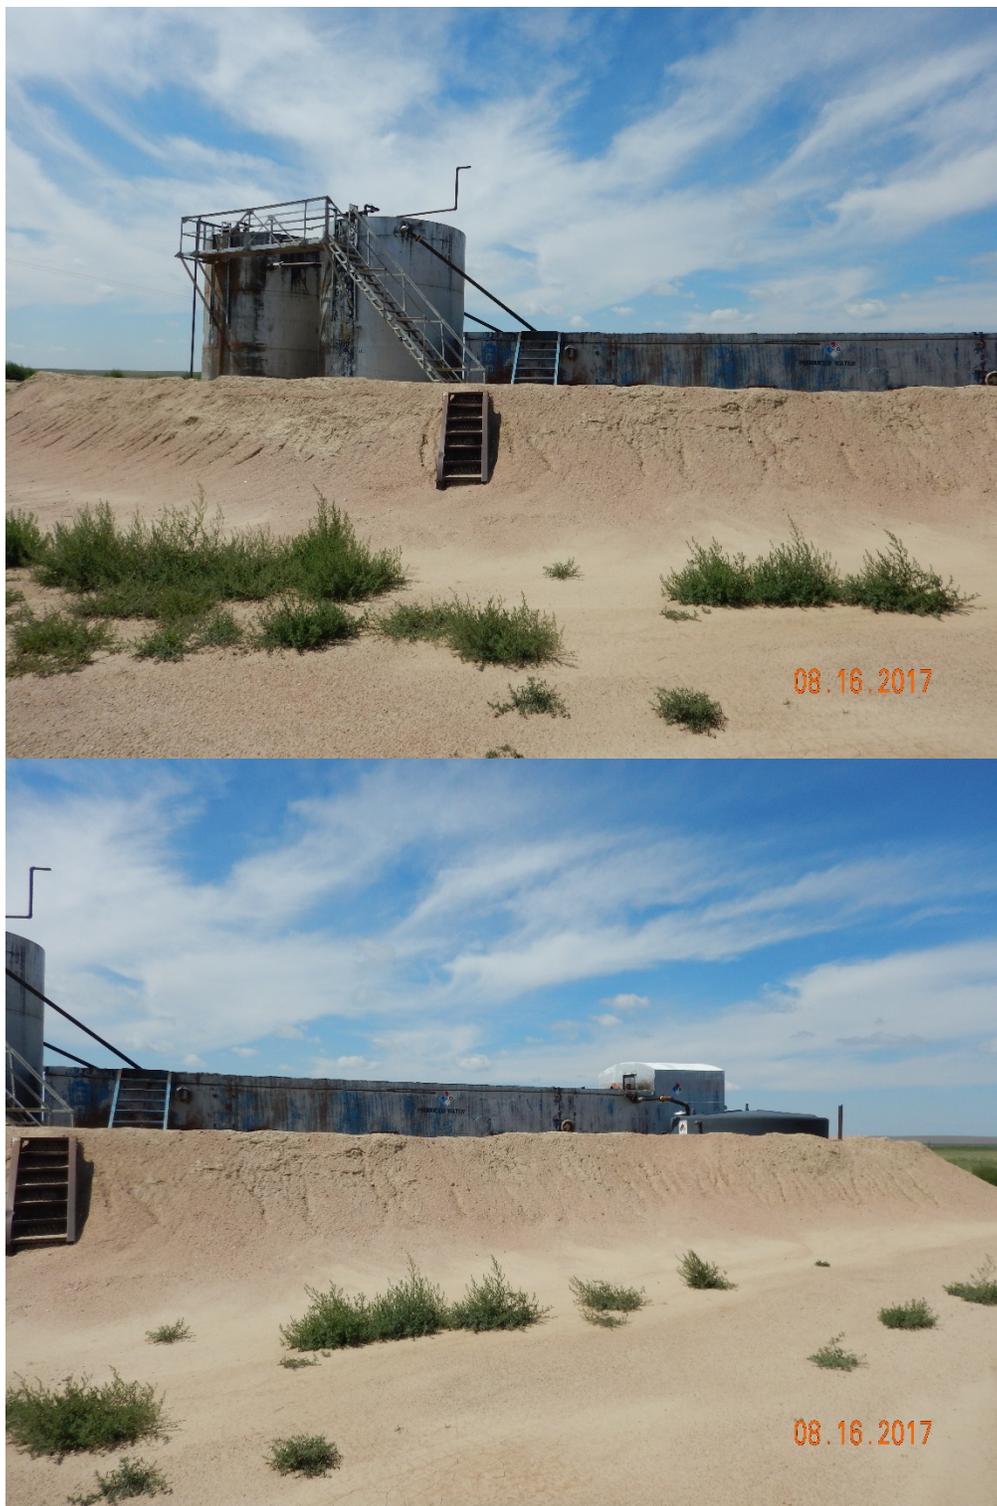
*Figure 16 - Produced water tanks NW of crude oil tank battery.*

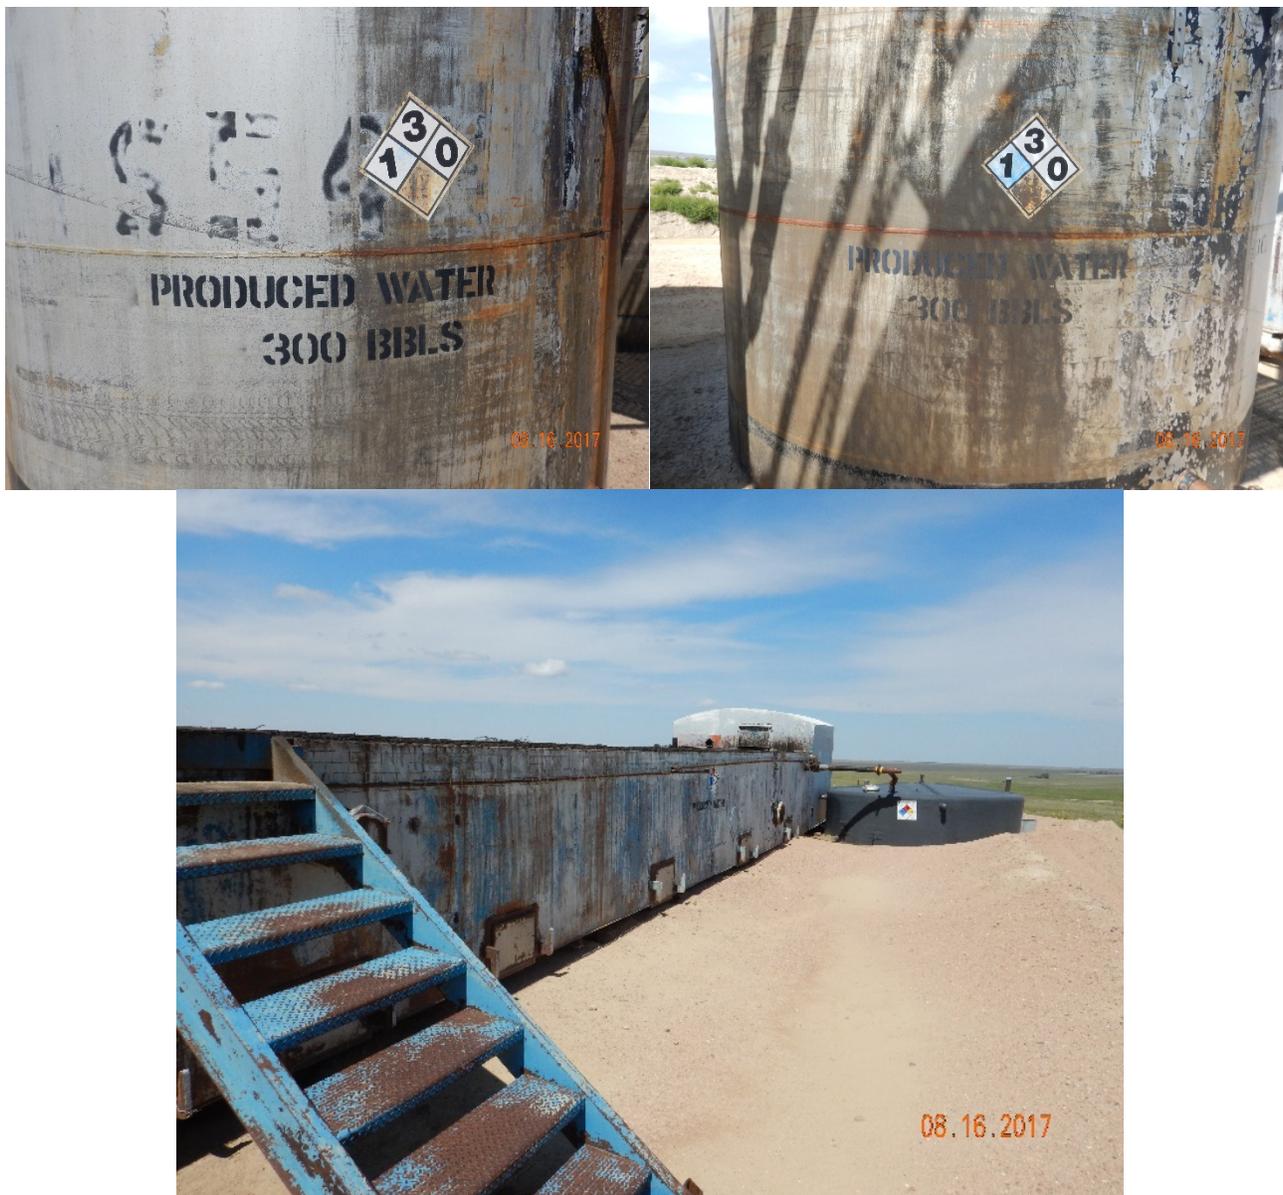
*Figure 17 - Placard and label issues with produced water tanks: Top photos: 300 bbl ASTs have faded NFPA placards and labels are illegible from a distance due to tank color and stains. Bottom photo: frac tank and PBV have NFPA placards but no volume labels.*

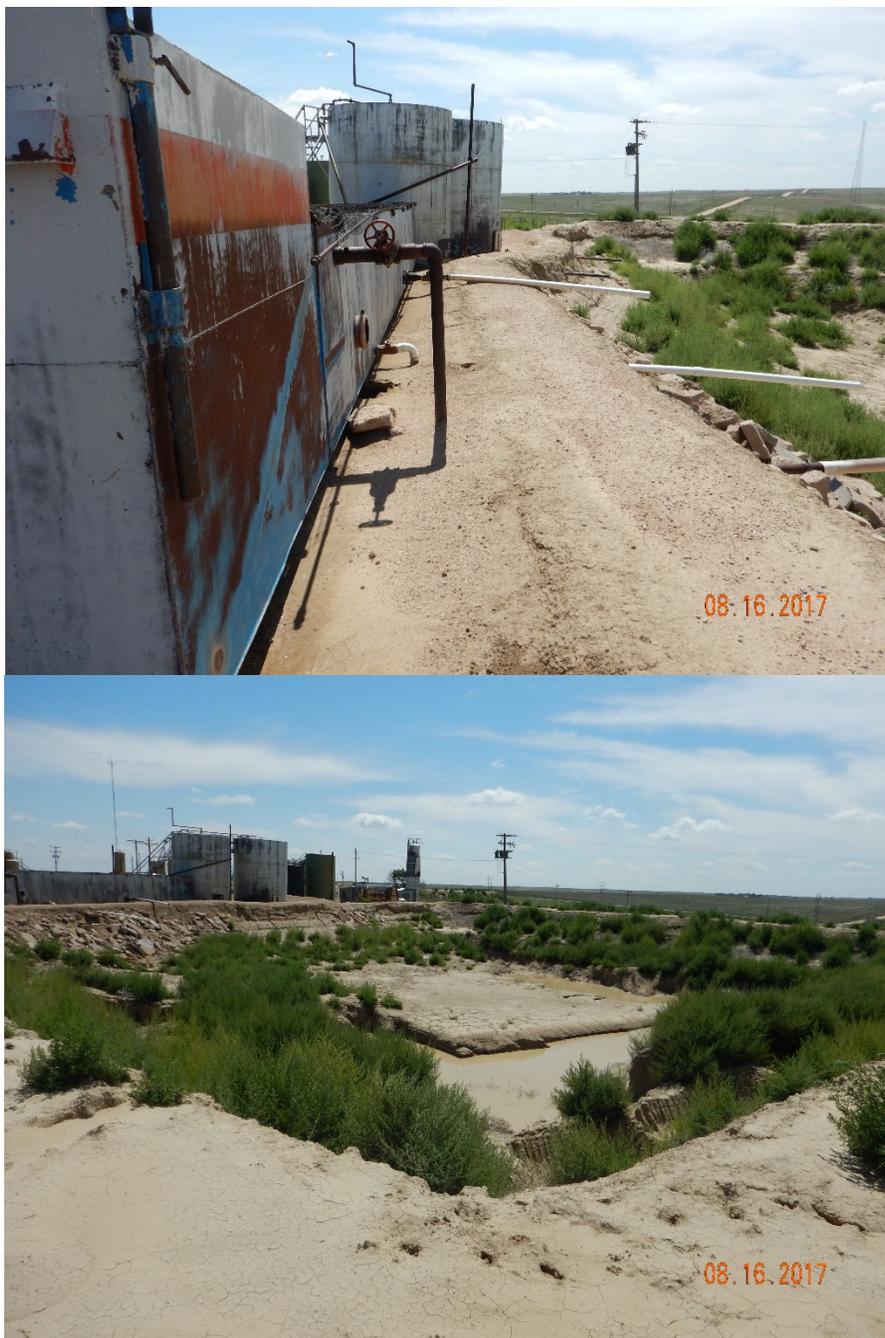
*Figure 18 - Produced water tanks share earthen berm (and are plumbed to) active pit facility #107647.*
