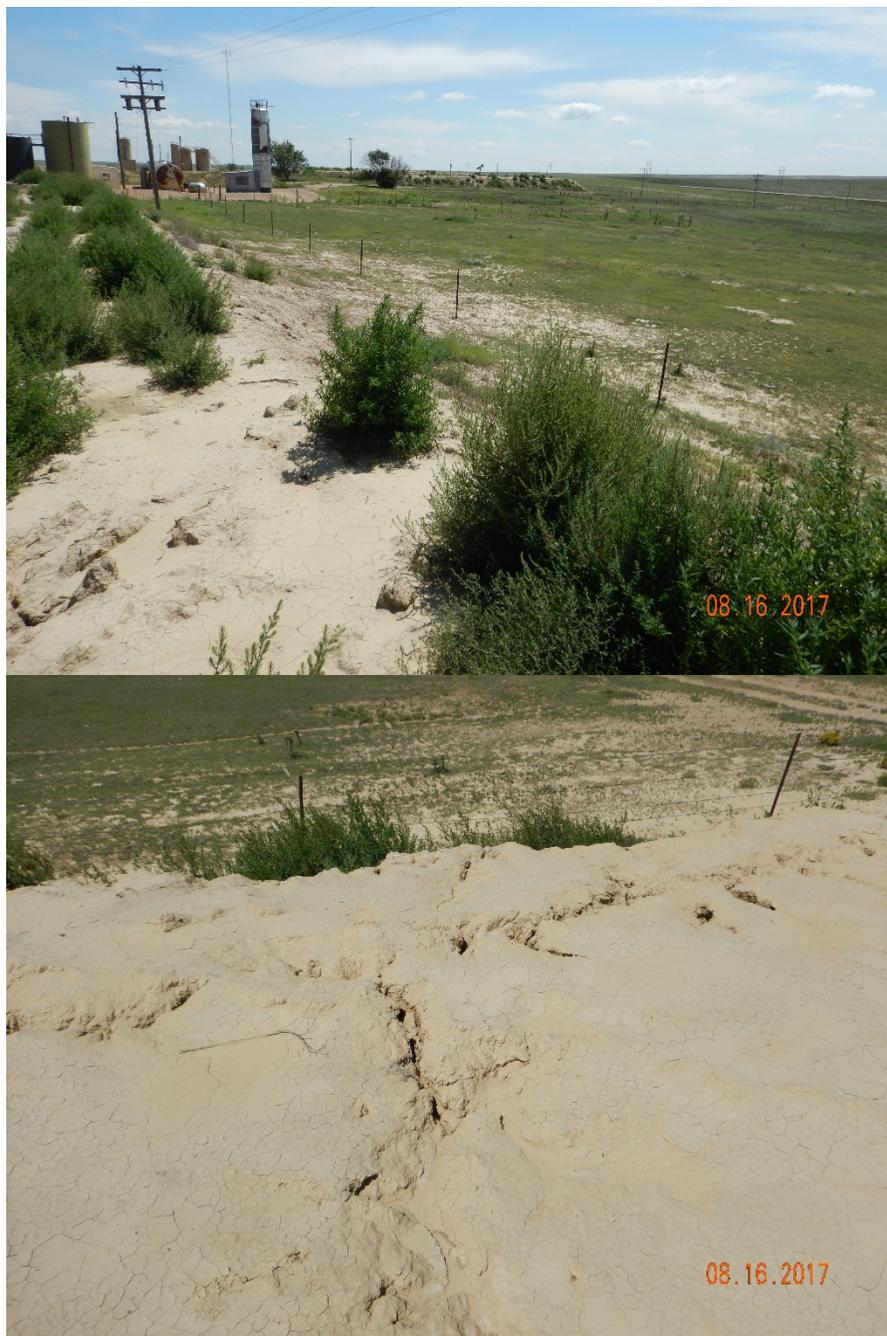
*Figure 19 - Evidence of berm erosion and off-site sediment transport to south (top photo) and west (bottom photo) of pit facility #107647.*

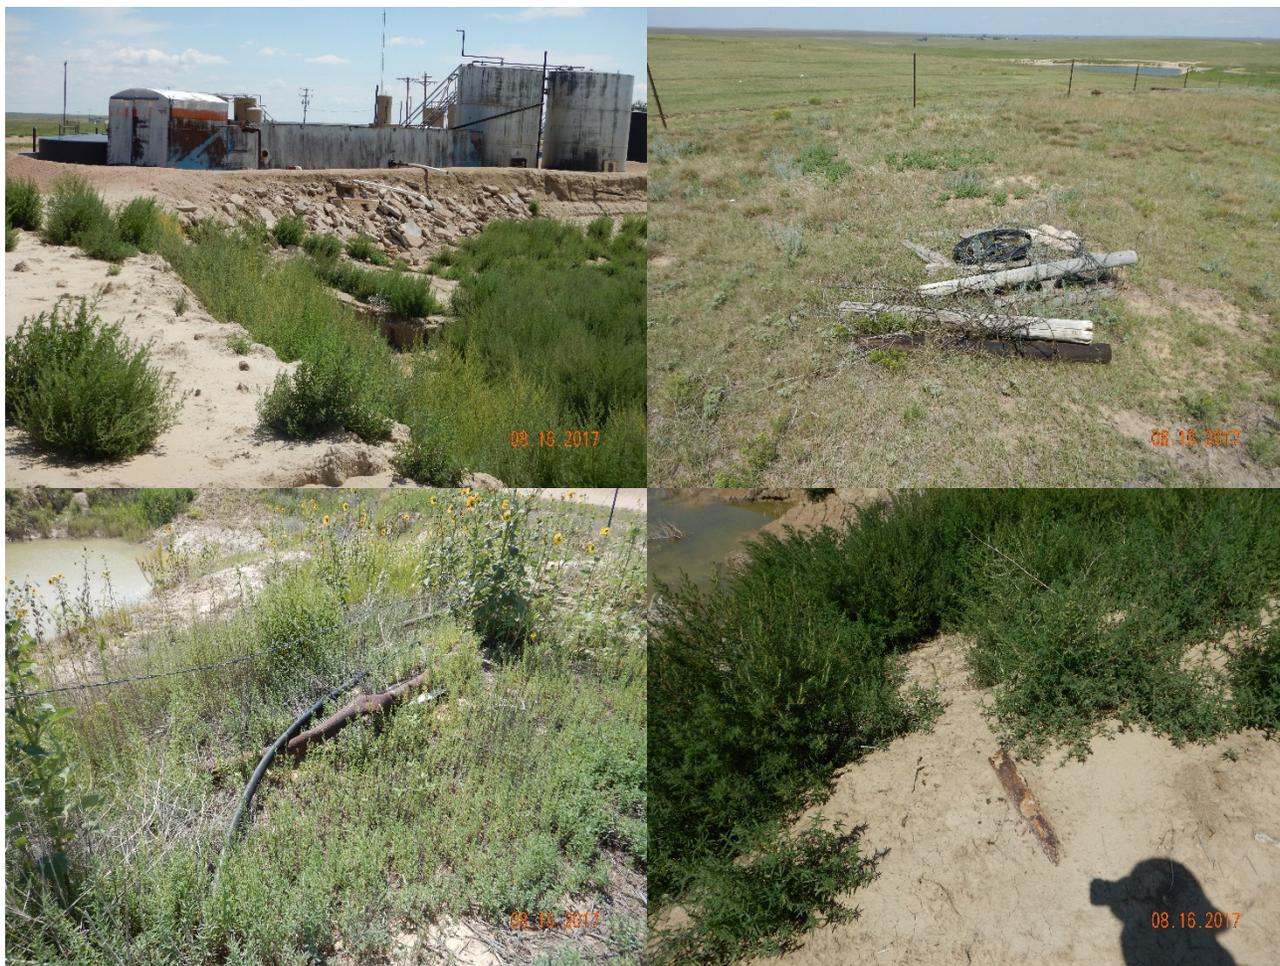
*Figure 20 - Trash, junk, and unused equipment around pit complex.*

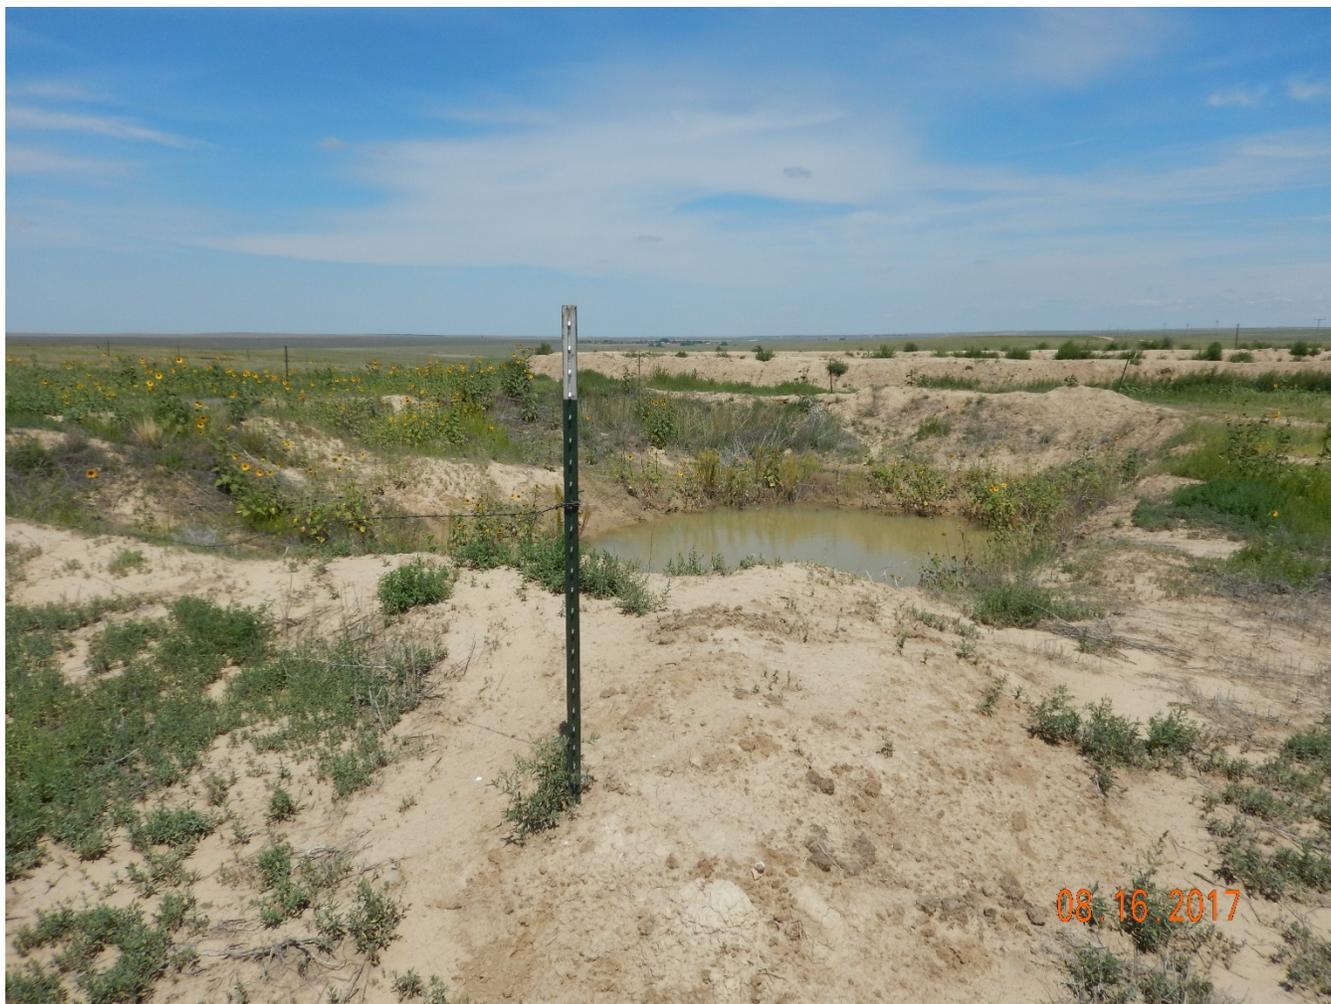
*Figure 21 - Open excavation associated with skim pit closure (facility IDs #107645 & #107646) and Remediation Project #8068 remains open, is overgrown with weeds, and is partially filled with water. Fence in need of repair.*

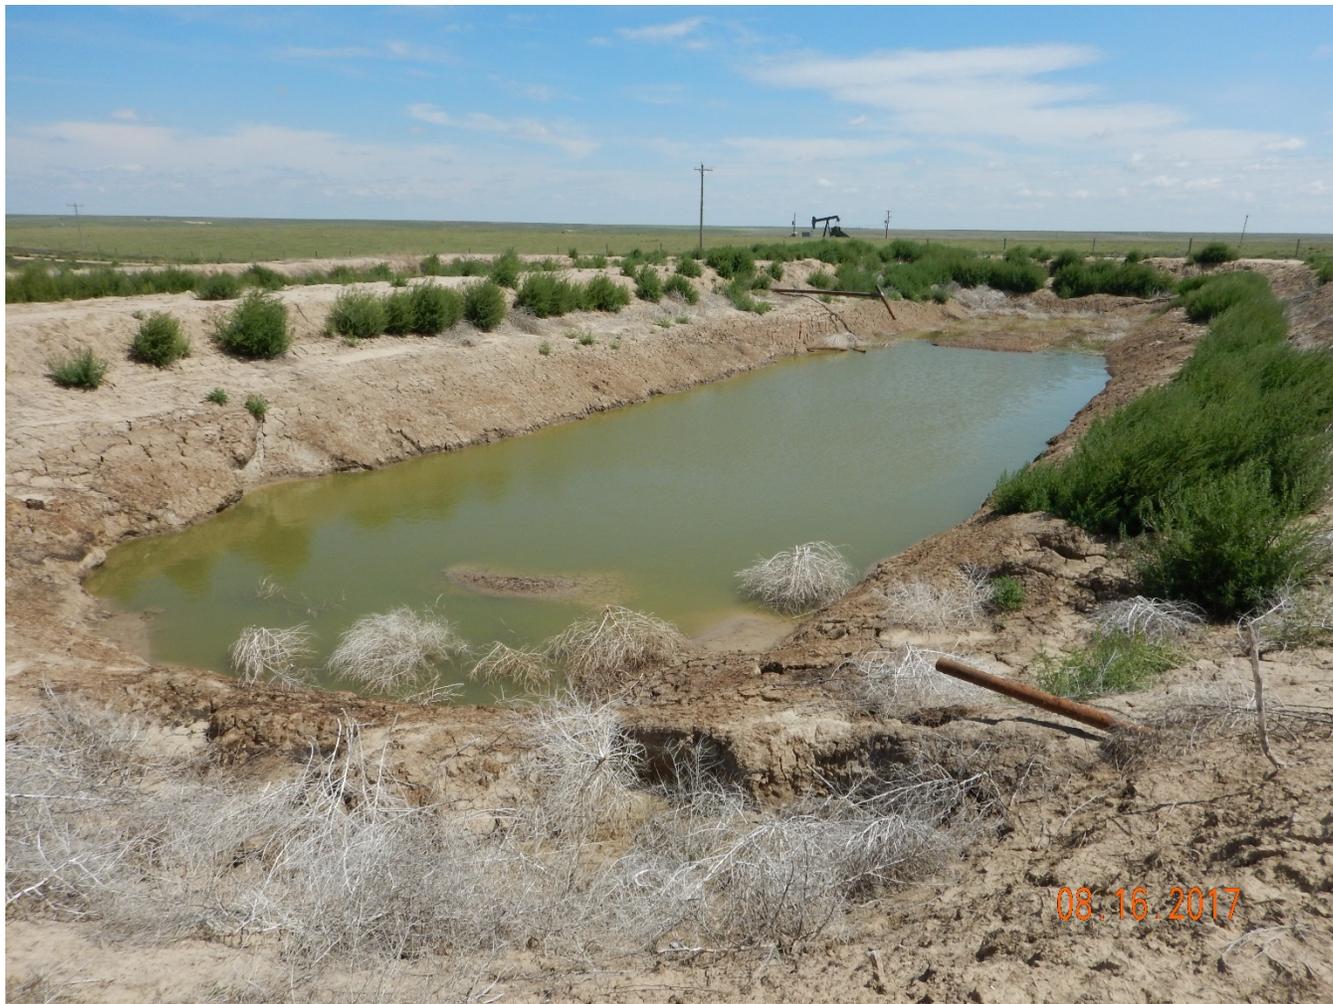
*Figure 22 - View of Pit Facility #107648 from SW corner.*

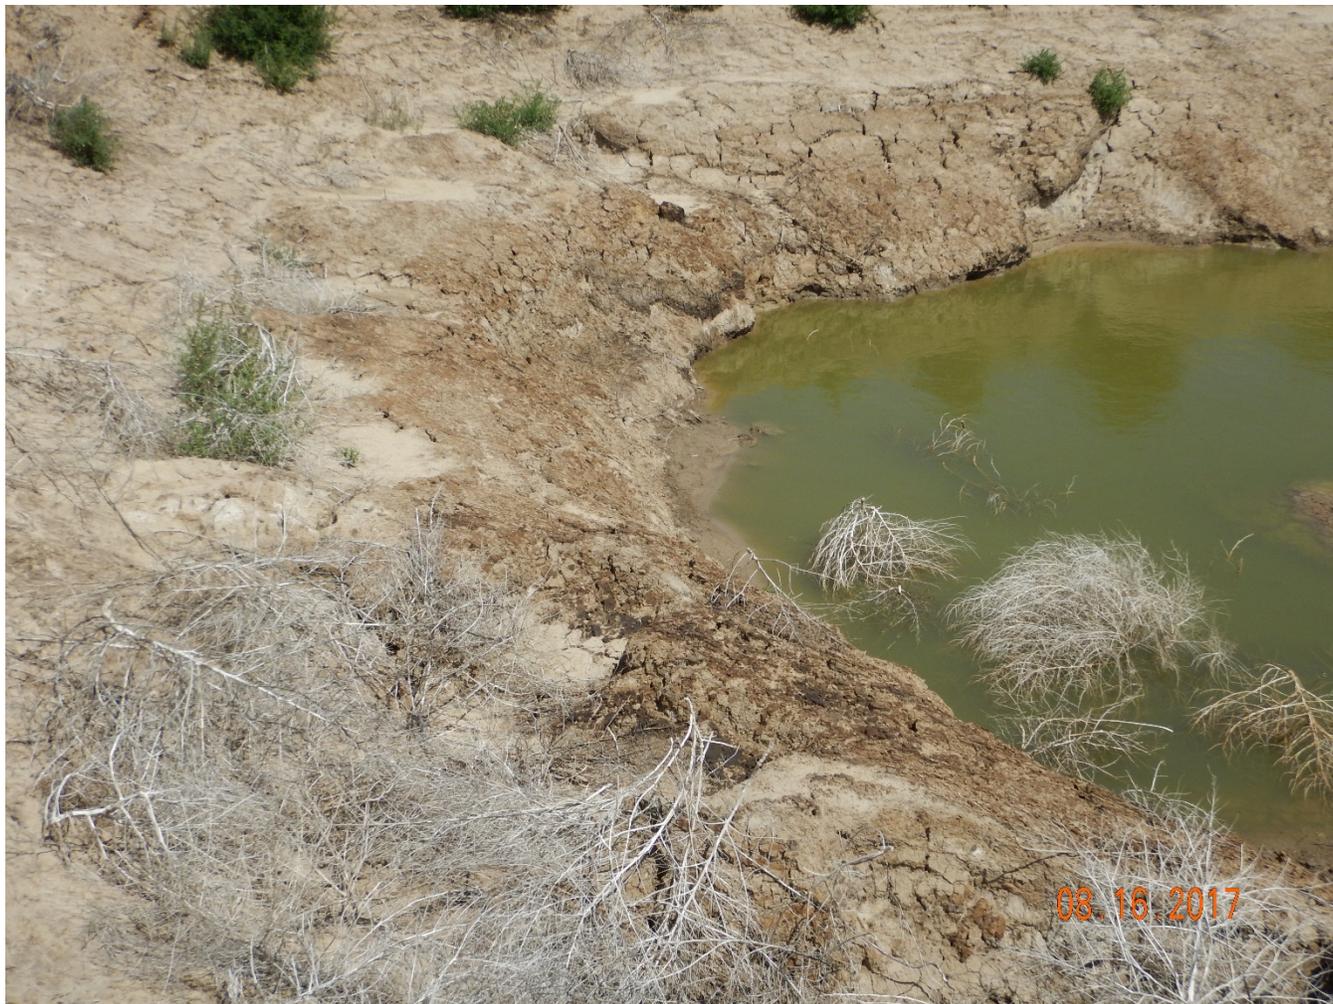
*Figure 23 - Localized, oil-stained soil at NW corner of Pit Facility #107648.*

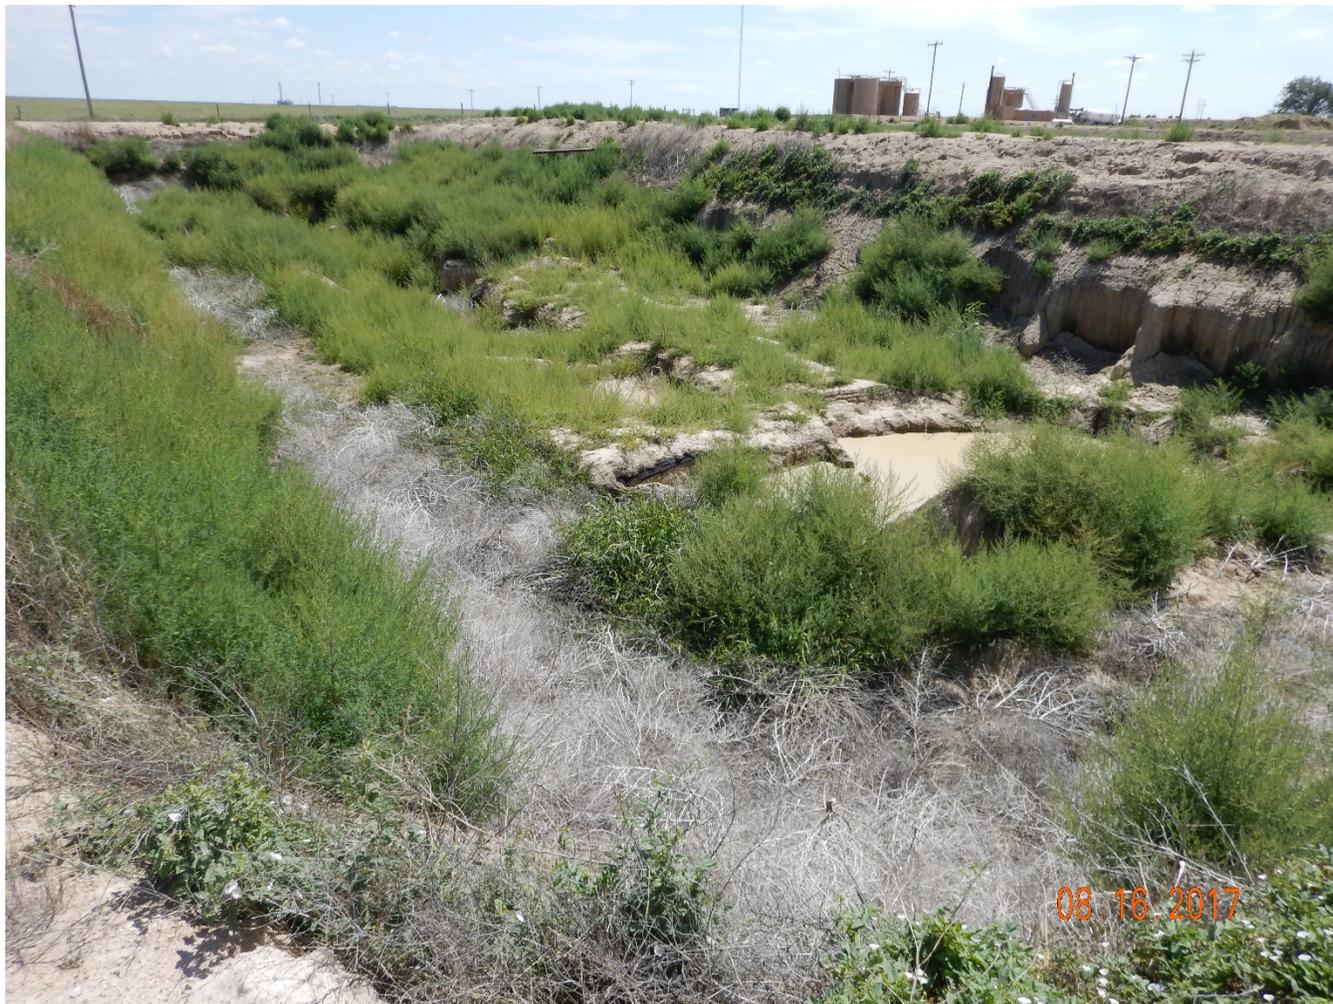
*Figure 24 - View of active pit facility #117577 from NW corner. Note abundance of weeds and oil-stained soil above water line in foreground.*

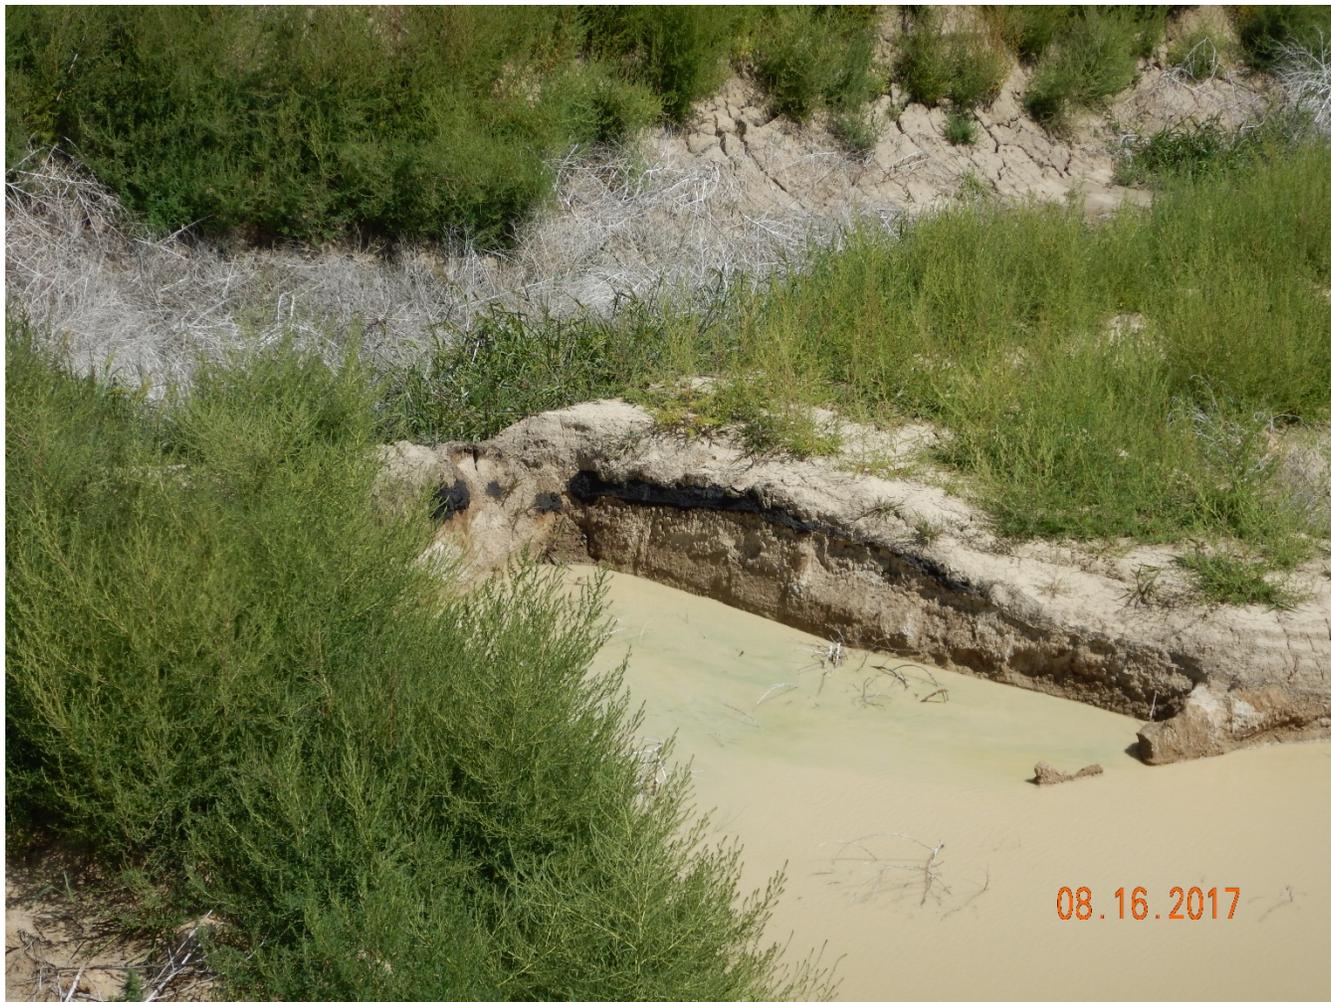
*Figure 25 - Oil-stained soil at NW corner of pit facility #117577.*
