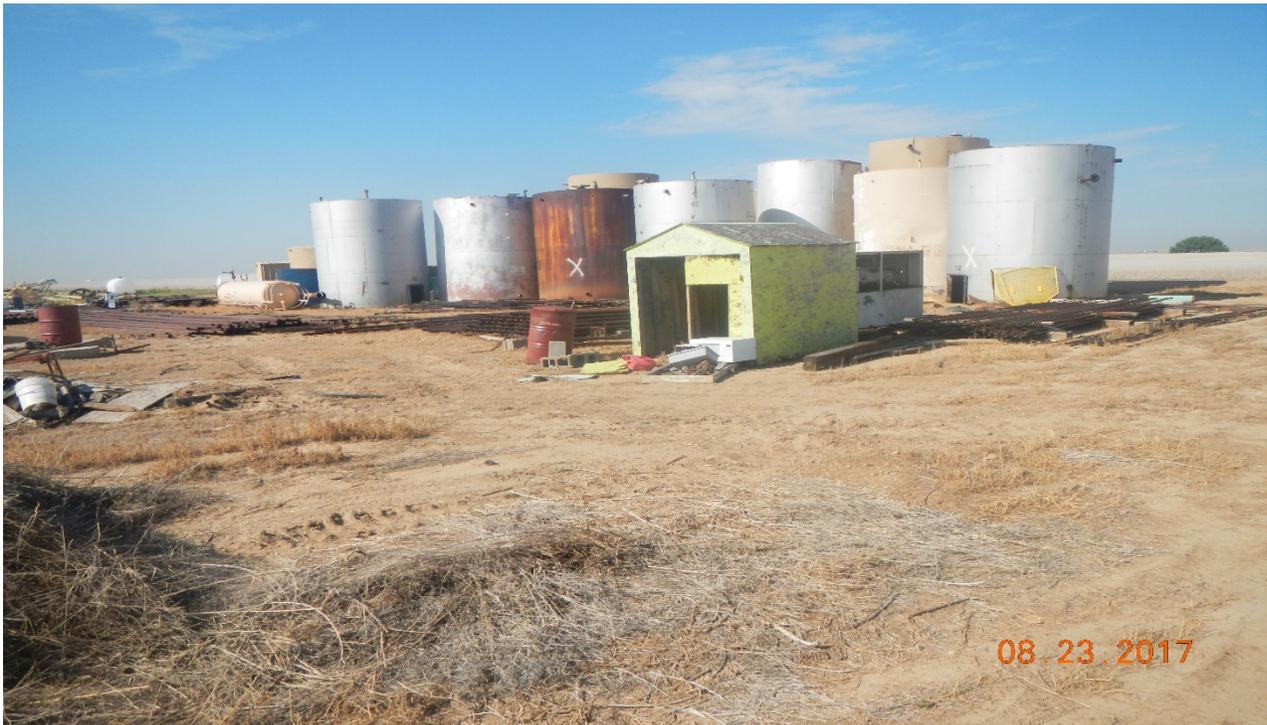
photo 1: Facing southwest towards the storage yard of unused equipment, waste, and debris.
Lat/Long:39.94756,-104.42335

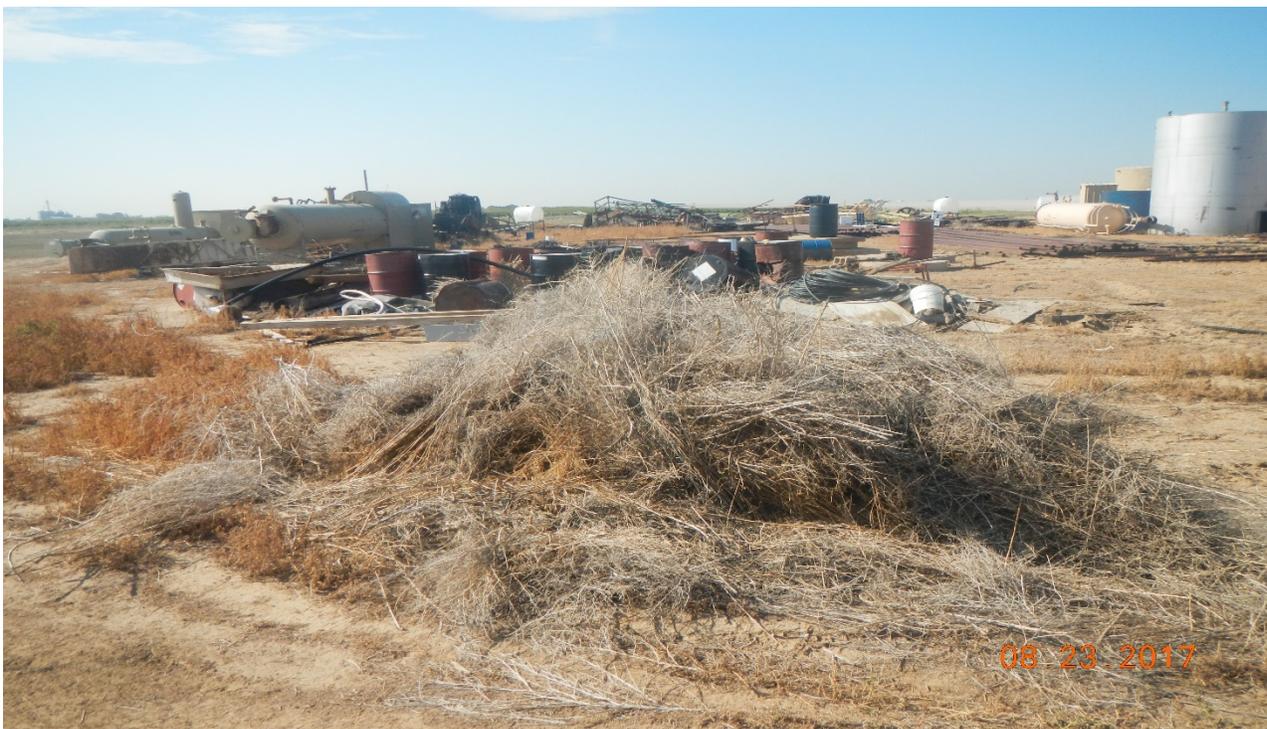
photo 2: Facing south toward the storage yard b of unused equipment, waste, and debris.

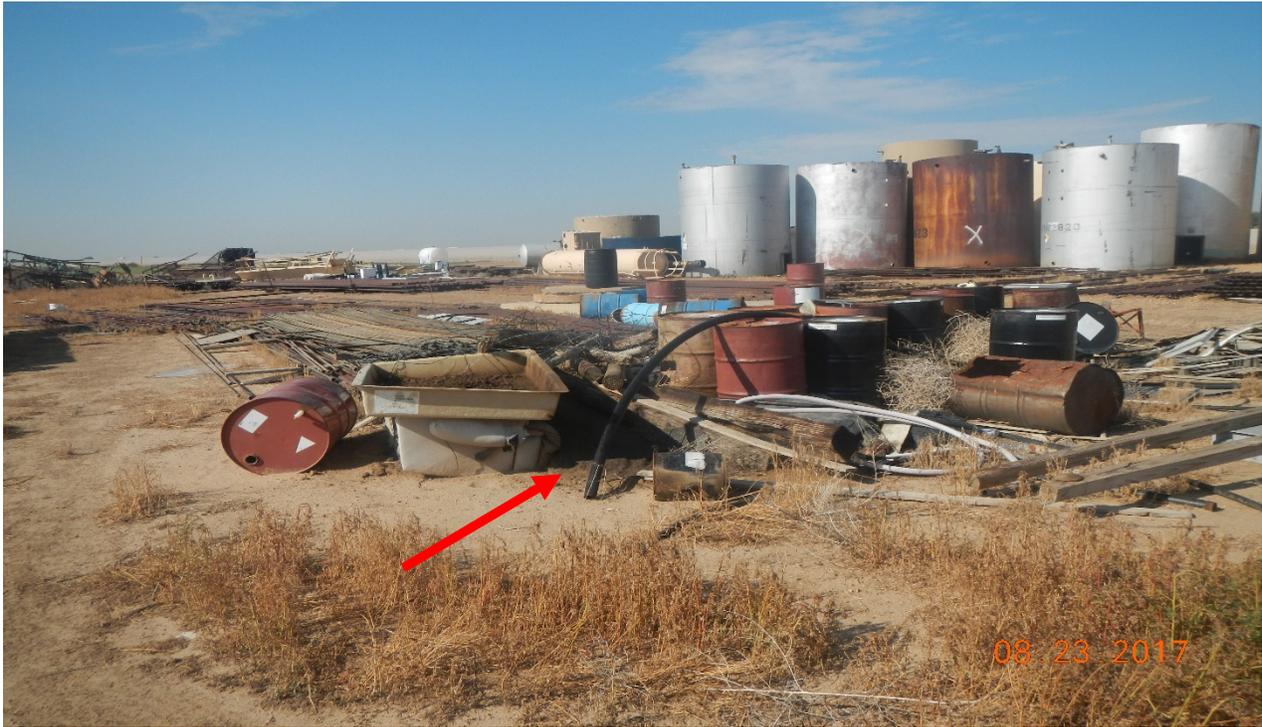
photo 3: There is oily waste around the barrels.

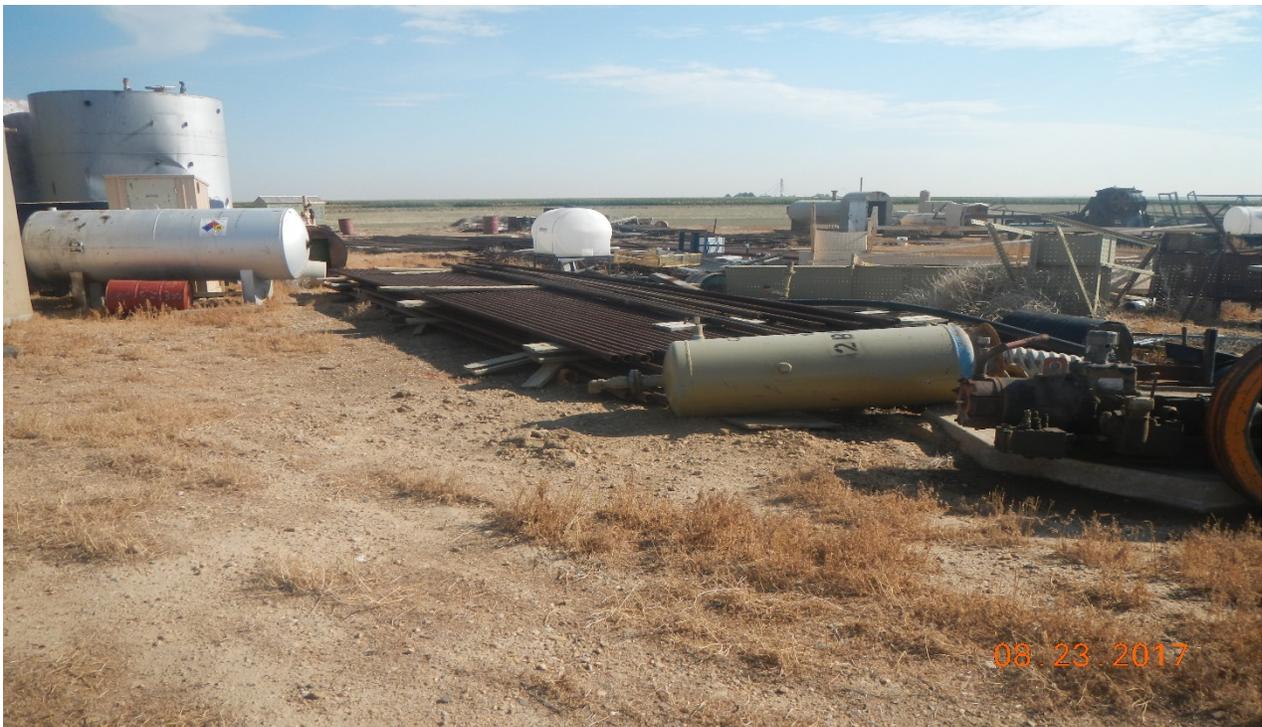
photo 4: Facing northeast toward the storage yard.

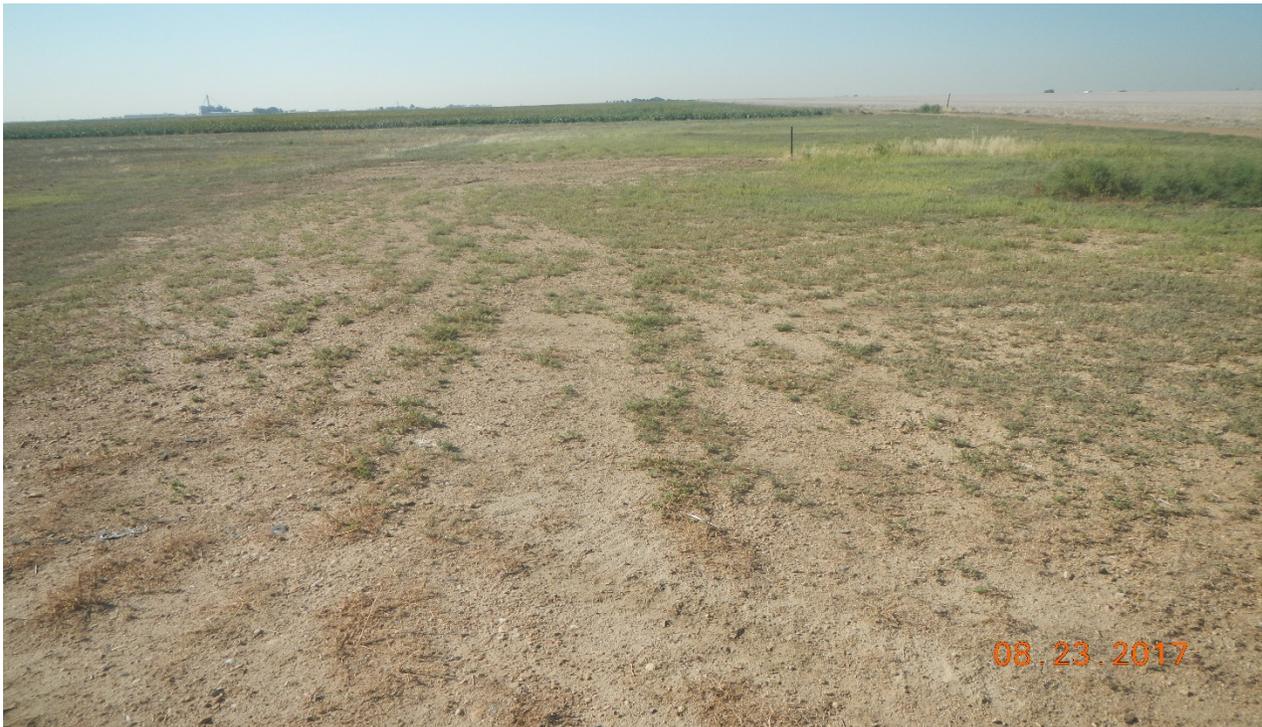
photo 5: Facing south where pipe riser was identified in the previous inspection. The pipe riser has been removed however this area has not yet been reclaimed.

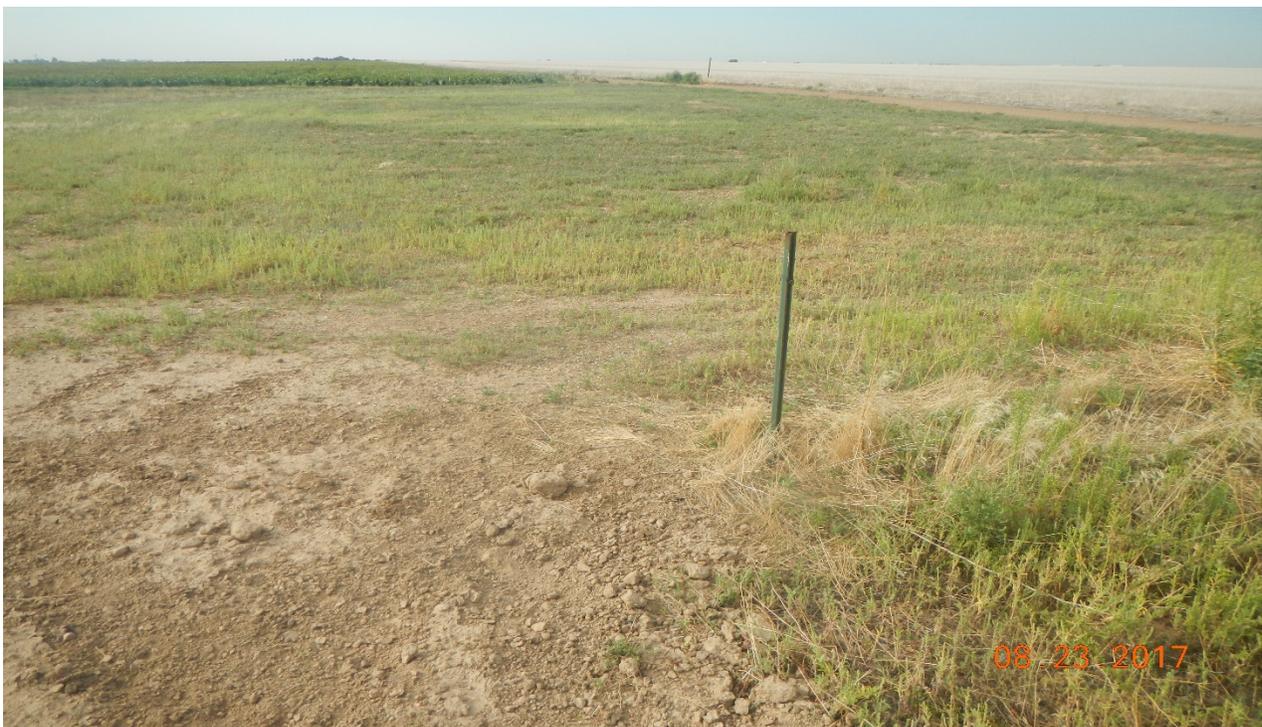
photo 6: There is a t-post where the riser was removed. Lat/Long:39.94706,-104.42354
