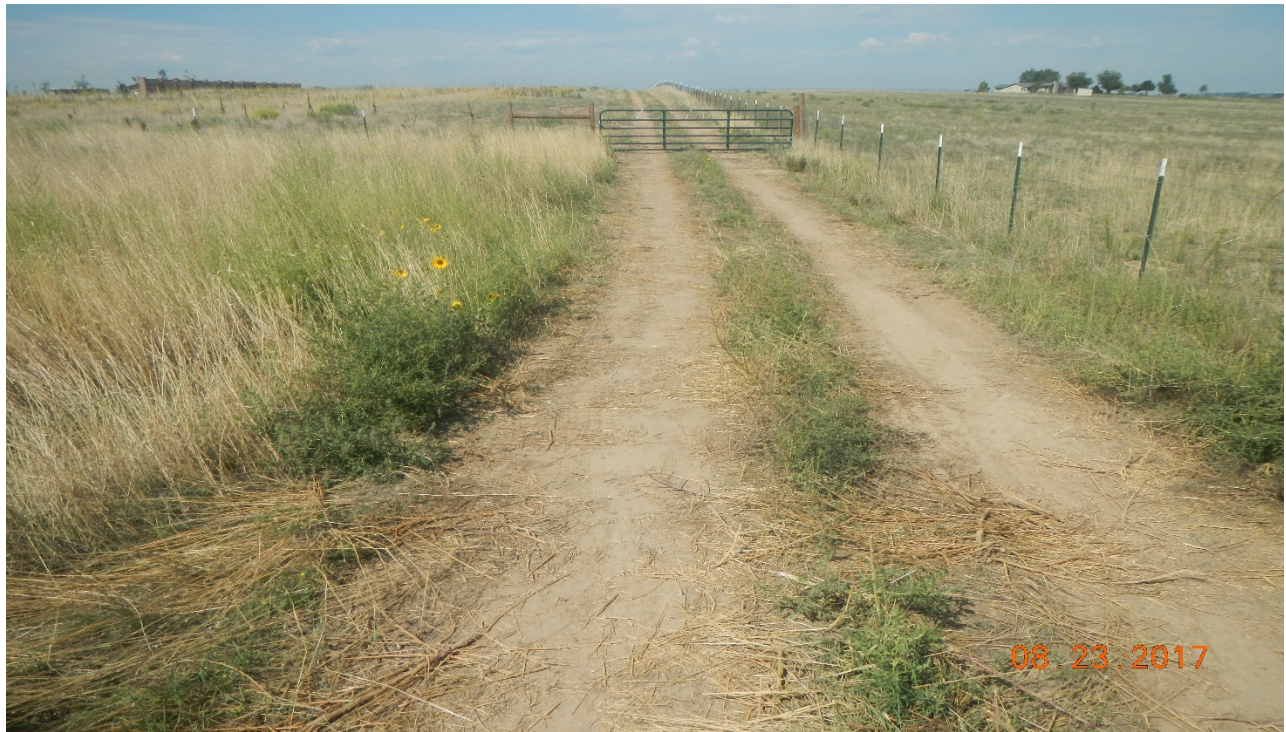
photo 1: Facing west toward the beginning of the former access road.

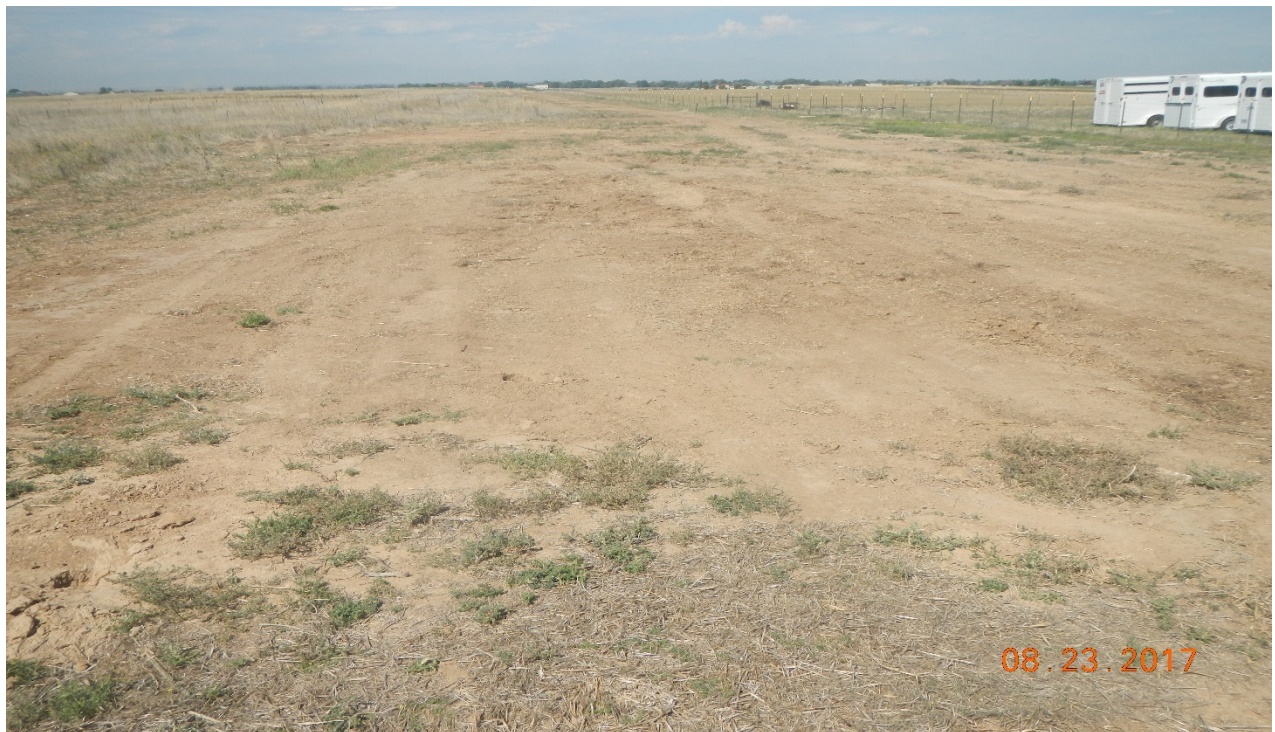
photo 2: The pipe riser identified in the previous inspections was removed.

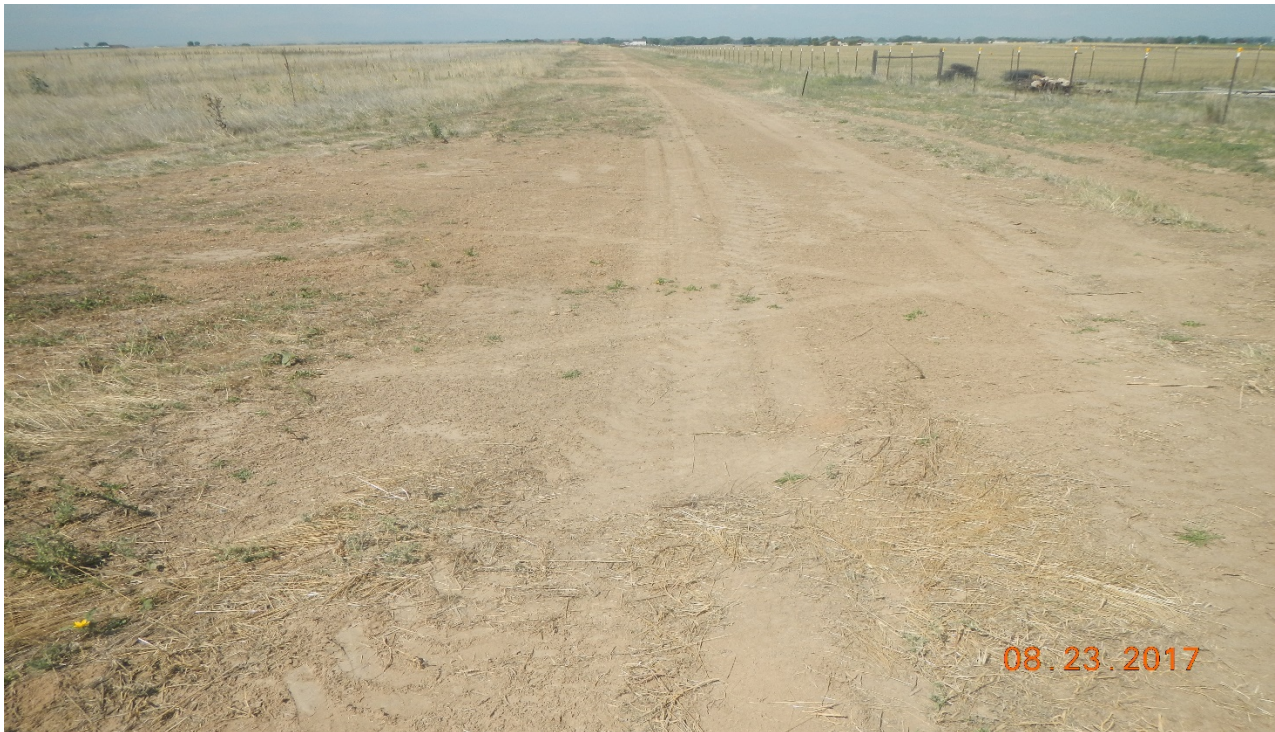
photo 3: Facing west beyond the location. Additional disturbance will need to be reclaimed.

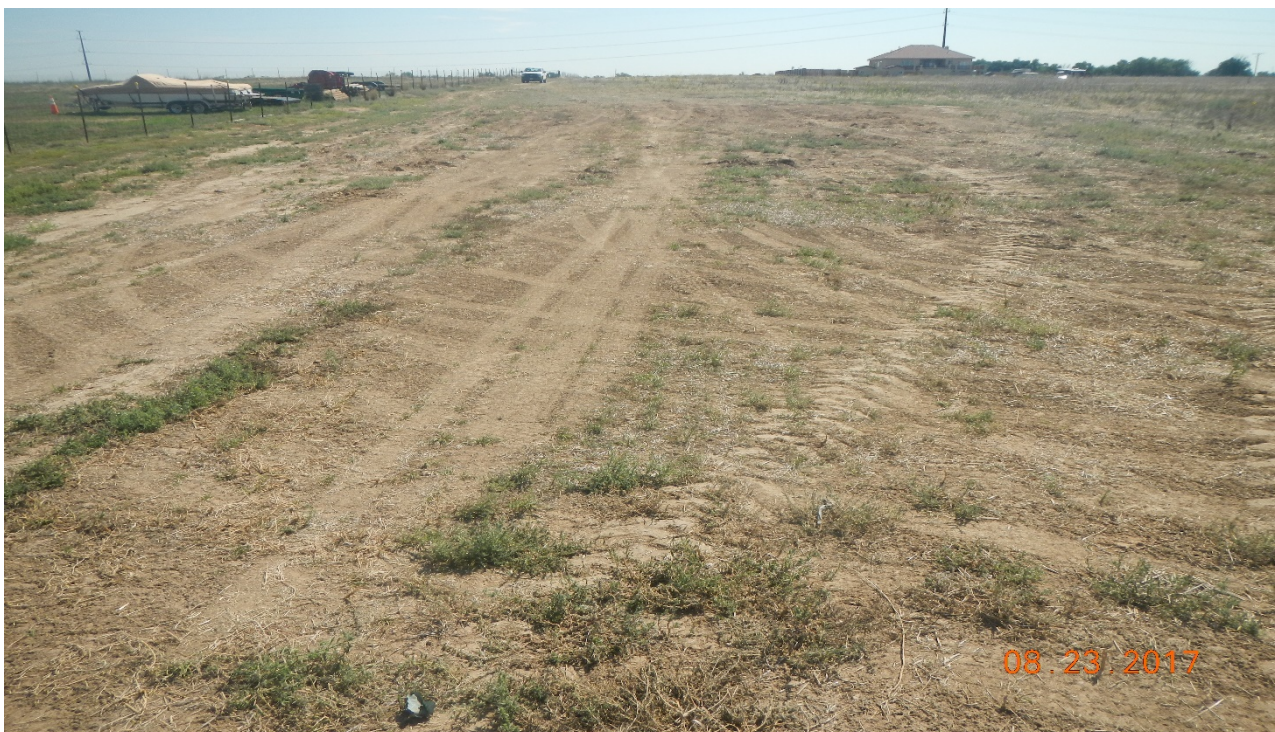
photo 4: Facing east toward the location.
