Construction and Stormwater Inspection

August 23, 2017

Operator: EXTRACTION OIL & GAS INC - #10459

Location ID: 429132

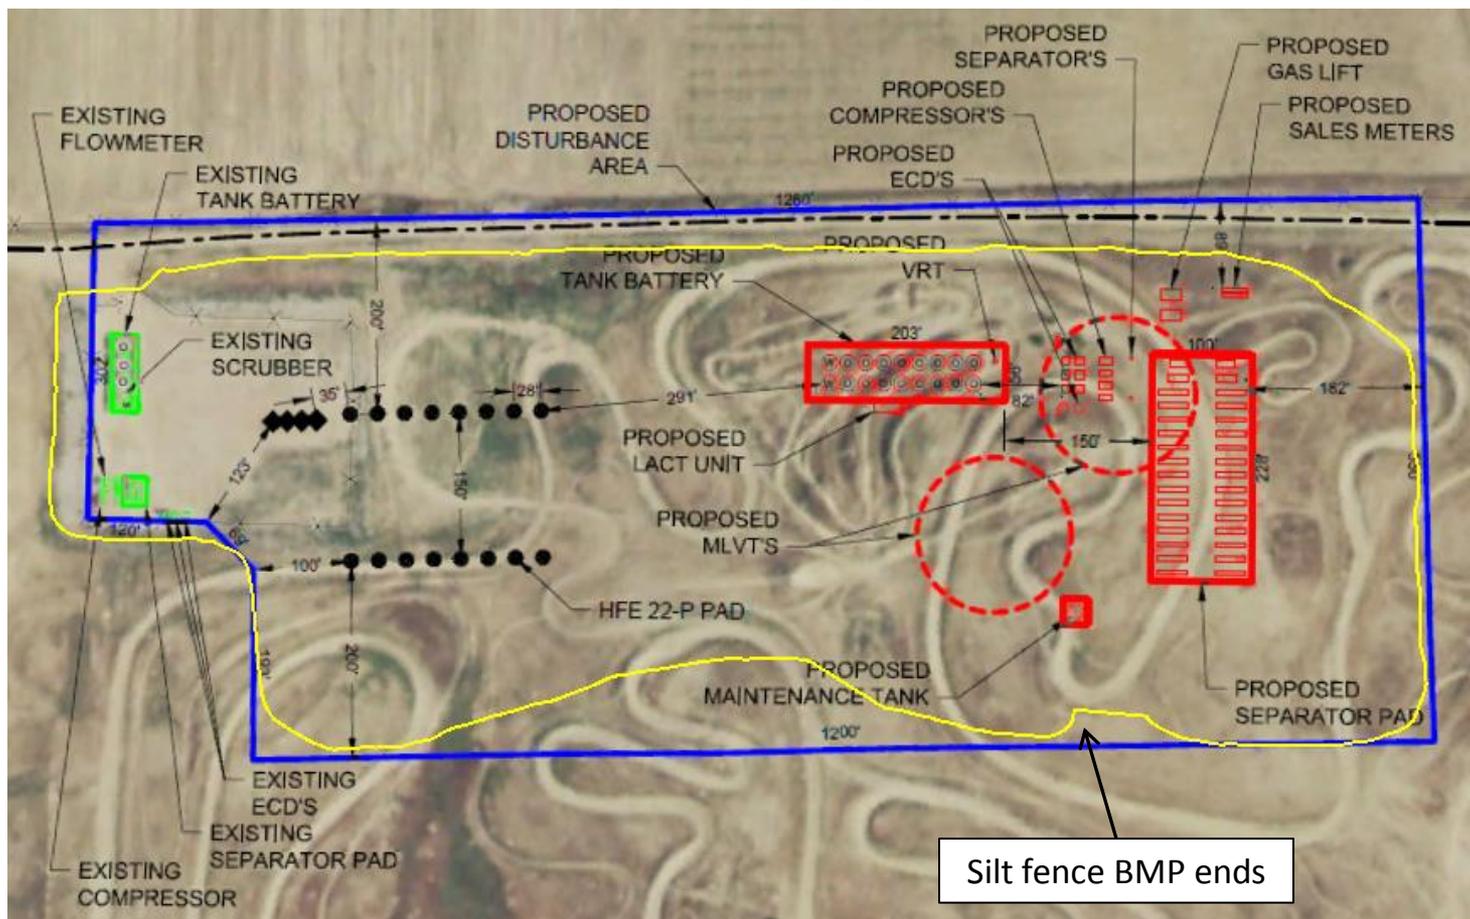
Extraction Production Facility Layout drawing overlaid with field collected data using a Trimble Juno 3B handheld device (yellow line). Silt fence BMP installed along western and a portion of the southern location, but stops just below the proposed maintenance tank. Appears stormwater run-on onto location is occurring right where the silt fence BMP ends. There were no erosion and/or sediment control BMPs along the eastern location. The eastern location has potential for stormwater runoff, as minor rill erosion was observed.

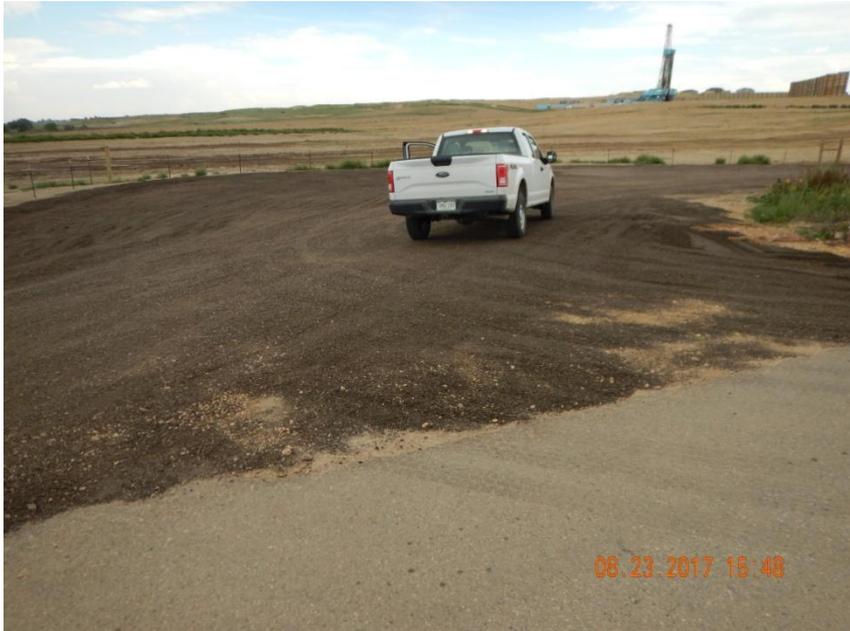
Photo 1. Photo taken from the entrance of location, facing East. Tracking pad devices installed at location- see next photo for more tracking pad BMPs.

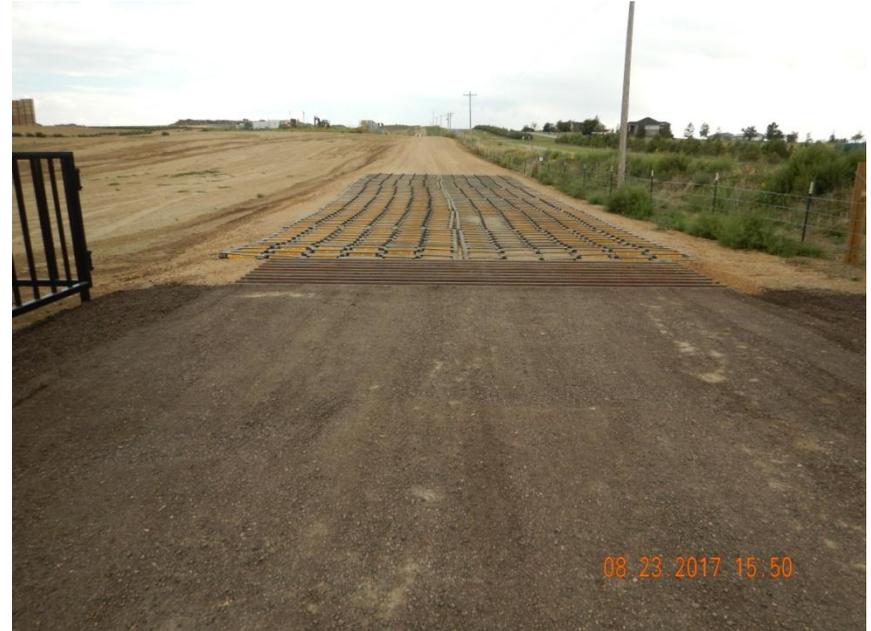
Photo 2. Photo taken from the entrance of location, facing South. Tracking pad devices installed at location.

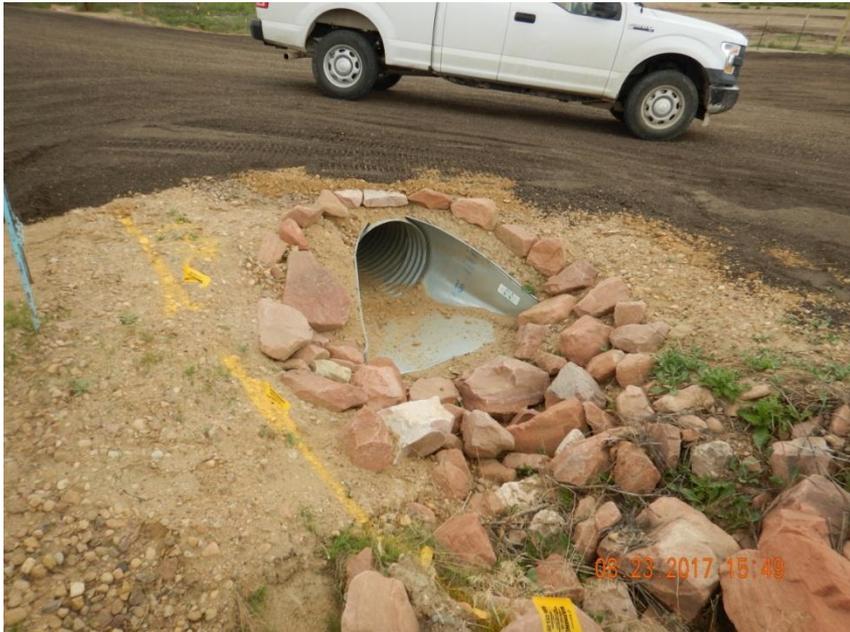
Photo 3. Photo taken from the entrance of location, facing North. Culvert installed along burrow ditch with stabilized inlet and outlet devices.

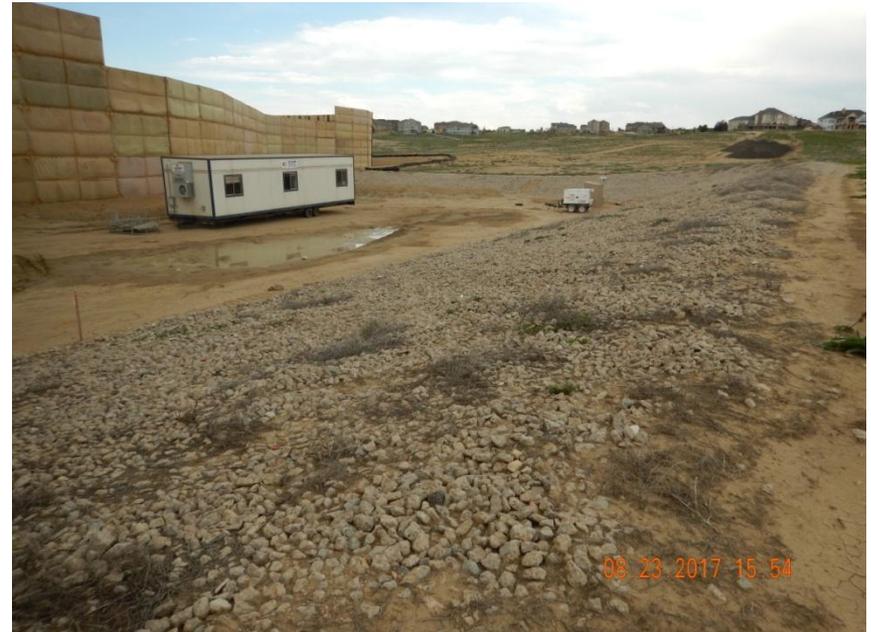
Photo 4. Photo taken from the northwest location, facing South. Cut slopes have been stabilized with rock material.

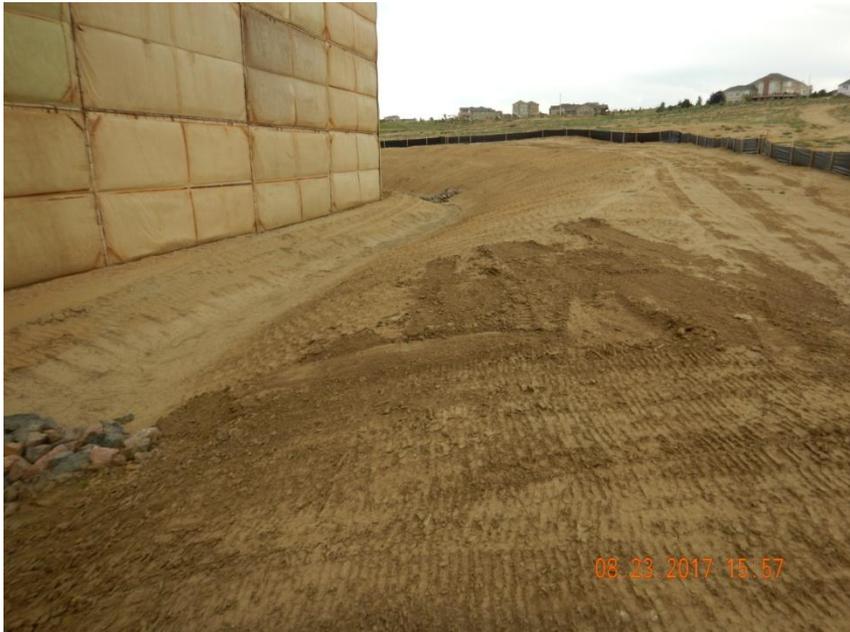
Photo 5. Photo taken from the western location, facing South. Ditch installed along the pad perimeter with check dams. Silt fence installed around the western and a portion of the southern location. Cut slopes have been tracked perpendicular with equipment for temporary stabilization.

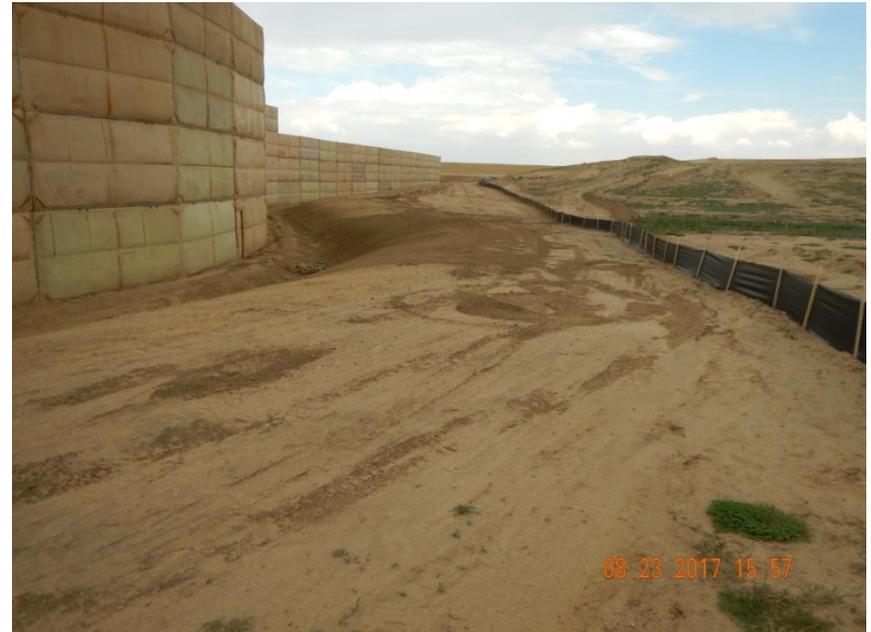
Photo 6. Photo taken from the southwestern location, facing East. Ditch installed along the pad perimeter with check dams. Silt fence BMP installed around the western and southern location. Cut slopes have been tracked perpendicular with equipment for temporary stabilization.

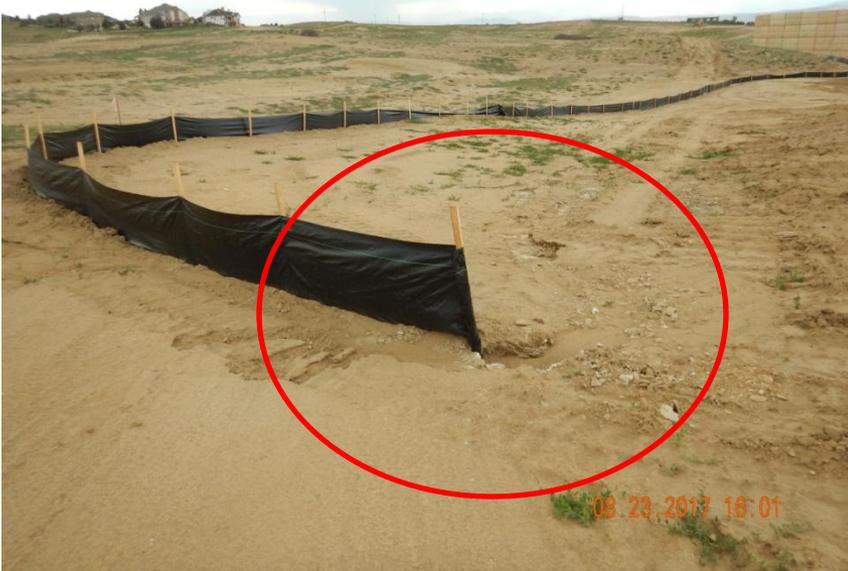
Photo 7. Photo taken from the southern location, facing West. A point of run-on onto location was observed right at the stopping point of the silt fence.

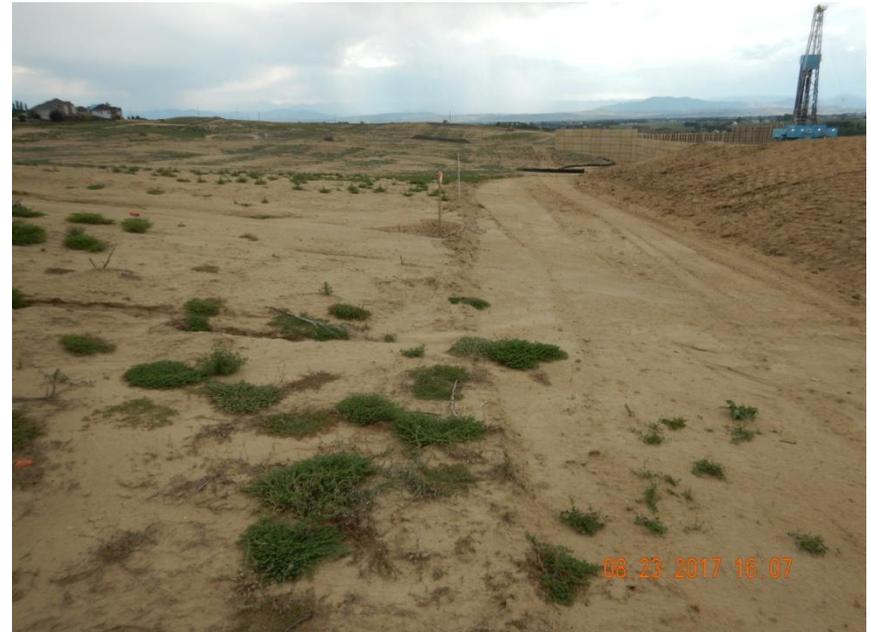
Photo 8. Photo taken from the southeastern location, facing West. Operator will need to manage and control run-on onto location.

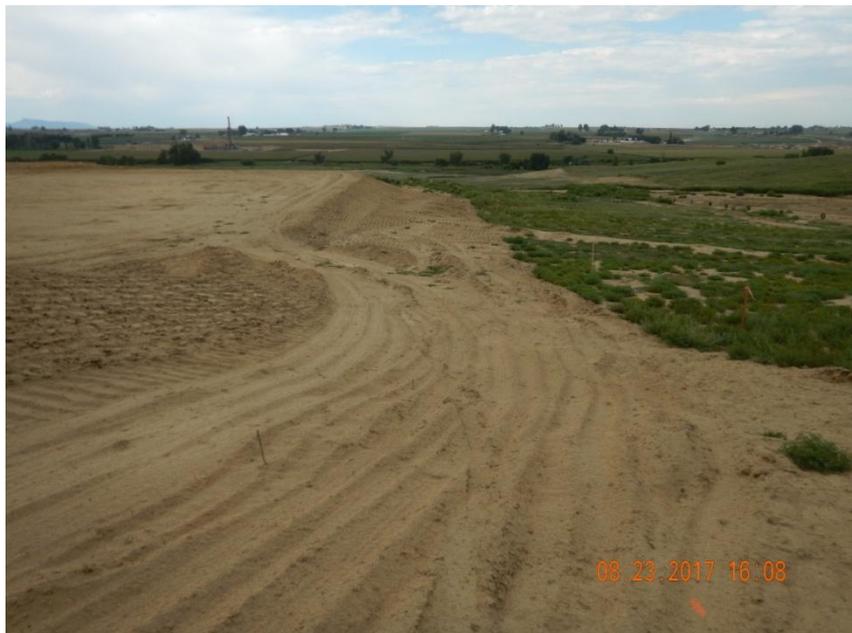
Photo 9. Photo taken from the southeastern location, facing North. There were no erosion and/or sediment control BMPs along the eastern location. The eastern location has potential for stormwater runoff, as minor rill erosion was observed.

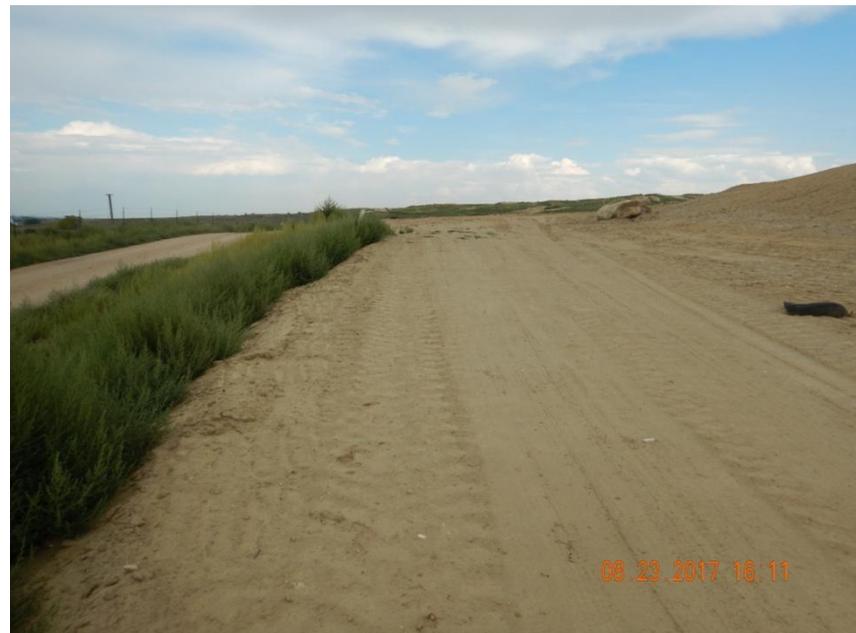
Photo 10. Photo taken from the northeastern location, facing East. There were no erosion and/or sediment control BMPs along this area. This area has potential for stormwater runoff.

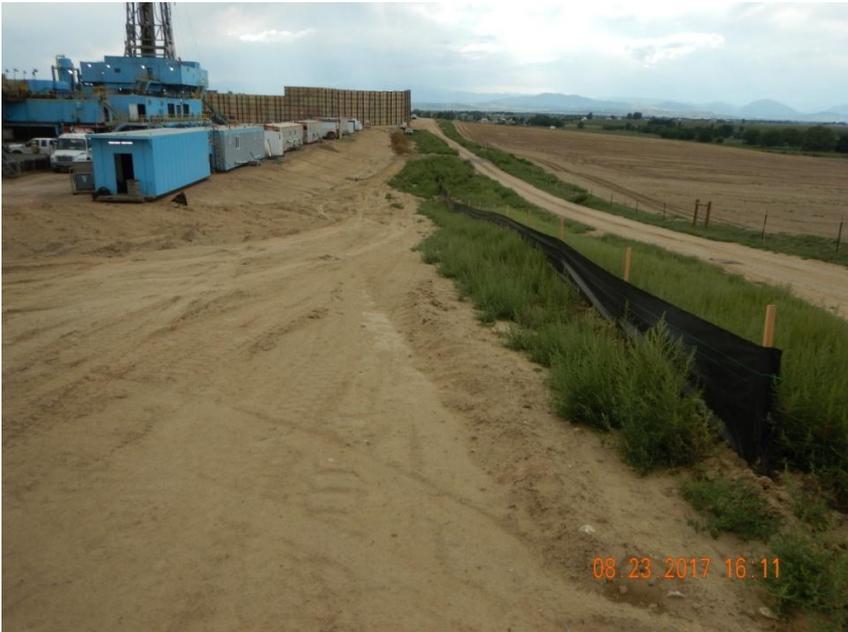
Photo 11. Photo taken from the northeastern location, facing West. Ditch installed along the pad perimeter with check dams. Silt fence installed around the western and a portion of the southern location. Fill slopes have been tracked perpendicular with equipment for temporary stabilization.

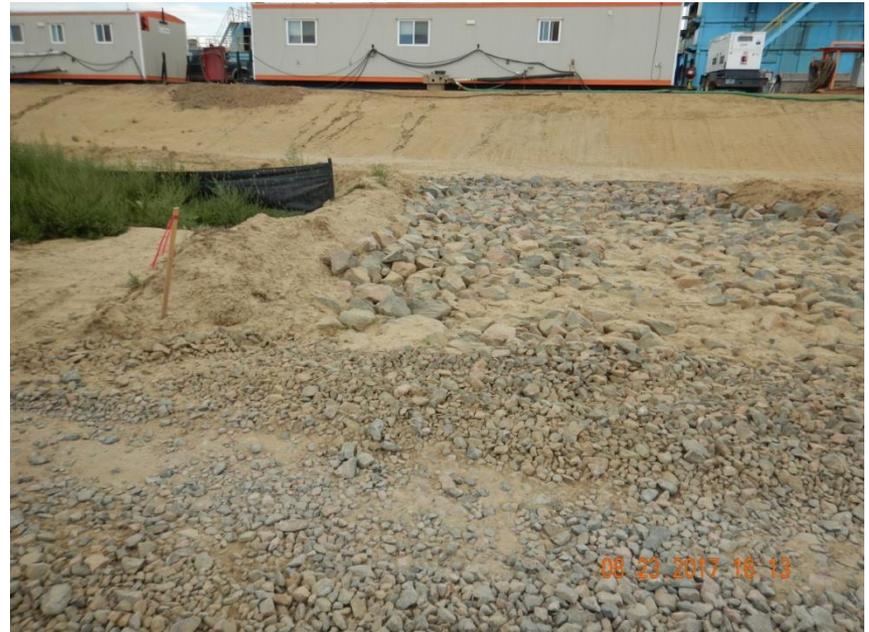
Photo 12. Photo taken from the north-central location, facing South. A stabilized area constructed of rip-rap has been installed for erosion control. However, this may not be considered a sufficient sediment control BMP, especially as sediment builds up within the rip-rap. More rip-rap was observed on the other side of the access road but, again, that may not be sufficient as a sediment control BMP.

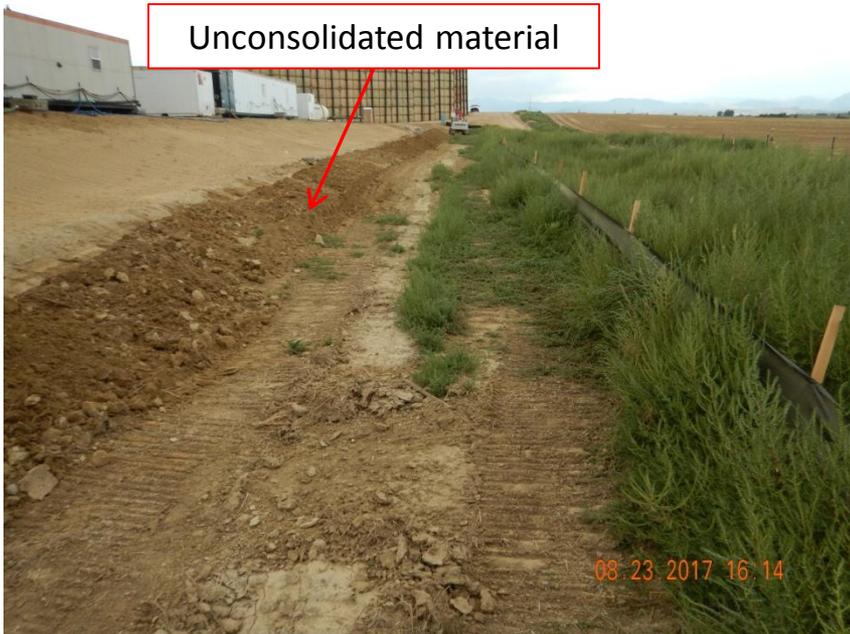
Photo 13. Photo taken from the northwestern location, facing West. Ditch installed along the pad perimeter with check dams, but unconsolidated material needs to be stabilized. Silt fence installed around the western and a portion of the southern location. Fill slopes have been tracked perpendicular with equipment for temporary stabilization.

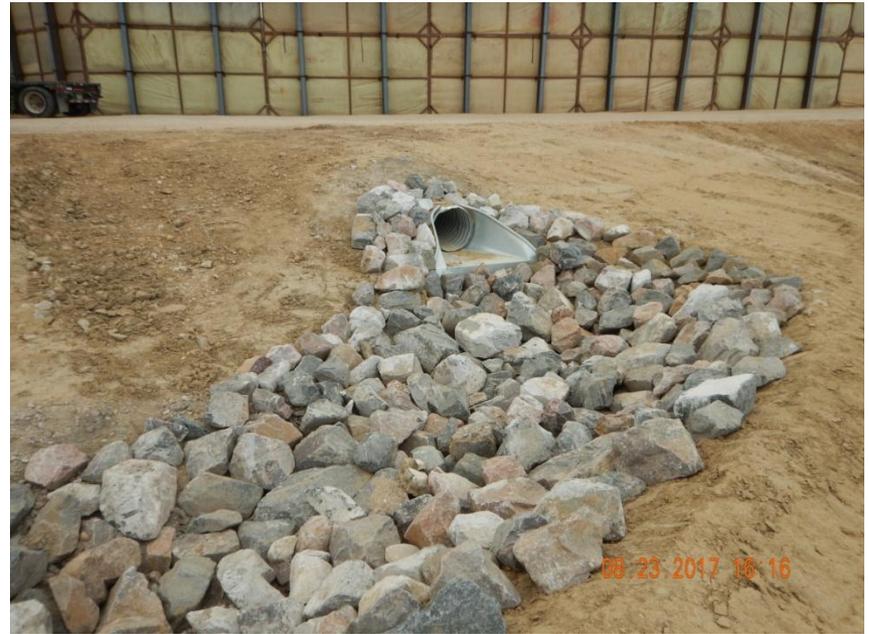
Photo 14. Photo taken from the northwest location, facing South. A stabilized outlet from a culvert installed in conjunction with the ditch BMP.
