Inspection Photos
Location Name: Dunn 1-13H
API # 123-34697

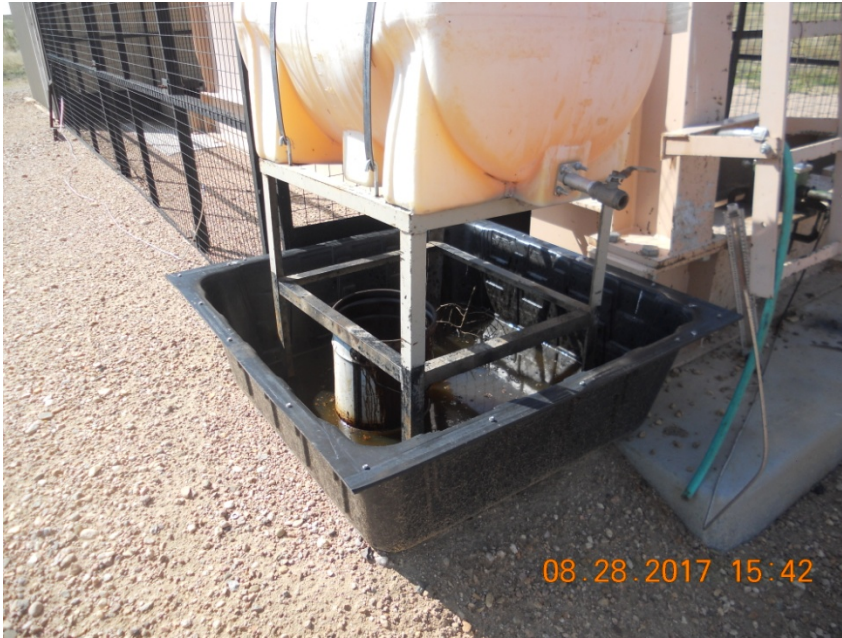
No netting containment

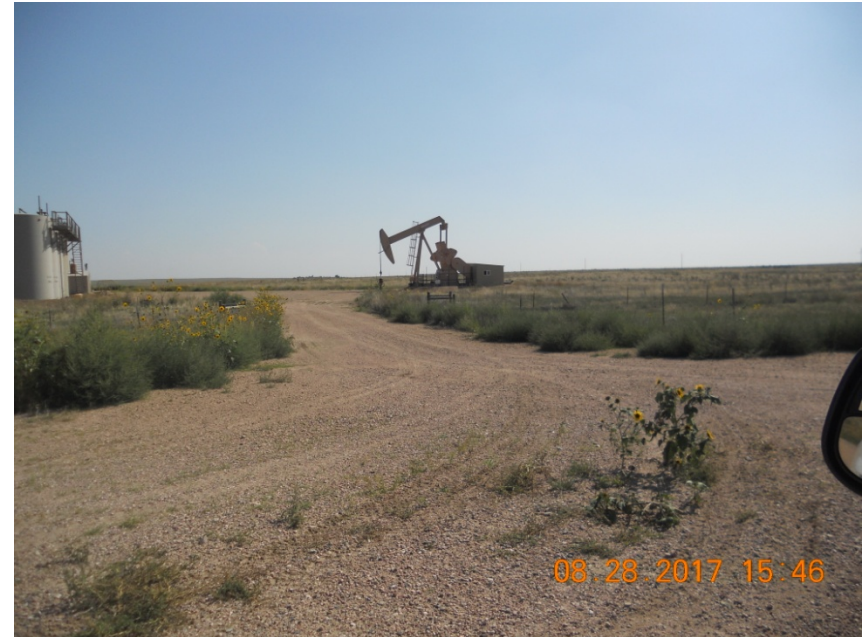
Wweeds at entrance & location
