Inspection Photos
Location Name: Cody 1
API: 05-057-05135

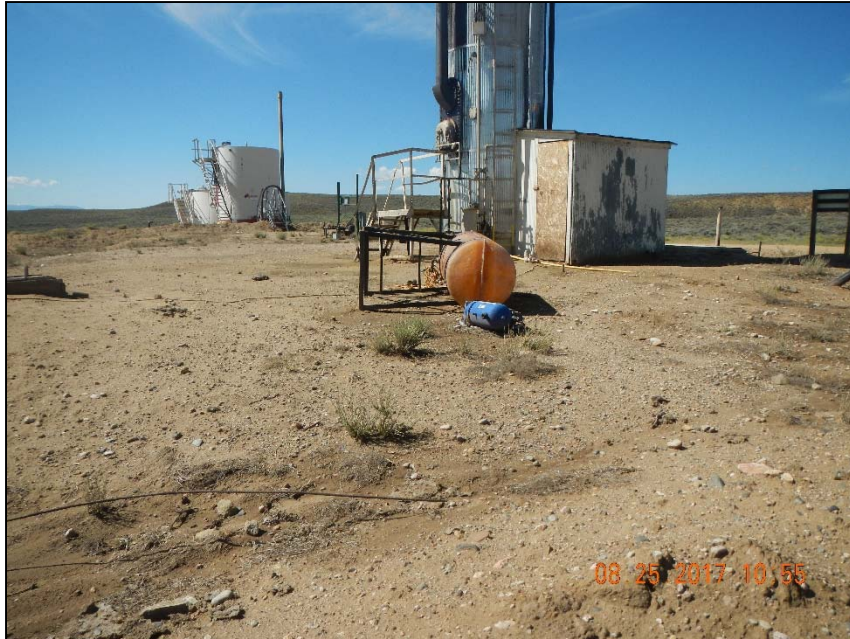
Photo 1. Methanol container knocked over with no secondary containment.

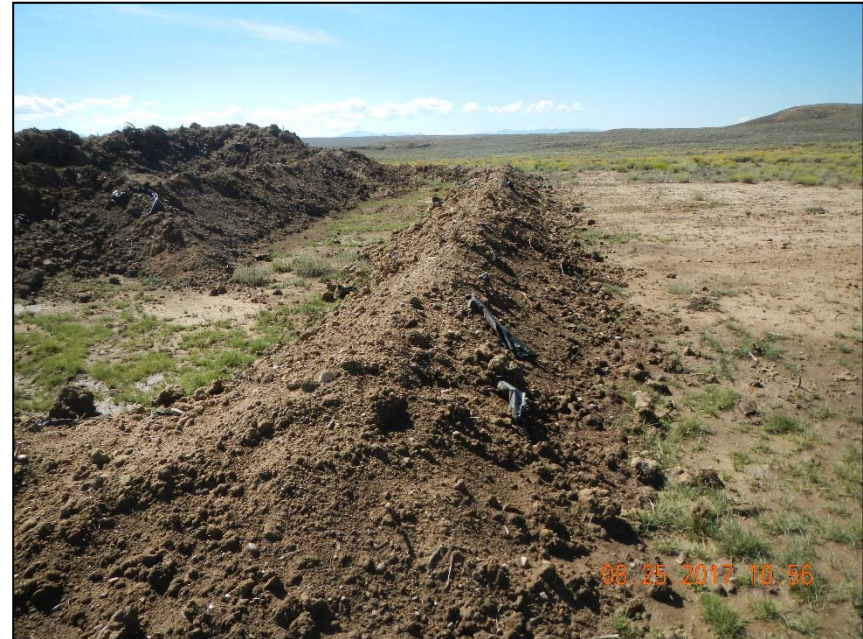
Photo 2. Land farm area with no containment. Berm around perimeter is unconsolidated and contains pieces of debris.

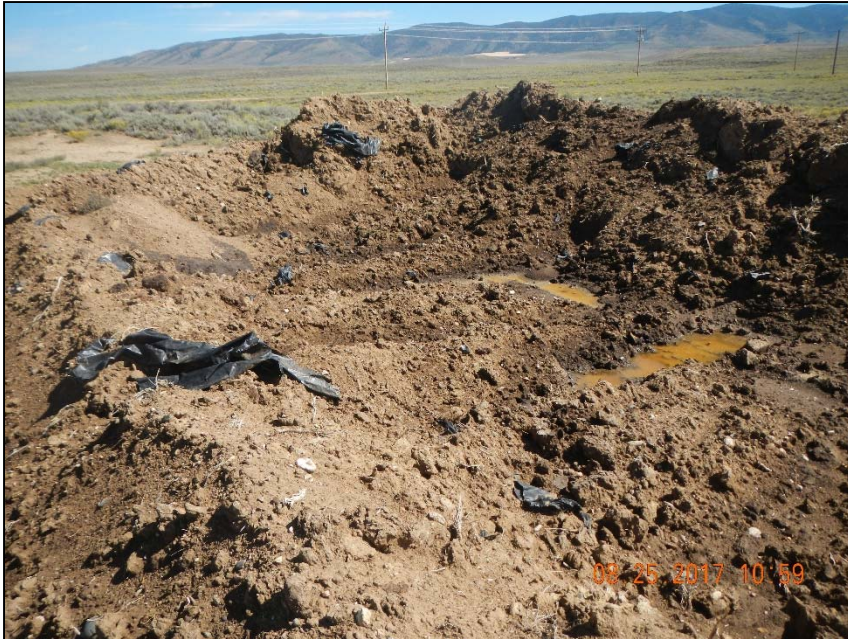
Photo 3. Land farm area with no containment. Berm around perimeter is unconsolidated and contains pieces of debris.

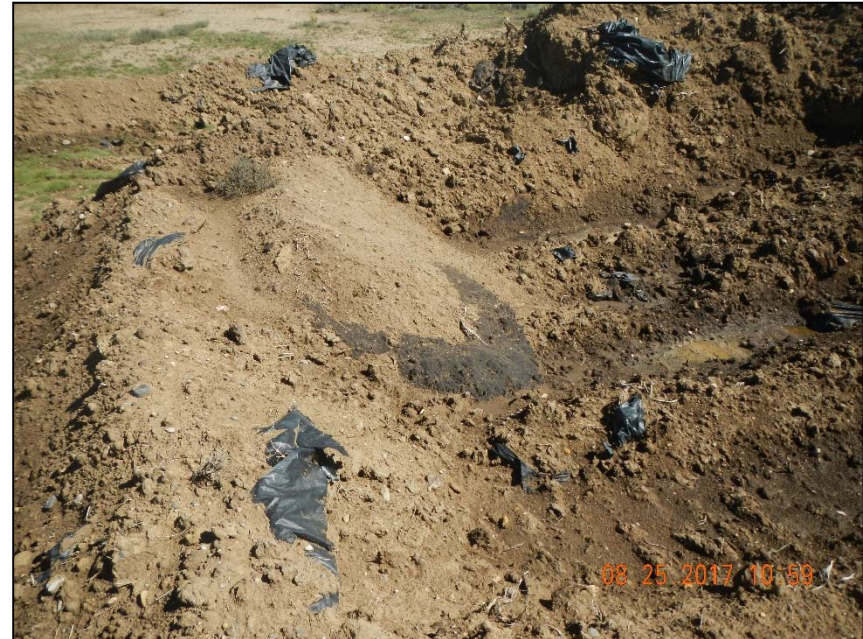
Photo 4. Close up. Land farm area with no containment. Berm around perimeter is unconsolidated and contains pieces of debris.
