## Inspection Photos

Location Name: Colorado Energy Federal 14-3

API: 05-123-19617

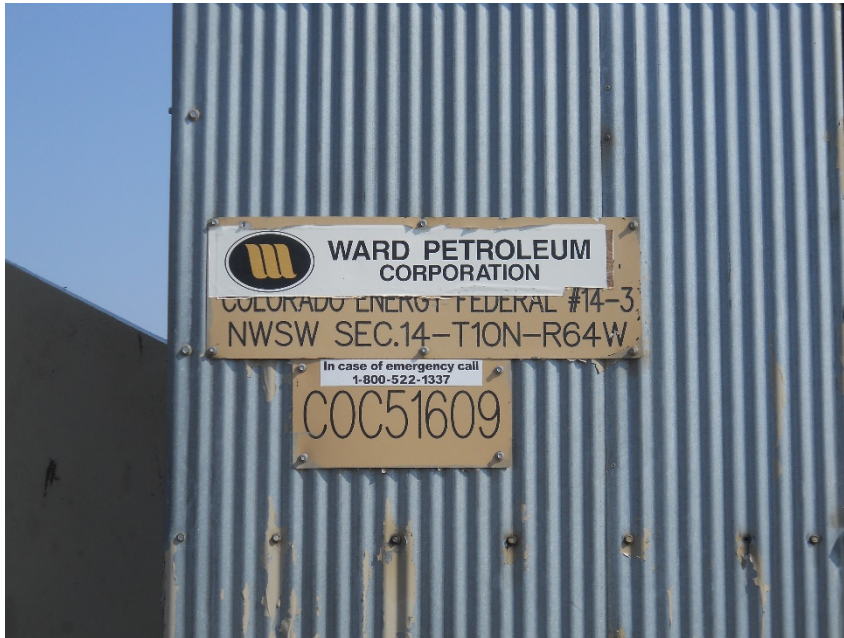
Wellhead sign on motor shed looking north

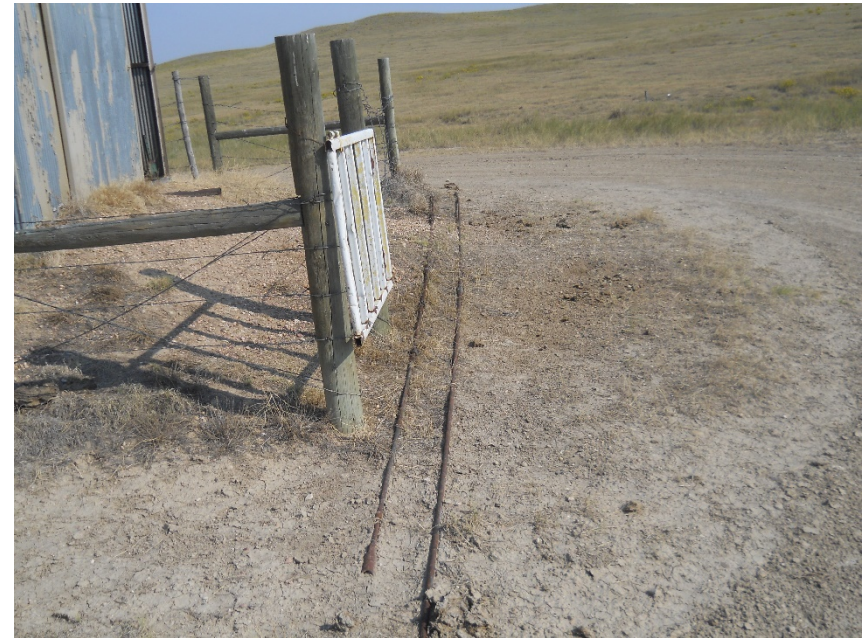
Unused rods south side of pump jack motor shed looking east

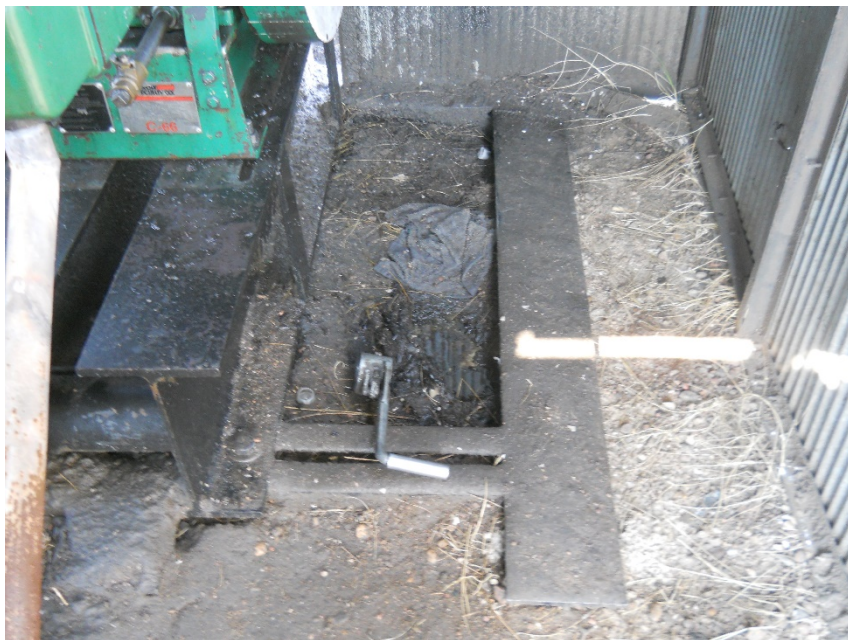
**Stained soil under pump jack motor on north side, standing fluid appears to be used motor oil**

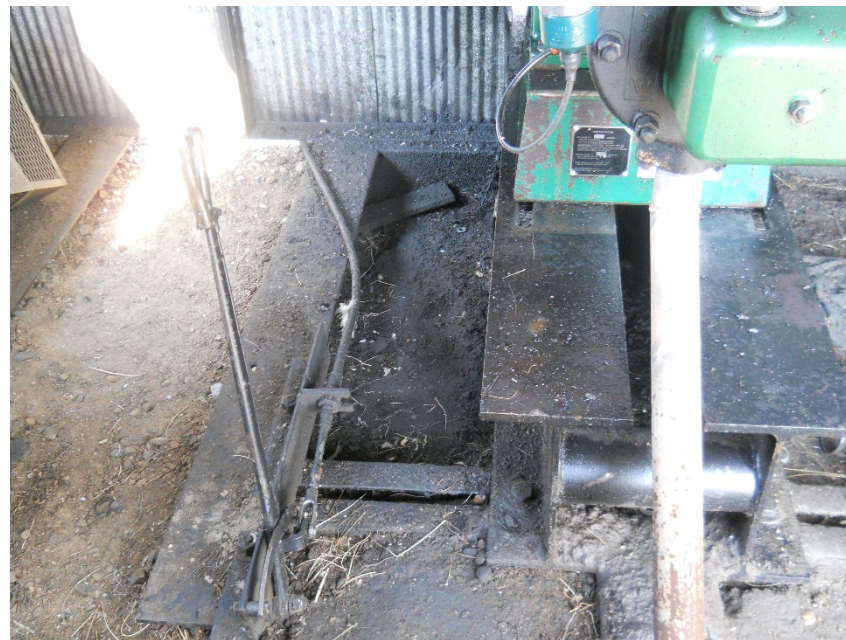
**Stained soil under pump jack motor on south side**

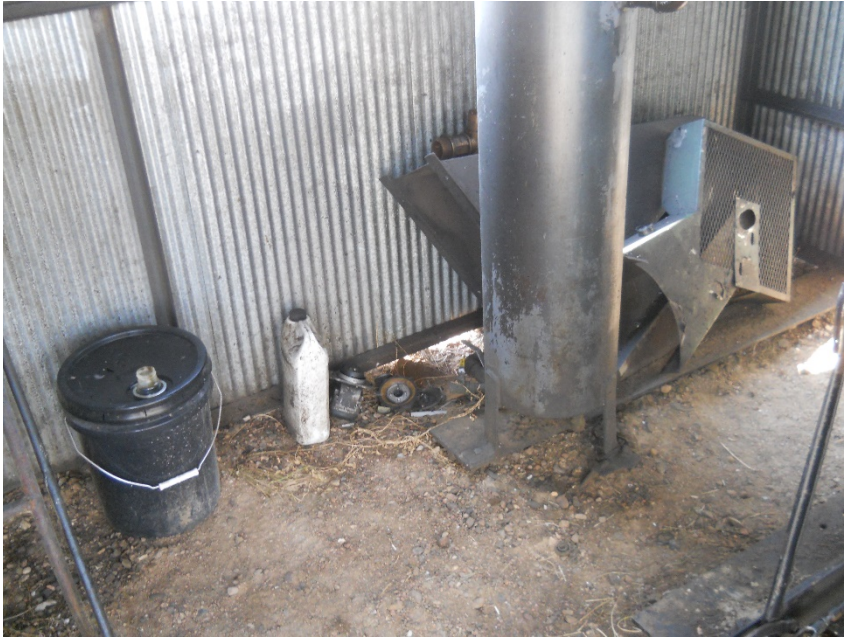
Unused equipment along south wall in pump jack motor shed

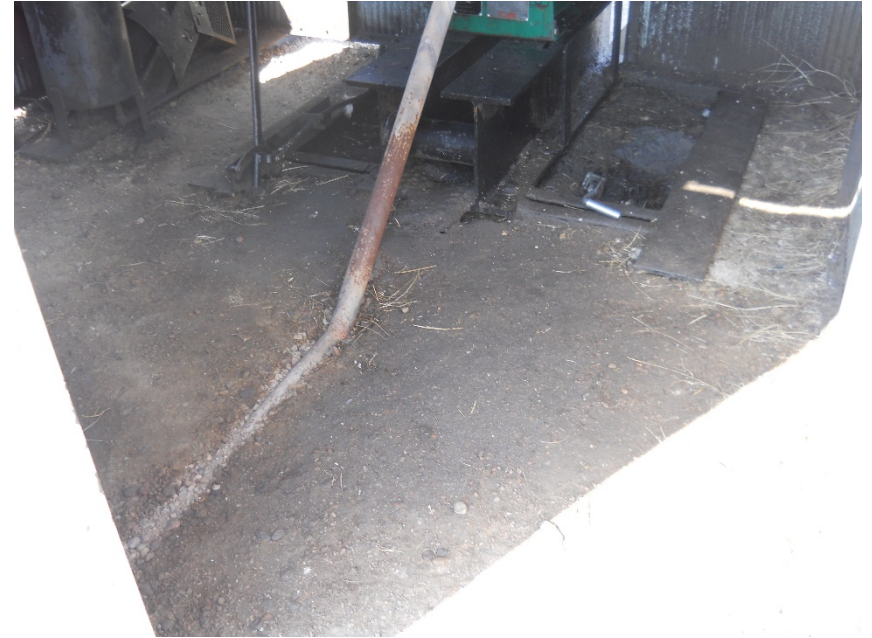
Stained soil in pump jack motor shed from entrance door looking west

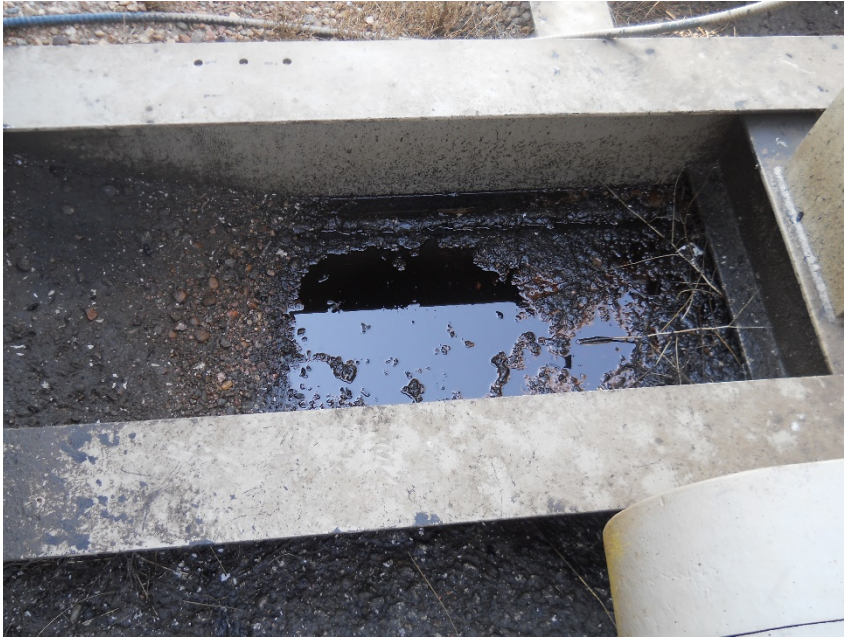
**Stained soil in skid of pump jack, north side. Standing fluid appears to be used motor oil.**

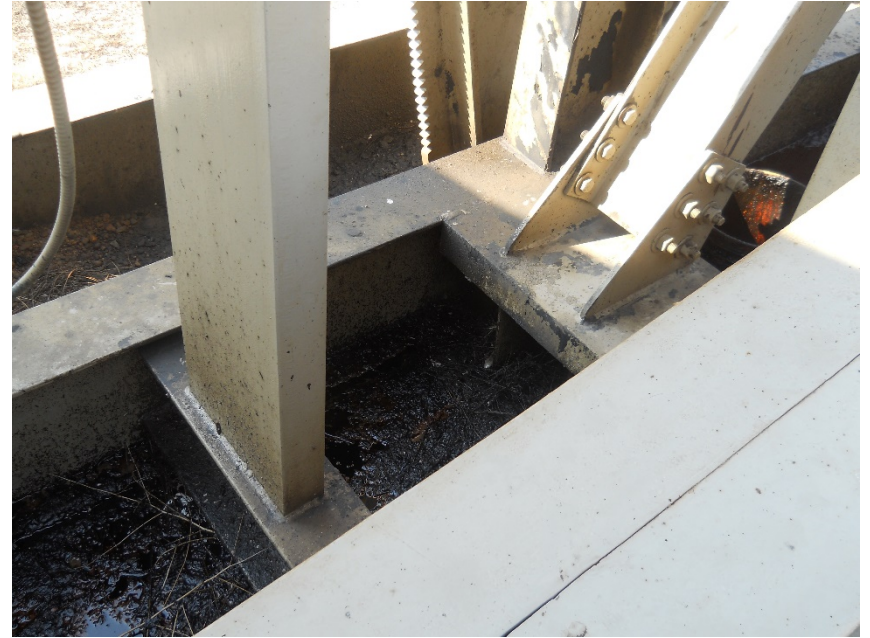
**Stained soil in skid of pump jack, north side.**

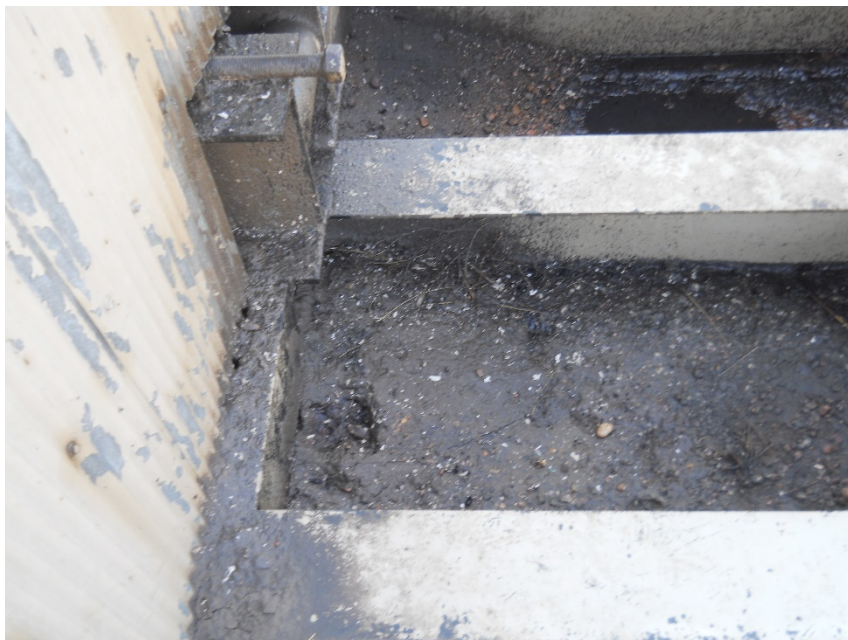
**Stained soil in skid of pump jack on north side and middle.  
Standing fluid appears to be used motor oil leaking from pump  
jack motor**

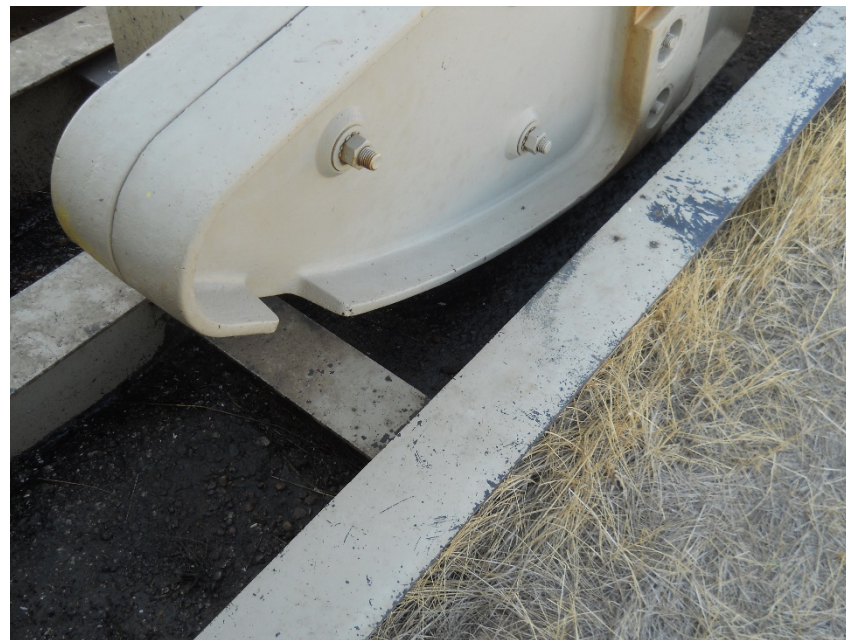
**Stained soil in skid of pump jack, north side**

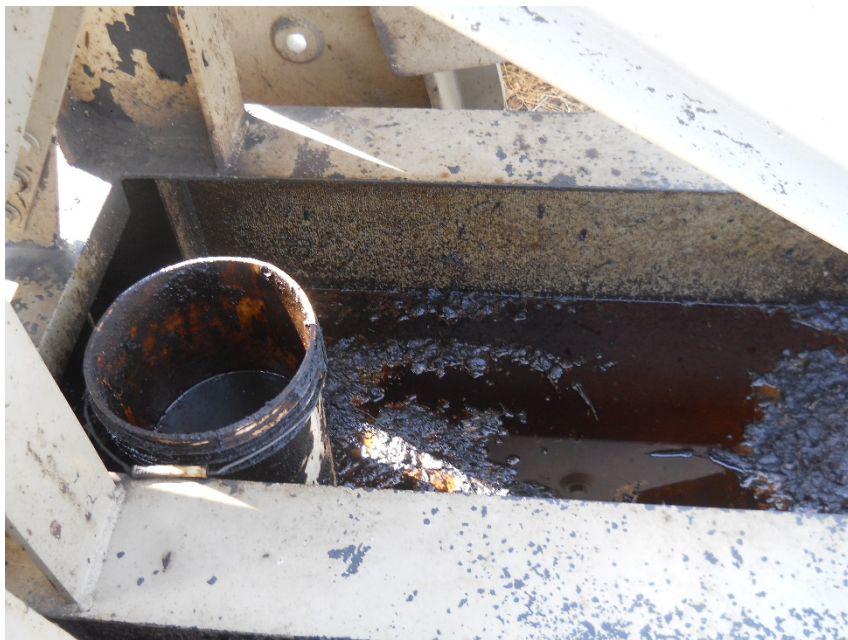
**Stained soil in skid of pump jack, center. Standing fluid appears to be used motor oil. 5 gallon bucket approx. half full with what appears to be used motor oil. No wildlife protection**

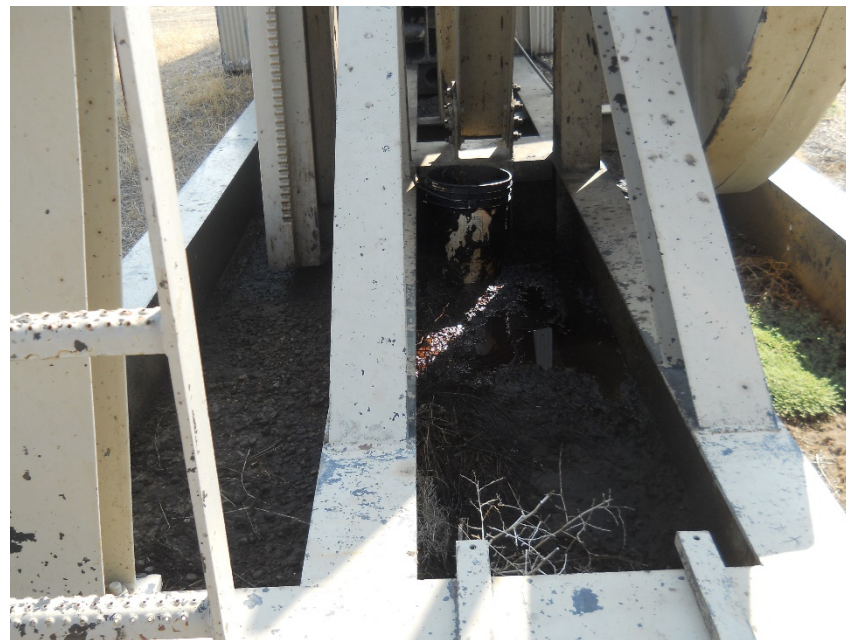
**Front of pump jack skid looking east. North side and center of skid have stained soil and standing fluid, 5 gallon open top container with no wildlife protection**

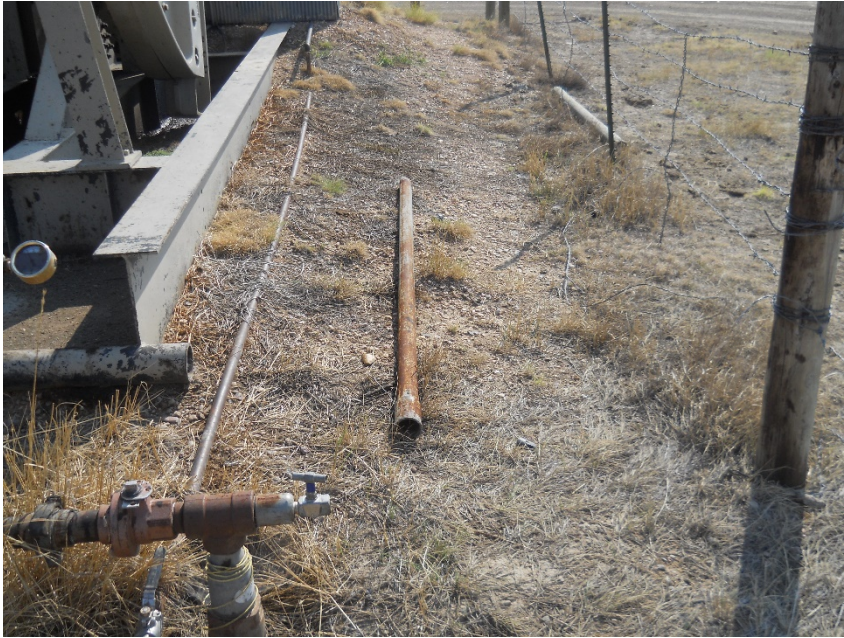
**Unused equipment south side of pump jack**

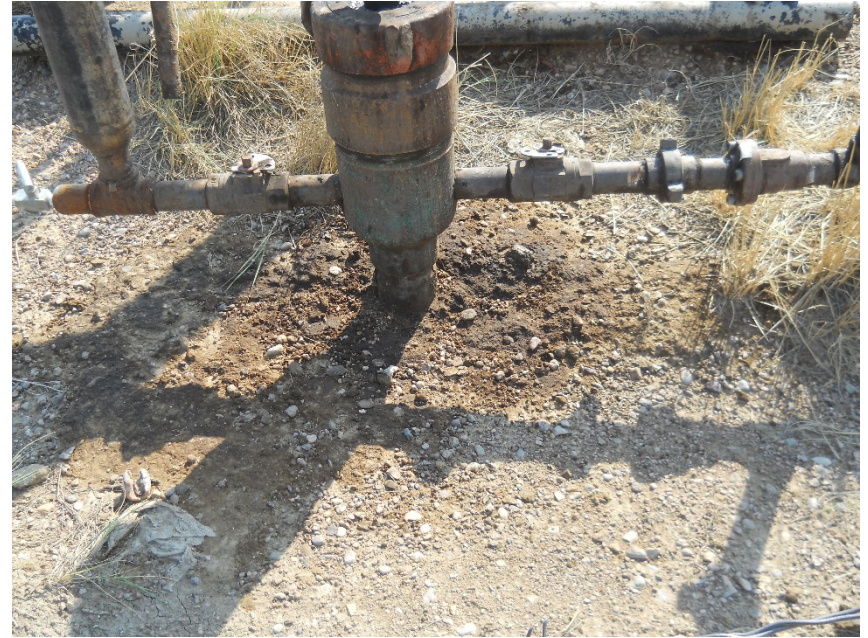
**Stained soil around wellhead, looking east.**

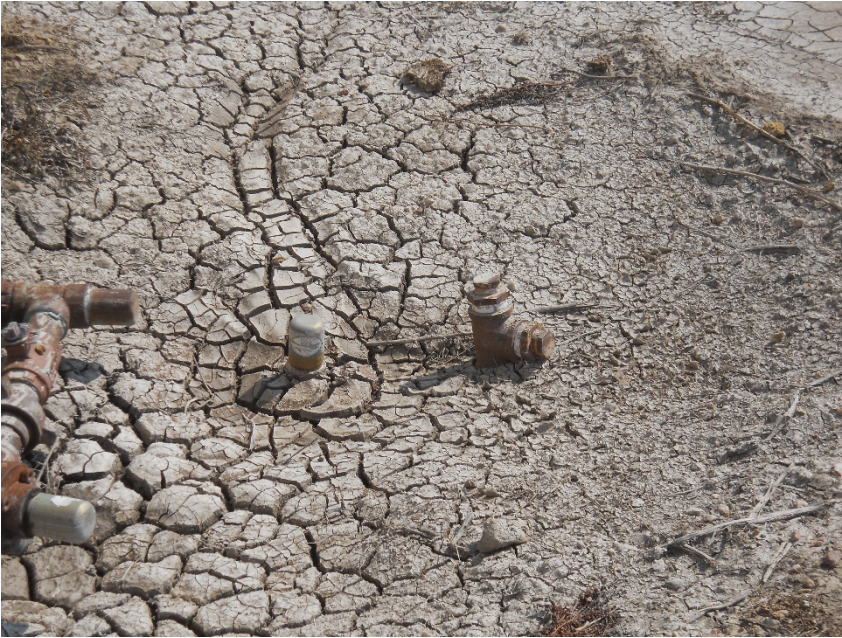
**2-2" unmarked/unused steel risers south side of east produced water tank**

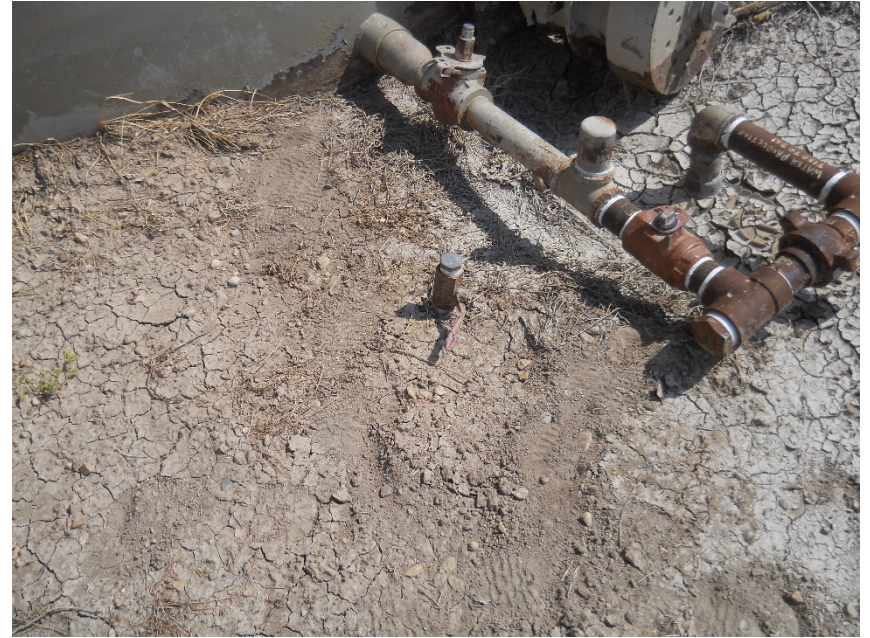
**1-1" unused/unmarked steel riser south side of east middle produced water tank**

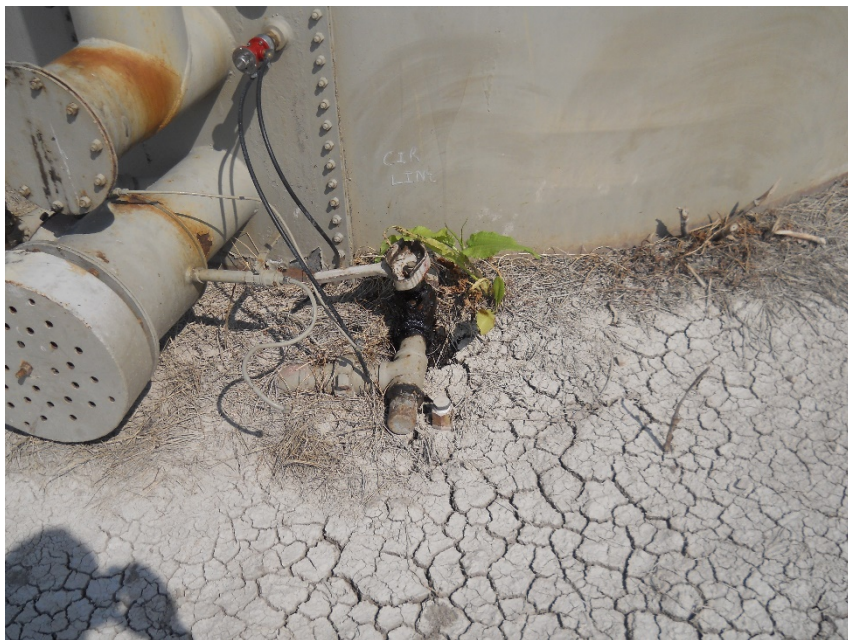
**Leaking drain valve on south side of west crude oil tank**

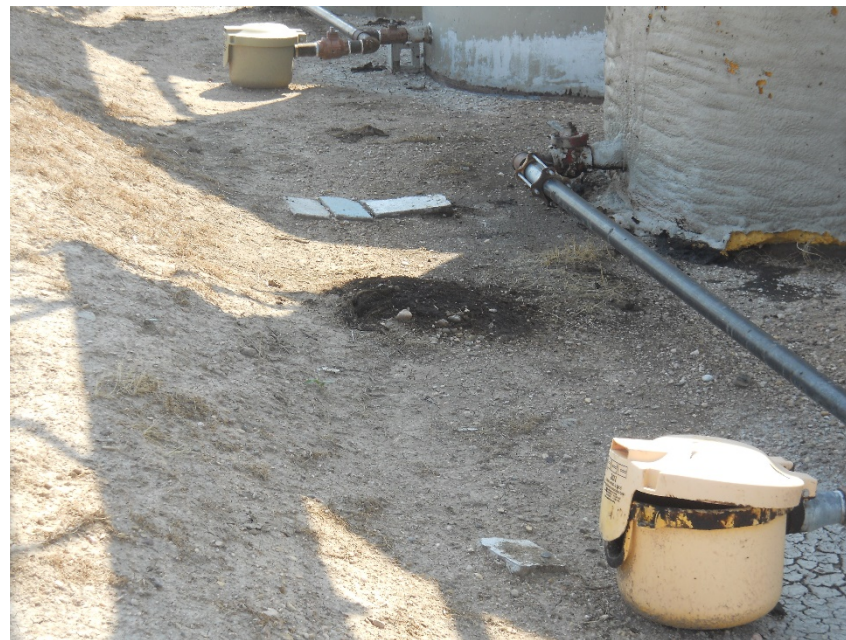
**Stained soil on north side of west middle crude tank**

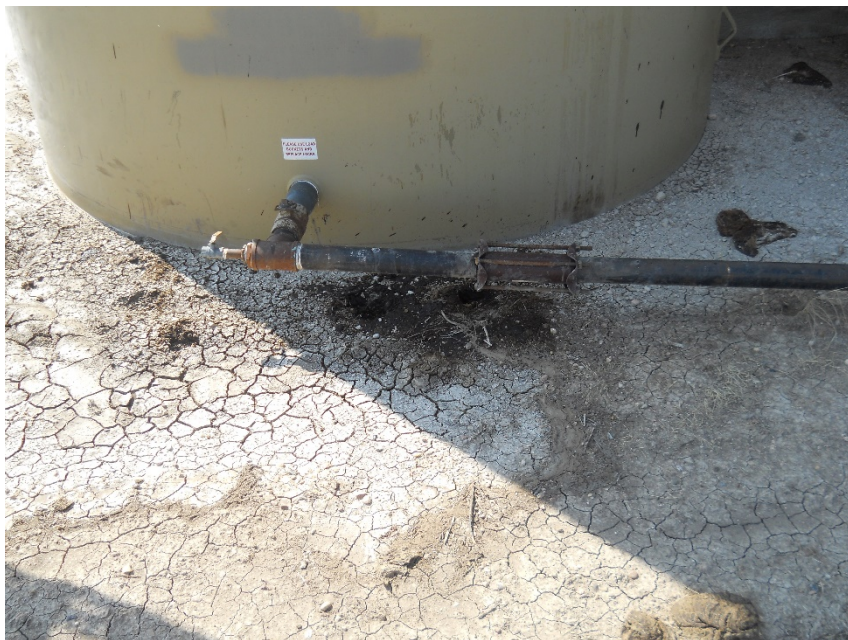
**Stained soil north side of east produced water tank**

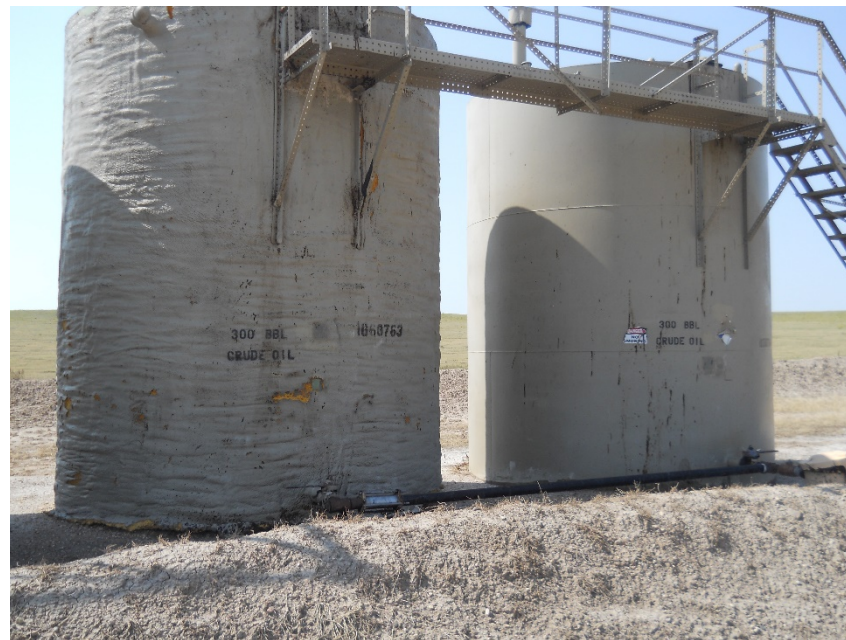
**Crude oil tanks looking southwest. East tank has no NFPA label, west tank NFPA label not legible**

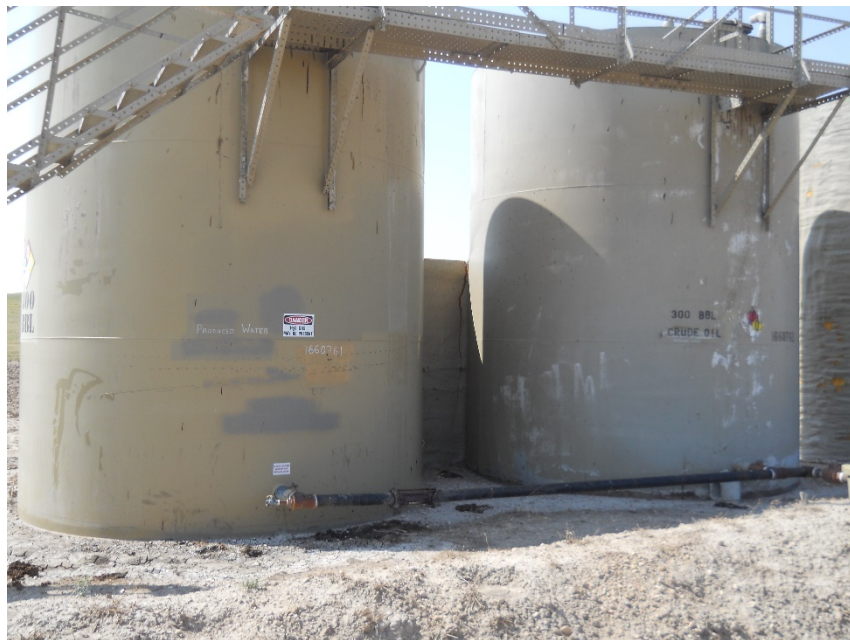
**Produced water tanks looking south. East tank has correct labeling, west tank is labeled as crude oil and has produced water written under it. Uncertain of its contents. West tank needs NFPA label replaced.**

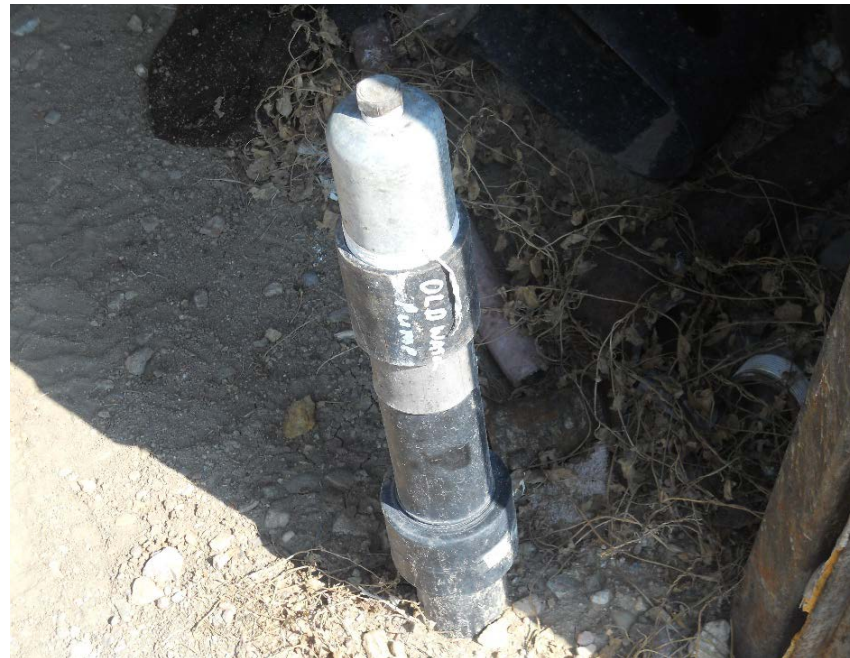
**2" unused/marked poly line at heater treater shed entrance.  
No LOTO**

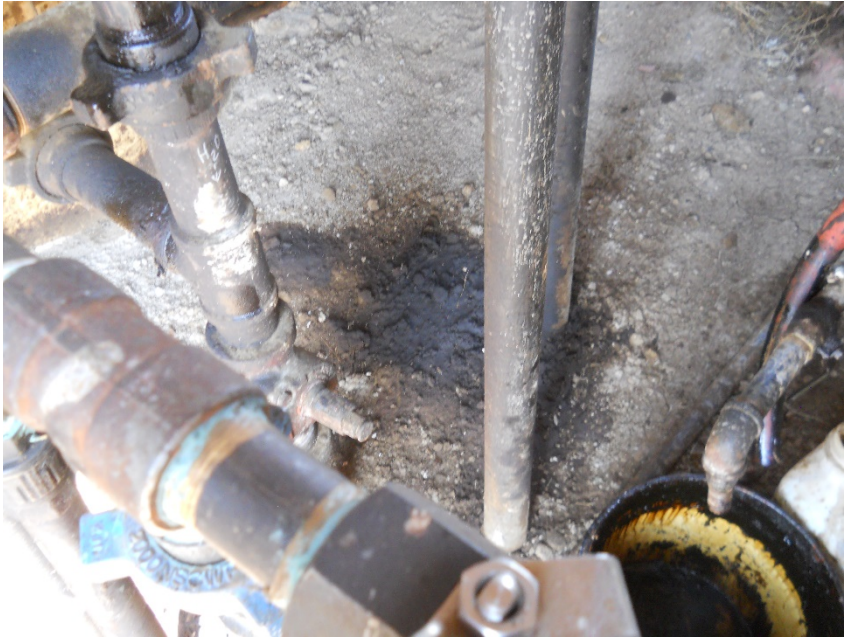
**Stained soil in heater treater shed under oil leg from leaking valve**

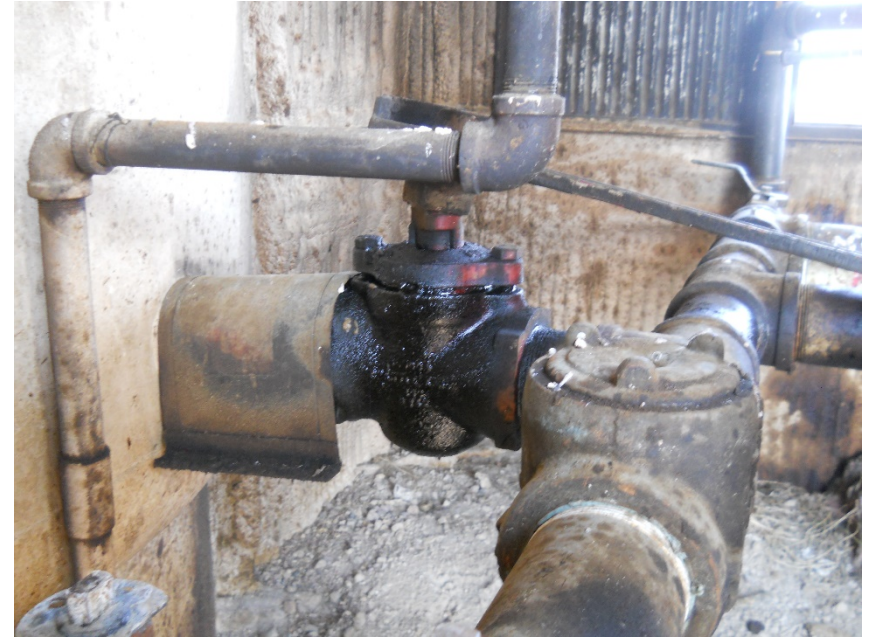
**Leaking oil valve in heater treater**

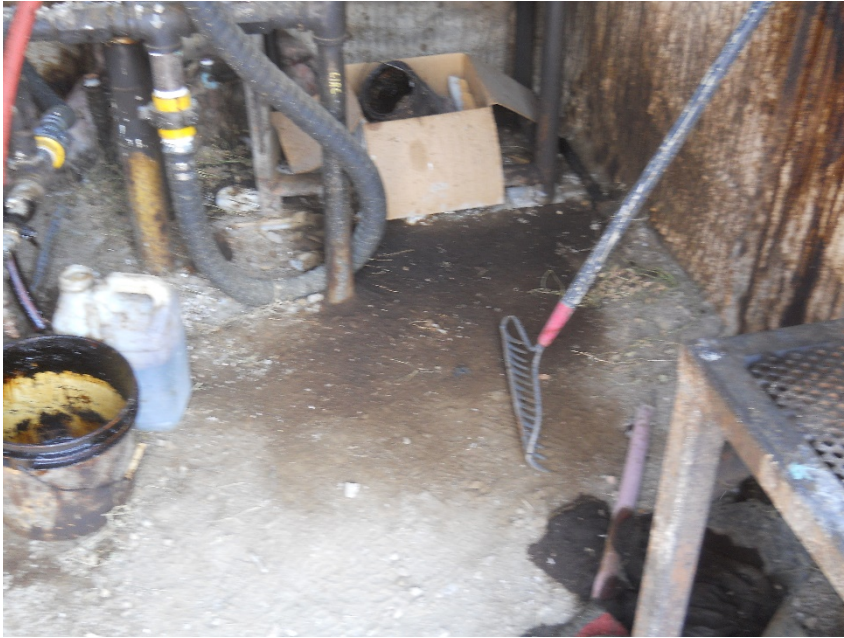
**Stained soil in heater treater shed looking north from door**

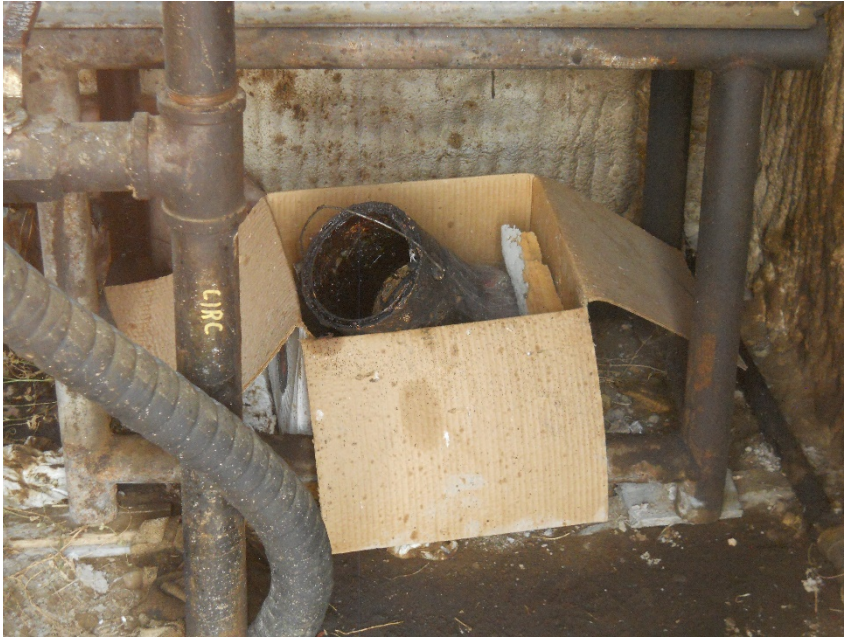
**Trash in heater treater shed, northeast corner**

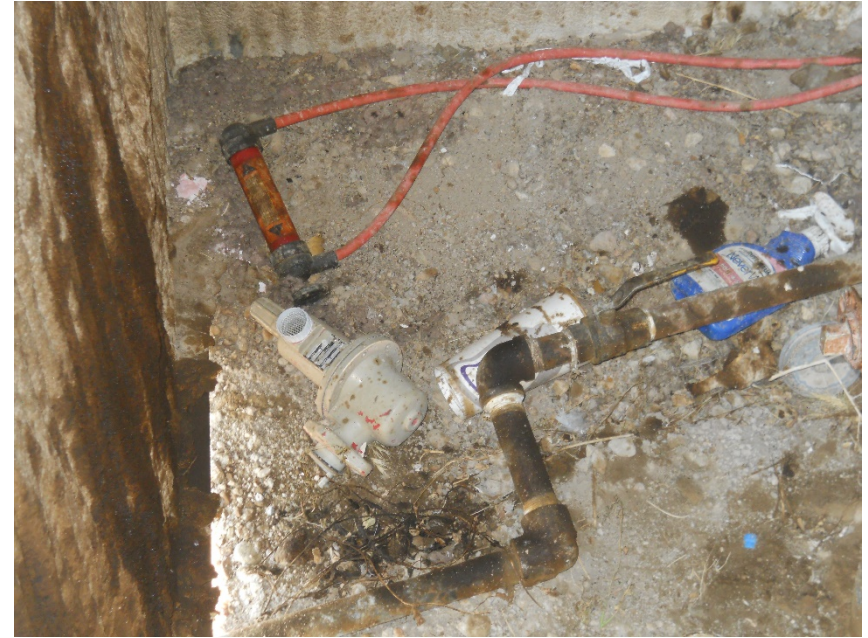
**Trash in heater treater shed, southwest corner**

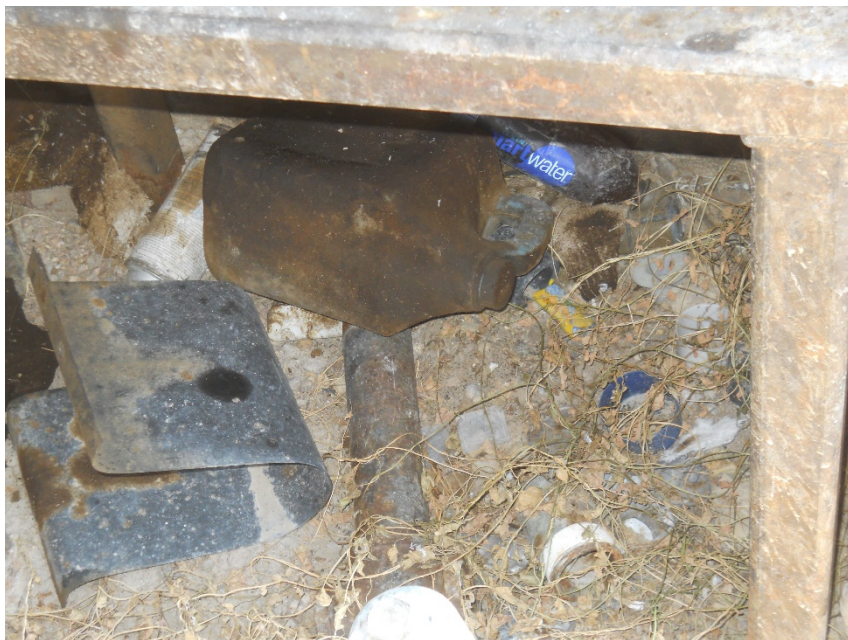
**Trash in heater treater shed, southeast corner**

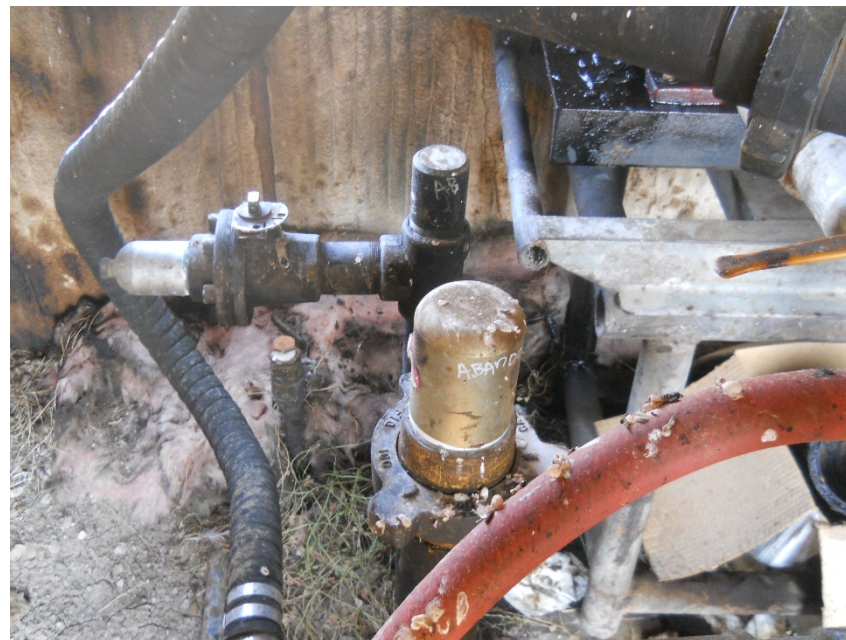
**3" unused/marked steel riser, 2" unused/marked steel riser  
in heater treater. No LOTO**

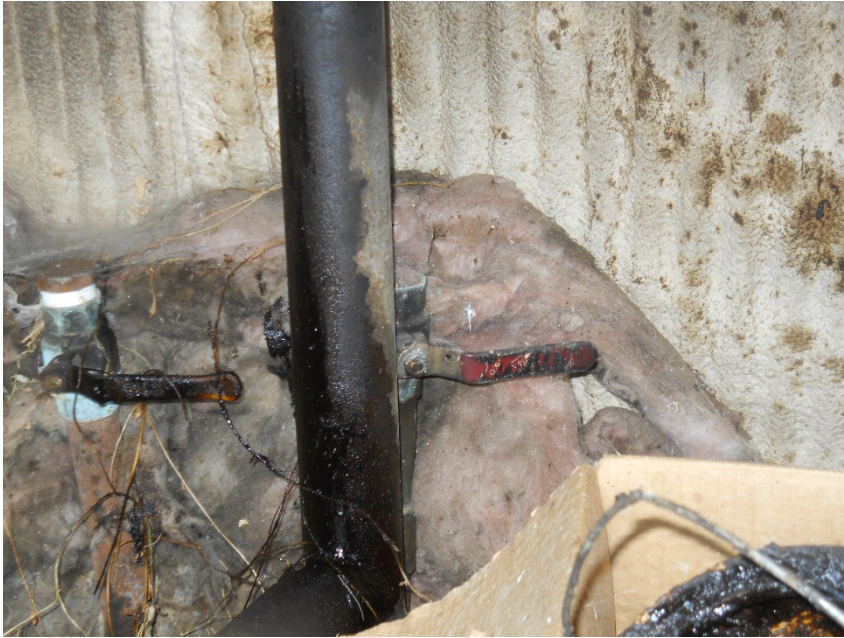
**2-1" unused/unmarked steel risers north wall in heater treater shed**

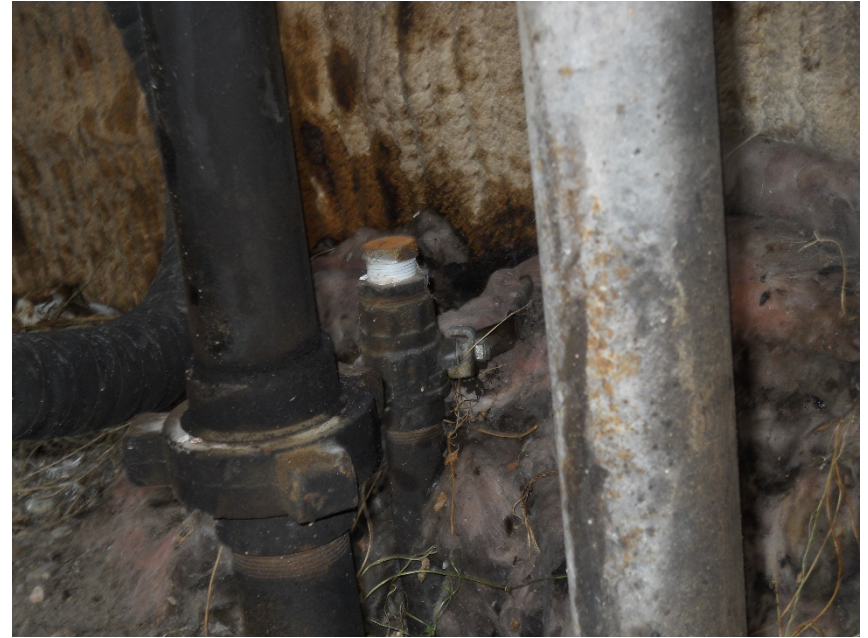
**1-1" unused/unmarked steel riser north wall in heater treater shed**
