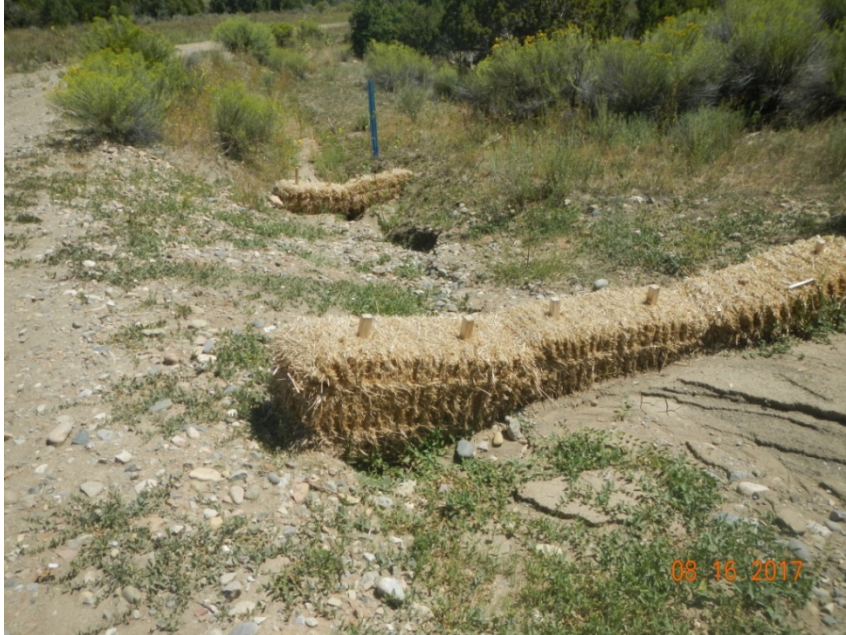
Photo 1: View of stormwater controls at the southern edge of the entrance to the well pad and access road. Need maintenance.

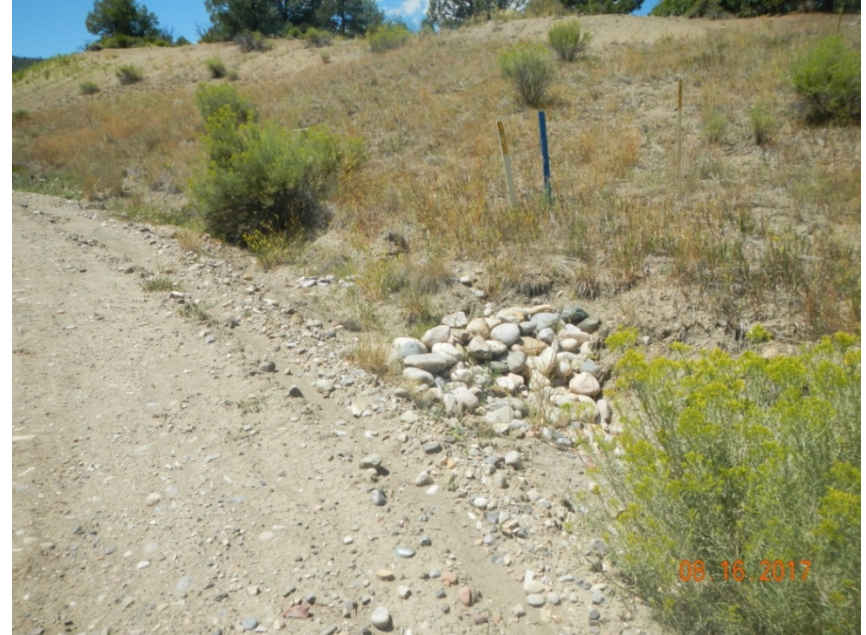
Photo 2: View of stormwater controls at the northern edge of the well pad entrance. Appear to be functioning.

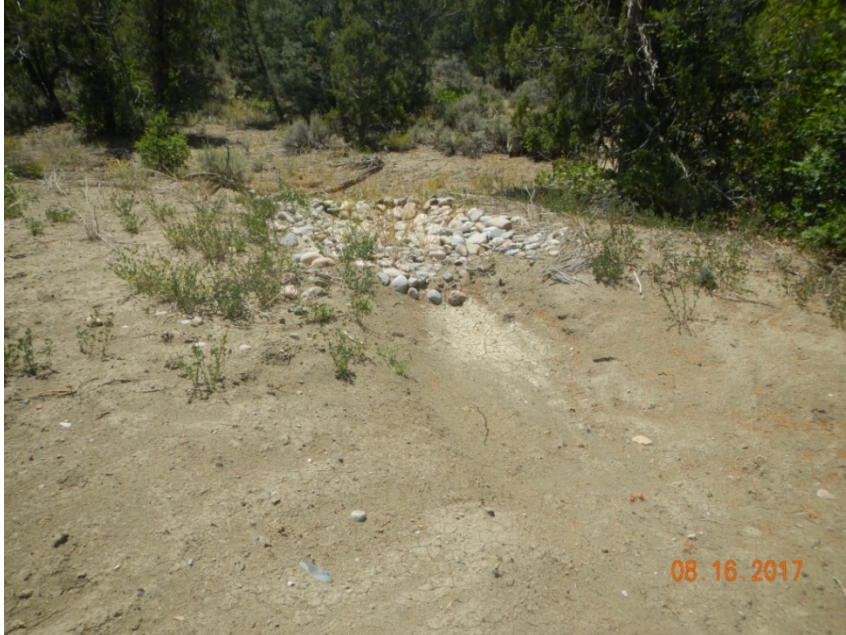
Photo 3: View of cobble run down along the northwestern edge of the project area appears to be functioning at this time.

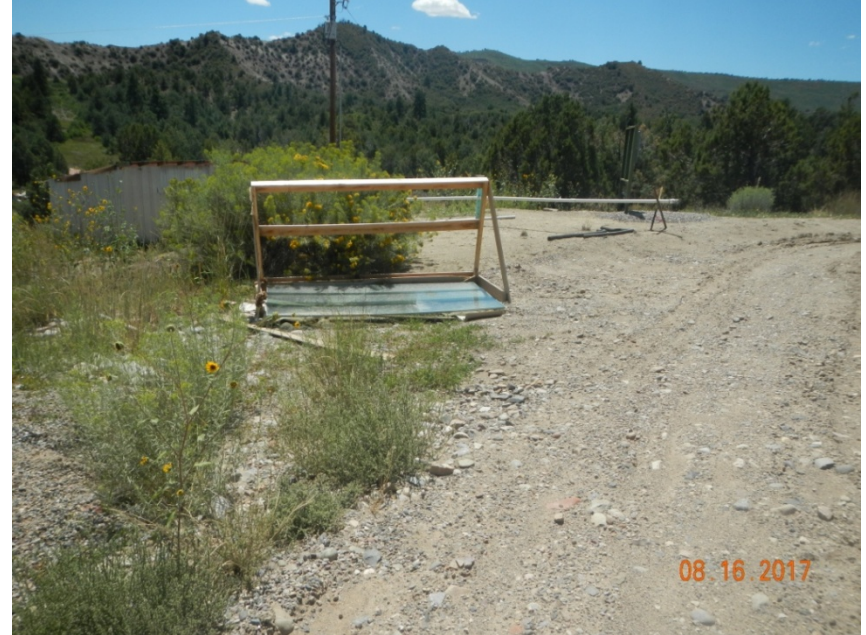
Photo 4: View of what appears to be surface owner debris in the southwestern portion of the project area. Corrective action to remove this has not been addressed.
