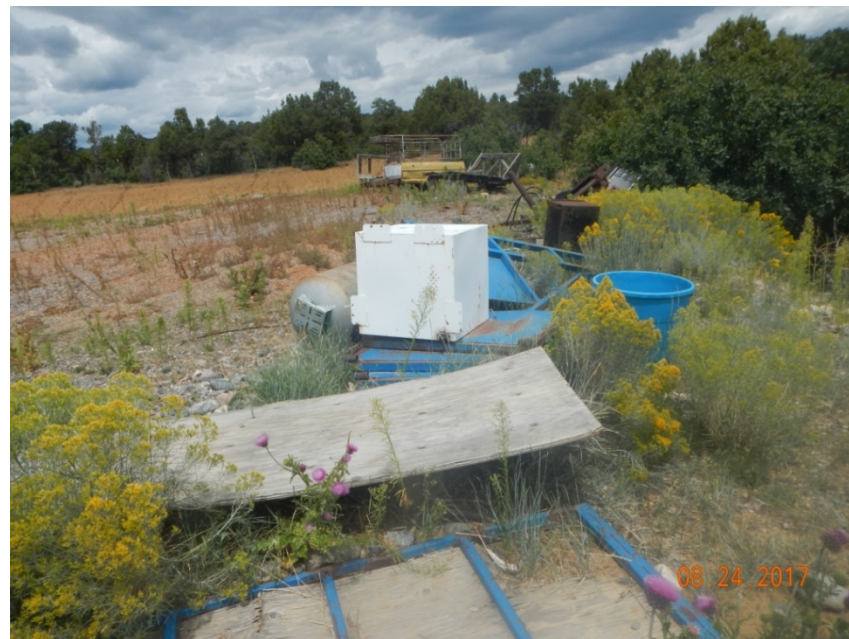
Photo 2: View of the eastern portion of the project area from the southeastern corner facing northward. What appears to be surface owner junk and debris is scattered throughout the interim reclamation area.

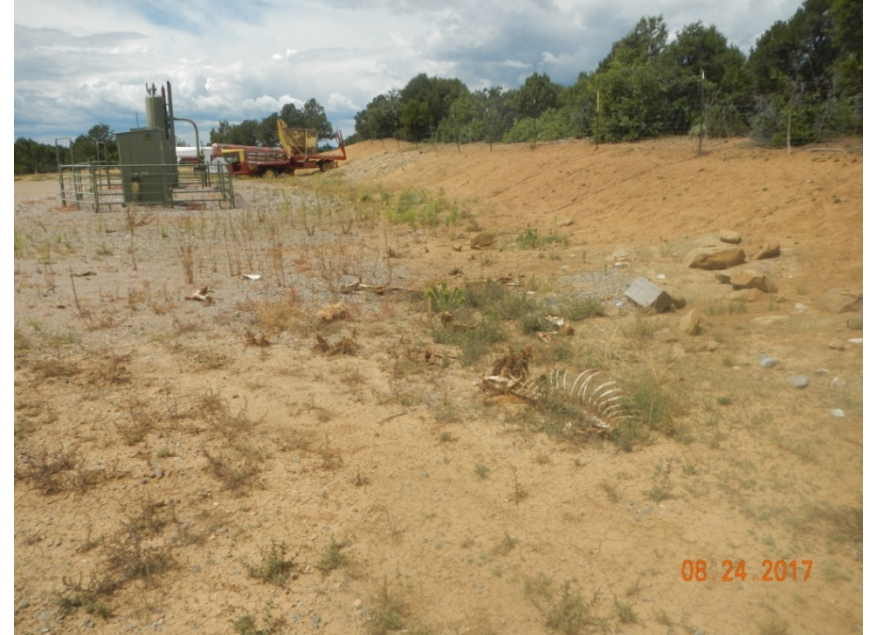
Photo 4: View of the northern portion of the project area from the northeastern corner facing westward. Exposed cut-slope is not stabilized.
