Interim Reclamation and Stormwater Inspection

August 29, 2017

Operator: EXTRACTION OIL & GAS LLC- #10459

Location ID: 427157

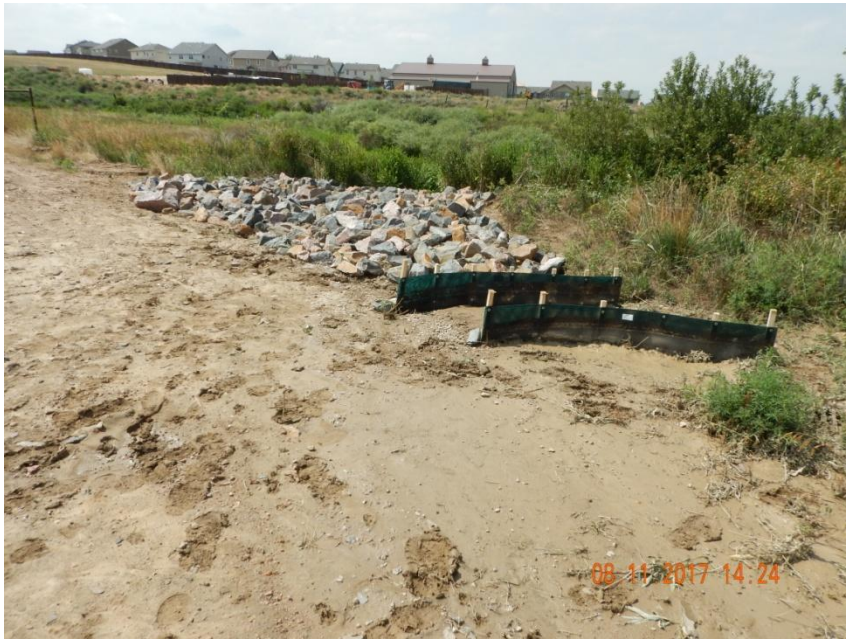
Photo 1. Photo taken August 11, 2017 east of the gully erosion repairs, facing West.

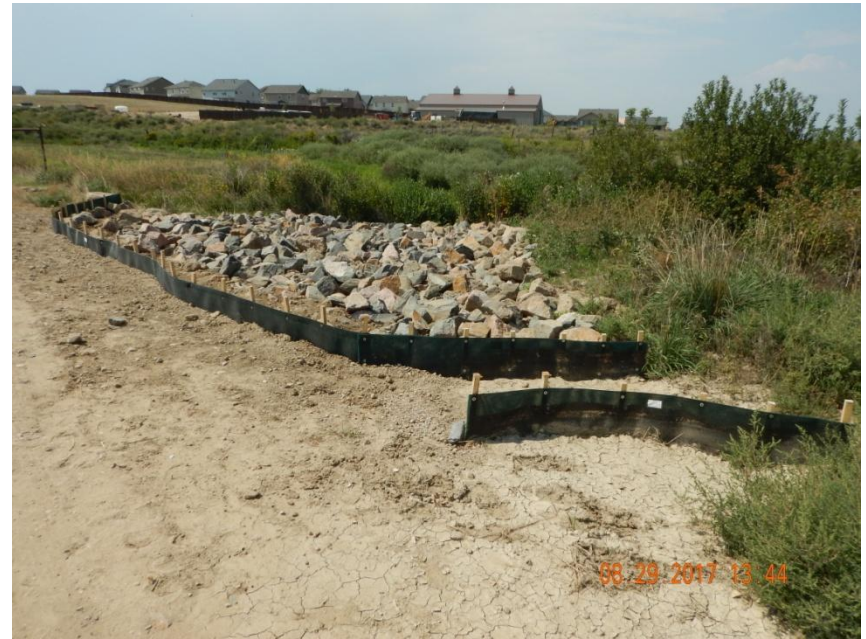
Photo 2. Photo taken August 29, 2017 east of the gully erosion repairs, facing West.

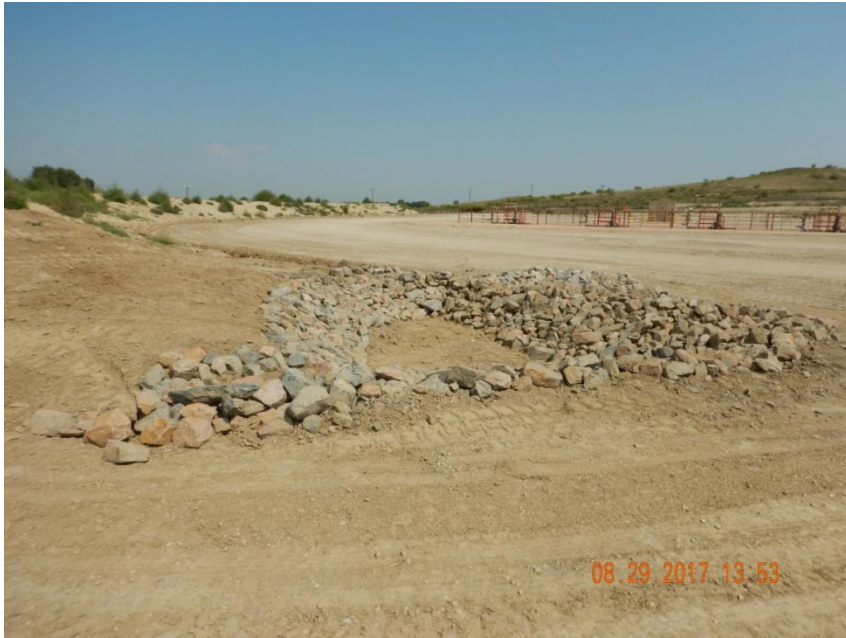
Photo 3. Photo taken from the northwestern facility, facing East. Appears the Operator has installed a sediment trap in conjunction with a ditch- see Photo 4.

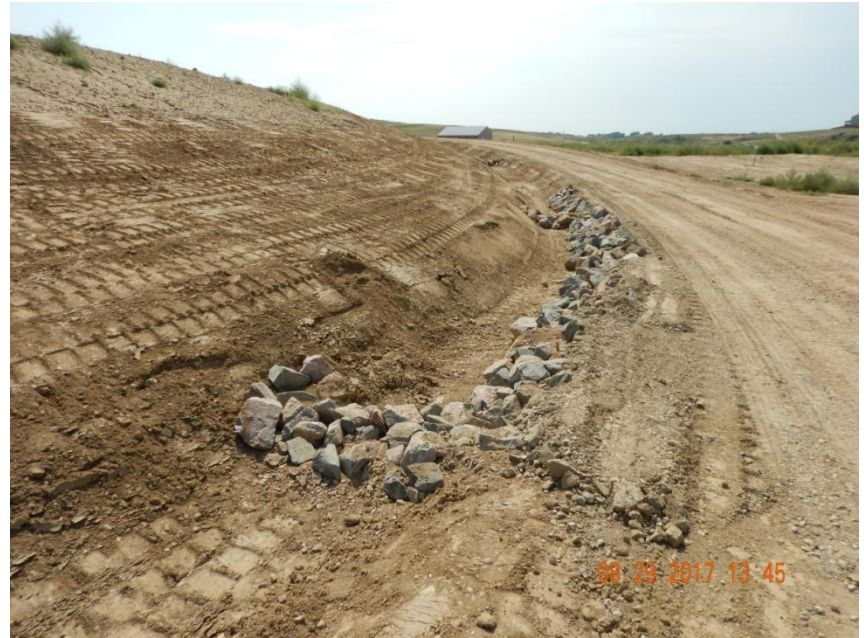
Photo 4. Photo taken north of the previous sediment trap, facing South. Operator has installed a ditch, armored with rock along portions, as well as check dams. Stormwater runoff appears to be directed to the sediment basin along the northeastern facility- see Photo 5.

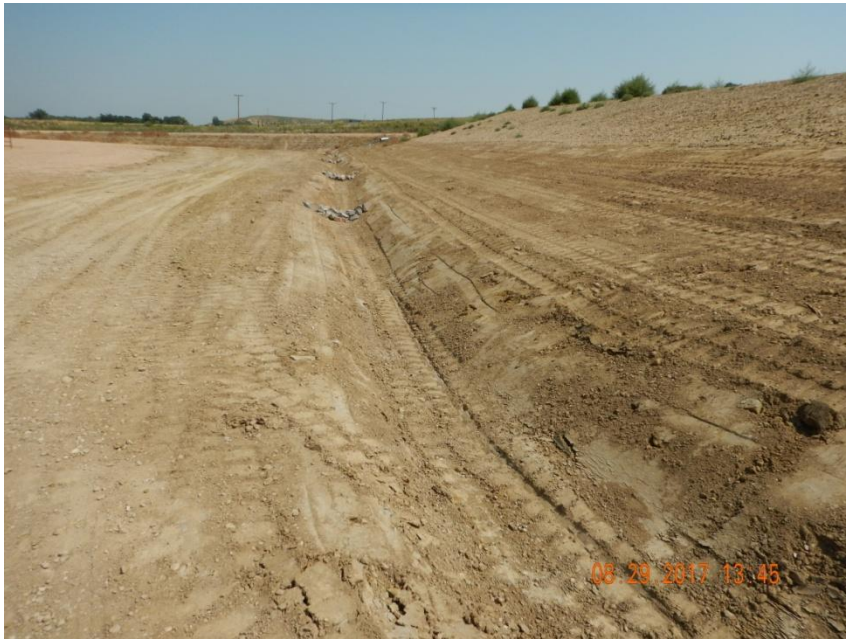
Photo 5. Photo taken from the previous Photo 4 location, facing East. Ditch has been installed that appears to be directed to the sediment basin along the northeastern facility.

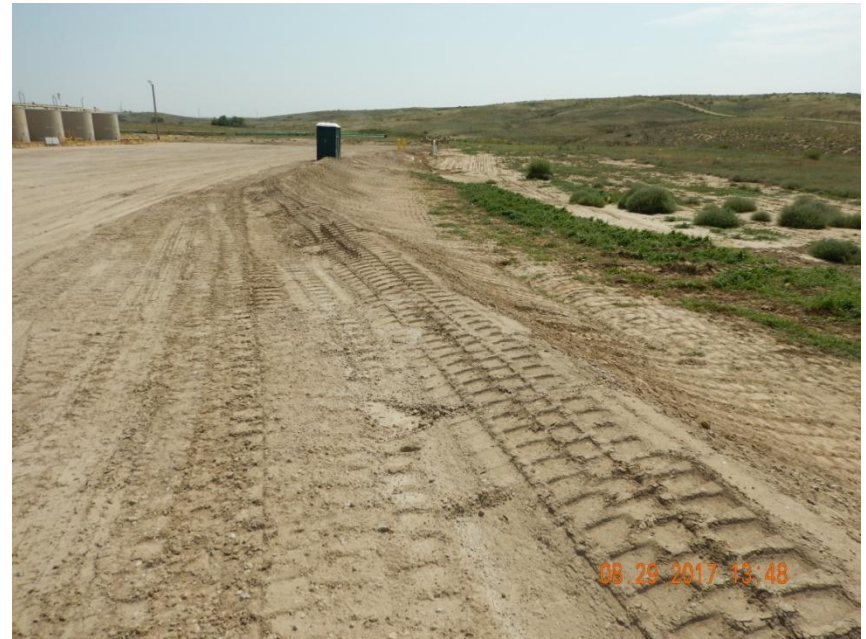
Photo 6. Photo taken from the western location, facing South. Appears the Operator has installed a berm along portions of the western location.

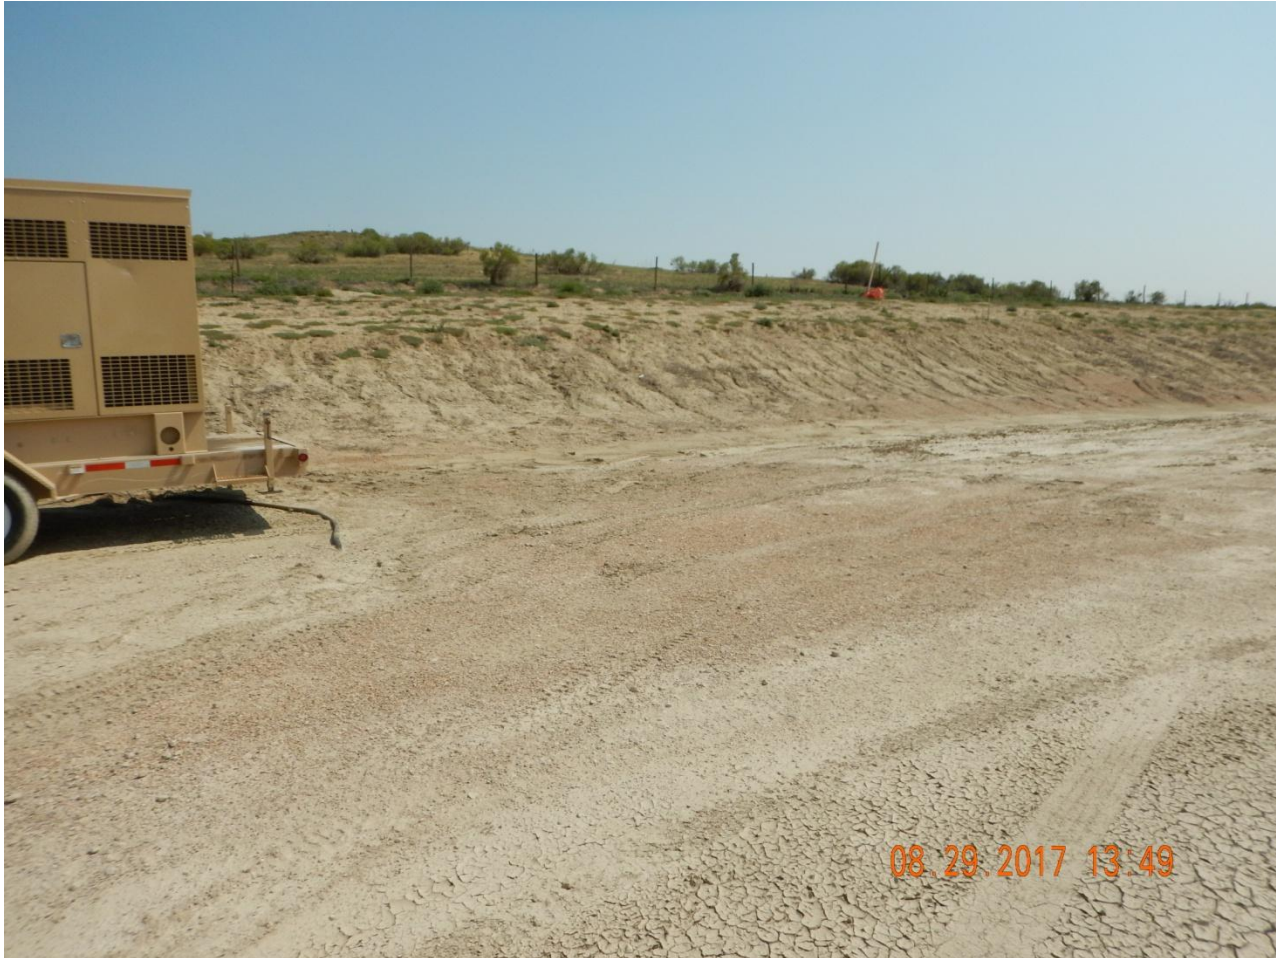
Photo 7. Photo taken from the southeastern location, facing Southeast. Does not appear the Operator has repaired rill erosion along the entire eastern cut slope.

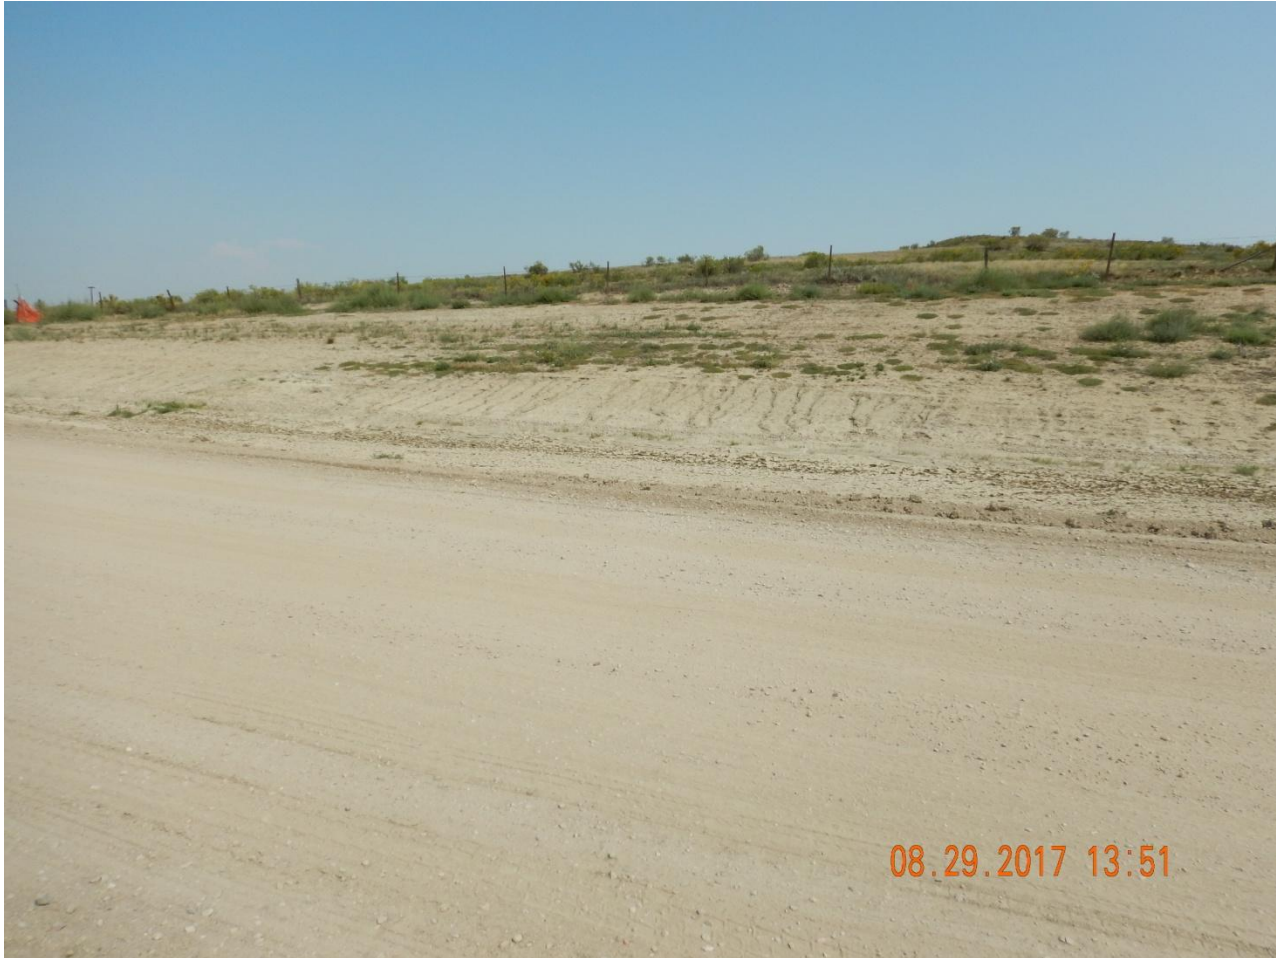
Photo 8. Photo taken from the eastern location, facing East. Does not appear the Operator has repaired rill erosion along the entire eastern cut slope.

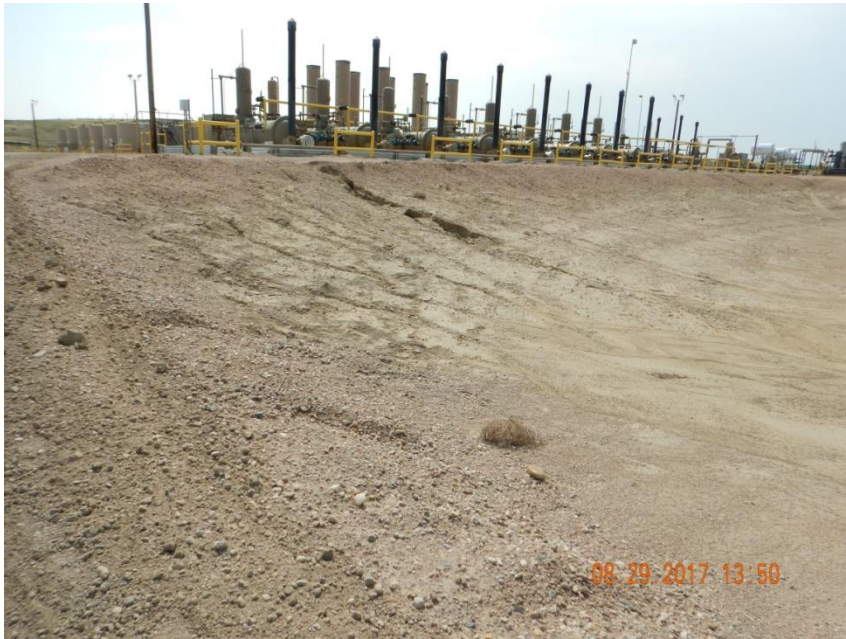
Photo 9. Photo taken from the east-central location, facing Southwest. Does not appear the Operator has repaired rill/gully erosion along the fill slope.

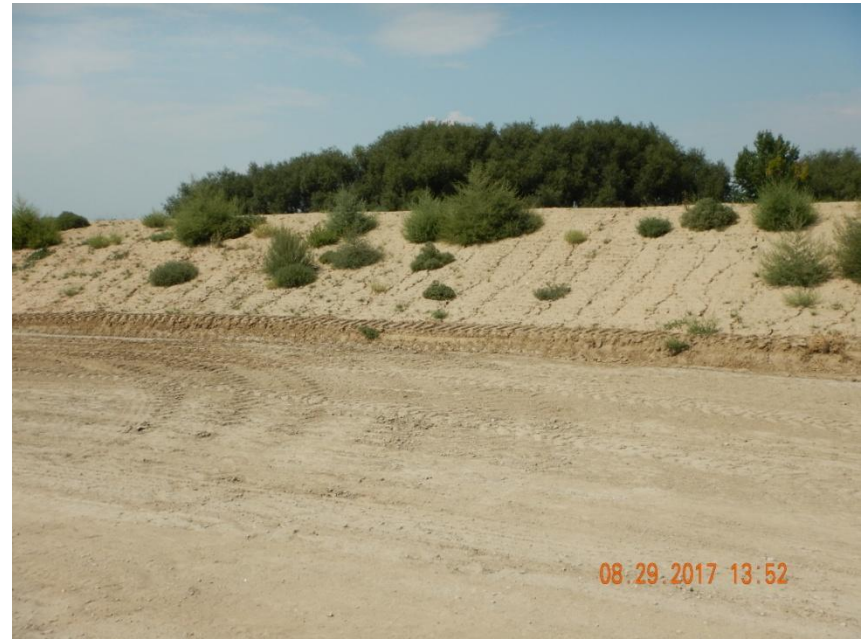
Photo 10. Photo taken from the central location, facing Northwest. Does not appear the Operator has repaired rill erosion along the soil stockpile.
