**COLORADO**  
Oil & Gas Conservation  
Commission  
Department of Natural Resources

Inspection Photos: Farleigh Oil DA Silver Spur API#057-06459

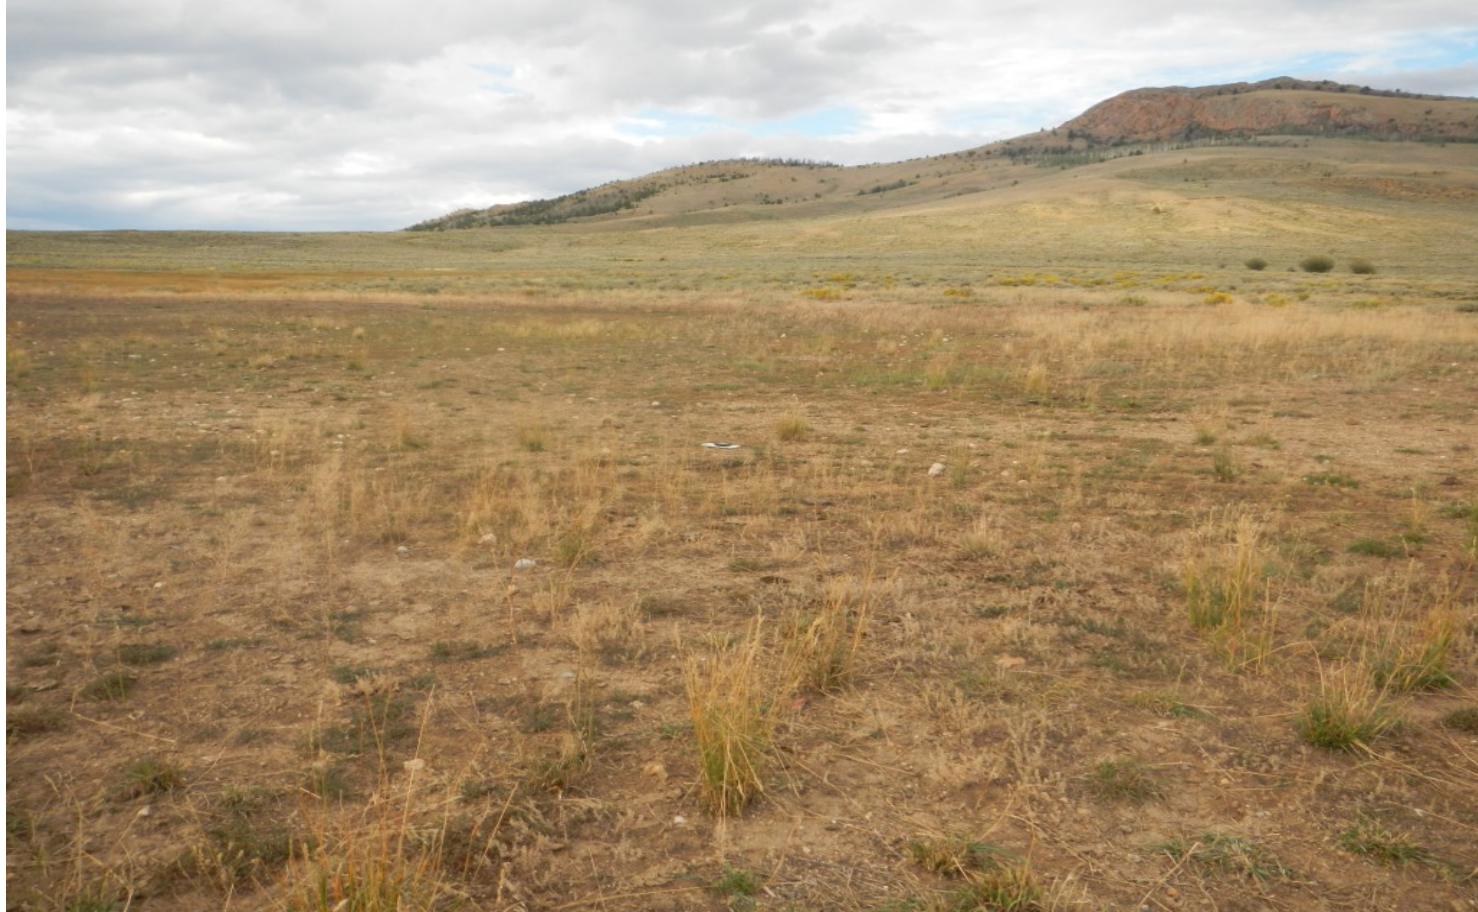
Photo#1:  
View to North over Location

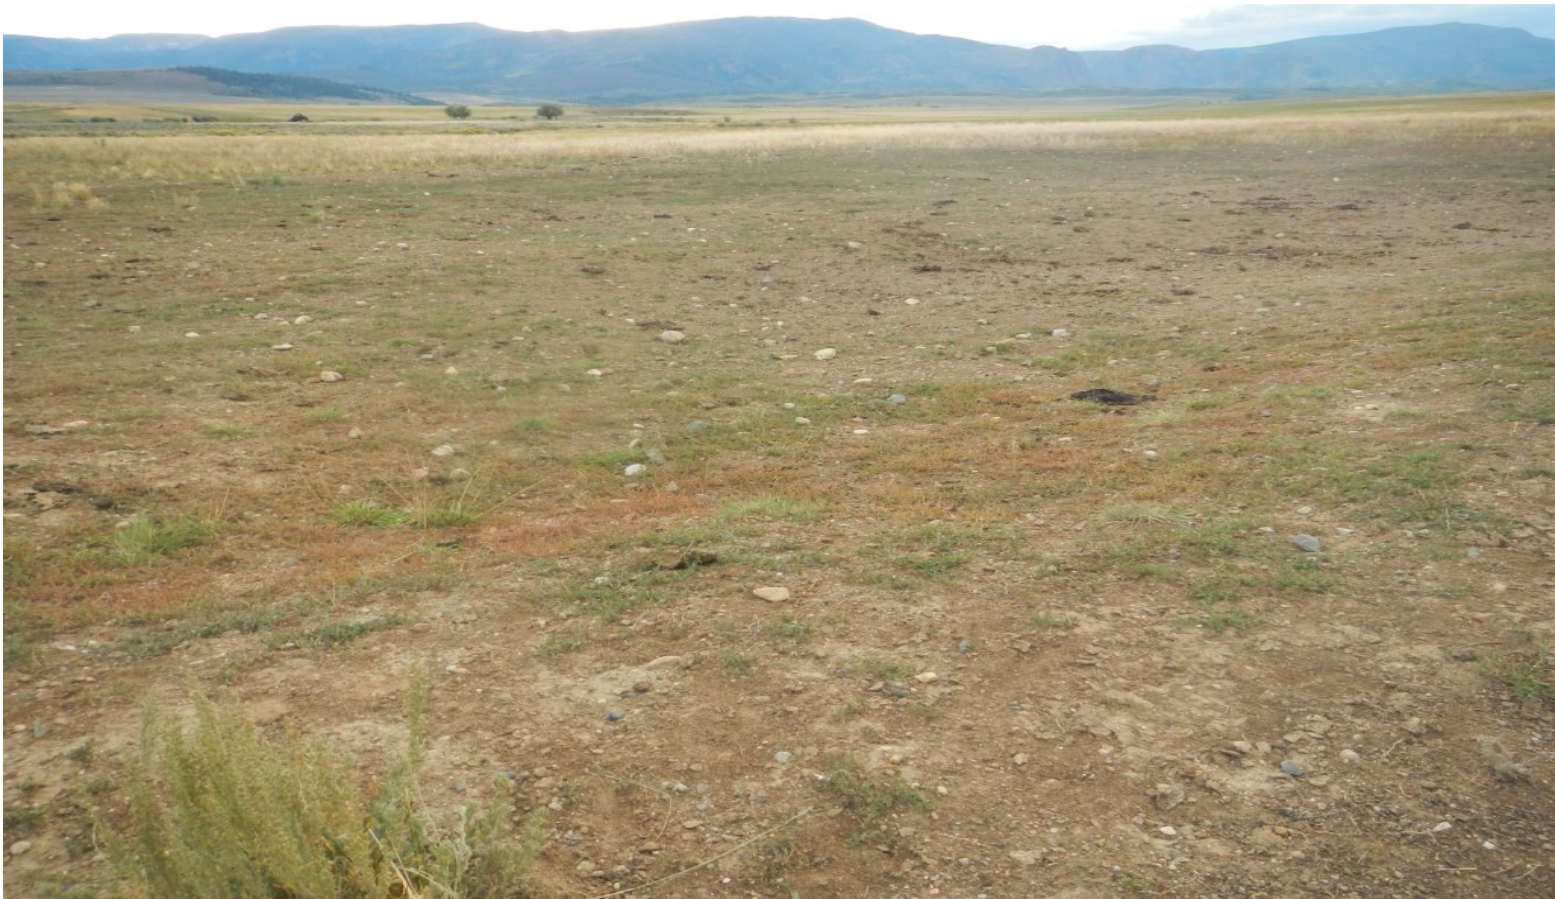
Photo#2:

Close up of Land Farm area that has not revegetated.

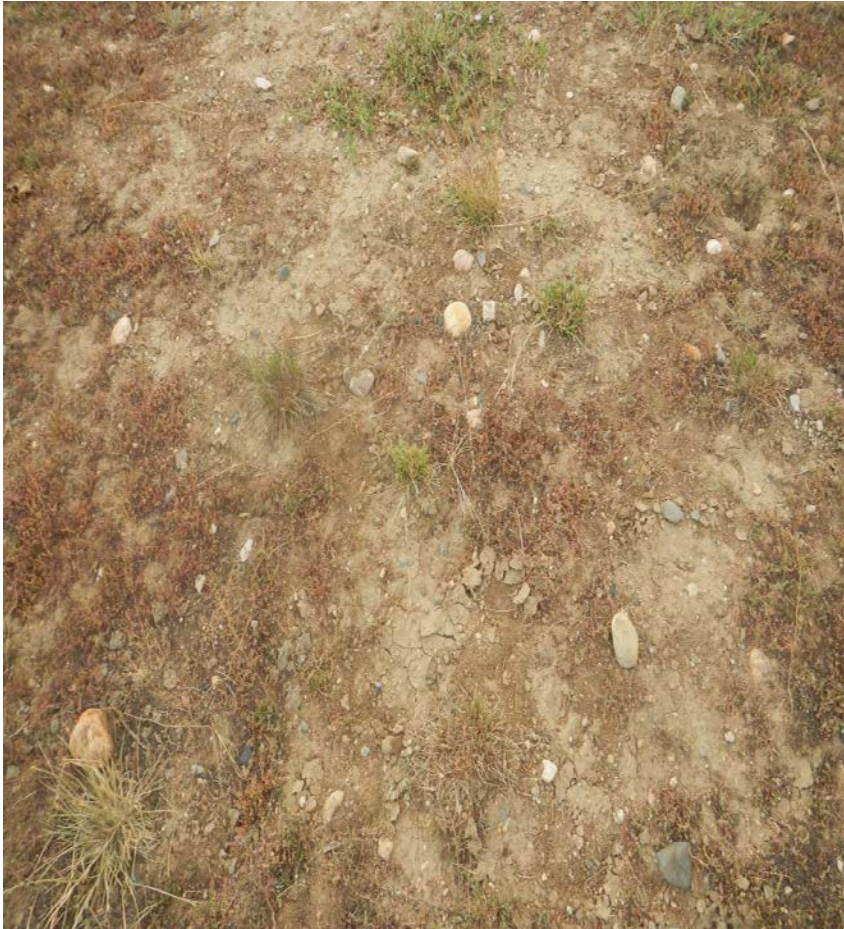
Photo#3:

Close up of ground conditions & Vegetation in unsuccessfully revegetated areas.

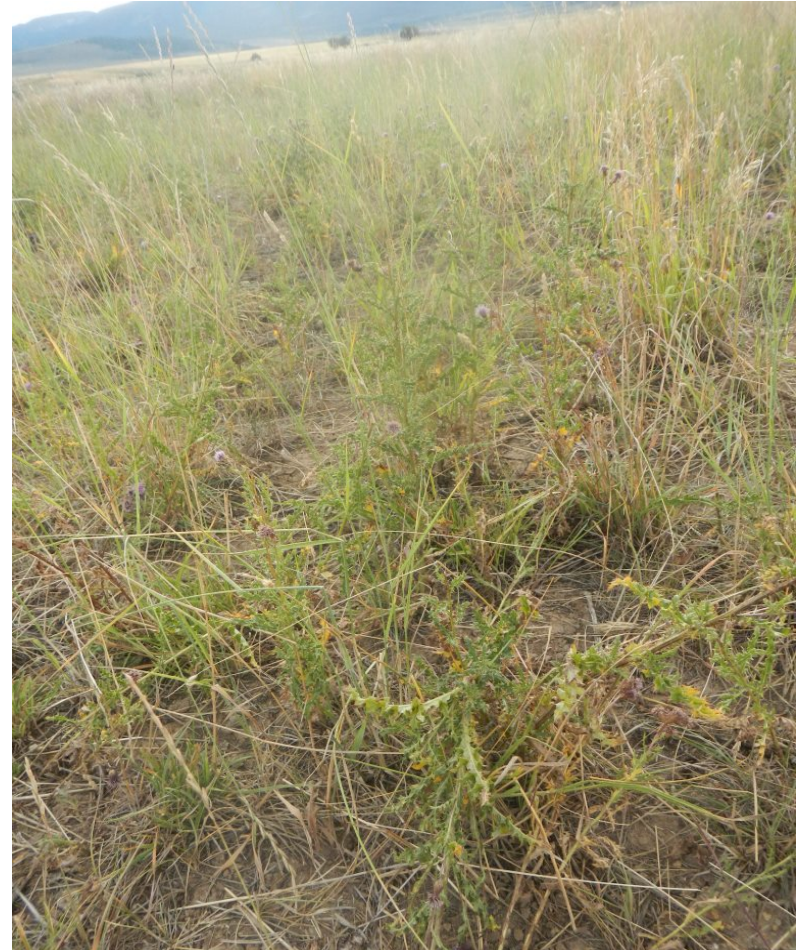
Photo#4:

Canada Thistle is established in revegetated areas
