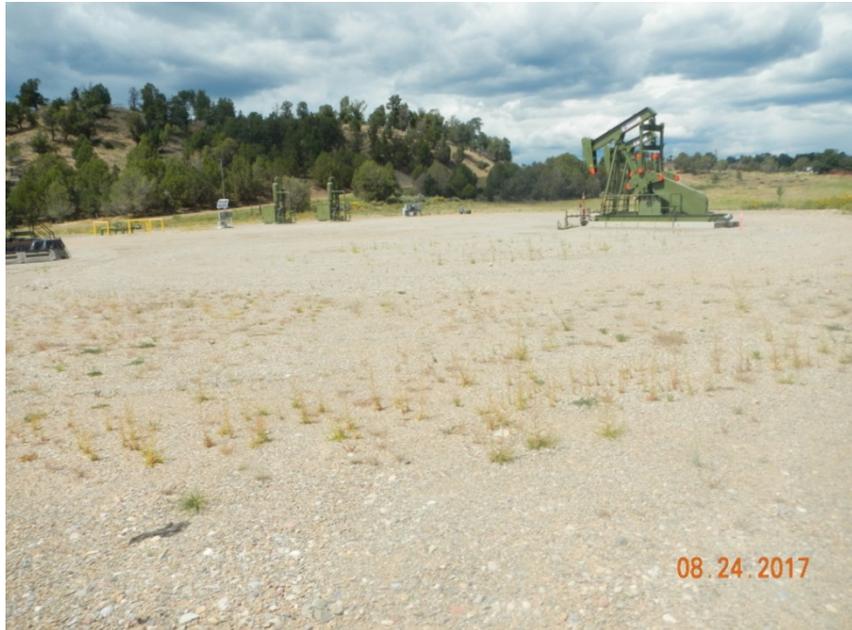
Photo 1: View of the project area from the southeastern corner facing center. Interim reclamation is needed.

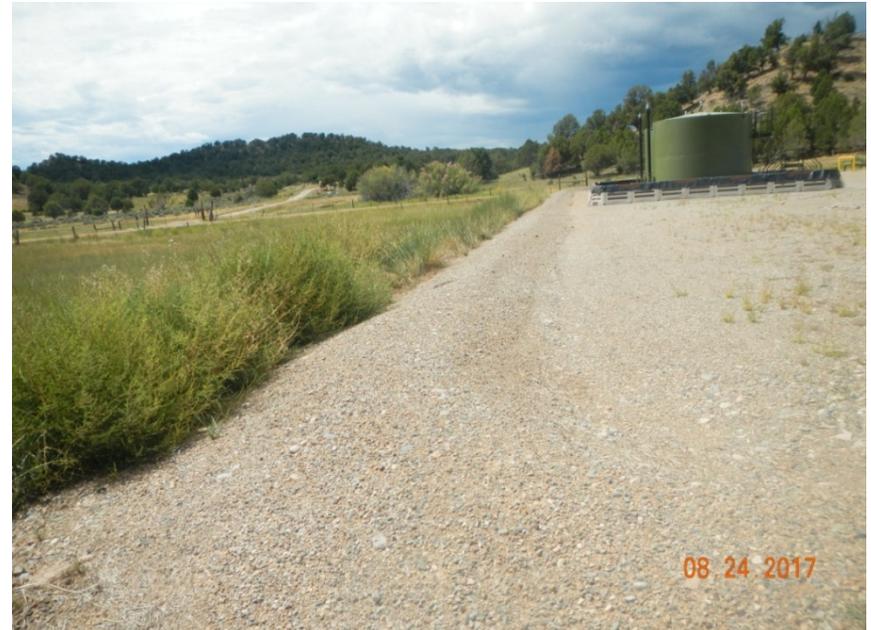
Photo 2: View of the southern portion of the project area from the southeastern corner facing westward. Revegetation is progressing with grasses such as western wheatgrass (*Pascopyrum smithii*) and dropseed (*Sporobolus* sp.). Musk thistles appear to be treated.

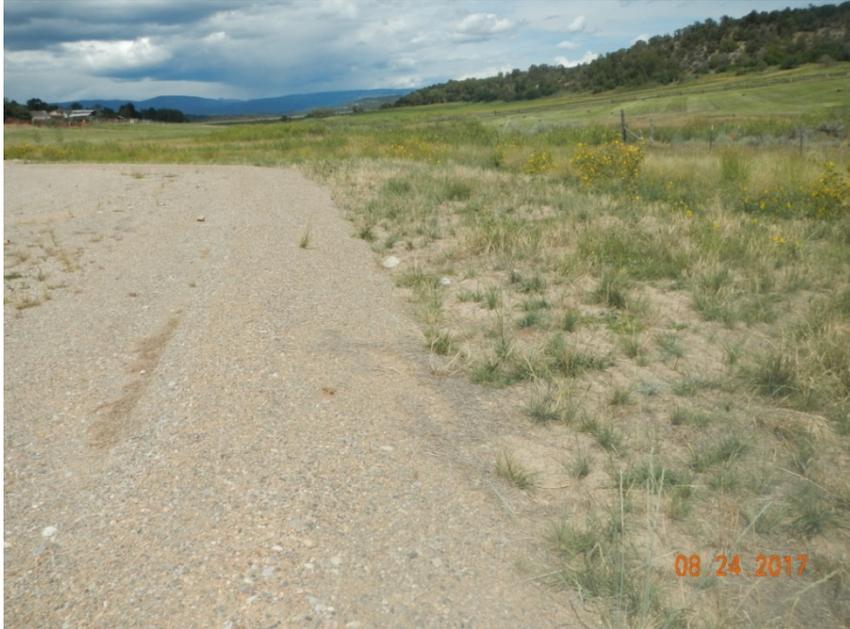
Photo 3: View of the eastern portion of the project area from the southeastern corner of the well pad facing northward.

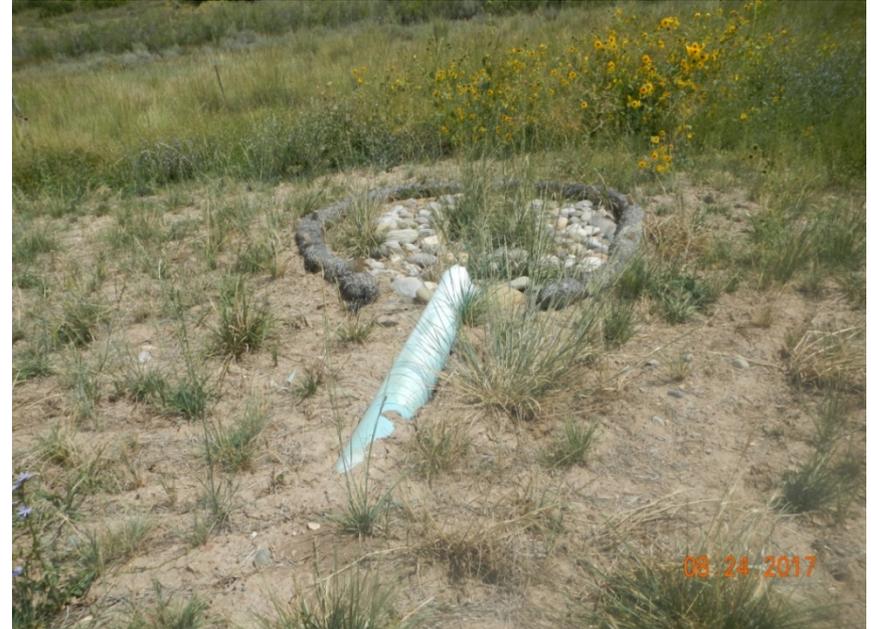
Photo 4: View of stormwater controls in the southern corner of the project area, appear to be functioning.
