Inspection Photos
Location Name: Merino 1
API: 05-075-09094
Inspection Date: August 30, 2017

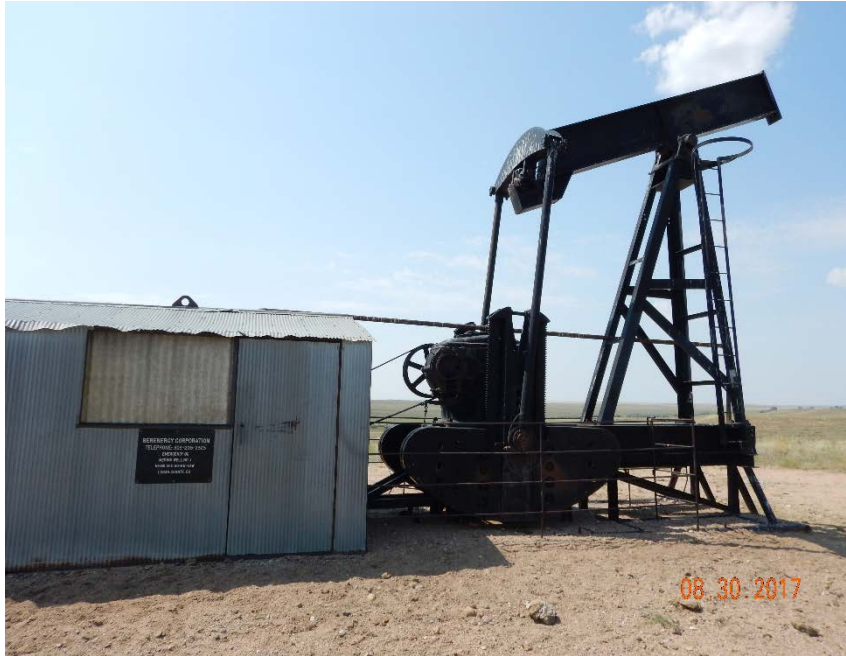
Photo #1 – Well sign, pump jack, and shed.

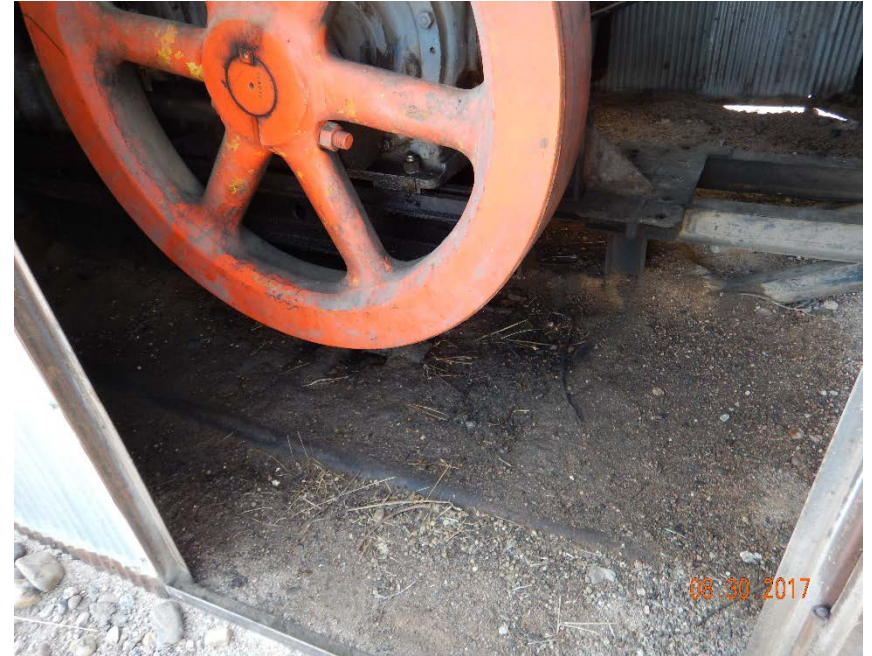
Photo #2 – Oil-stained soil beneath prime mover.

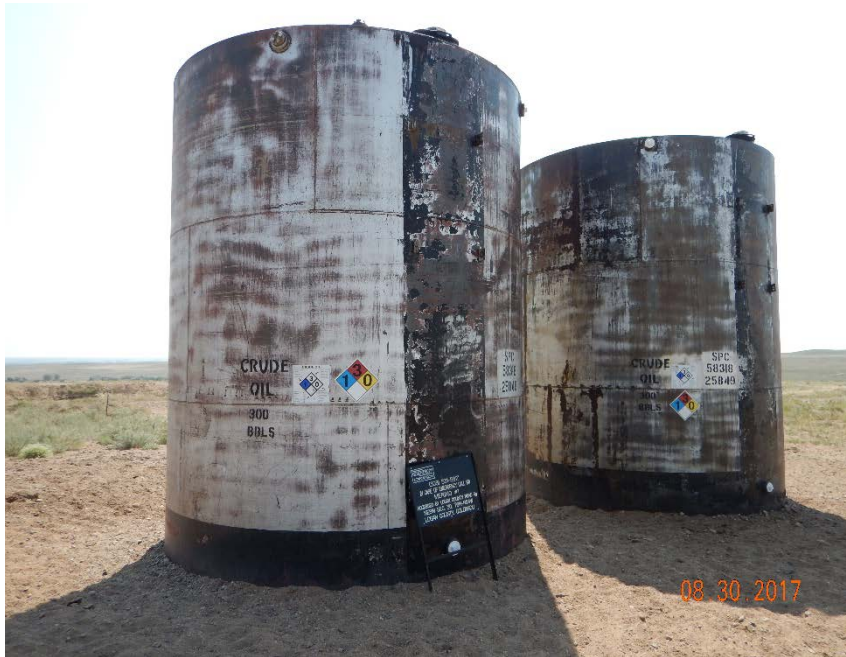
Photo #3 – Crude oil ASTs lacking earthen berm.

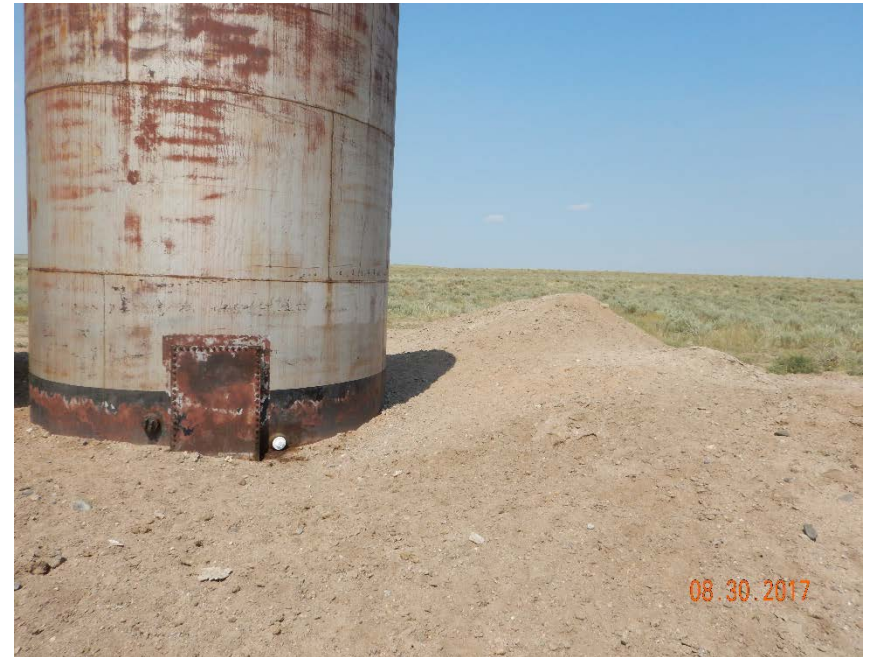
Photo #4 – Soil stockpile east of crude oil ASTs.

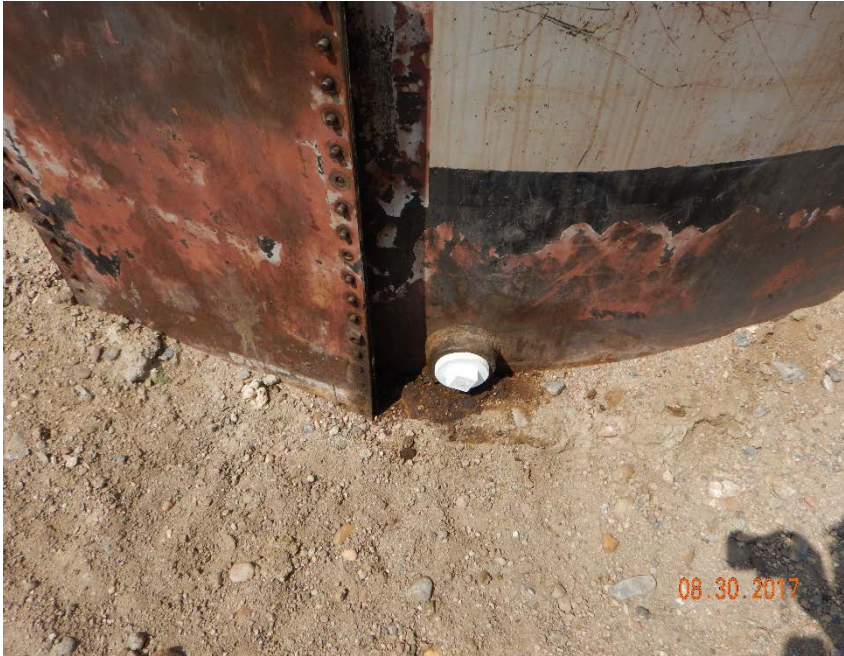
Photo #5 – Localized, stained soil beneath east crude oil AST, as indicated in previous FIR.

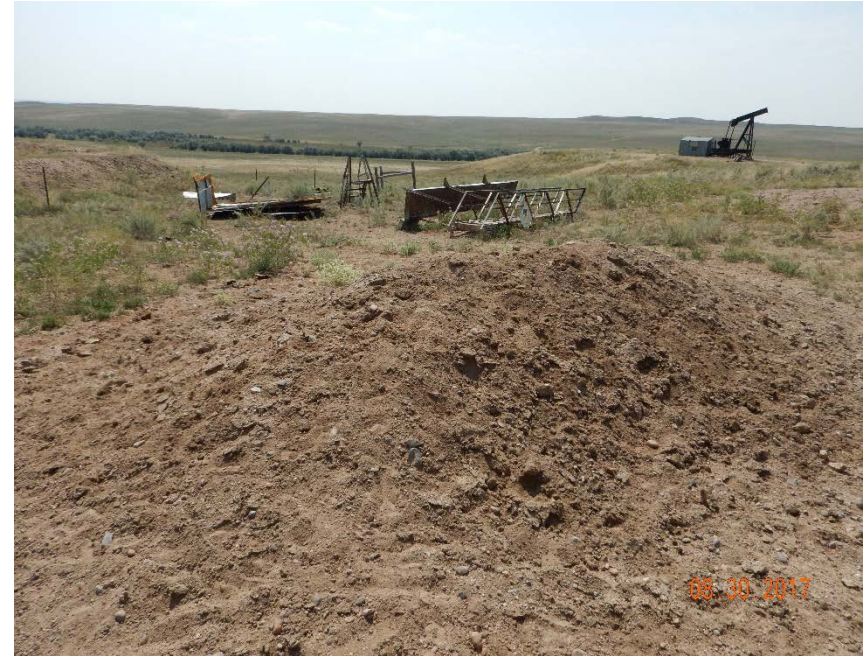
Photo #6- Soil stockpile (possible former berm) at SW corner of tank battery. Note: junk/debris in background.

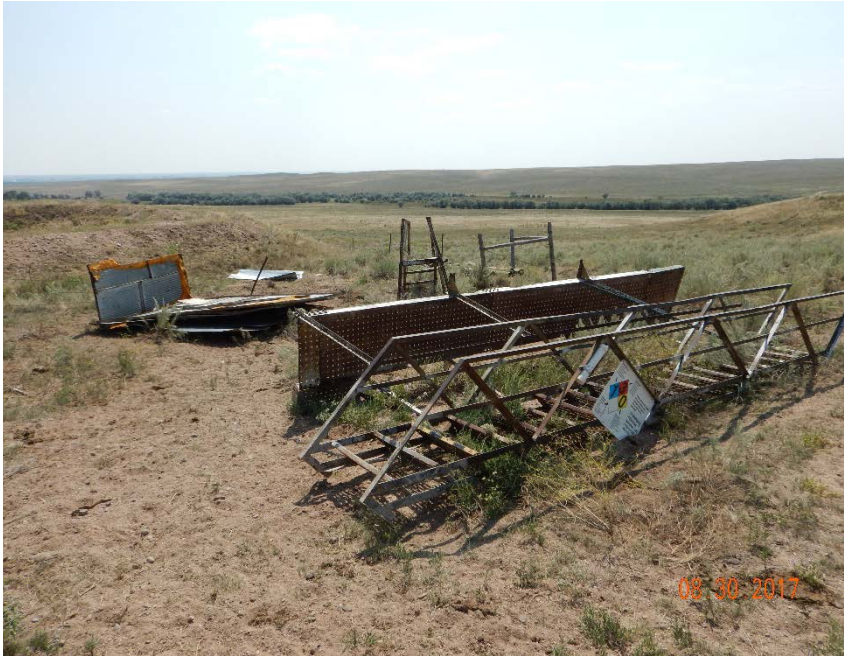
Photo #7 – Former AST stairway and VHT shed debris located SW of crude oil AST.

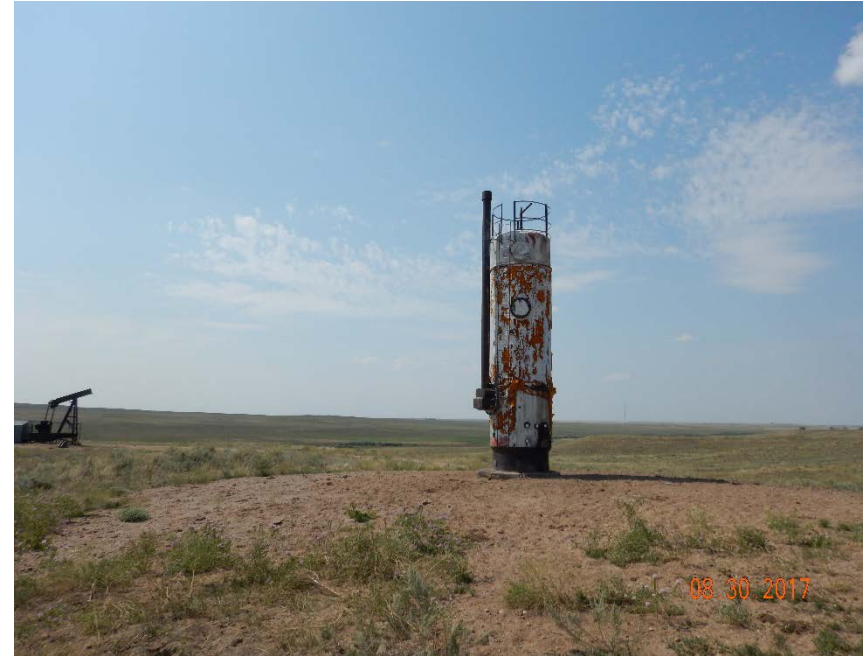
Photo #8 – VHT.

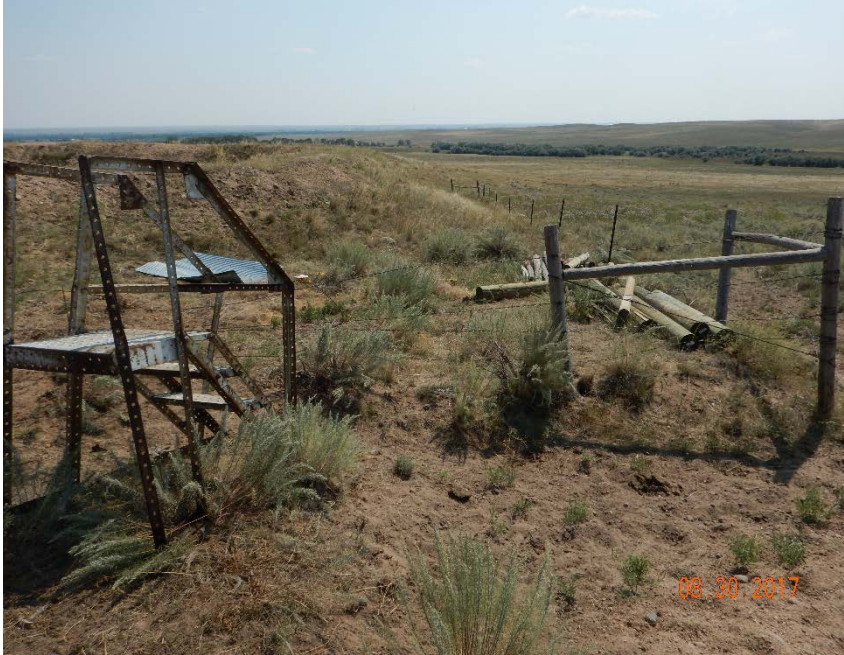
Photo #9 – Junk fence posts and barbed wire at NW corner of pit complex.

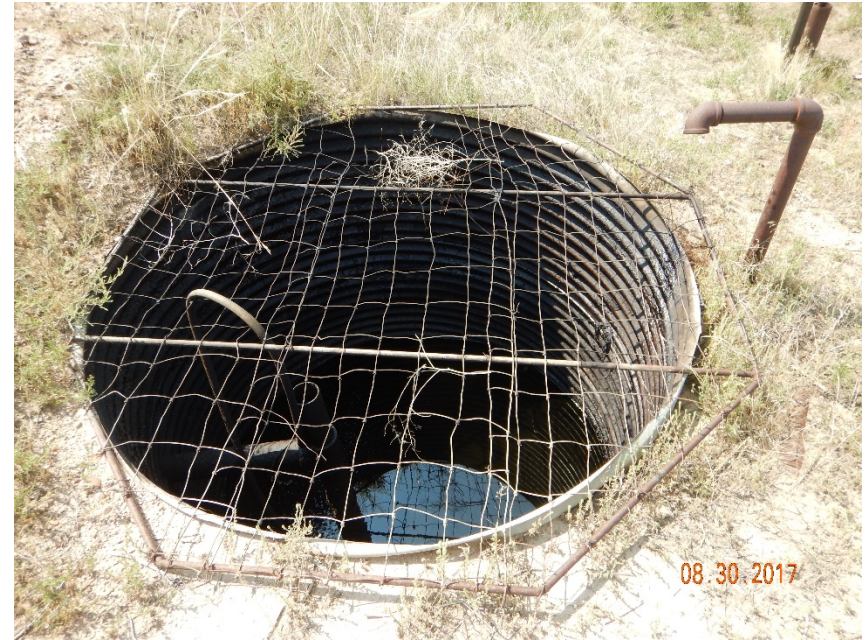
Photo #10 – Tinhorn skim pit with fluid remaining. Note: flowline risers in and outside of pit and damaged mesh (toward top of photo).

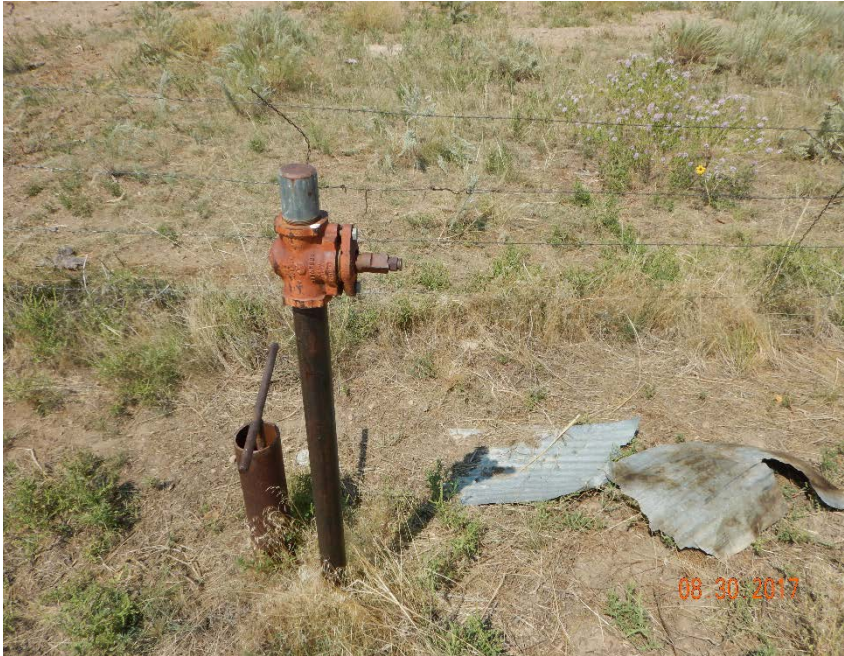
Photo #11 – Abandoned 2" flowline riser and 4" riser for valve control located NW of tinhorn.

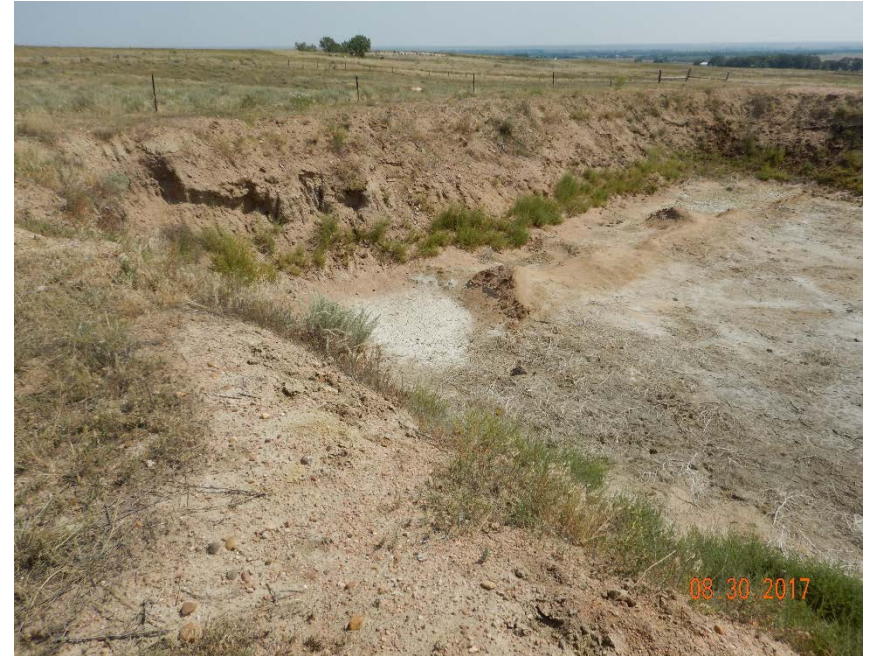
Photo #12 – View of produced water pit, Facility ID #110650, from tinhorn (looking SE).

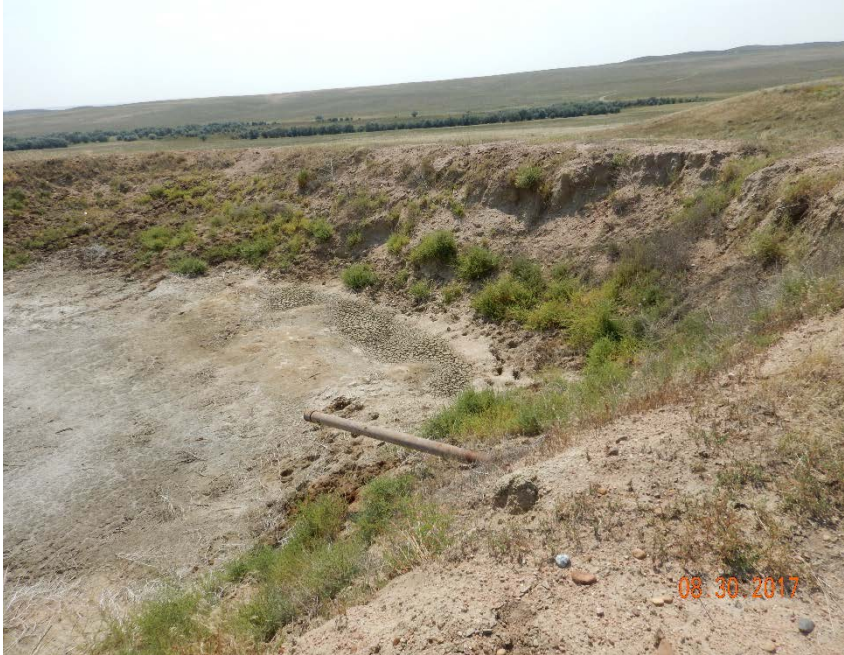
Photo #13 – View of produced water pit from tinhorn (looking SW). Note: localized, oil-stained waste underlying inlet from tinhorn.

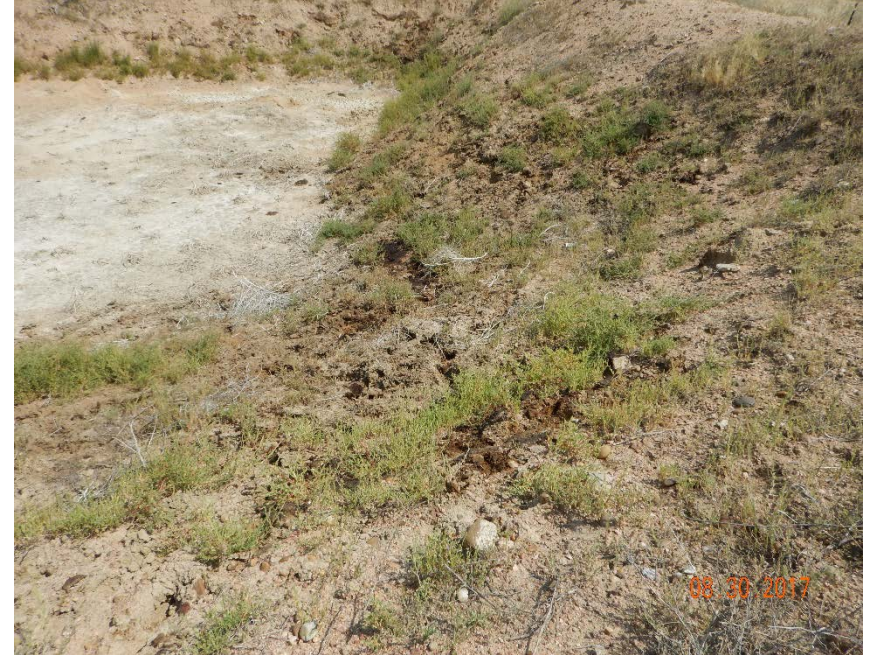
Photo #14 – Oil-stained soil at NW corner of pit.

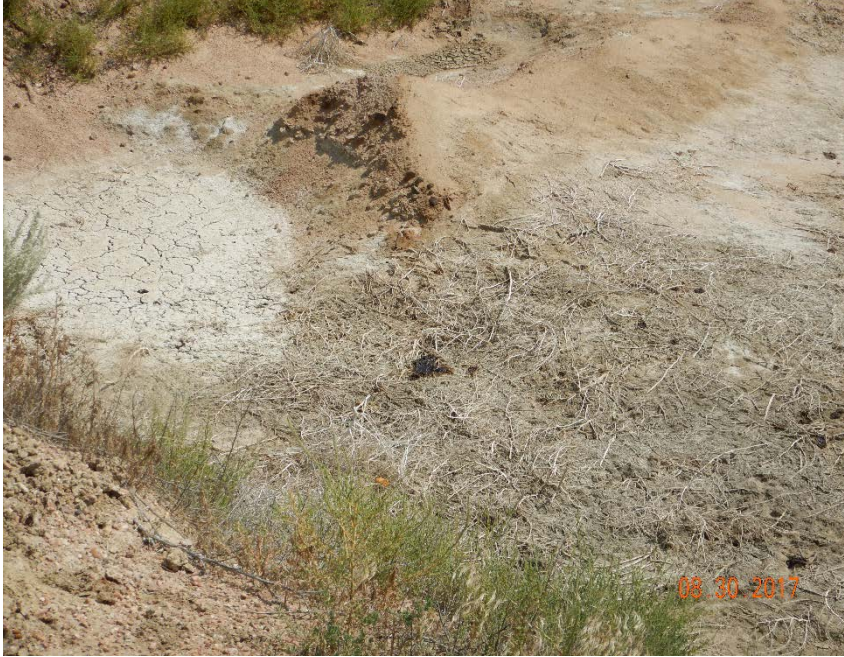
Photo #15 – Oil-stained soil at NE corner of produced water pit.

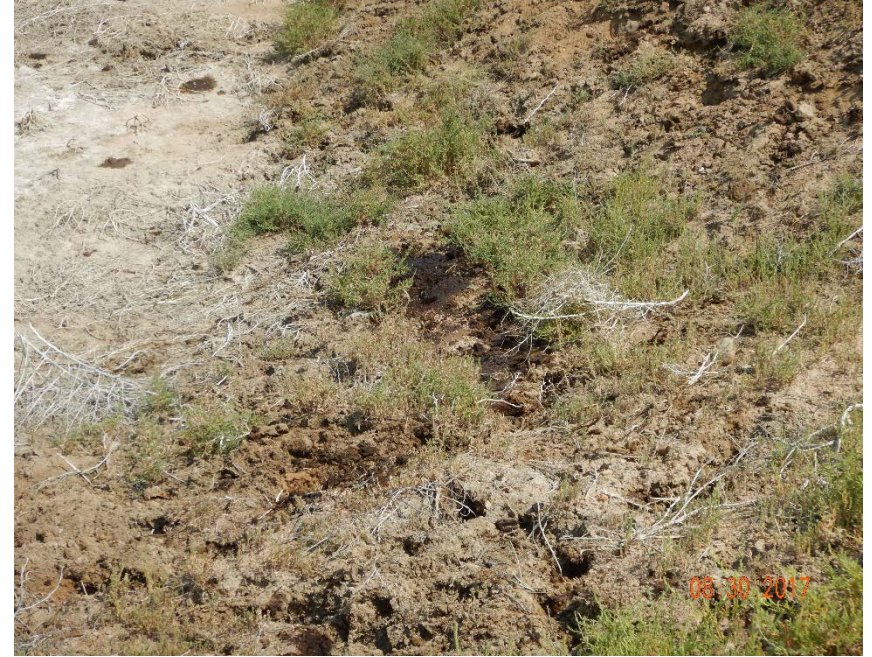
Photo #16 – Oil-stained soil at SW corner of produced water pit.

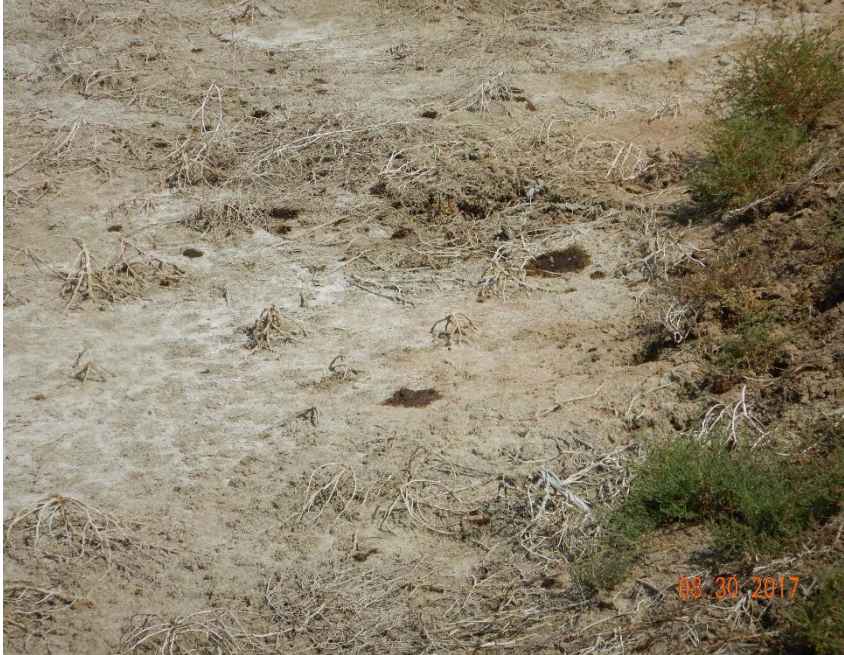
Photo #17 – Localized, oil-stained soil along south side of pit.

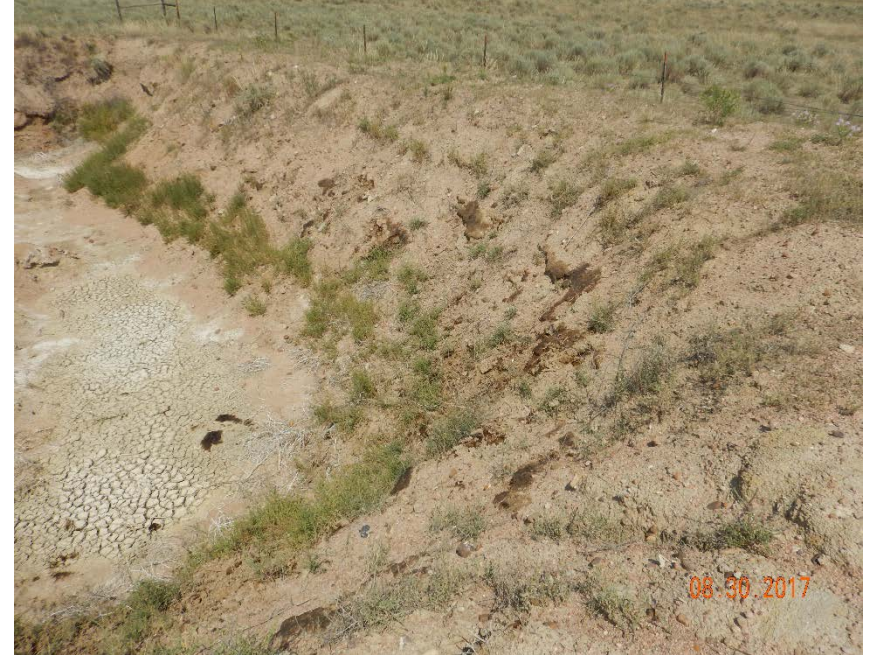
Photo #18 – Localized, oil-stained soil at SE corner of pit.

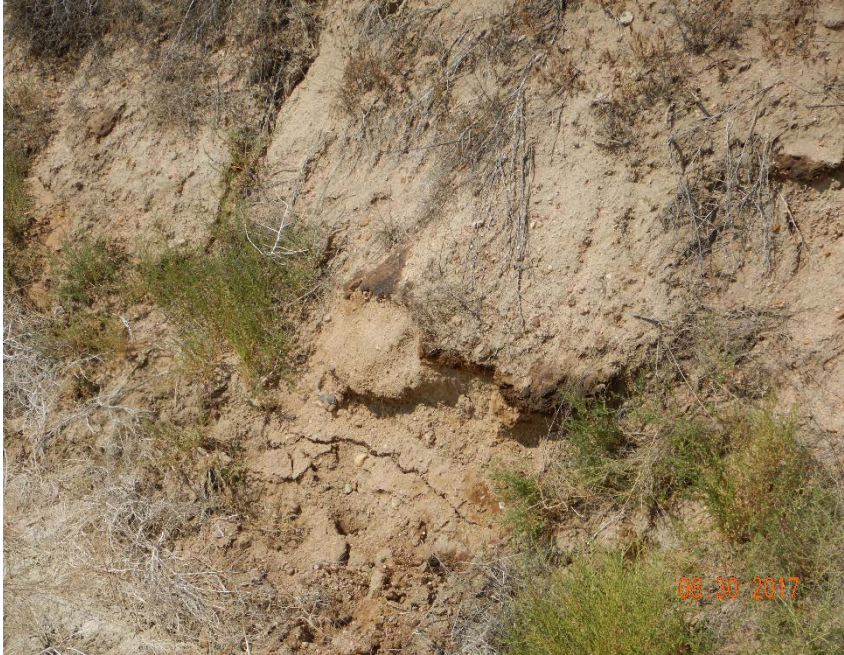
Photo #19 – Localized, oil-stained soil at NE corner of pit.

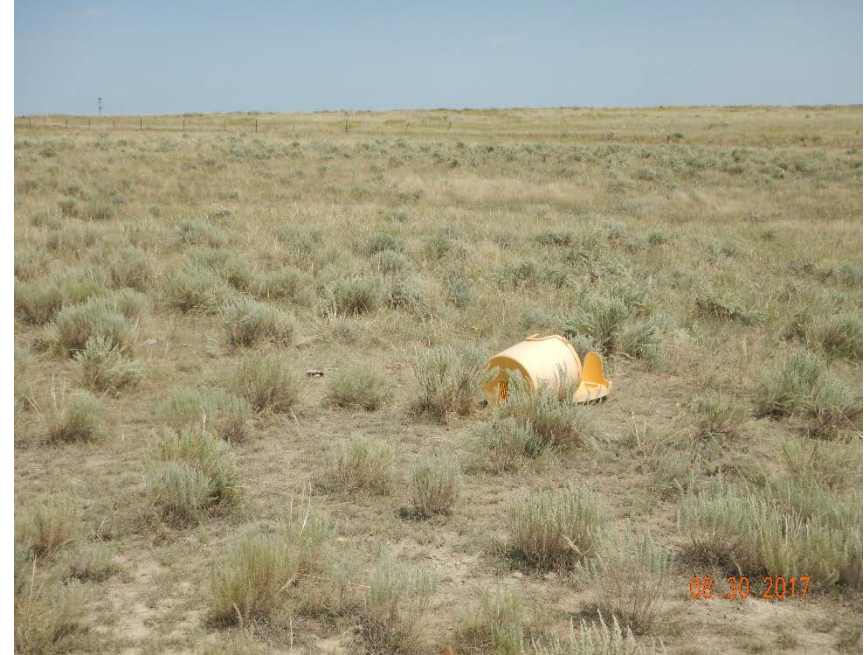
Photo #20 – Unused truck loadout containment device east of pit complex.
