Construction and Stormwater Inspection

September 6, 2017

Operator: SRC ENERGY INC- #10311

Location ID: 451277

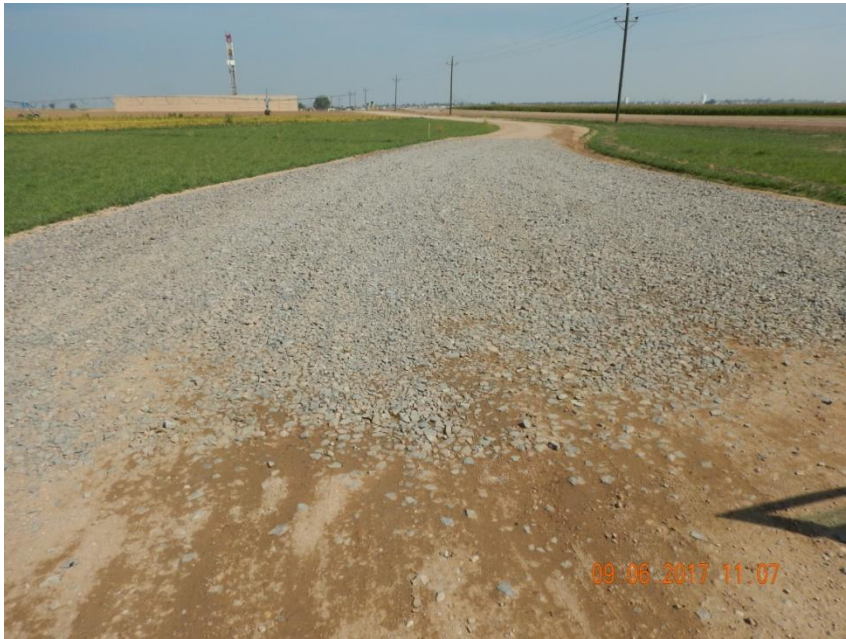
Photo 1. Photo taken from the entrance of the well pad location, facing North. Tracking pad device installed at location.

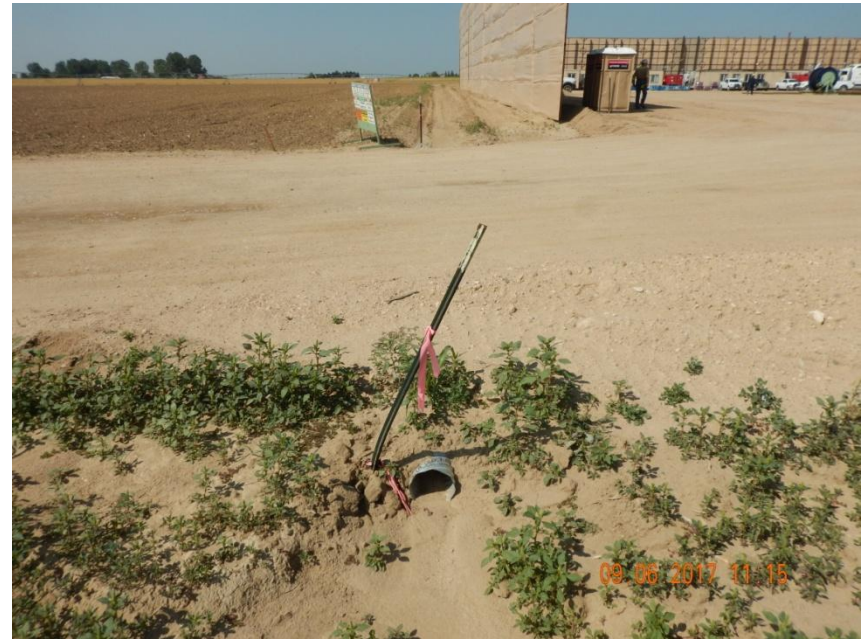
Photo 2. Photo taken from the southeast well pad location, facing West. Ditch and berm BMP installed around the perimeter of the well pad location.

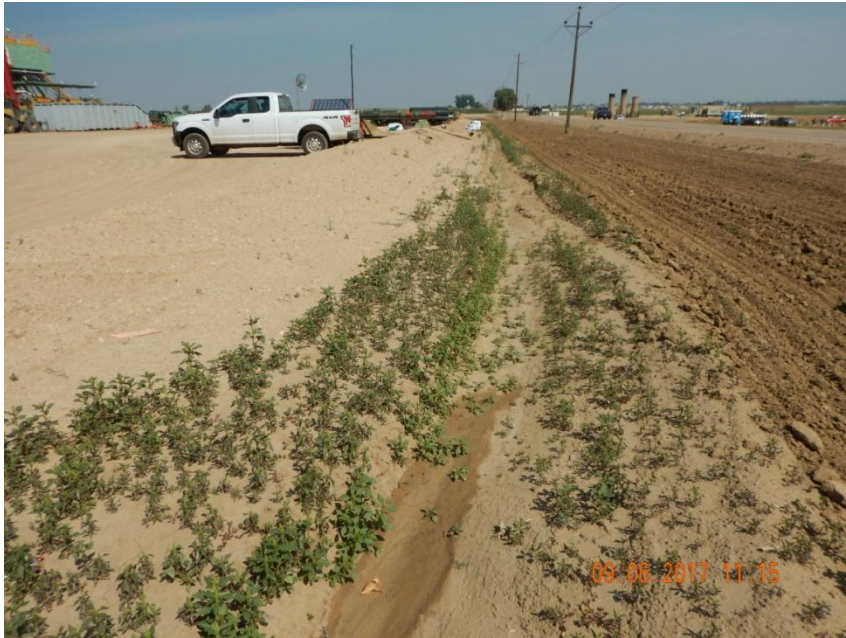
Photo 3. Photo taken from the southeast well pad location, facing North. Ditch and berm BMP installed around the perimeter of the well pad location.

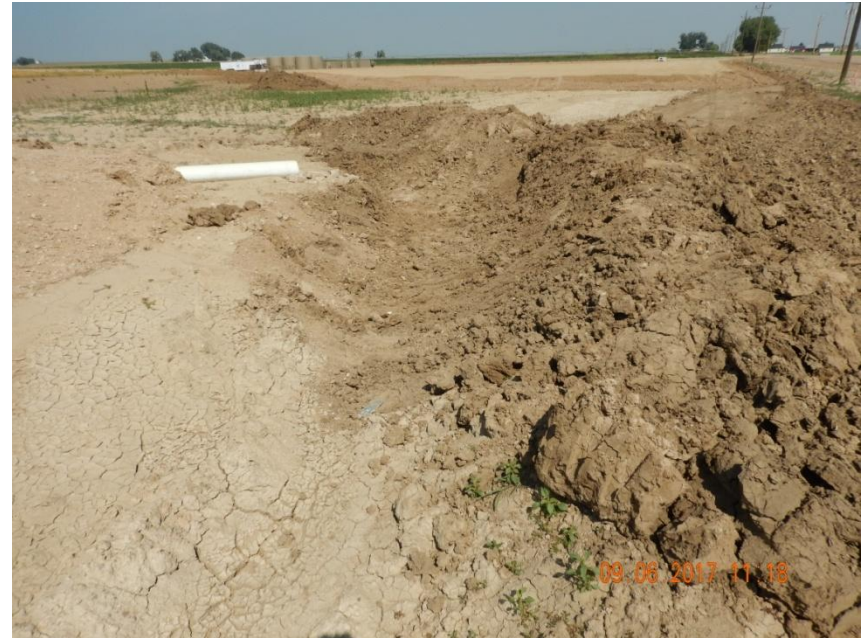
Photo 4. Photo taken from the northeast well pad location, facing North. Sediment trap embankment berms have not been compacted and still needs a stabilized outlet structure.

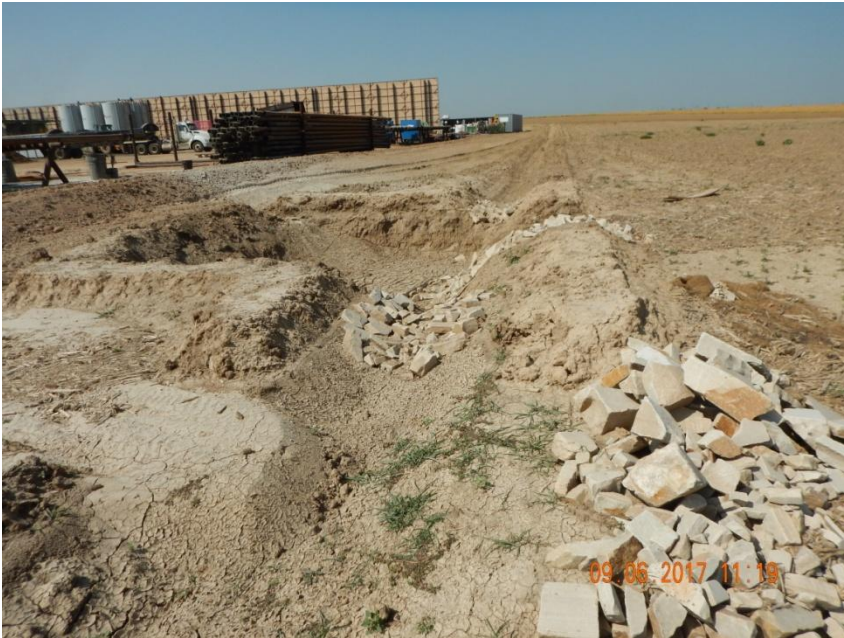
Photo 5. Photo taken from the northeast well pad location, facing West. Sediment trap installed with a stabilized outlet structure.

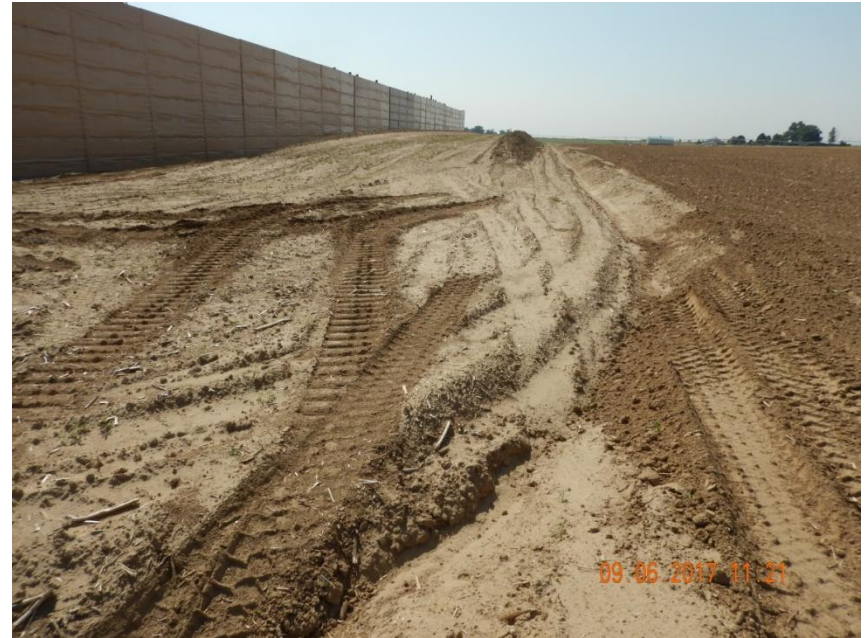
Photo 6. Photo taken from the northwest well pad location, facing South. Ditch and berm BMP installed around the perimeter of the well pad location. Also, photo illustrates topsoil stockpile stored along the west perimeter of the location.

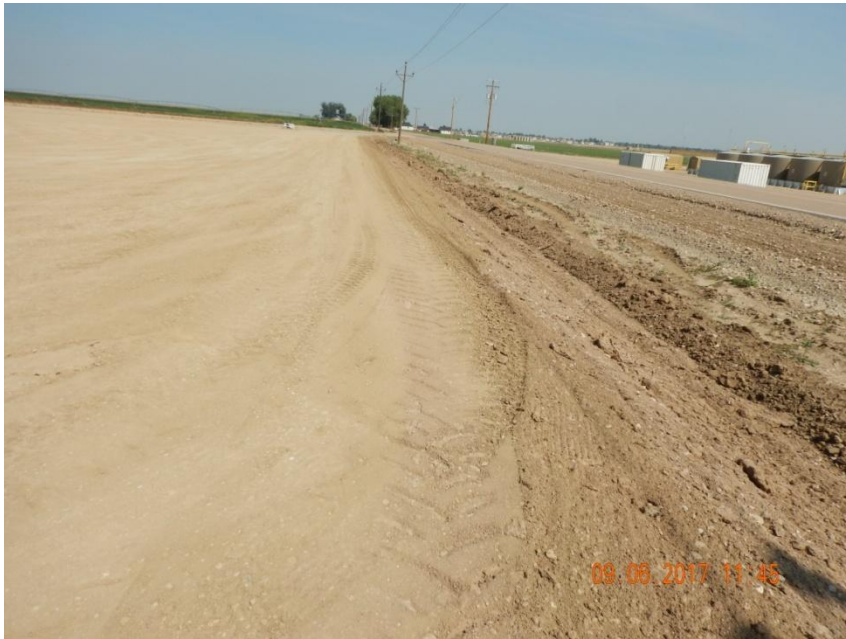
Photo 7. Photo taken from the southeast production facility, facing North. Only an unconsolidated berm along the eastern perimeter of the location.

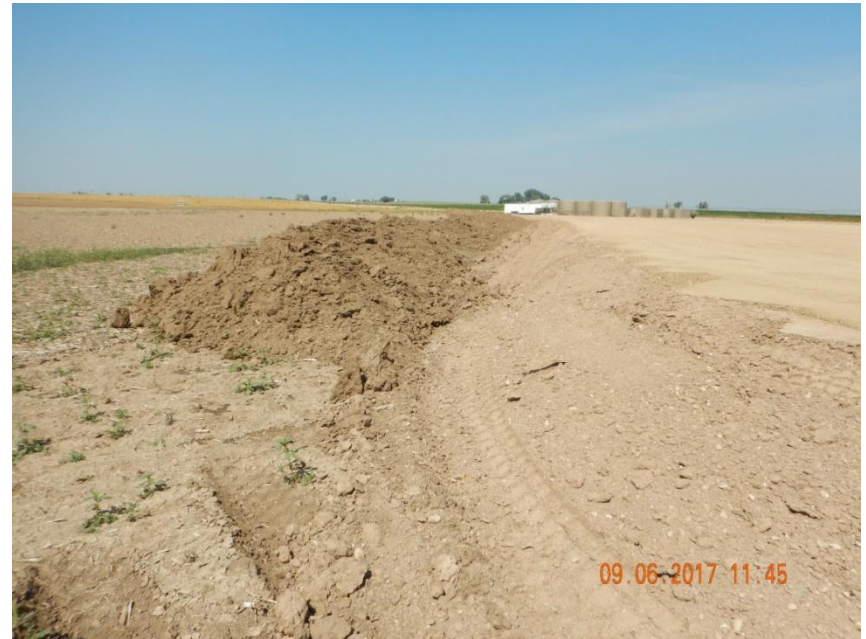
Photo 8. Photo taken from the southern production facility, facing Northwest. No observed BMP. Topsoil material still needs to be stored.

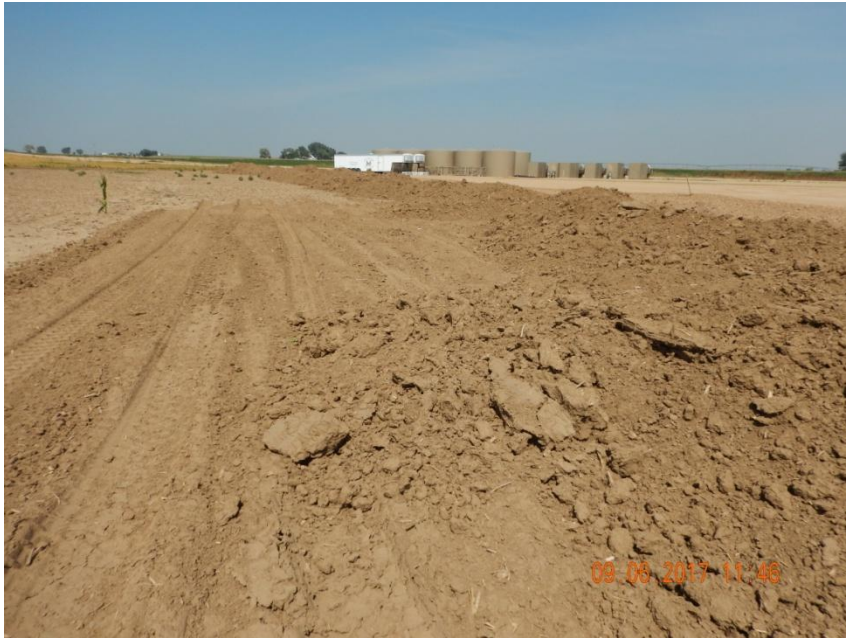
Photo 9. Photo taken from the western production facility, facing Northwest. No observed BMP. Topsoil material still needs to be stored.

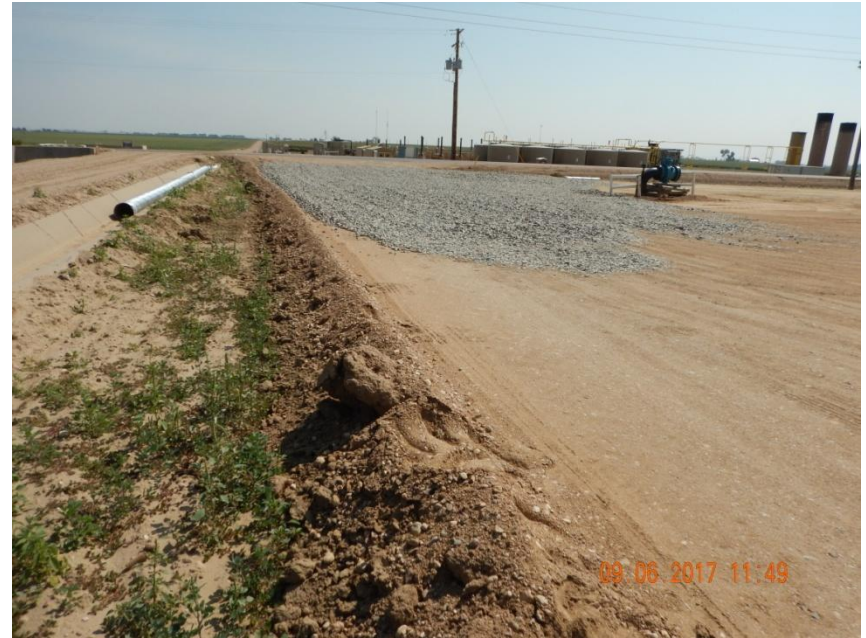
Photo 10. Photo taken from the entrance of the production facility, facing East. Tracking pad device installed at location. Unconsolidated berm observed along portions of the northern production facility.
