Inspection Photos
Location Name: Parr-State #28-1
API: 05-005-06431
Inspection Date: September 7, 2017

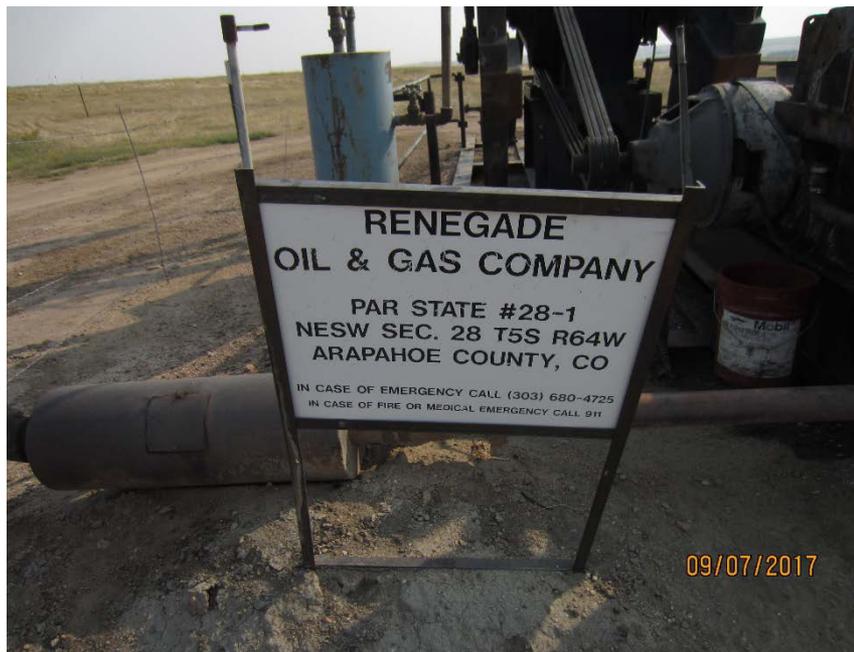
Photo #1 – Well sign.

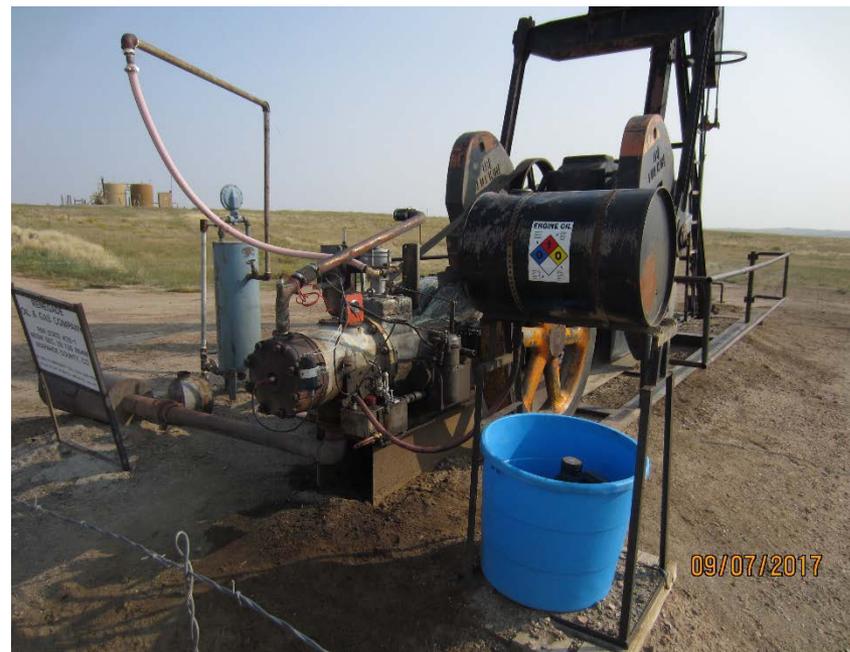
Photo #2 – Localized, stained soil beneath day tank and prime mover.

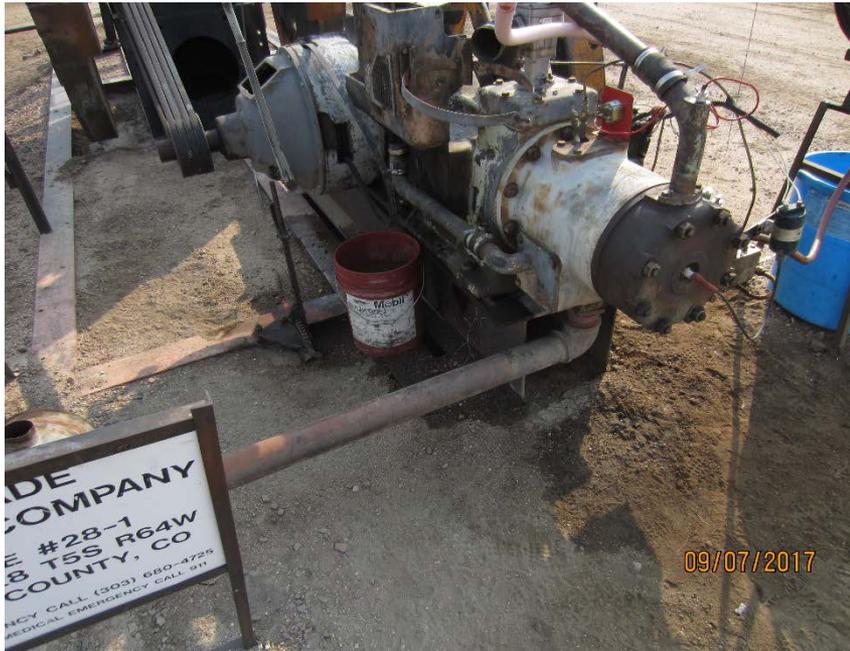
Photo #3 – Localized, oil-stained soil beneath prime mover.

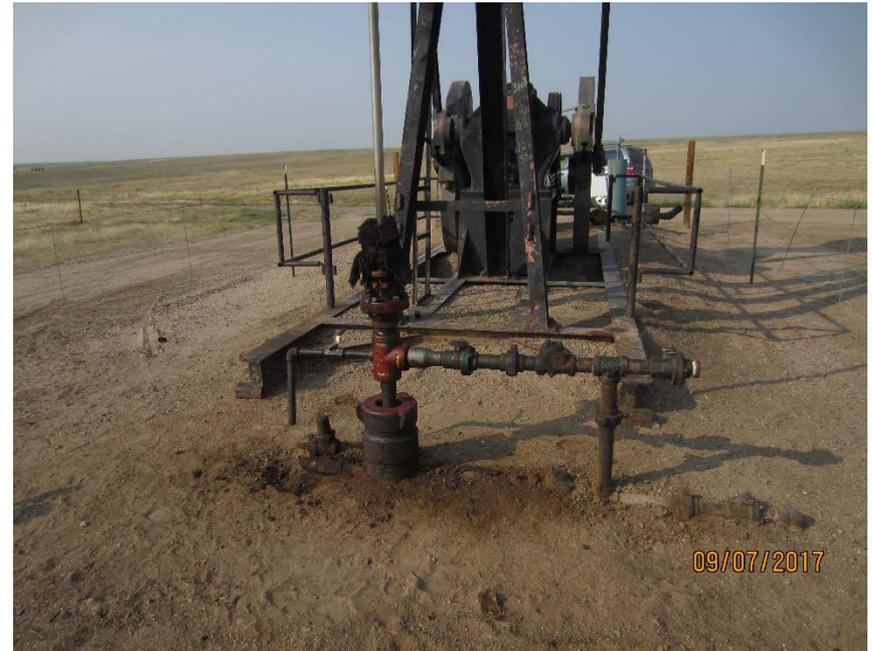
Photo #4 – Localized, oil-stained soil at wellhead. Note oily rag tied above stuffing box.

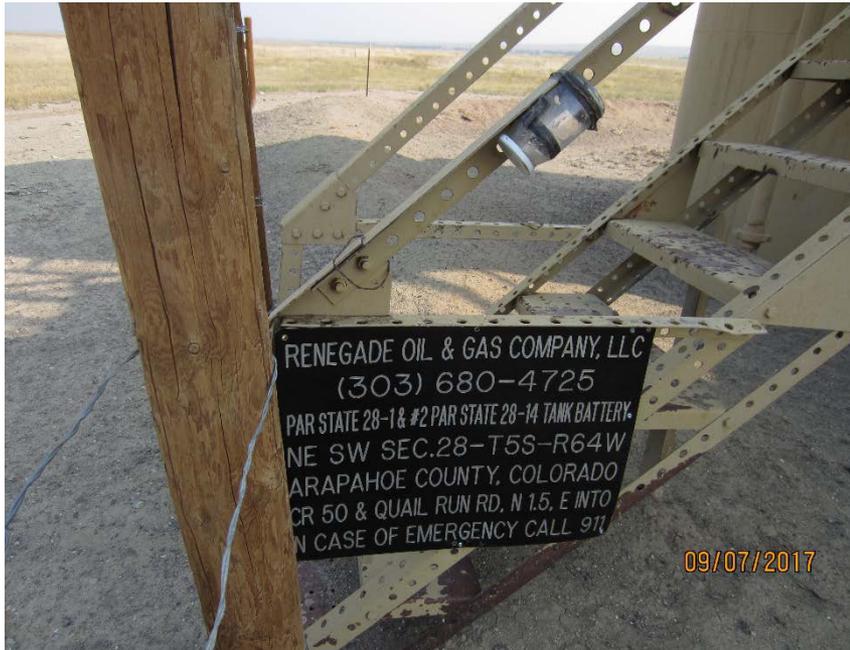
Photo #5 – Battery sign.

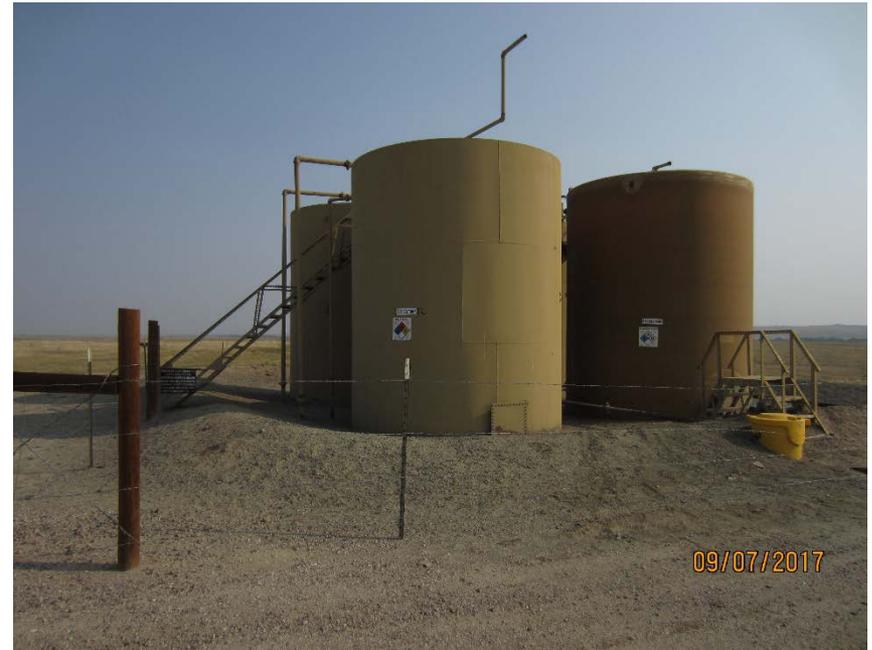
Photo #6 – Tank battery (view from SW corner).

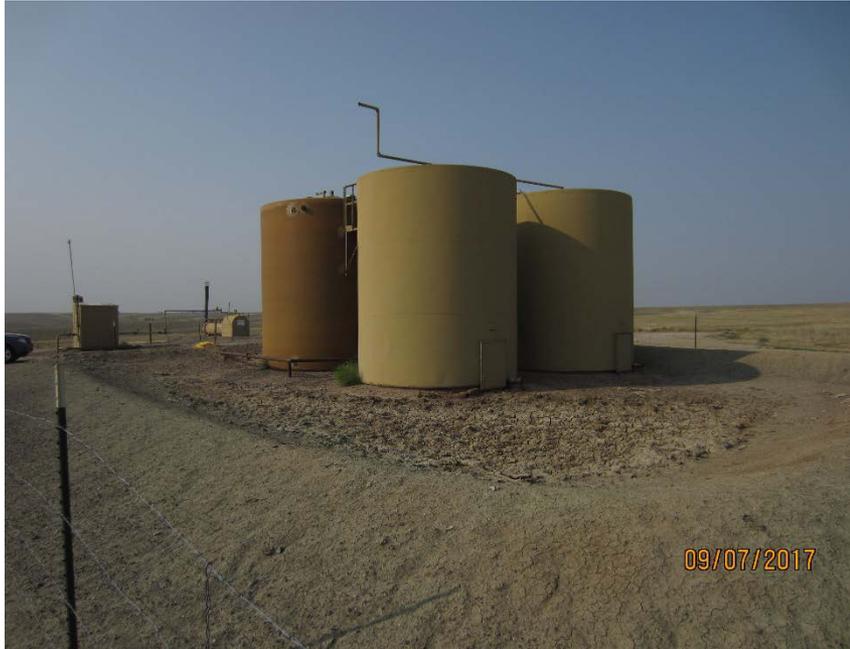
Photo #7 – View of tank battery from NE corner. Note that berm is shallow due to erosion.

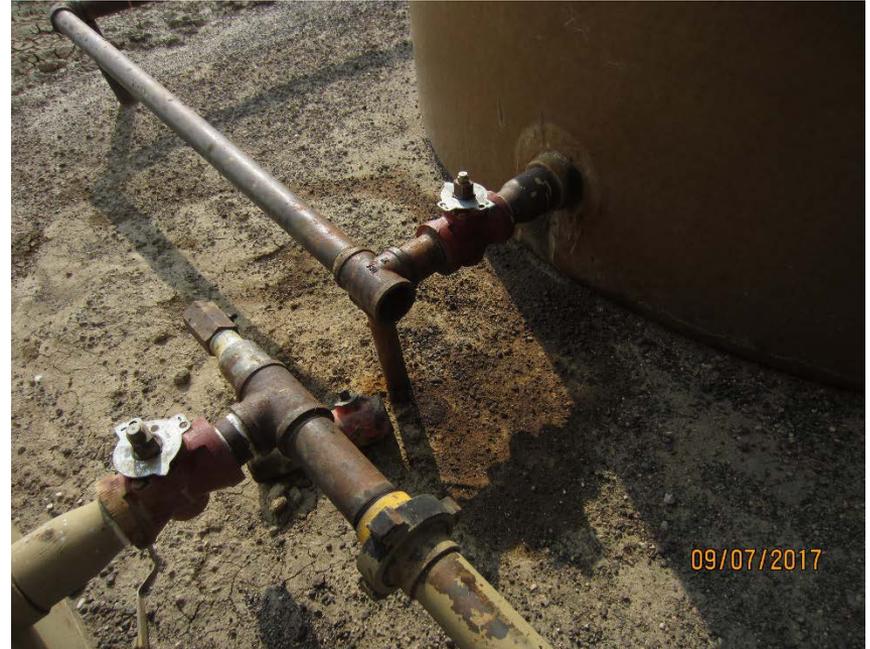
Photo #8 – Localized, oil-stained soil beneath valve on north side of produced water AST. Note uncapped pipe in center of photo.

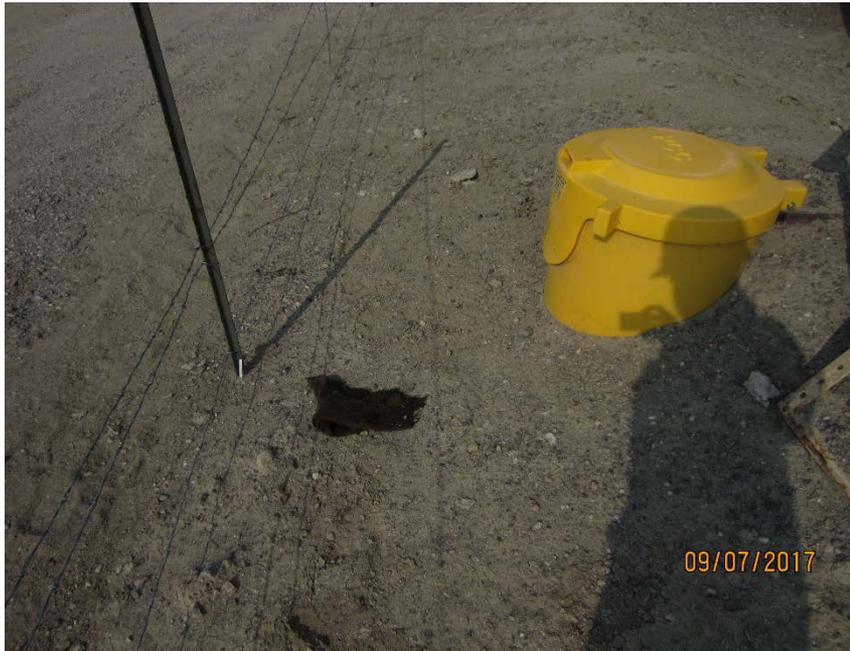
Photo #9 – Oily rag near truck loadout.

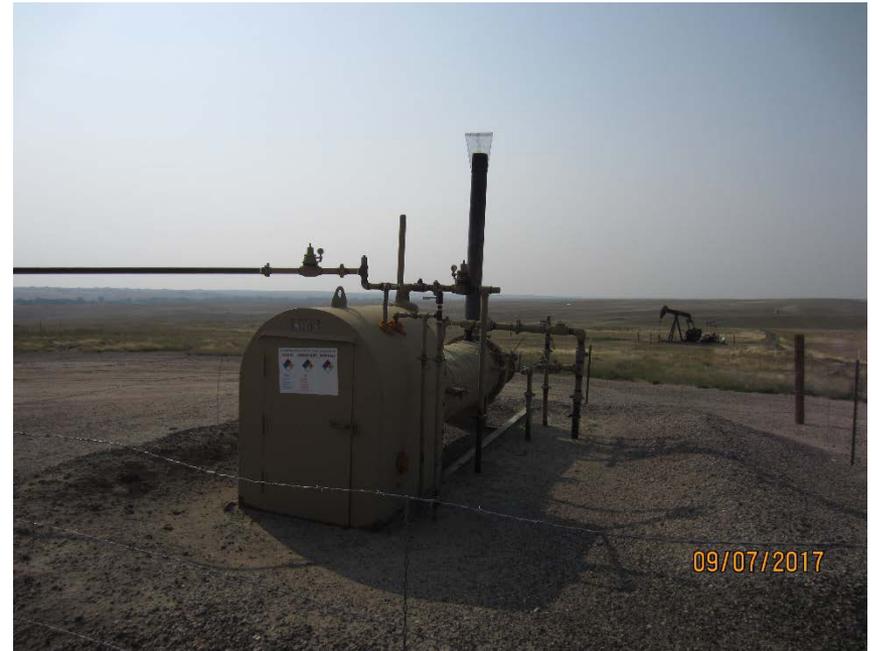
Photo #10 – Heated horizontal separator with barbed wire fence and bird protection.

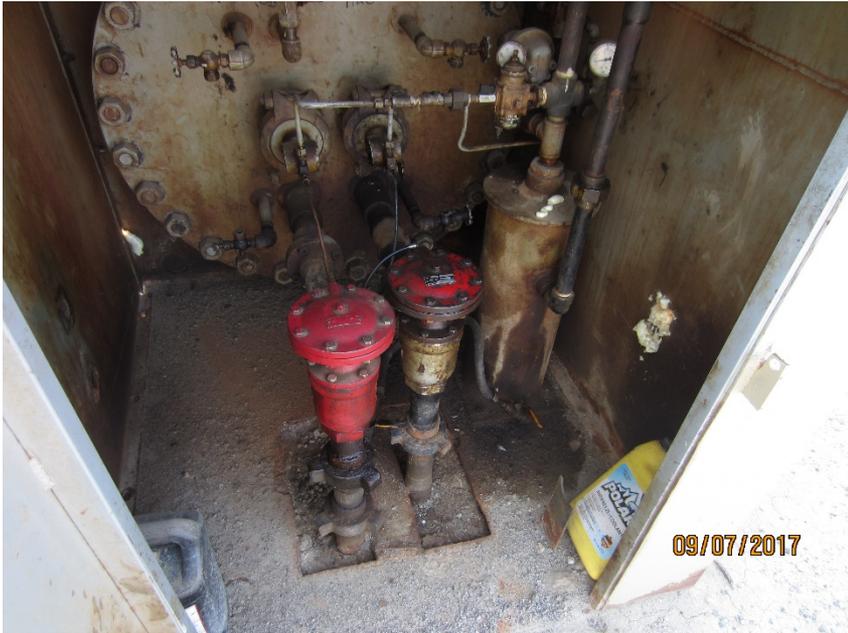
Photo #11 – Localized, oil-stained soil and equipment on north side of separator.

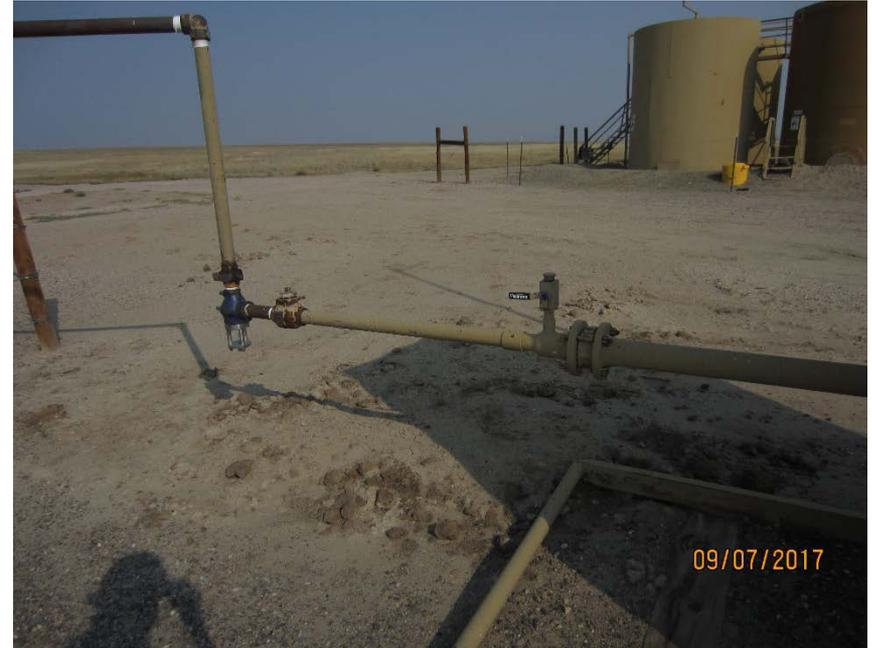
Photo #12 – Flowlines referenced in 6/22/2017 FIR have been removed in accordance with corrective actions.
