# Construction and Stormwater Inspection

September 7, 2017

Operator: BURLINGTON RESOURCES OIL & GAS LP- #26580

Location ID: 439225

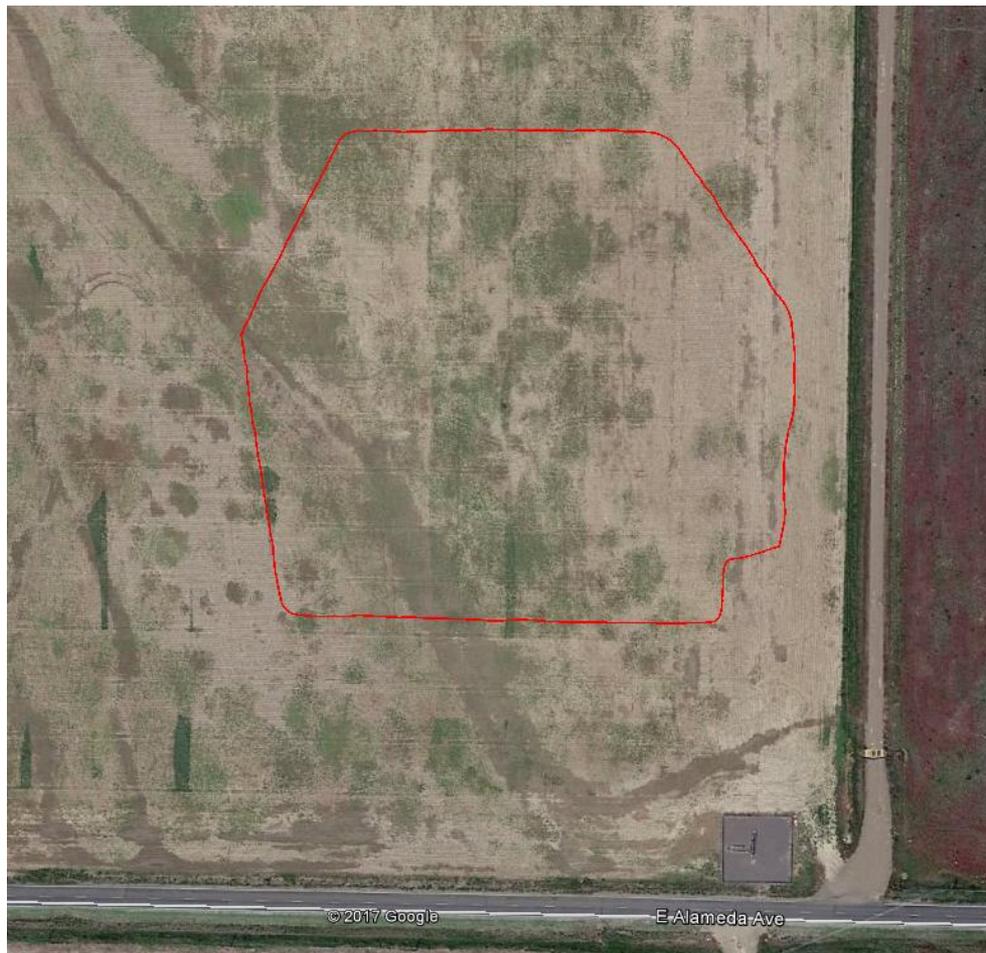
Google Earth imagery taken on June 14, 2016 illustrating the location that was mapped on September 7, 2017 using a Trimble Juno 3B handheld device. GPS data would indicate construction disturbance was exceeded by approximately 2.41 acres (55% overbuilt), totaling 6.76 acres.

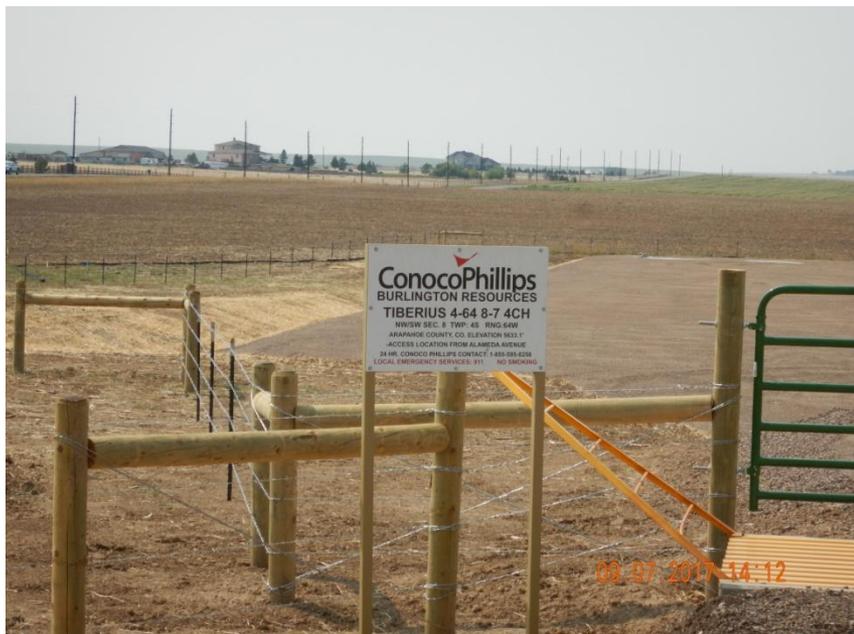
**Photo 1.** Well sign taken at the entrance of location, facing West.

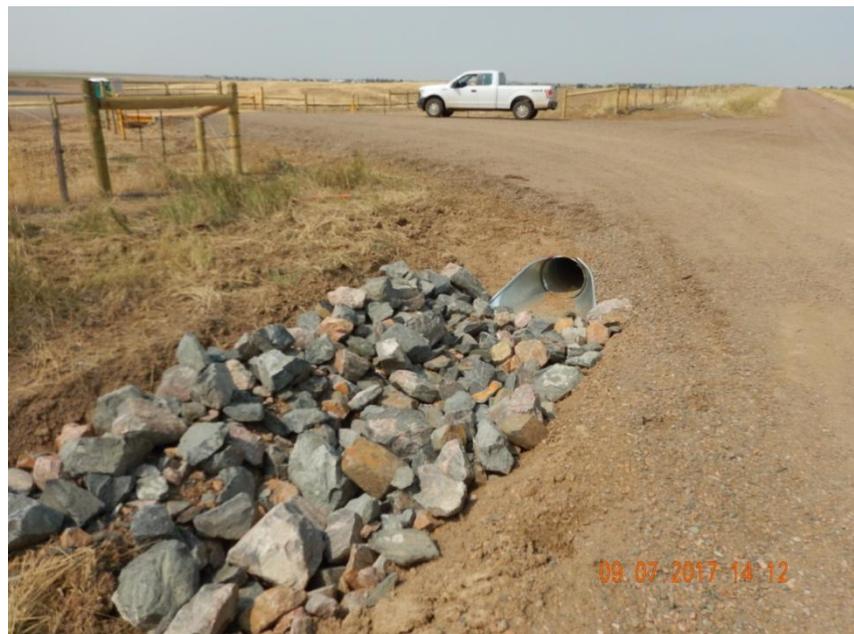
**Photo 2.** Photo taken from the entrance of location, facing North. A culvert installed at the entrance with a stabilized inlet and outlet area.

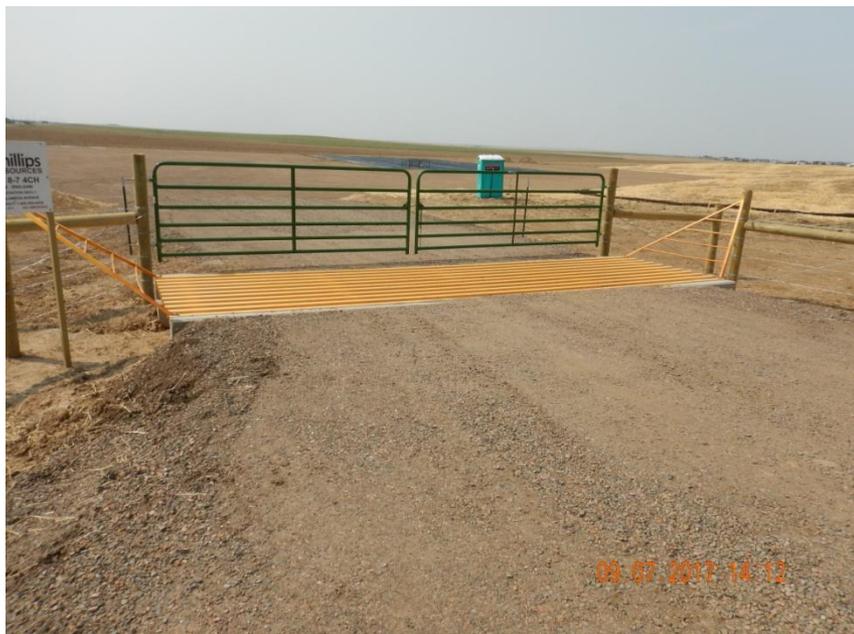
**Photo 3.** Photo taken from the entrance of location, facing West. Cattle guard installed at the entrance of location.

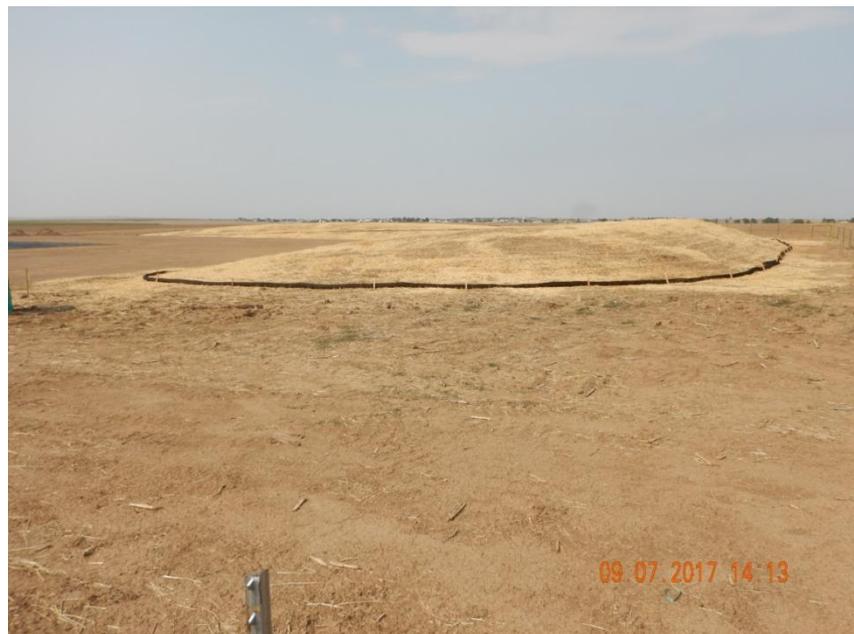
**Photo 4.** Photo taken from the eastern location, facing North. Appears topsoil has been salvaged and stored along the eastern and northern well pad perimeters. Topsoil has been mulched with a filter wattle installed around the toe of slope.

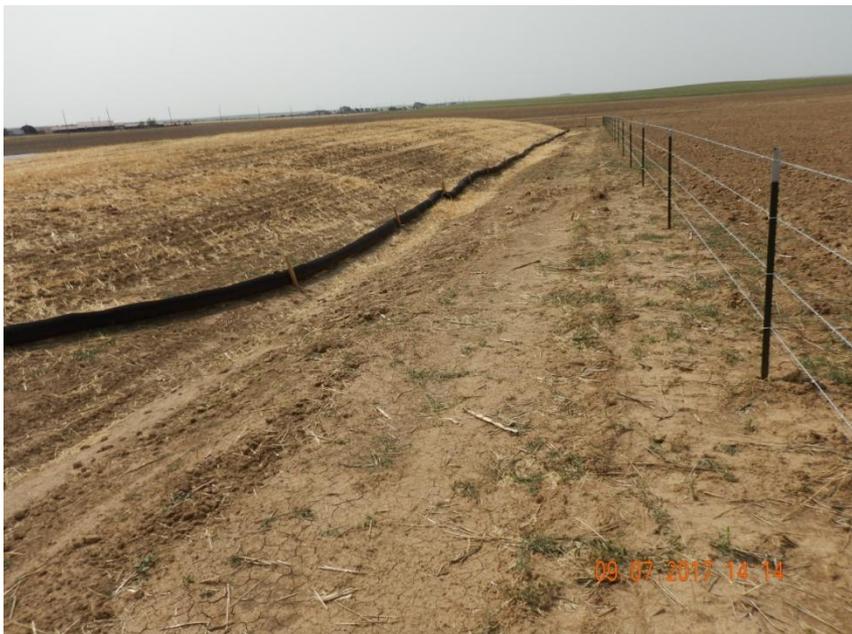
**Photo 5.** Photo taken from the northern location, facing West. Ditch BMP has been installed around well pad perimeter and portions of the outer perimeter.

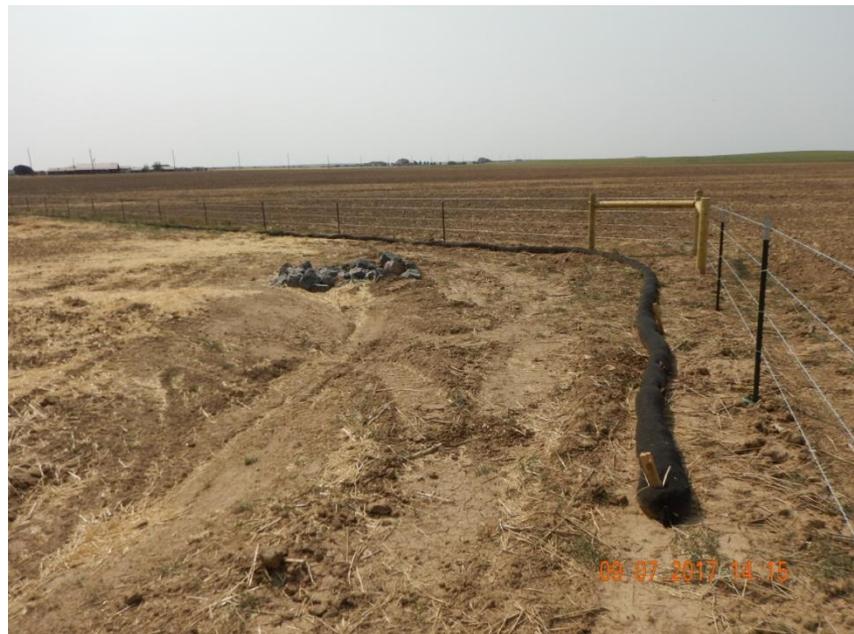
**Photo 6.** Photo taken from the northwest location, facing West. Ditch BMP that installed around the northern topsoil stockpile ends at a stabilized area made of rip-rap. Filtrexx BMPs have been installed along the northwestern, western, and southern location perimeters.

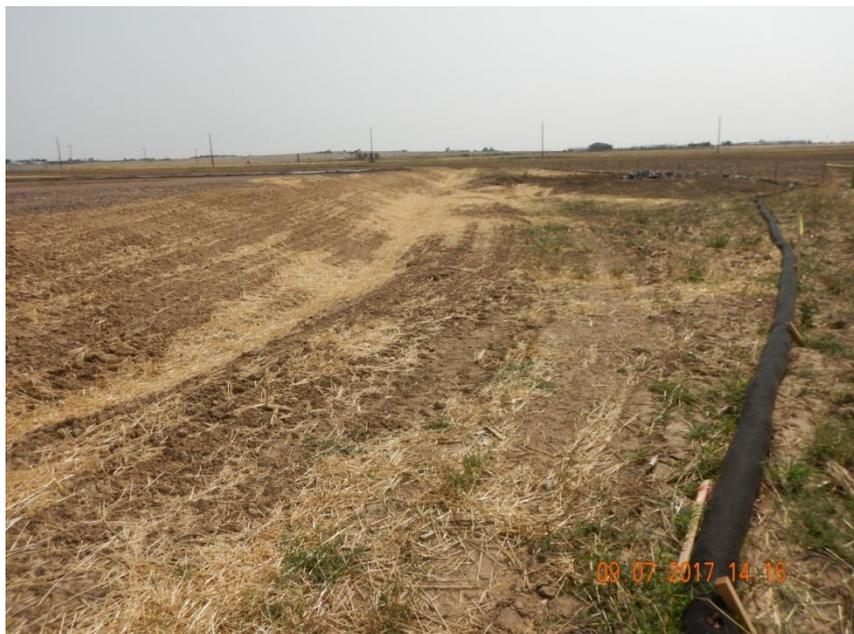
**Photo 7.** Photo taken from the northwest location, facing South. Ditch BMP installed around the well pad perimeter is directed to the western sediment trap- see photo 9.

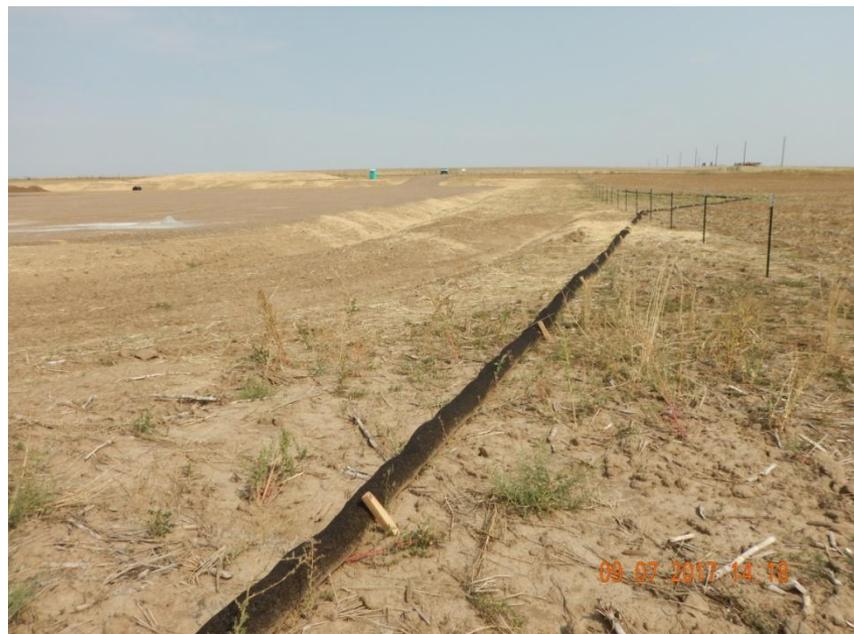
**Photo 8.** Photo taken from the southwest location, facing East. Ditch BMP has been installed around well pad perimeter and portions of the outer perimeter, in addition to filtrex BMP outside of the ditch BMP. A small portion along the southern perimeter outside of the fenced area was not mapped but appeared to be oil and gas disturbances. Ditch and filtrex BMP observed outside the fenced area.

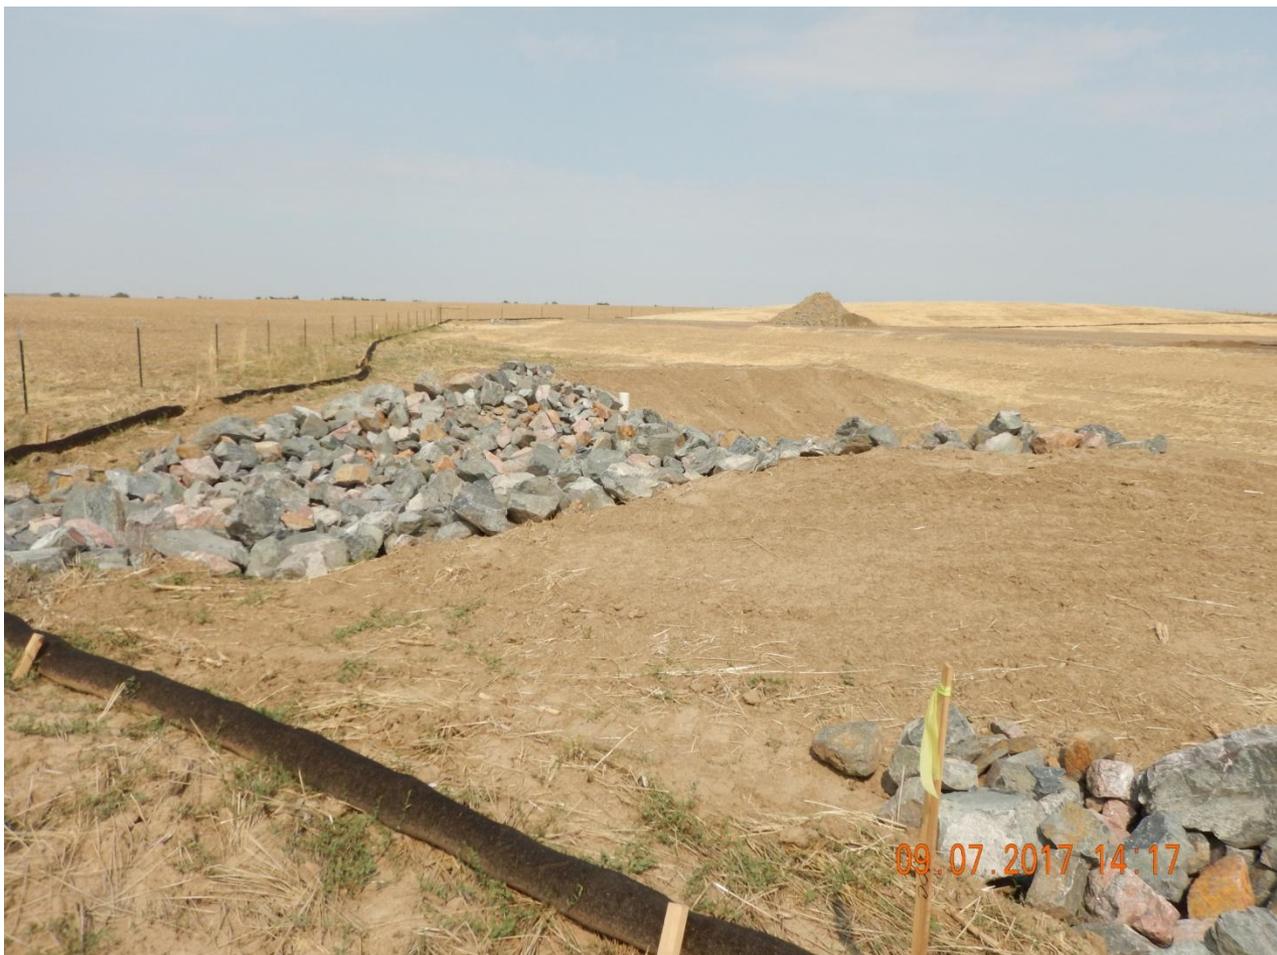
**Photo 9.** Photo taken from the western sediment trap, facing North. Sediment trap has been installed with a stabilized outlet, in addition to filtrex BMP along the outer perimeter.
