Inspection Photos
Location Name: Texaco Fee 6214
Location ID: 323831

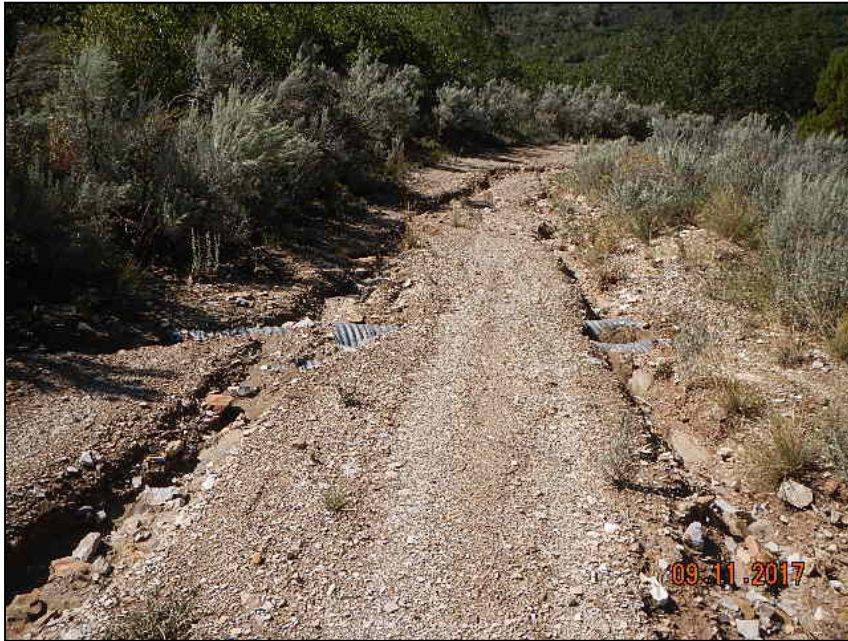
Photo 1. Access road is heavily eroded.

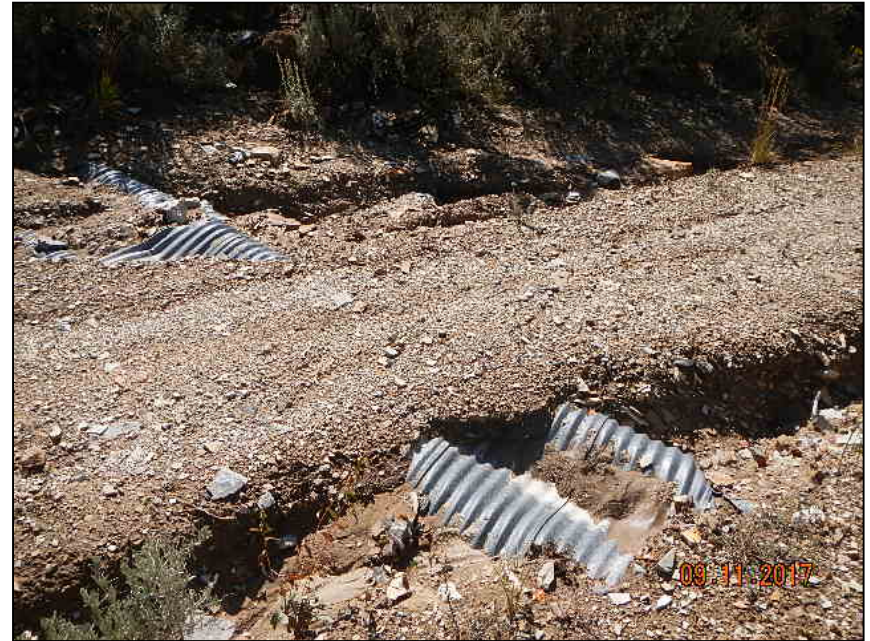
Photo 2. Culvert is damaged and non-functional.
