Construction and Stormwater Inspection

September 8, 2017

Operator: CRESCENT POINT ENERGY U.S. CORP - #10520

Inspection Photos
Location Name: Anderson Facility
Location ID: 447898

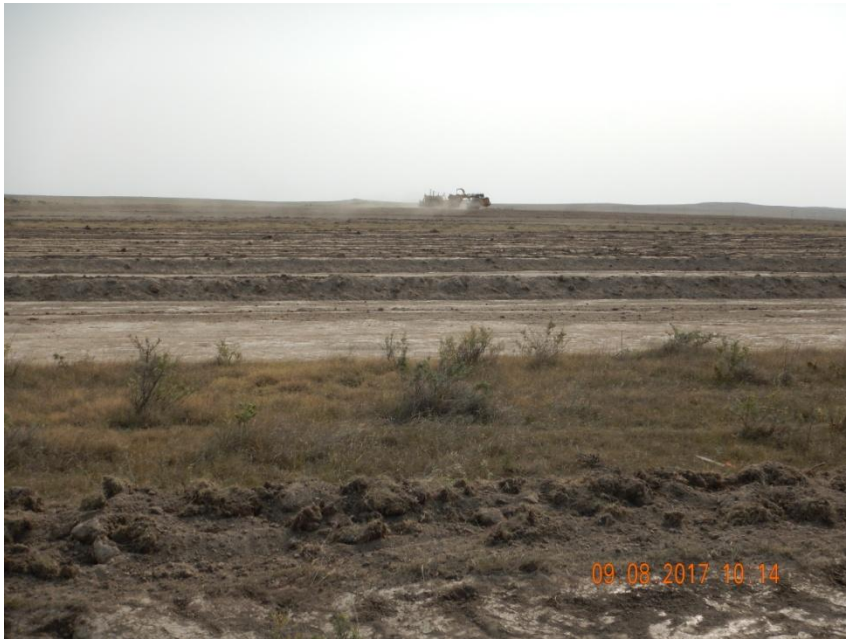
Photo 1. Photo taken from the western location, facing East. Topsoil salvage operations IN-PROCESS. Temporary BMP (i.e., ditch) installed around in the entire perimeter of the location.

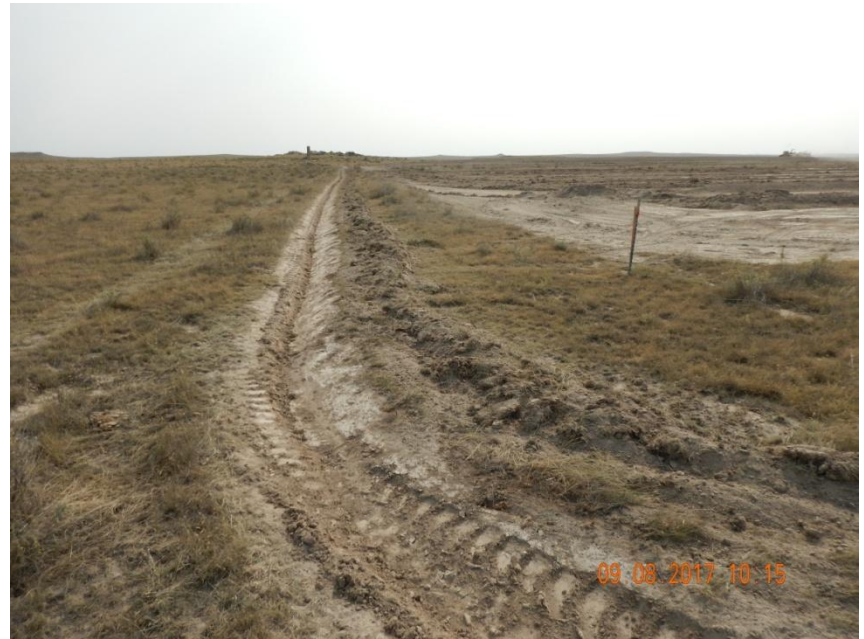
Photo 2. Photo taken from the northwest location, facing East. Topsoil salvage operations IN-PROCESS. Temporary BMP (i.e., ditch) installed around in the entire perimeter of the location.

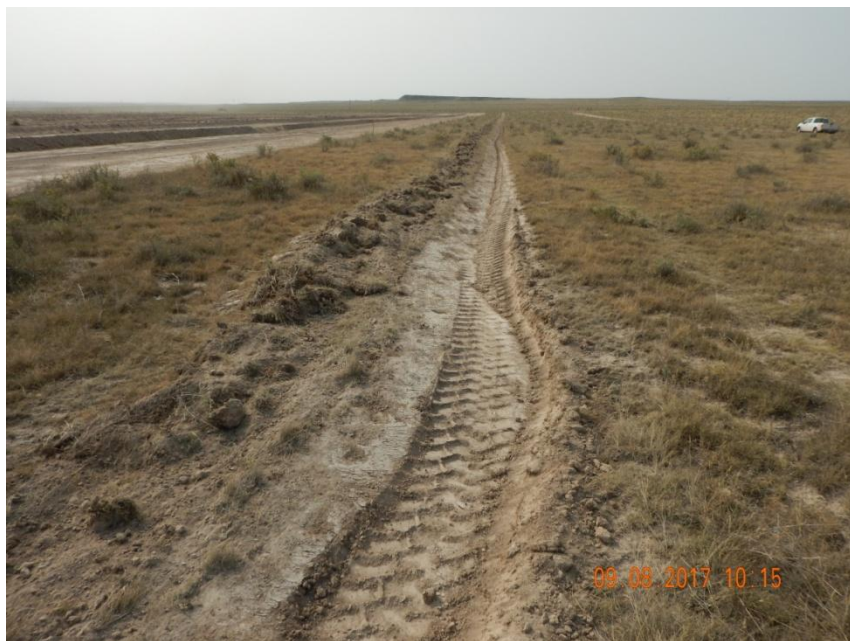
Photo 3. Photo taken from the northwest location, facing South. Topsoil salvage operations IN-PROCESS. Temporary BMP (i.e., ditch) installed around in the entire perimeter of the location.

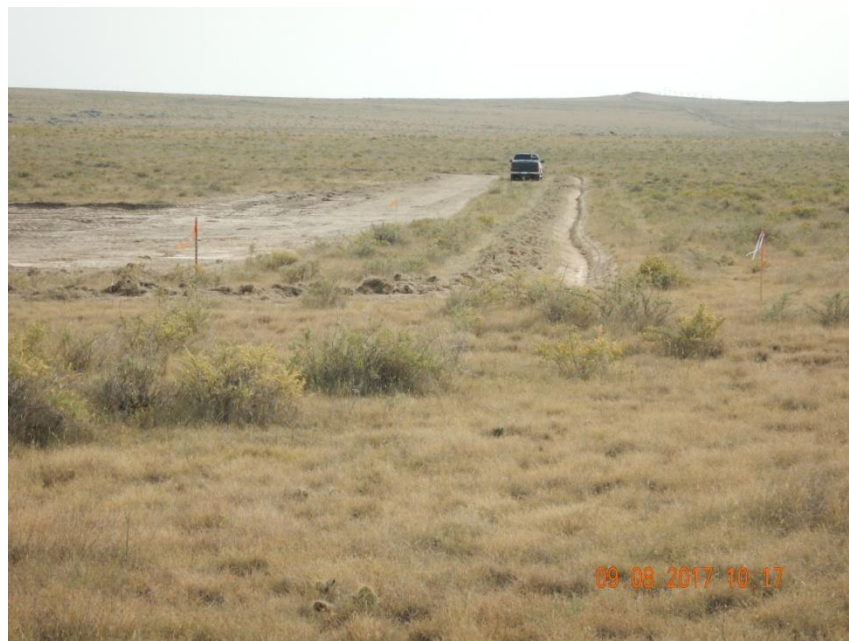
Photo 4. Photo taken from the Southwest location, facing East. Topsoil salvage operations IN-PROCESS. Temporary BMP (i.e., ditch) installed around in the entire perimeter of the location.
